GW - 045

**Re: Inspection Report, GW-045
Kutz Gas Plant, Williams Four Corners
San Juan County, New Mexico**

OCD Inspection: Williams Four Corners, Kutz Gas Plant, GW - 045

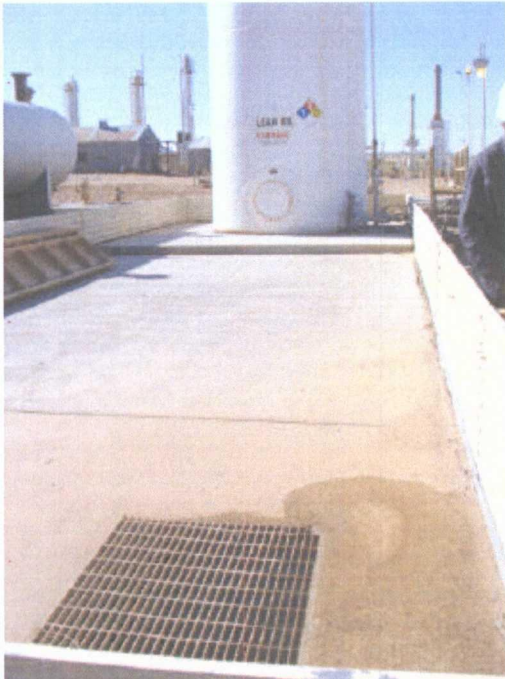
1. **Photos 1 & 14:** Sumps appear to have fluids in them. The permit conditions require that fluids in small sumps be removed within 72 hours. It is not known that these fluids have been present greater than 72 hours; this is just a reminder that fluids shall be removed within the prescribe time referenced in the permit conditions. Williams Four Corners shall inform the Kutz personnel of this condition.

Photo 1: Sump contained fluids.

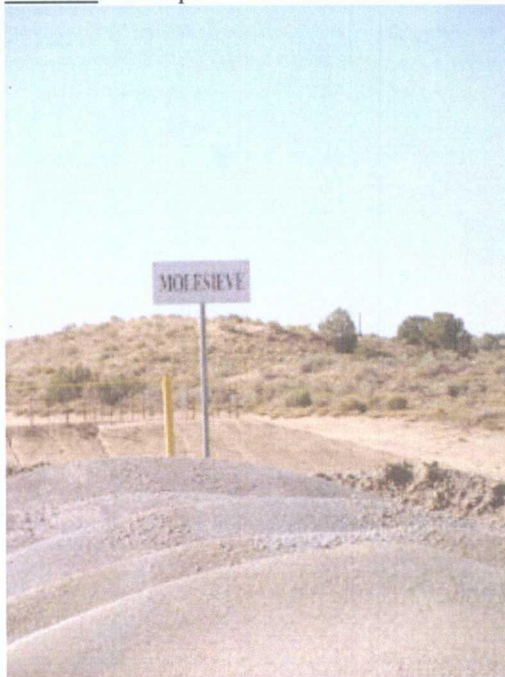
2. **Photos 2 & 3:** Used activated carbon and molecular sieves placed within earthen bermed cells. Used filter waste should not be placed directly on the ground. Williams Four Corners shall reconfigure the ir holding area and not have waste placed directly on the ground. Waste is not allowed to accumulate more then 180 days unless approved by the OCD, see Condition Item 6 of permit for details. If waste has been there greater than 180 days, please provide to the OCD this approval. The OCD request testing results and manifest of current waste located in cells.

Photo 2: Used "Molesieve" located in cells on ground.

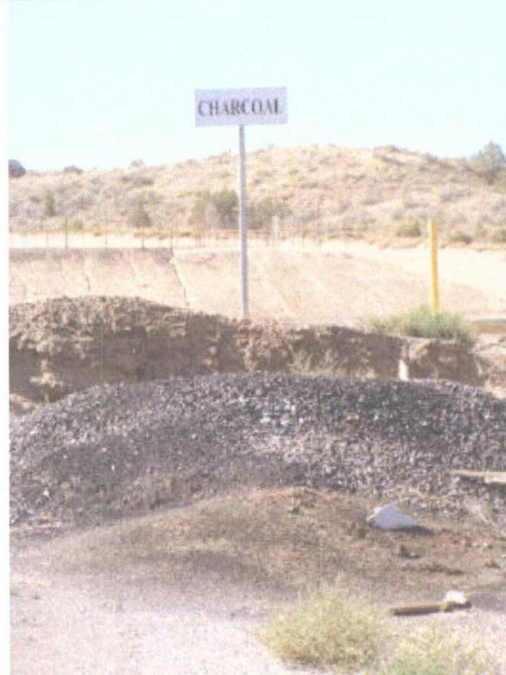
Photo 3: Used charcoal located in cells located on ground.

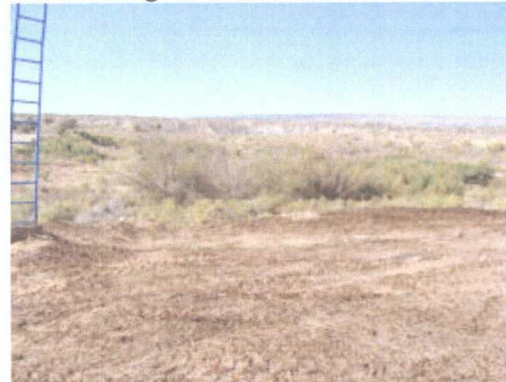
3. **Photos 4 & 5:** Iron sponge is dispersed on the ground. The OCD request; reasons for performing this task; were any ignitability testing completed to the waste sponge; the duration of this practice and any record from the OCD for approval of this activity.

Photo 4: Iron sponge media spread out.

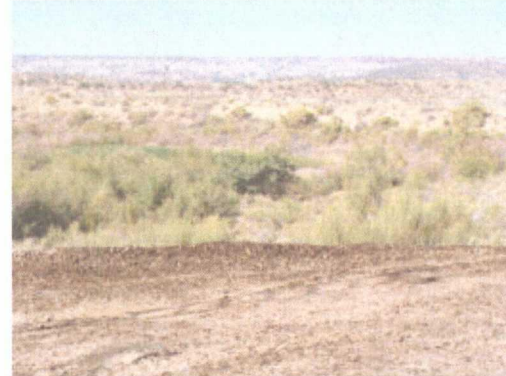
Photo 5: Iron sponge media spread out near a wash.

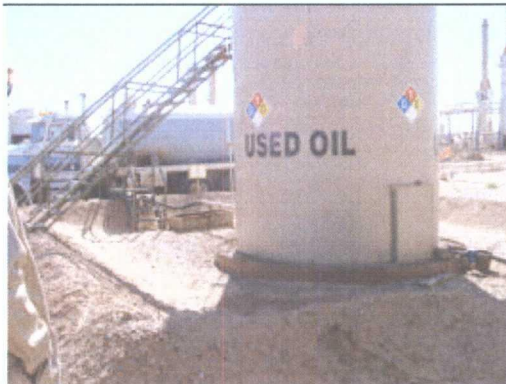
4. **Photo 6:** AST needs to have a liner placed underneath it. Williams Four Corners shall reconfigure AST to conform to the permit requirements before the next permit renewal.

Photo 6: AST with no non permeable barrier.

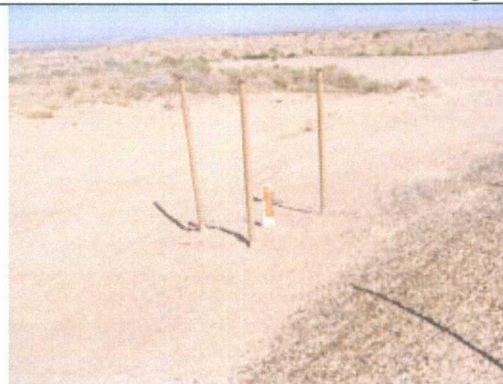
5. **Photo 7-10:** The flare pond located on the southwest site of the facility with leak detection system. Fluids appeared to be in the leak detection system. OCD was informed that the pond previously had a leak in its liner. The OCD is requesting the following: a history of this event and its resolution, including drawings/schematics of pond; the waste acceptance profile sheet for the pond; and the records for monitoring of the leak detection system. Williams Four Corners shall remove the liquids from the leak detection system and monitor fluid levels if present.

Photo 9: Leak detection for pond located on west side.

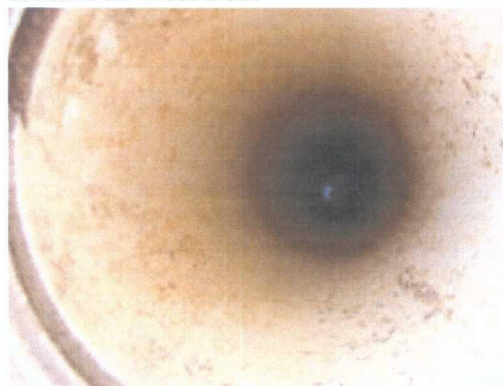
Photo 10: Fluid in pond leak detection system.

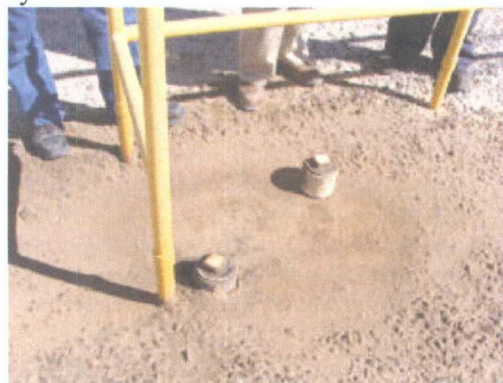
6. **Photo 11:** A discharge was noted around these two protruding conduits. Please clean up the contaminated soil and submit to the OCD a resolution to prevent this event from reoccurring.

Photo 11: Ports with soil staining near water tanks, assume gasoline.

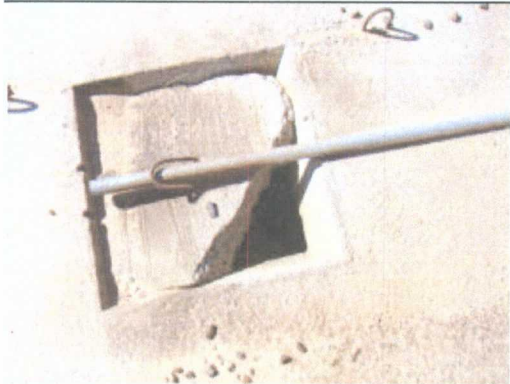
7. **Photos 12, 13, 15:** One of many sumps located on site. The leak detection system in all sumps appeared to have fluids in them. Williams Four Corners shall remove all fluids in their sumps leak detection system and verify to the OCD that their sumps meet integrity. The OCD request the testing data records of all their sumps including cleaning records.

Photo 12: A cemented BGT located on the west side of plant with a cracked lid.

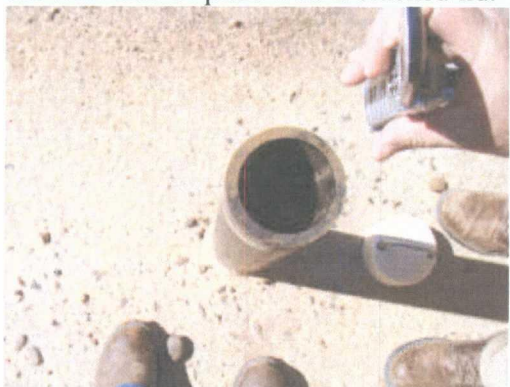
Photo 13: Leak detection for BGT, appeared to have fluids in system.

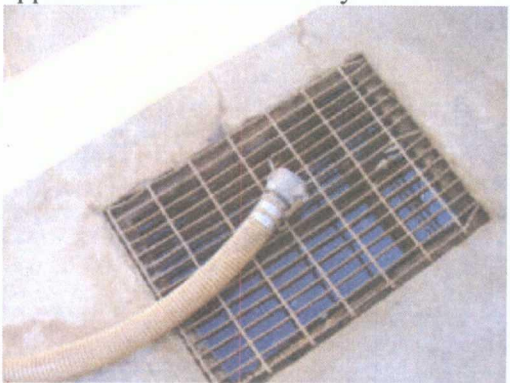
Photo 14: Sump filled with fluids.

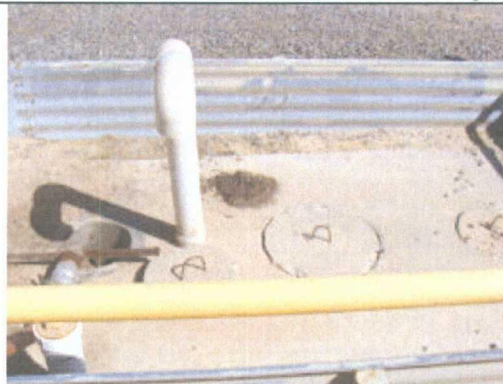
Photo 15: Second concrete BGT located within the facility. Its leak detection appeared to have fluids.

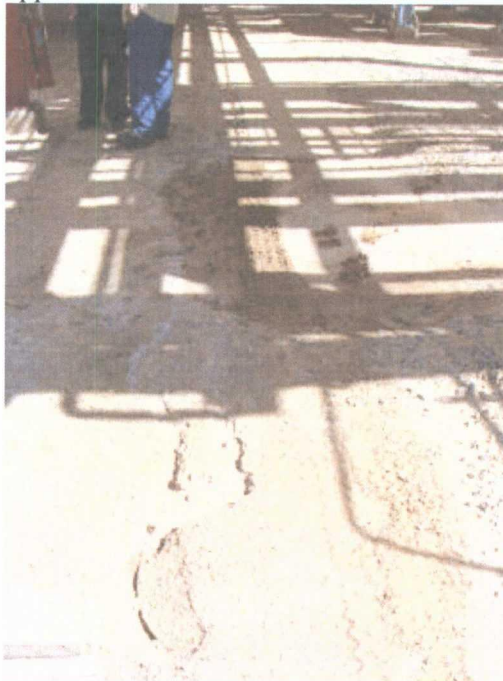
8. **Photo 16:** Fluids drained into this unknown drainage area near the south end of the processing area. Where is the fluid draining to? Provide the OCD the details of this scenario.

Photo 16: Fluids (rainwater) are draining into this area, assumed a storm drain cover.

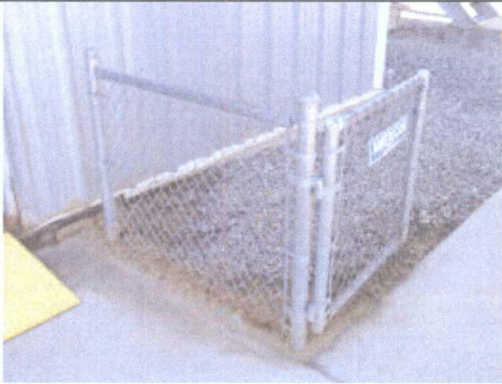
9. **Photo 17-21:** Several areas of soil staining. Williams Four Corners shall prevent any discharges on to the ground. Doing so is a violation of this discharge plan permit.

Photo 17: Gravel/soil contamination around building doorway.

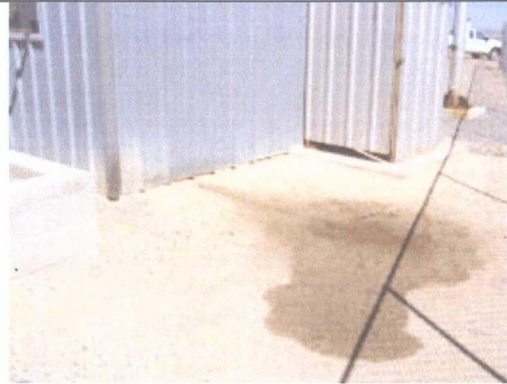
Photo 19: Leaked diesel on to ground underneath conduit of Photo 18.

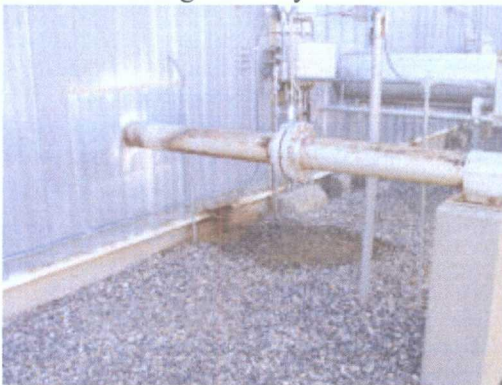
Photo 18: A leak at building and conduit interface.

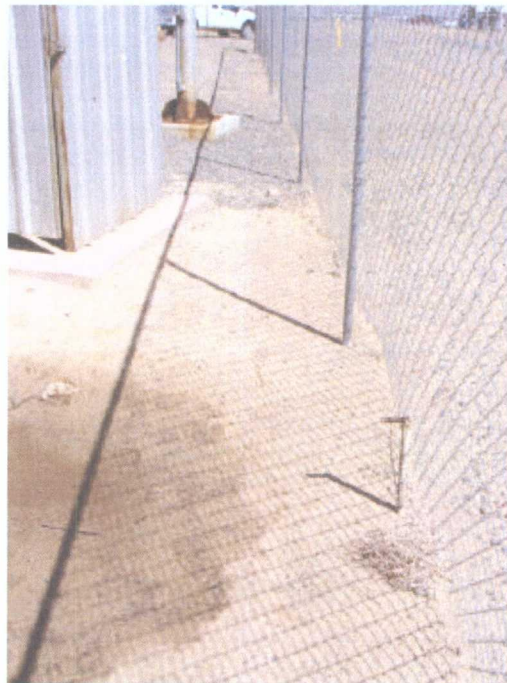
Photo 20: Edge of leak near facility fence.

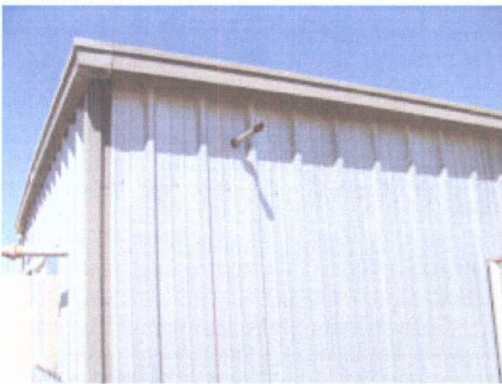
Photo 18: Conduit protruding from main fire pump building appears to have leaked diesel.

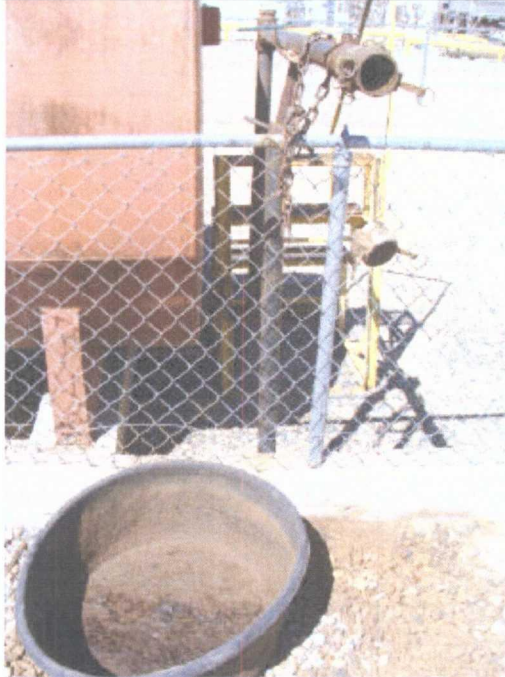
Photo 21: Drip pan area for used oil tank has discharge on to ground.

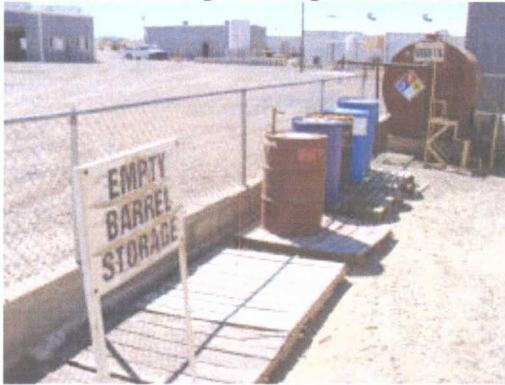
10. **Photo 22:** Williams Four Corners shall adhere to all conditions pertaining to drum storage at this facility.

Photo 22: Drum storages, full or partially full barrels located on pallets.
