GW - 283

**INSPECTION
&
DATA**

**Southern Union Gas Services
Jal South Compressor Station
GW-283**

**Re: Jal South Compressor Station
Southern Union Gas Services
Jal, New Mexico
Oil Storage Containment Area Capacity**

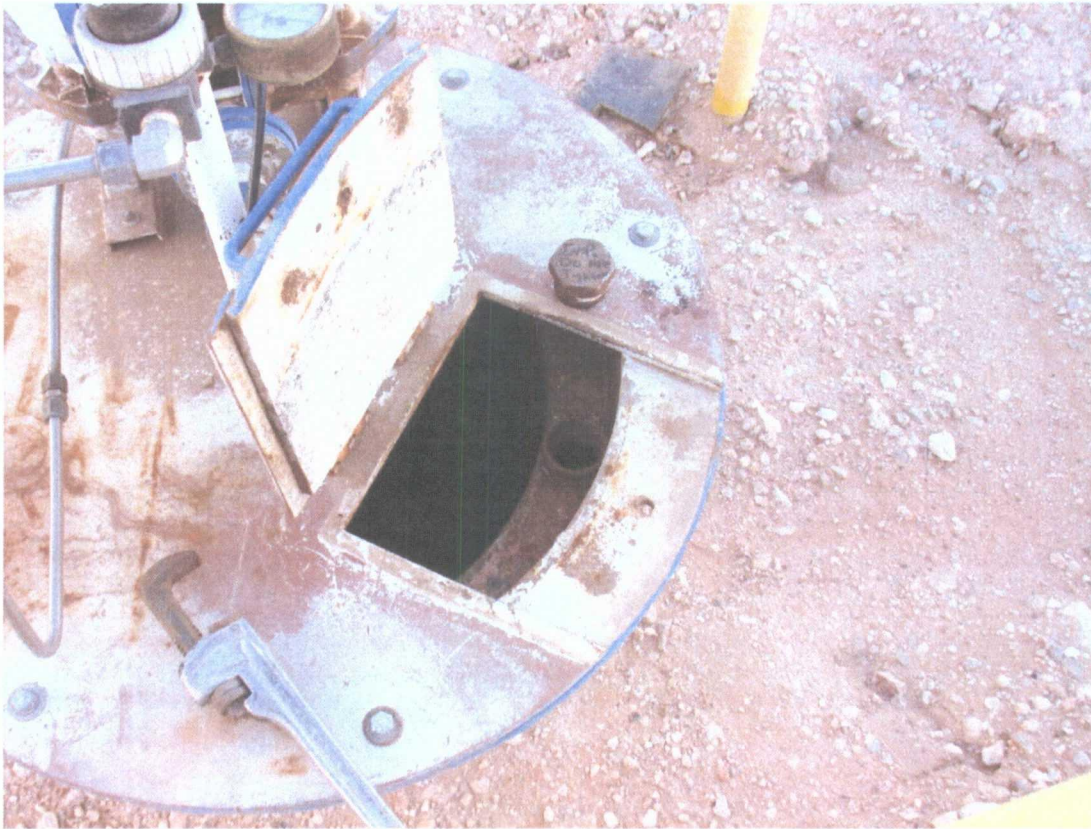
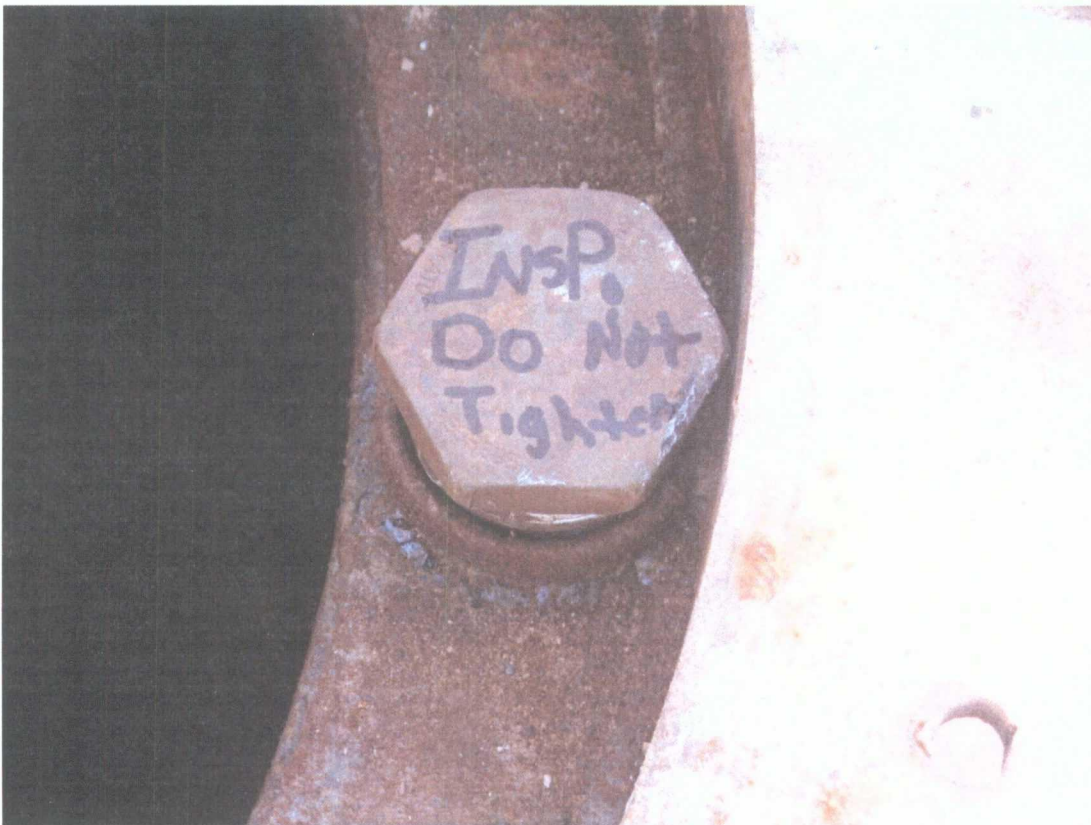
Photo 1: Inspection plug on sump containment

The plug was loosened and labeled hand tighten, inspection plug.

The sump total outside dimensions are 3 ft. diameter by 13 ft. in depth. The inner sump dimensions are approximately 2 inches less than that allowing for an air space between the outer and inner walls.

Station Sump Inspection plug

OCD * **STILL OPEN:** The OCD requested inspection records for this sump and all other sumps on at this facility please provide. The OCD considers this an unresolved item.

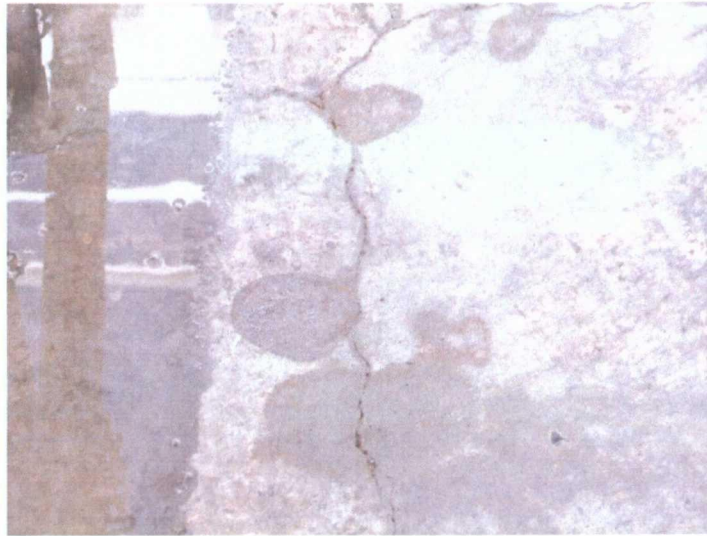
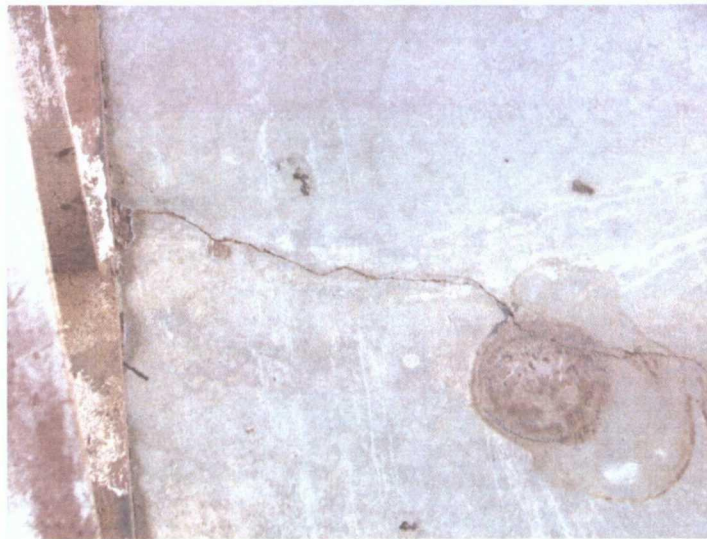
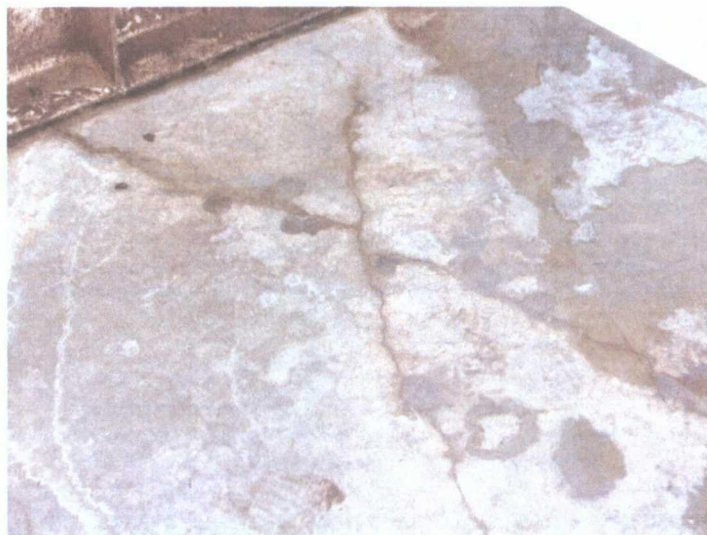
Photo 6-9: Large tank containment area.

The containment area was cleaned on 10/7/08. During the cleaning event it was discovered that the concrete containment bottom and sides were coated with a tar/roskote substance that had started flaking and coming loose in several locations. All of the material was removed and placed in plastic bags, samples were taken to make sure the material does not contain asbestos. Pending the results of the analytical, the material will be properly disposed of. Also during the cleaning event several cracks were discovered in the floor and sides of the concrete containment. We had a RPE calculate the tank volumes and containment capacity to make sure that the containment capacity was sufficient, his assessment is attached. Our plan is to determine if the area beneath the floor of the containment has been impacted by drilling holes in the floor and testing the soil beneath the floor. If the tests are negative we will plug the holes, remove the waste water and condensate tanks, thoroughly clean the area and spray a rhino lining on the concrete. Bids have already gone out to contractors to perform the necessary work.

Concrete containment floor
After cleaning 10/7/08

Please provide the OCD an update on the results of the soil beneath the floor and the status of the crack work and rhino spray.

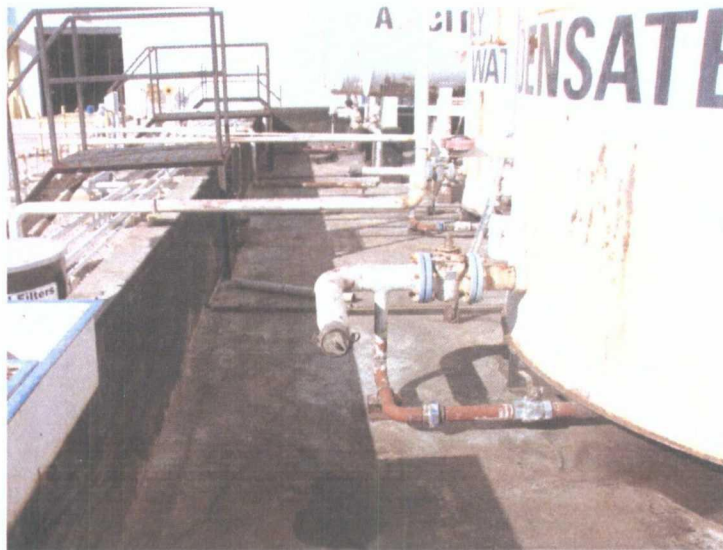
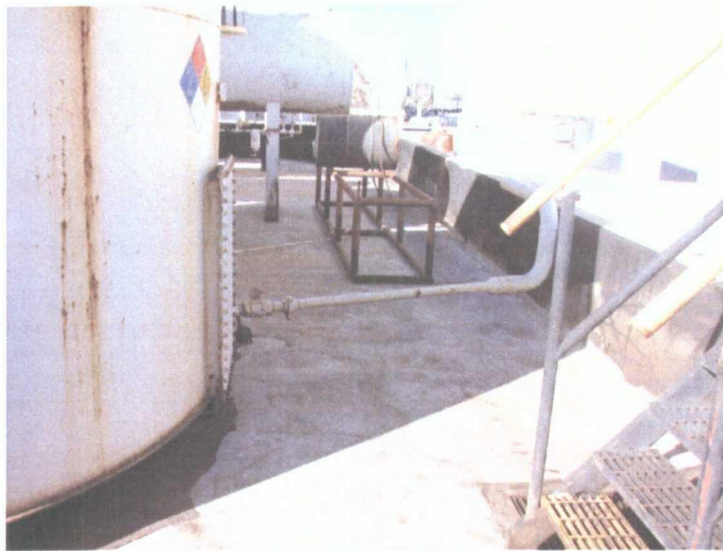
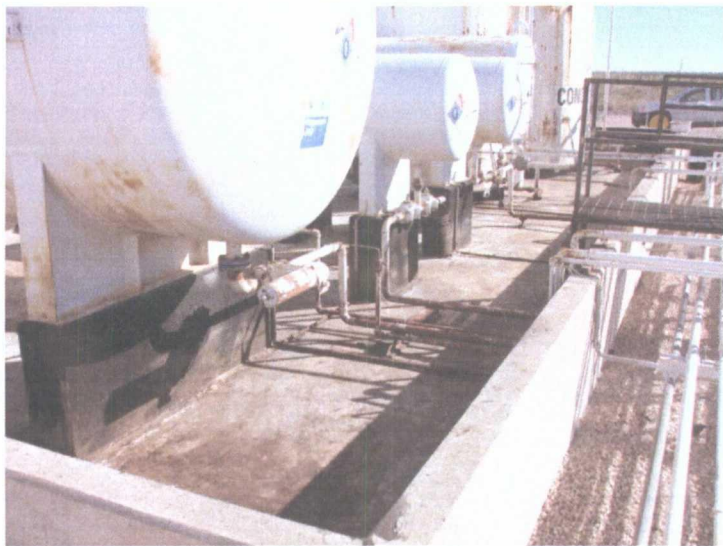
Containment area as Bid
For re-lining

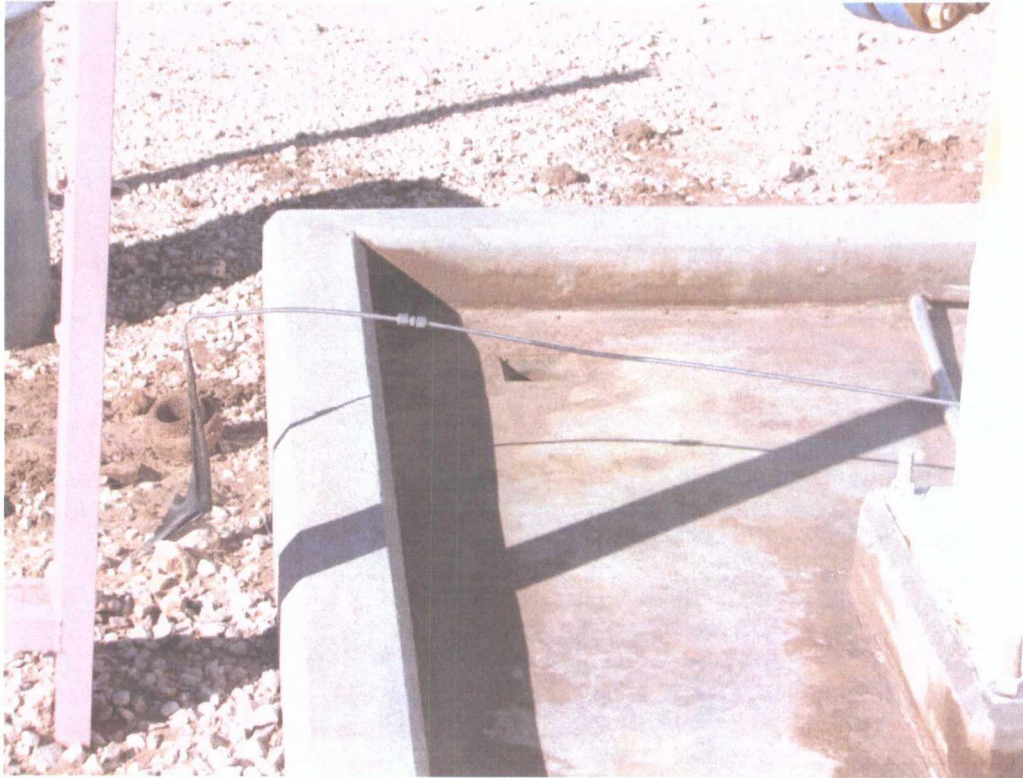
Photo 5: Containment drain port.

There was a foreman plug in the drain port beneath the sand and debris that had accumulated in the containment. This drain port is common with all of the other drain lines that were tested in 2008. SUGS will send a facility diagram identifying the drain ports and lines.

Scrubber Catch Basin with common drain opening

OCD * **STILL OPEN:** still open until the OCD receives and reviews facility diagram.

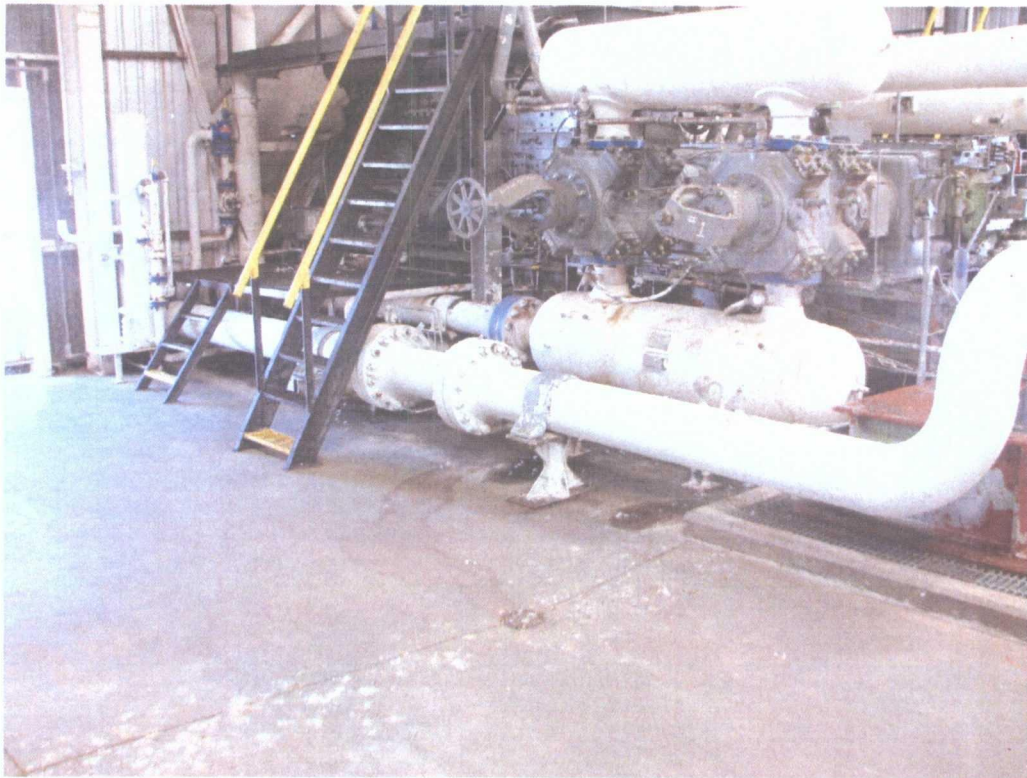
Photo 2-4: Lube oil on floor.

The lube oil on the floor was from a loose drain plug on the filter pot.

The plug was tightened and the area has been cleaned. The floor of the compressor engine room is designed to drain to one of 3 floor drains located between the units. These are used to collect leaks and wash down fluids around the units and drain them to the sump.

Engine room floor Drain
