EMSU-B #908 INJECTION LINE C141 CLOSURE REPORT

API 30-025-043136

NMOCD RP #1944

May 8, 2009

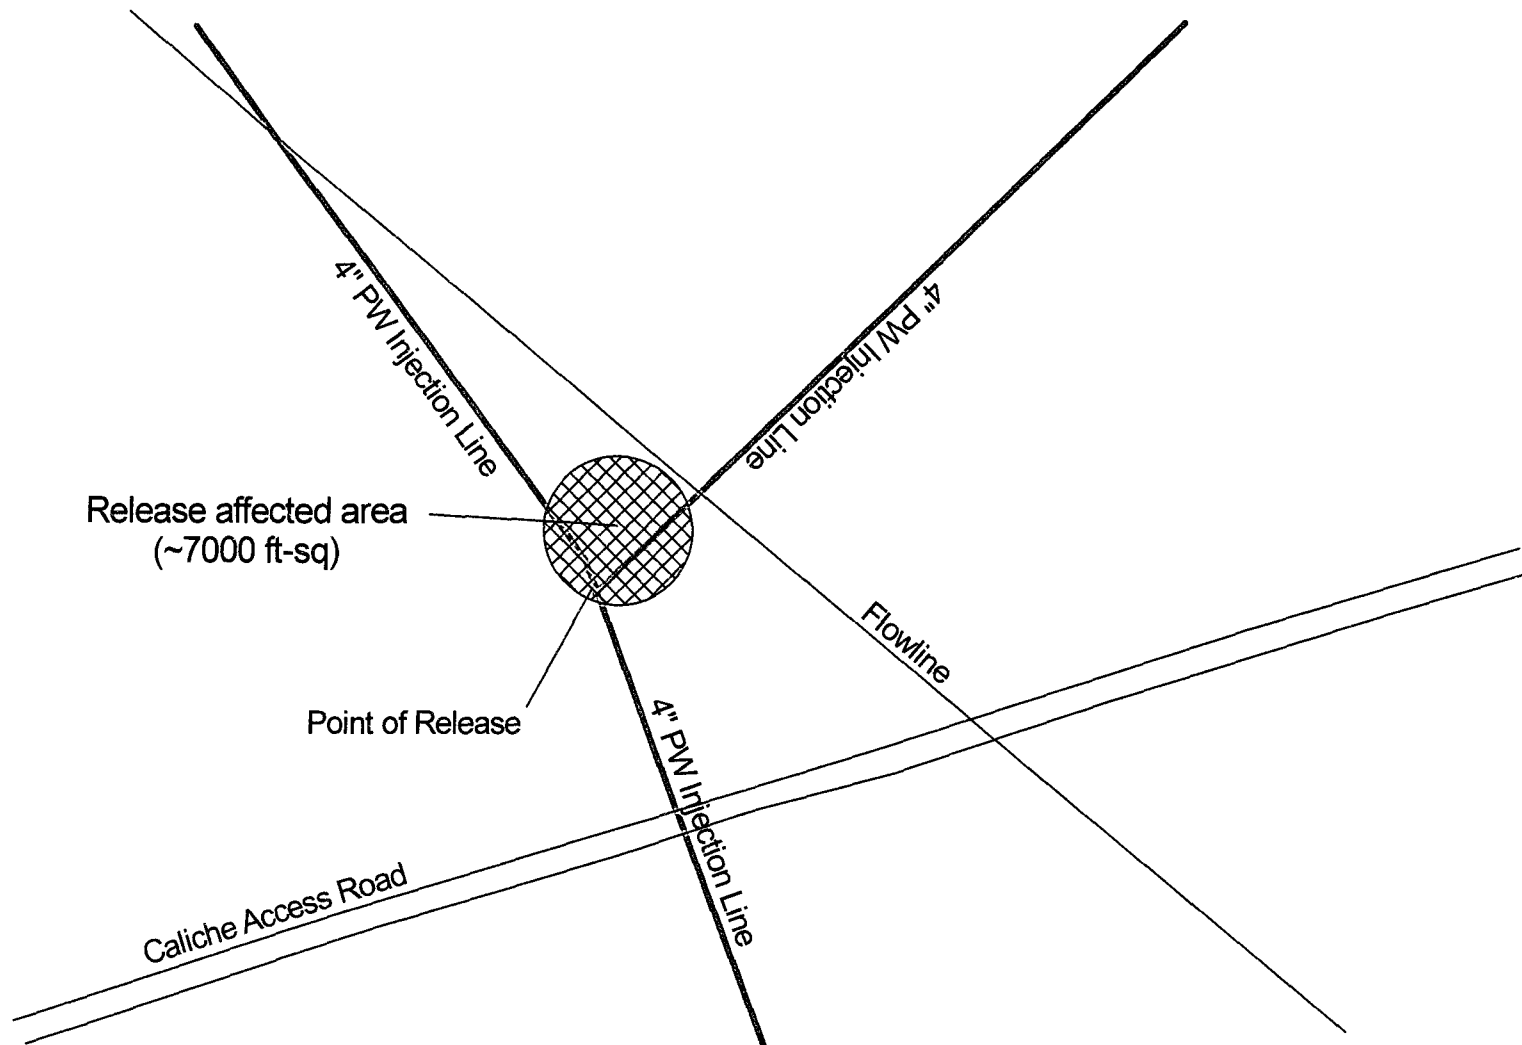
Plate 5
Release Site Detail
XTO Energy, Inc.
EMSU B #908 Water Line

The primary Contaminant of Concern (COC) was total chlorides and TPH resulting from the produced water release on 9/7/08. Hydrocarbon contamination was significant but limited to the top 7-ft of the affected area. The areal extent of the release was roughly circular with an approximate area of 7,000-ft² (~100-ft diameter)

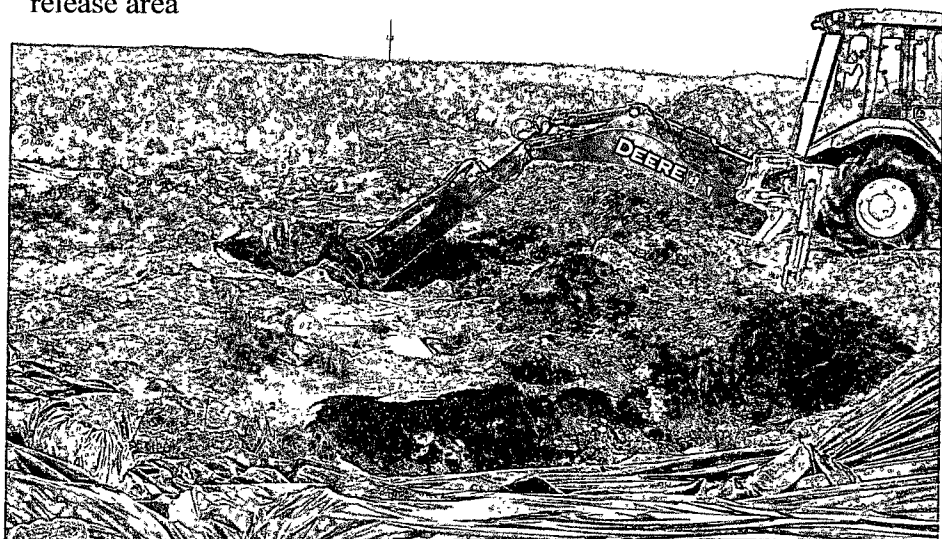
09/11/08 – Excavation of saturated
release area

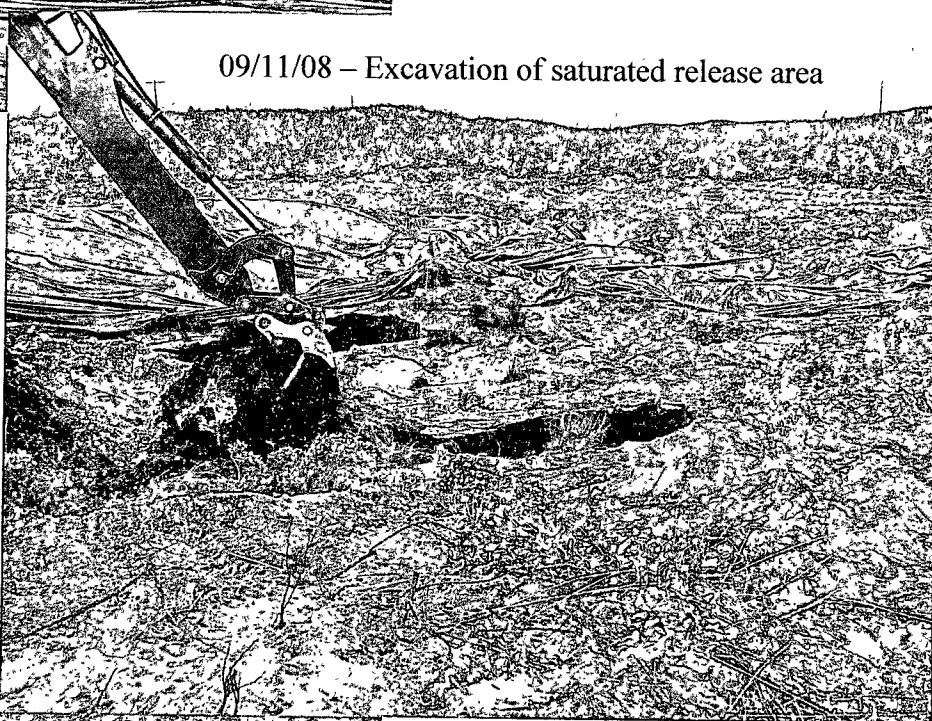
09/11/08 – Excavation of saturated release area

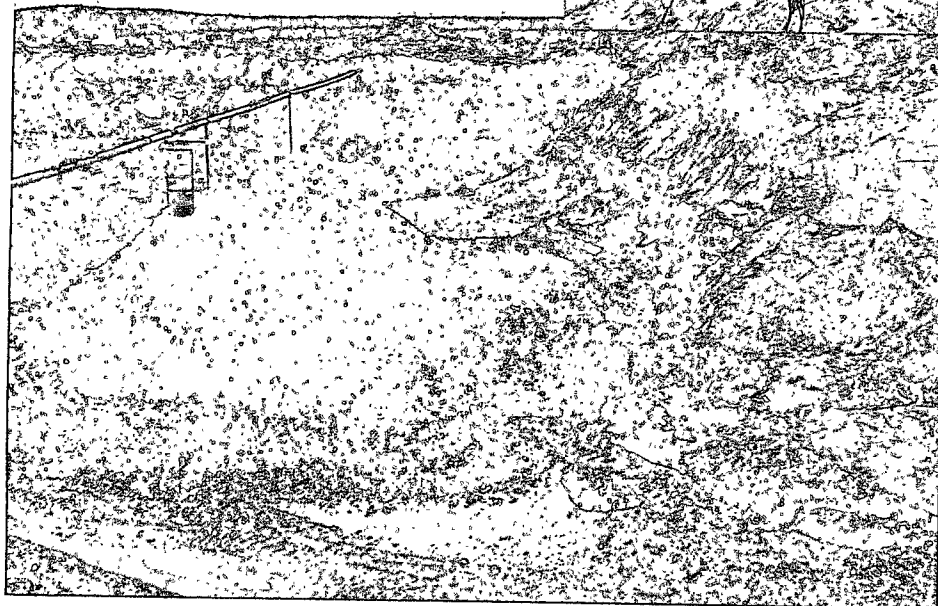
12/17/08 – Final excavated release area

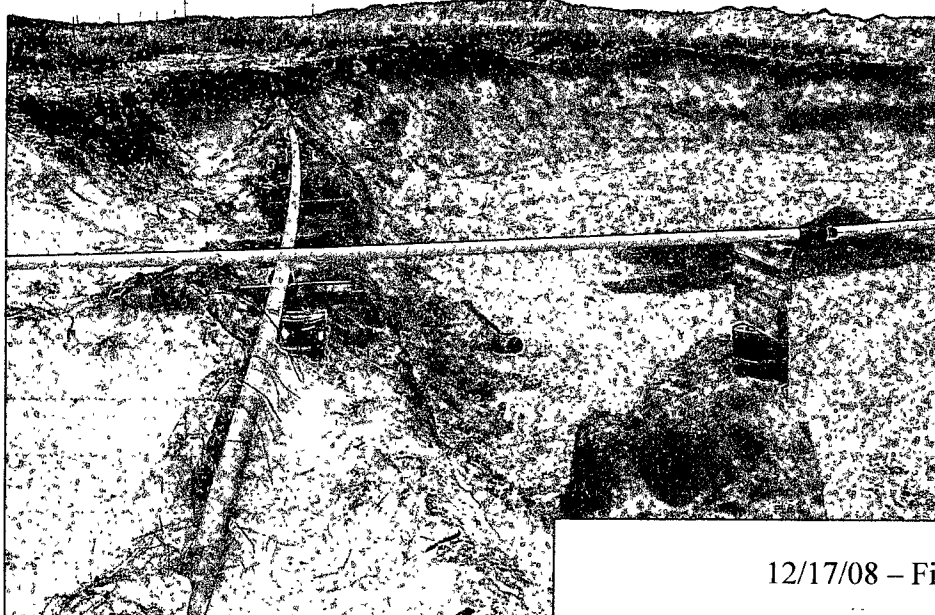
12/17/08 – Final excavated release area

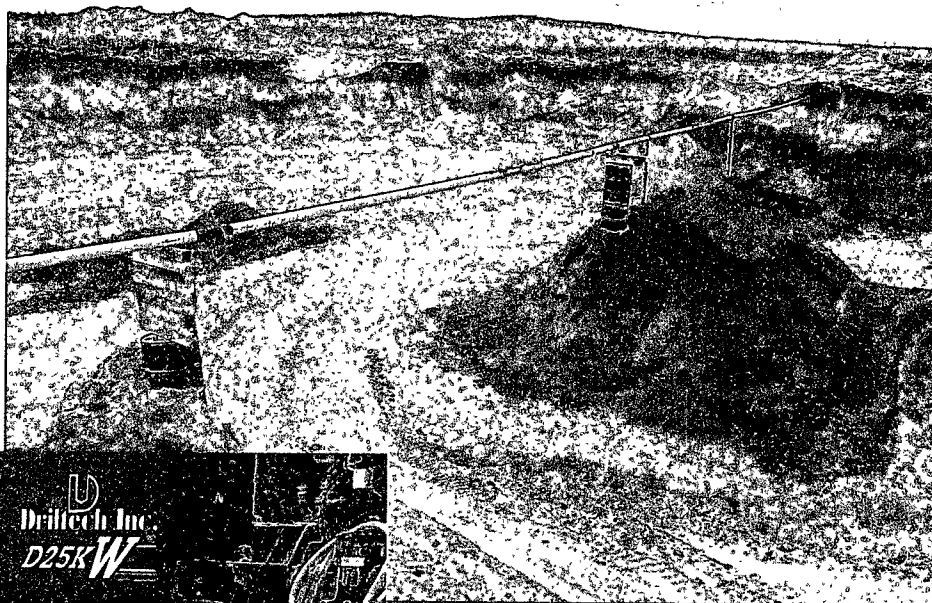
12/17/08 – Final excavated release area

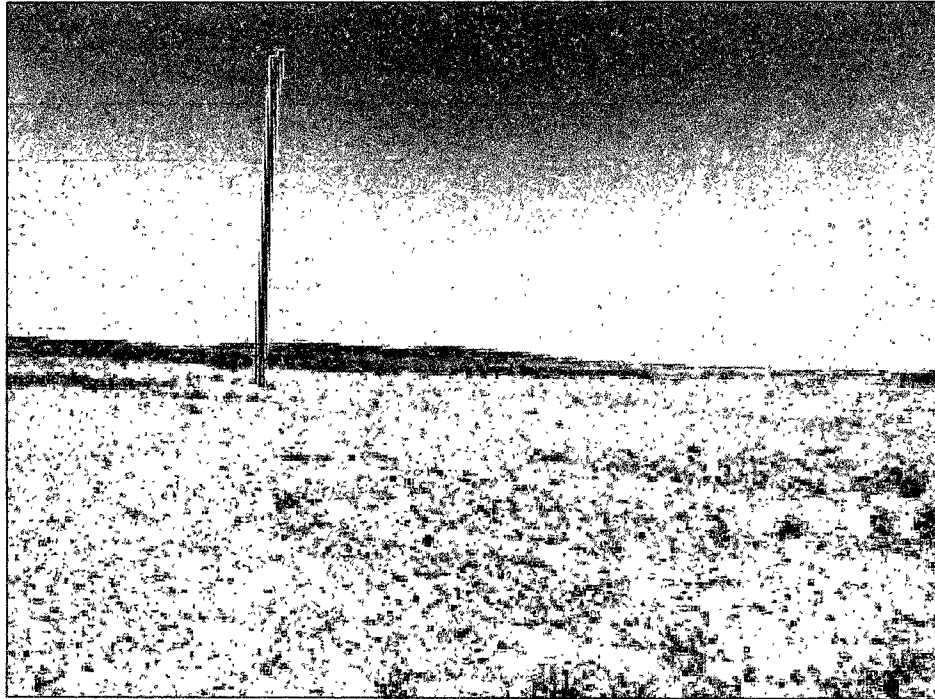
12/17/08 - Delineation bore hole on south side of excavation rim - no water at 80' bgs

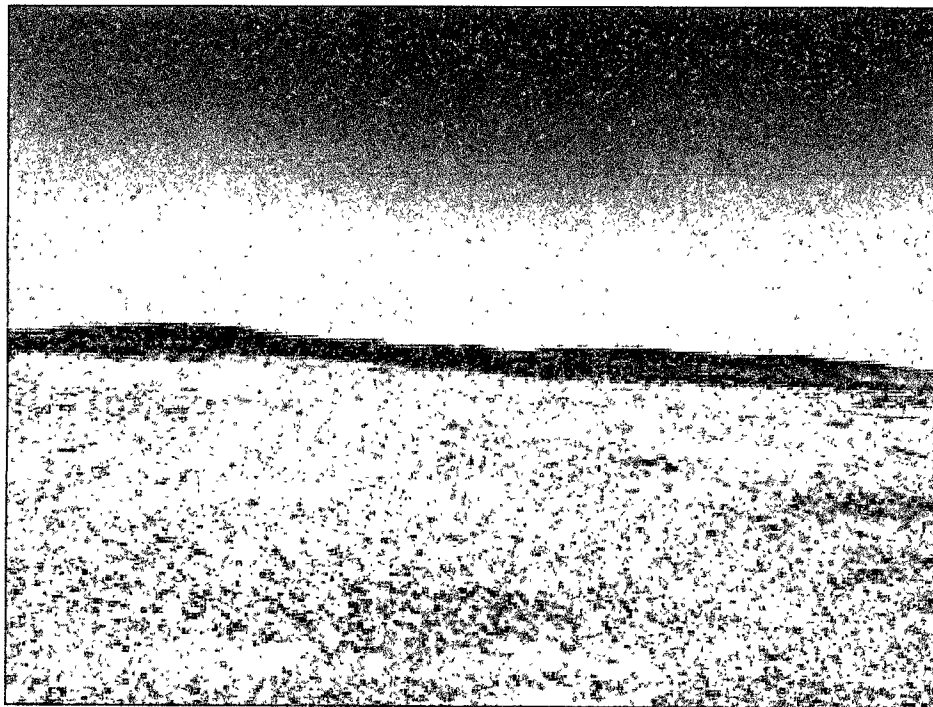
Backfill and contouring completed
