R. T. HICKS CONSULTANTS, LTD.

August 12, 2009

RE: Seven Produced Fluid Releases at sites operated by Marks and Garner Production Ltd, Company in Eddy County, NM as follows:

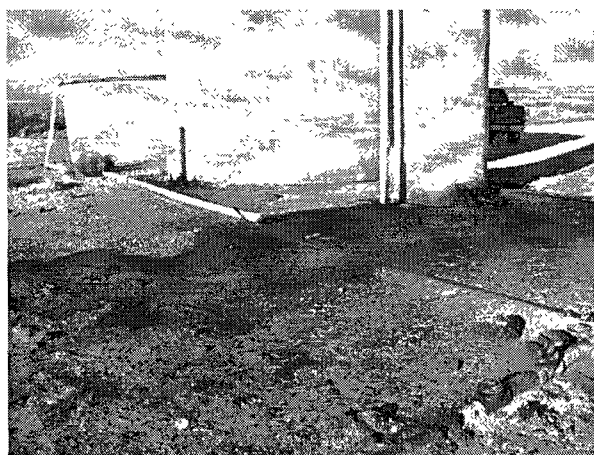
A release of heavy "tank bottom" oil occurred from a broken valve at the base of a large separator and extends approximately 30 feet down slope. We used a hand auger to obtain soil samples at depths of 0.5, 1.0, and 3.0 feet below the free liquid. Results of laboratory analyses on selected samples for benzene, toluene, ethylbenzene, xylenes; and gasoline, diesel, and oil range hydrocarbons as well as field screening and laboratory results are provided on the table below:

None of the hydrocarbon concentrations measured at the Levers Federal No. 7 site exceeds the 1993 NMOCD or 2006 NMED Guideline soil screening levels. The fact that the concentrations of regulated constituents do not exceed NMED Guidelines allows us to conclude that the impacted soil does not represent a threat to fresh water or public health. The recommended corrective action for this site is:

1. Remove out-of-service vessels or repair all leaks
2. Excavate the upper 6-inches of earth within the spill footprint
3. Mix the excavated spill material with 2-5 parts clean soil

4. Use this blended soil for the construction of firewalls around tank batteries (use now or stockpile on site for future use)
5. At abandonment of the site the surface will be restored according to the landowner's specifications

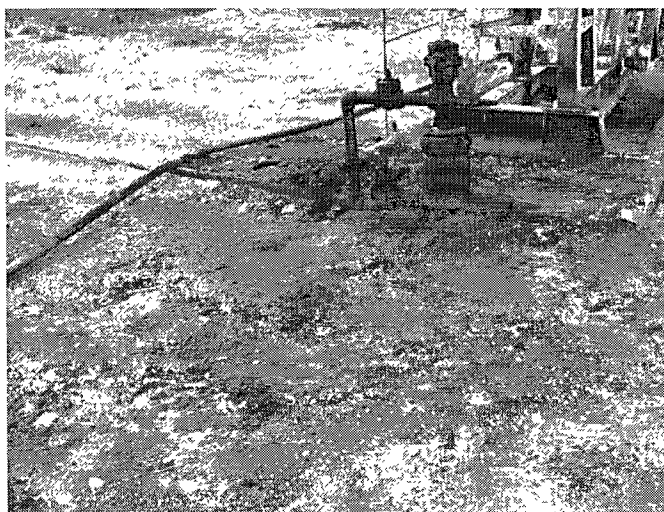
A release of oil occurred from the well head which extends approximately 10 feet in all directions. The table below presents field screening and the laboratory results from soil samples at the surface and at depths of 2.0, 3.0, 4.0, 5.0 and 6.0 feet below the stained area.

Total Petroleum Hydrocarbon (TPH) concentrations measured at the Levers No. 3 site exceeds the 1993 NMOCD Guideline levels but concentrations generally decrease from the surface to the auger refusal depth (6 feet below the surface). Most importantly, none of the regulated hydrocarbon concentrations exceed the 2006 NMED Guideline levels. The fact that the concentrations of regulated constituents do not exceed NMED Guidelines allows us to conclude that the impacted soil does not represent a threat to fresh water or public health. The recommended corrective action for this site is:

1. Remove out-of-service vessels or repair all leaks
2. Excavate the upper 1-2 feet of earth within the spill footprint
3. Mix the excavated spill material with 2-5 parts clean soil
4. Use this blended soil for the construction of firewalls around tank batteries (use now or stockpile on site for future use)
5. Collect a composite sample of the blended soil to demonstrate that constituents are at concentrations that comply with NMOCD Rules and provide letter report to NMOCD
6. At abandonment of the site the surface will be restored according to the landowner's specifications

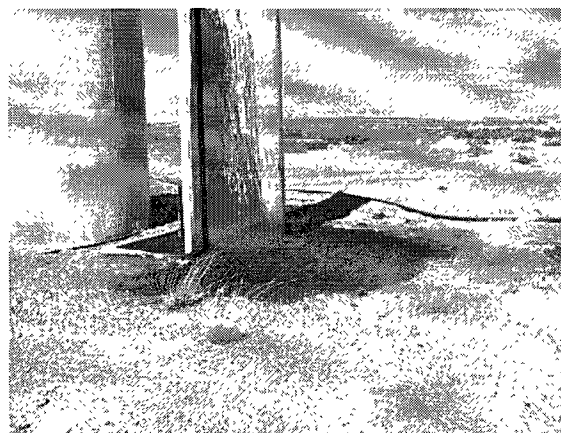
A release of heavy "tank bottom" oil occurred from a broken valve at the base and from a pipe joint near the top of the separator. The spill area extends approximately 30 feet down slope. Laboratory results of soil samples recovered using a hand auger at depths of 0.5, 1.0, and 3.0 feet below the free liquid and field screening are provided on the table below:

TPH concentrations measured from near the surface at the Red-12 Federal No. 1 site exceeds the 1993 NMOCD Guideline levels but decreases to below the guideline levels at 3 feet below the surface. None of the regulated hydrocarbon concentrations exceed the 2006 NMED Guideline levels. The fact that the concentrations of regulated constituents do not exceed NMED Guidelines allows us to conclude that the impacted soil does not represent a threat to fresh water or public health. The recommended corrective action for this site is:

1. Remove out-of-service vessels or repair all leaks
2. Excavate the upper 6-12 inches of earth within the spill footprint
3. Mix the excavated spill material with 2-5 parts clean soil
4. Use this blended soil for the construction of firewalls around tank batteries (use now or stockpile on site for future use)
5. Collect a composite sample of the blended soil to demonstrate that constituents are at concentrations that comply with NMOCD Rules and provide letter report to NMOCD
6. At abandonment of the site the surface will be restored according to the landowner's specifications

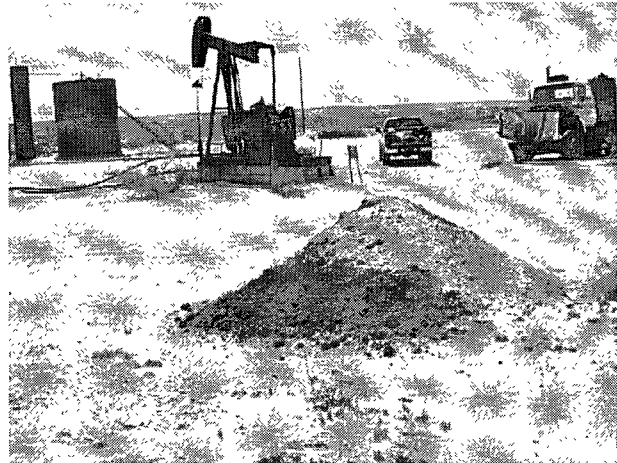
The operator excavated and stockpiled soil from an apparent release of oil that occurred prior to our characterization. Laboratory and field results from soil samples recovered from the stockpile and below the spill footprint are provided on the table below:

The hydrocarbon concentrations from the removed stockpiled soil at Cave State No. 4 site exceeds the 1993 NMOCD Guideline levels for TPH and the 2006 NMED Guideline levels for benzene. None of the hydrocarbon concentrations measured from the remaining (deeper) soil exceeds either the 1993 NMOCD or 2006 NMED Guideline soil screening levels.

The fact that the concentrations of regulated constituents do not exceed NMED Guidelines allows us to conclude that the impacted soil below the original spill footprint does not represent a threat to fresh water or public health.

We recommend that the operator mix the stockpile with clean soil and utilize it for the construction of a firewall at one of the active tank batteries.

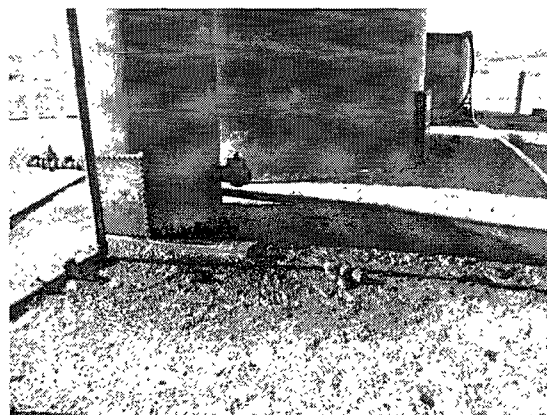
A release of heavy "tank bottom" oil occurred from a broken valve at the base of a separator and extends approximately 20 feet down slope. Results of laboratory and field analyses of soil samples recovered using a hand auger at depths of 0.5, 1.0, and 3.0 feet below the free liquid are provided on the table below:

TPH concentrations measured from near the surface at the Red-12 State No. 2 site exceeds the 1993 NMOCD Guideline levels but decreases to below the guideline levels at 3 feet below the surface. None of the measured hydrocarbon concentrations exceed the 2006 NMED Guideline levels. The fact that the concentrations of regulated constituents do not exceed NMED Guidelines allows us to conclude that the impacted soil does not represent a threat to fresh water or public health. The recommended corrective action for this site is:

1. Remove out-of-service vessels or repair all leaks
2. Excavate the upper 6-12 inches of earth within the spill footprint
3. Mix the excavated spill material with 2-5 parts clean soil
4. Use this blended soil for the construction of firewalls around tank batteries (use now or stockpile on site for future use)
5. Collect a composite sample of the blended soil to demonstrate that constituents are at concentrations that comply with NMOCD Rules and provide letter report to NMOCD.
6. At abandonment of the site the surface will be restored according to the landowner's specifications.

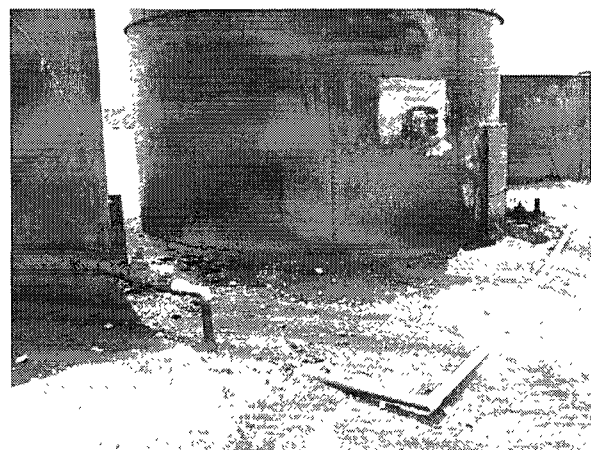
A release of heavy "tank bottom" oil occurred from leaks located at the base of a 500-bbl oil tank and a separator. The surface staining is present in an area of approximately 500 ft². A composite surface soil sample was recovered from the stained area and subsurface soil samples were recovered from two hand auger borings at depths of 1.0 and 2.0 feet below the free liquid. Laboratory analyses were performed to determine the concentrations of benzene, toluene, ethylbenzene, xylenes; and gasoline, diesel, and oil range hydrocarbons. Field screening and laboratory results are provided on the table below:

TPH concentrations measured from near the surface at the Red-12 State No. 3 site exceeds the 1993 NMOCD Guideline levels but decreases to below the guideline levels at 1 and 2 feet below the surface. None of the measured hydrocarbon concentrations exceed the 2006 NMED Guideline soil screening levels. The fact that the concentrations of regulated constituents do not exceed NMED Guidelines allows us to conclude that the impacted soil does not represent a threat to fresh water or public health. The recommended corrective action for this site is:

1. Remove out-of-service vessels or repair all leaks
2. Excavate the upper 1-2 feet of earth within the spill footprint
3. Mix the excavated spill material with 2-5 parts clean soil
4. Use this blended soil for the construction of firewalls around tank batteries (use now or stockpile on site for future use)
5. Collect a composite sample of the blended soil to demonstrate that constituents are at concentrations that comply with NMOCD

Rules and provide letter report to NMOCD

- At abandonment of the site the surface will be restored according to the landowner's specifications.

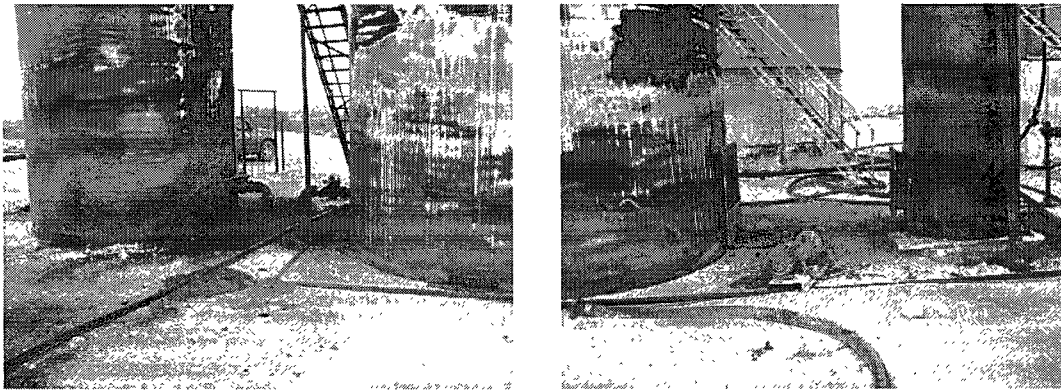
Historic spills within the tank battery have occurred resulting in an "asphalt-like" stained soil area of approximately 400 ft². A composite surface soil sample was recovered from the stained area and laboratory analyses were performed to determine the concentrations of benzene, toluene, ethylbenzene, xylenes; and gasoline, diesel, and oil range hydrocarbons. Laboratory results are provided on the table below:

TPH concentrations measured from near the surface at the Red-12 State No. 4 battery site exceed the 1993 NMOCD Guideline levels but none of the measured hydrocarbon concentrations exceed the 2006 NMED Guideline levels. The fact that the concentrations of regulated constituents do not exceed NMED Guidelines allows us to conclude that the hydrocarbon-impacted soil does not represent a threat to fresh water or public health. The recommended corrective action for this site is:

- Repair all leaks
- Excavate the upper 1-2 feet of earth within the spill footprint
- Mix the excavated spill material with 2-5 parts clean soil
- Use this blended-asphaltic soil for the construction of firewalls around tank batteries (use now or stockpile on site for future use)
- Collect a composite sample of the blended soil to demonstrate that constituents are at concentrations that comply with NMOCD Rules and provide letter report to NMOCD
- At abandonment of the site, disc hay and other organic material into hydrocarbon-impacted soil to open soil structure and permit infiltration of precipitation. Repeat tilling and addition of organic material or other soil amendments as necessary to meet landowner mandates for surface restoration and thereby eliminate the threat to the environment (i.e. soil and habitat) posed by the hydrocarbon-impacted soils

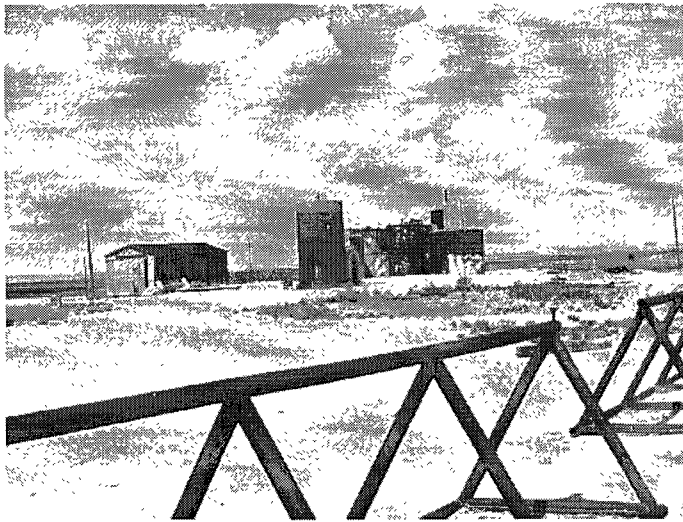
The tank battery is located on a topographically high area and much of the soil within the bermed area and the surrounding topographically low areas exhibit characteristics of one or more historic brine water releases. Three hand auger borings were installed in the low areas surrounding the tank battery in order to better characterize the extent of the chloride-impacted soil. Plate 2 is a site map drawn on a July 2005 satellite photograph that depicts the current extent of stressed vegetation, the location of the hand auger borings, and the laboratory results from soil samples recovered at the site. It should be noted that the extent of the stressed vegetation observed during the inspection has changed since 2005. Some of the vegetation to the north and south has decreased while areas to the west appear to have recovered.

At the topographically low areas to the north and west of the tank batteries chloride concentrations in soil prevent re-vegetation. The vertical extent of the impacted soil could not be determined due to auger refusal. Further investigations at the Red-12 State No. 4 site will be conducted to verify the vertical extent of the chloride-impacted soil in order to determine the potential threat to ground water. Following the completion of these activities a final report will be submitted to the NMOCD.
