RE: Seven Produced Fluid Releases at sites operated by Marks and Garner Production Ltd, Company in Eddy County, NM as follows:

Site Name (type)	Location (T-R-Sec.-Unit)	OCD Reference No.
Levers Fed. No. 7 (battery)	T-16-S, R-29-E, Sec 33 (J)	2RP-304
Levers No. 3Y (well)	T-16-S, R-29-E, Sec 33 (N)	2RP-305
Red 12 Fed. No. 1 (battery)	T-16-S, R-29-E, Sec 33 (O)	2RP-306
Cave State No. 4 (well)	T-17-S, R-29-E, Sec 4 (F)	2RP-307
Red 12 State No. 2 (battery)	T-17-S, R-29-E, Sec 4 (H)	2RP-308
Red 12 State No. 3 (battery)	T-17-S, R-29-E, Sec 5 (J)	2RP-309
Red 12 State No. 4 (battery)	T-17-S, R-29-E, Sec 5 (O)	2RP-310

R.T. Hicks Consultants is pleased to submit the results of the initial characterization activities on the behalf of Marks and Garner Production Ltd. The production area is approximately 6.5 miles northwest of Loco Hills, New Mexico. Plate 1 depicts the location of each site relative to lease roads, sections lines, and Bear Grass Draw. On June 22 and 23, 2009 Hicks Consultants inspected each of the sites to document the source and type of release, describe the resulting environmental impact, and recover "worst case" soil samples in order to determine the corrective actions req

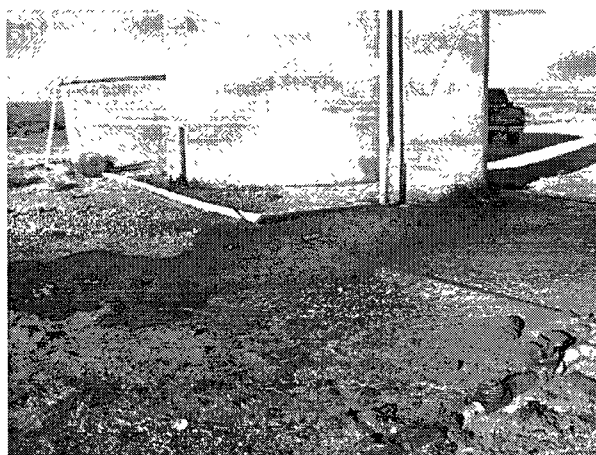
Levers Federal No. 7 Battery (OCD Reference No. 2RP-304)

A release of heavy “tank bottom” oil occurred from a broken valve at the base of a large separator and extends approximately 30 feet down slope. We used a hand auger to obtain soil samples at depths of 0.5, 1.0, and 3.0 feet below the free liquid. Results of laboratory analyses on selected samples for benzene, toluene, ethylbenzene, xylenes; and gasoline, diesel, and oil range hydrocarbons as well as field screening and laboratory results are provided on the table below:

None of the hydrocarbon concentrations measured at the Levers Federal No. 7 site exceeds the 1993 NMOCD or 2006 NMED Guideline soil screening levels. The fact that the concentrations of regulated constituents do not exceed NMED Guidelines allows us to conclude that the impacted soil does not represent a threat to fresh water or public health. The recommended corrective action for this site is:

1. Remove out-of-service vessels or repair all leaks
2. Excavate the upper 6-inches of earth within the spill footprint
3. Mix the excavated spill material with 2-5 parts clean soil

4. Use this blended soil for the construction of firewalls around tank batteries (use now or stockpile on site for future use)
5. At abandonment of the site the surface will be restored according to the landowner's specifications

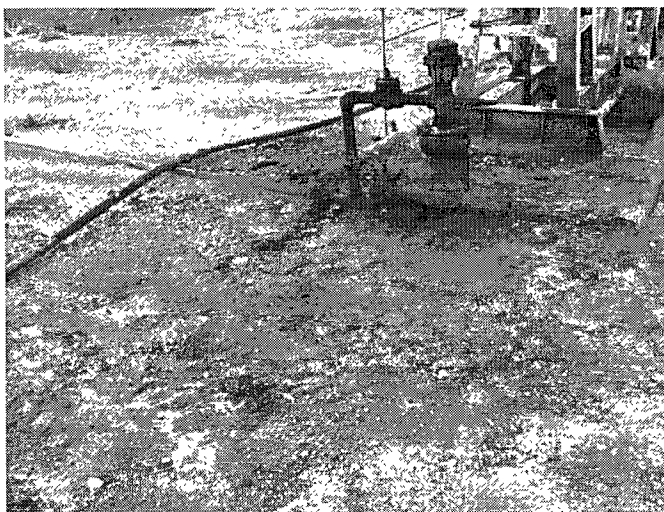
Levers No. 3 Well (OCD Reference No. 2RP-305)

A release of oil occurred from the well head which extends approximately 10 feet in all directions. The table below presents field screening and the laboratory results from soil samples at the surface and at depths of 2.0, 3.0, 4.0, 5.0 and 6.0 feet below the stained area.

Total Petroleum Hydrocarbon (TPH) concentrations measured at the Levers No. 3 site exceeds the 1993 NMOCD Guideline levels but concentrations generally decrease from the surface to the auger refusal depth (6 feet below the surface). Most importantly, none of the regulated hydrocarbon concentrations exceed the 2006 NMED Guideline levels. The fact that the concentrations of regulated constituents do not exceed NMED Guidelines allows us to conclude that the impacted soil does not represent a threat to fresh water or public health. The recommended corrective action for this site is:

1. Remove out-of-service vessels or repair all leaks
2. Excavate the upper 1-2 feet of earth within the spill footprint
3. Mix the excavated spill material with 2-5 parts clean soil
4. Use this blended soil for the construction of firewalls around tank batteries (use now or stockpile on site for future use)
5. Collect a composite sample of the blended soil to demonstrate that constituents are at concentrations that comply with NMOCD Rules and provide letter report to NMOCD
6. At abandonment of the site the surface will be restored according to the landowner's specifications

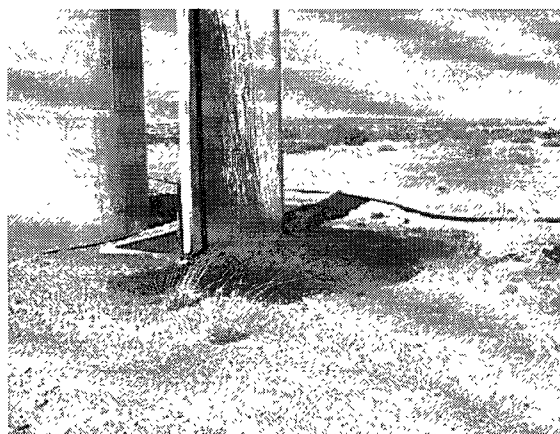
Red-12 Federal No. 1 Battery (OCD Reference No. 2RP-306)

A release of heavy "tank bottom" oil occurred from a broken valve at the base and from a pipe joint near the top of the separator. The spill area extends approximately 30 feet down slope. Laboratory results of soil samples recovered using a hand auger at depths of 0.5, 1.0, and 3.0 feet below the free liquid and field screening are provided on the table below:

TPH concentrations measured from near the surface at the Red-12 Federal No. 1 site exceeds the 1993 NMOCD Guideline levels but decreases to below the guideline levels at 3 feet below the surface. None of the regulated hydrocarbon concentrations exceed the 2006 NMED Guideline levels. The fact that the concentrations of regulated constituents do not exceed NMED Guidelines allows us to conclude that the impacted soil does not represent a threat to fresh water or public health. The recommended corrective action for this site is:

1. Remove out-of-service vessels or repair all leaks
2. Excavate the upper 6-12 inches of earth within the spill footprint
3. Mix the excavated spill material with 2-5 parts clean soil
4. Use this blended soil for the construction of firewalls around tank batteries (use now or stockpile on site for future use)
5. Collect a composite sample of the blended soil to demonstrate that constituents are at concentrations that comply with NMOCD Rules and provide letter report to NMOCD
6. At abandonment of the site the surface will be restored according to the landowner's specifications

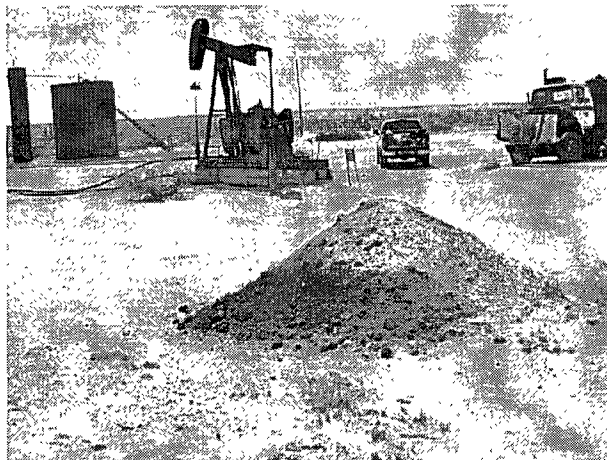
Cave State No. 4 Well (OCD Reference No. 2RP-307)

The operator excavated and stockpiled soil from an apparent release of oil that occurred prior to our characterization. Laboratory and field results from soil samples recovered from the stockpile and below the spill footprint are provided on the table below:

The hydrocarbon concentrations from the removed stockpiled soil at Cave State No. 4 site exceeds the 1993 NMOCD Guideline levels for TPH and the 2006 NMED Guideline levels for benzene. None of the hydrocarbon concentrations measured from the remaining (deeper) soil exceeds either the 1993 NMOCD or 2006 NMED Guideline soil screening levels.

The fact that the concentrations of regulated constituents do not exceed NMED Guidelines allows us to conclude that the impacted soil below the original spill footprint does not represent a threat to fresh water or public health.

We recommend that the operator mix the stockpile with clean soil and utilize it for the construction of a firewall at one of the active tank batteries.

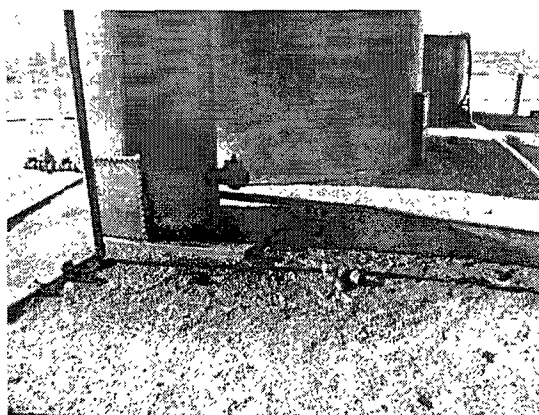
Red-12 State No. 2 Battery (OCD Reference No. 2RP-308)

A release of heavy "tank bottom" oil occurred from a broken valve at the base of a separator and extends approximately 20 feet down slope. Results of laboratory and field analyses of soil samples recovered using a hand auger at depths of 0.5, 1.0, and 3.0 feet below the free liquid are provided on the table below:

TPH concentrations measured from near the surface at the Red-12 State No. 2 site exceeds the 1993 NMOCD Guideline levels but decreases to below the guideline levels at 3 feet below the surface. None of the measured hydrocarbon concentrations exceed the 2006 NMED Guideline levels. The fact that the concentrations of regulated constituents do not exceed NMED Guidelines allows us to conclude that the impacted soil does not represent a threat to fresh water or public health. The recommended corrective action for this site is:

1. Remove out-of-service vessels or repair all leaks
2. Excavate the upper 6-12 inches of earth within the spill footprint
3. Mix the excavated spill material with 2-5 parts clean soil
4. Use this blended soil for the construction of firewalls around tank batteries (use now or stockpile on site for future use)
5. Collect a composite sample of the blended soil to demonstrate that constituents are at concentrations that comply with NMOCD Rules and provide letter report to NMOCD.
6. At abandonment of the site the surface will be restored according to the landowner's specifications.

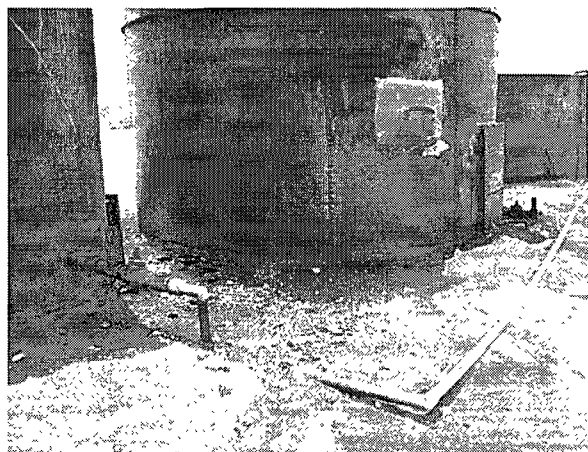
Red-12 State No. 3 Battery (OCD Reference No. 2RP-309)

A release of heavy "tank bottom" oil occurred from leaks located at the base of a 500-bbl oil tank and a separator. The surface staining is present in an area of approximately 500 ft². A composite surface soil sample was recovered from the stained area and subsurface soil samples were recovered from two hand auger borings at depths of 1.0 and 2.0 feet below the free liquid. Laboratory analyses were performed to determine the concentrations of benzene, toluene, ethylbenzene, xylenes; and gasoline, diesel, and oil range hydrocarbons. Field screening and laboratory results are provided on the table below:

TPH concentrations measured from near the surface at the Red-12 State No. 3 site exceeds the 1993 NMOCD Guideline levels but decreases to below the guideline levels at 1 and 2 feet below the surface. None of the measured hydrocarbon concentrations exceed the 2006 NMED Guideline soil screening levels. The fact that the concentrations of regulated constituents do not exceed NMED Guidelines allows us to conclude that the impacted soil does not represent a threat to fresh water or public health. The recommended corrective action for this site is:

1. Remove out-of-service vessels or repair all leaks
2. Excavate the upper 1-2 feet of earth within the spill footprint
3. Mix the excavated spill material with 2-5 parts clean soil
4. Use this blended soil for the construction of firewalls around tank batteries (use now or stockpile on site for future use)
5. Collect a composite sample of the blended soil to demonstrate that constituents are at concentrations that comply with NMOCD

Rules and provide letter report to NMOCD

- At abandonment of the site the surface will be restored according to the landowner's specifications.

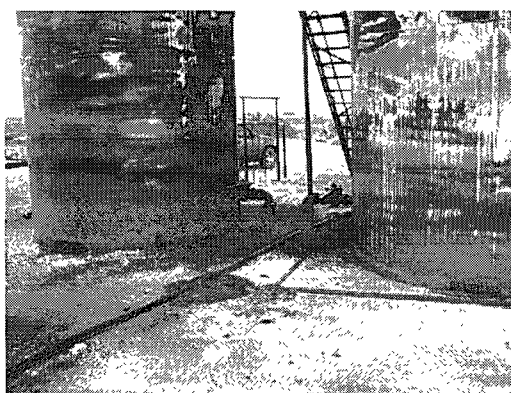
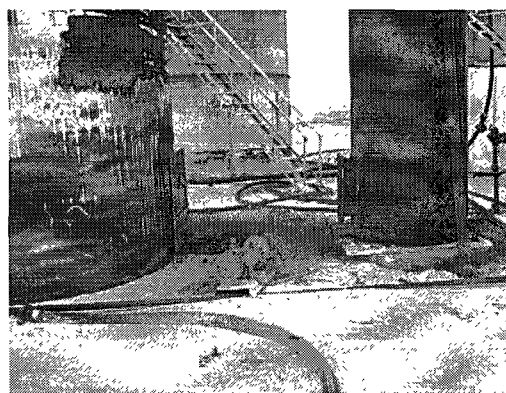
Red-12 State No. 4 Battery and Injector (OCD Reference No. 2RP-310)

Historic spills within the tank battery have occurred resulting in an "asphalt-like" stained soil area of approximately 400 ft². A composite surface soil sample was recovered from the stained area and laboratory analyses were performed to determine the concentrations of benzene, toluene, ethylbenzene, xylenes; and gasoline, diesel, and oil range hydrocarbons. Laboratory results are provided on the table below:

TPH concentrations measured from near the surface at the Red-12 State No. 4 battery site exceed the 1993 NMOCD Guideline levels but none of the measured hydrocarbon concentrations exceed the 2006 NMED Guideline levels. The fact that the concentrations of regulated constituents do not exceed NMED Guidelines allows us to conclude that the hydrocarbon-impacted soil does not represent a threat to fresh water or public health. The recommended corrective action for this site is:

- Repair all leaks
- Excavate the upper 1-2 feet of earth within the spill footprint
- Mix the excavated spill material with 2-5 parts clean soil
- Use this blended-asphaltic soil for the construction of firewalls around tank batteries (use now or stockpile on site for future use)
- Collect a composite sample of the blended soil to demonstrate that constituents are at concentrations that comply with NMOCD Rules and provide letter report to NMOCD
- At abandonment of the site, disc hay and other organic material into hydrocarbon-impacted soil to open soil structure and permit infiltration of precipitation. Repeat tilling and addition of organic material or other soil amendments as necessary to meet landowner mandates for surface restoration and thereby eliminate the threat to the environment (i.e. soil and habitat) posed by the hydrocarbon-impacted soils

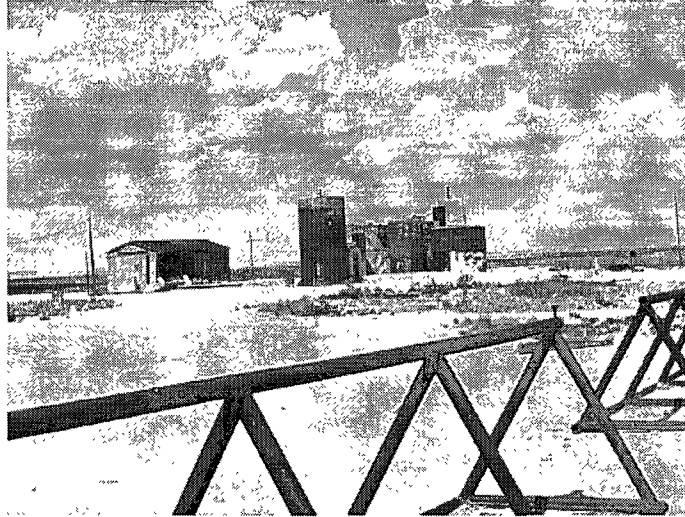
The tank battery is located on a topographically high area and much of the soil within the bermed area and the surrounding topographically low areas exhibit characteristics of one or more historic brine water releases. Three hand auger borings were installed in the low areas surrounding the tank battery in order to better characterize the extent of the chloride-impacted soil. Plate 2 is a site map drawn on a July 2005 satellite photograph that depicts the current extent of stressed vegetation, the location of the hand auger borings, and the laboratory results from soil samples recovered at the site. It should be noted that the extent of the stressed vegetation observed during the inspection has changed since 2005. Some of the vegetation to the north and south has decreased while areas to the west appear to have recovered.

At the topographically low areas to the north and west of the tank batteries chloride concentrations in soil prevent re-vegetation. The vertical extent of the impacted soil could not be determined due to auger refusal. Further investigations at the Red-12 State No. 4 site will be conducted to verify the vertical extent of the chloride-impacted soil in order to determine the potential threat to ground water. Following the completion of these activities a final report will be submitted to the NMOCD.
