R. T. HICKS CONSULTANTS, LTD.

August 12, 2009

RE: Seven Produced Fluid Releases at sites operated by Marks and Garner Production Ltd, Company in Eddy County, NM as follows:

Site Name (type)	Location (T-R-Sec.-Unit)	OCD Reference No.
Levers Fed. No. 7 (battery)	T-16-S, R-29-E, Sec 33 (J)	2RP-304
Levers No. 3Y (well)	T-16-S, R-29-E, Sec 33 (N)	2RP-305
Red 12 Fed. No. 1 (battery)	T-16-S, R-29-E, Sec 33 (O)	2RP-306
Cave State No. 4 (well)	T-17-S, R-29-E, Sec 4 (F)	2RP-307
Red 12 State No. 2 (battery)	T-17-S, R-29-E, Sec 4 (H)	2RP-308
Red 12 State No. 3 (battery)	T-17-S, R-29-E, Sec 5 (J)	2RP-309
Red 12 State No. 4 (battery)	T-17-S, R-29-E, Sec 5 (O)	2RP-310

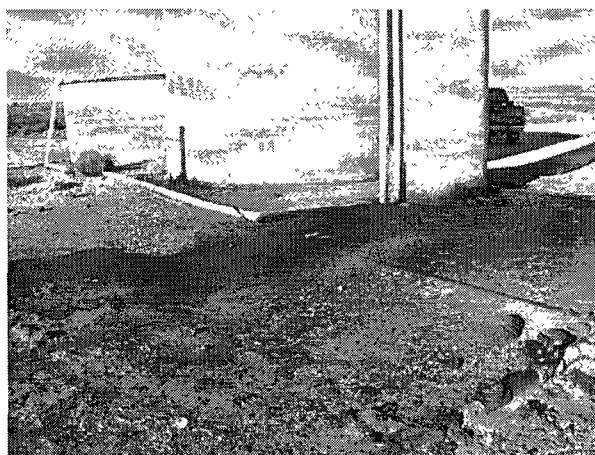
A release of heavy "tank bottom" oil occurred from a broken valve at the base of a large separator and extends approximately 30 feet down slope. We used a hand auger to obtain soil samples at depths of 0.5, 1.0, and 3.0 feet below the free liquid. Results of laboratory analyses on selected samples for benzene, toluene, ethylbenzene, xylenes; and gasoline, diesel, and oil range hydrocarbons as well as field screening and laboratory results are provided on the table below:

None of the hydrocarbon concentrations measured at the Levers Federal No. 7 site exceeds the 1993 NMOCD or 2006 NMED Guideline soil screening levels. The fact that the concentrations of regulated constituents do not exceed NMED Guidelines allows us to conclude that the impacted soil does not represent a threat to fresh water or public health. The recommended corrective action for this site is:

1. Remove out-of-service vessels or repair all leaks
2. Excavate the upper 6-inches of earth within the spill footprint
3. Mix the excavated spill material with 2-5 parts clean soil

4. Use this blended soil for the construction of firewalls around tank batteries (use now or stockpile on site for future use)
5. At abandonment of the site the surface will be restored according to the landowner's specifications

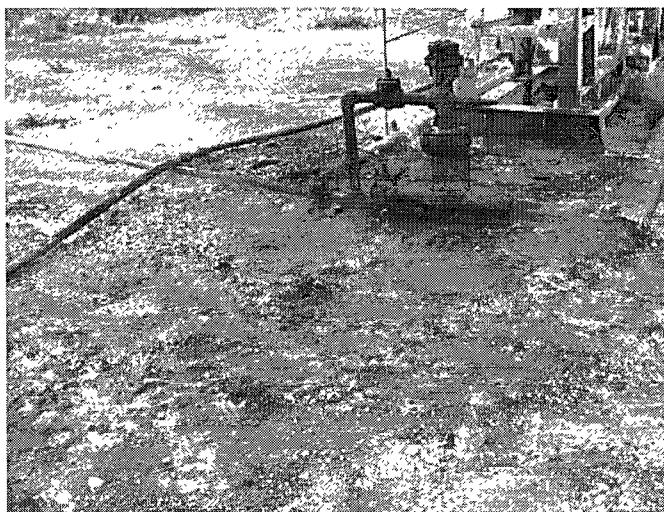
A release of oil occurred from the well head which extends approximately 10 feet in all directions. The table below presents field screening and the laboratory results from soil samples at the surface and at depths of 2.0, 3.0, 4.0, 5.0 and 6.0 feet below the stained area.

Total Petroleum Hydrocarbon (TPH) concentrations measured at the Levers No. 3 site exceeds the 1993 NMOCD Guideline levels but concentrations generally decrease from the surface to the auger refusal depth (6 feet below the surface). Most importantly, none of the regulated hydrocarbon concentrations exceed the 2006 NMED Guideline levels. The fact that the concentrations of regulated constituents do not exceed NMED Guidelines allows us to conclude that the impacted soil does not represent a threat to fresh water or public health. The recommended corrective action for this site is:

1. Remove out-of-service vessels or repair all leaks
2. Excavate the upper 1-2 feet of earth within the spill footprint
3. Mix the excavated spill material with 2-5 parts clean soil
4. Use this blended soil for the construction of firewalls around tank batteries (use now or stockpile on site for future use)
5. Collect a composite sample of the blended soil to demonstrate that constituents are at concentrations that comply with NMOCD Rules and provide letter report to NMOCD
6. At abandonment of the site the surface will be restored according to the landowner's specifications

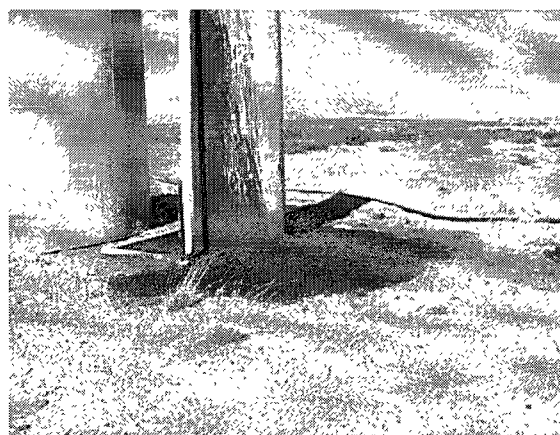
A release of heavy "tank bottom" oil occurred from a broken valve at the base and from a pipe joint near the top of the separator. The spill area extends approximately 30 feet down slope. Laboratory results of soil samples recovered using a hand auger at depths of 0.5, 1.0, and 3.0 feet below the free liquid and field screening are provided on the table below:

TPH concentrations measured from near the surface at the Red-12 Federal No. 1 site exceeds the 1993 NMOCD Guideline levels but decreases to below the guideline levels at 3 feet below the surface. None of the regulated hydrocarbon concentrations exceed the 2006 NMED Guideline levels. The fact that the concentrations of regulated constituents do not exceed NMED Guidelines allows us to conclude that the impacted soil does not represent a threat to fresh water or public health. The recommended corrective action for this site is:

1. Remove out-of-service vessels or repair all leaks
2. Excavate the upper 6-12 inches of earth within the spill footprint
3. Mix the excavated spill material with 2-5 parts clean soil
4. Use this blended soil for the construction of firewalls around tank batteries (use now or stockpile on site for future use)
5. Collect a composite sample of the blended soil to demonstrate that constituents are at concentrations that comply with NMOCD Rules and provide letter report to NMOCD
6. At abandonment of the site the surface will be restored according to the landowner's specifications

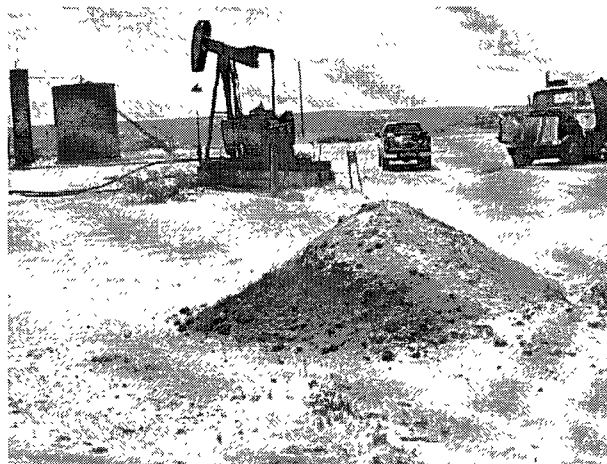
The operator excavated and stockpiled soil from an apparent release of oil that occurred prior to our characterization. Laboratory and field results from soil samples recovered from the stockpile and below the spill footprint are provided on the table below:

The hydrocarbon concentrations from the removed stockpiled soil at Cave State No. 4 site exceeds the 1993 NMOCD Guideline levels for TPH and the 2006 NMED Guideline levels for benzene. None of the hydrocarbon concentrations measured from the remaining (deeper) soil exceeds either the 1993 NMOCD or 2006 NMED Guideline soil screening levels.

The fact that the concentrations of regulated constituents do not exceed NMED Guidelines allows us to conclude that the impacted soil below the original spill footprint does not represent a threat to fresh water or public health.

We recommend that the operator mix the stockpile with clean soil and utilize it for the construction of a firewall at one of the active tank batteries.

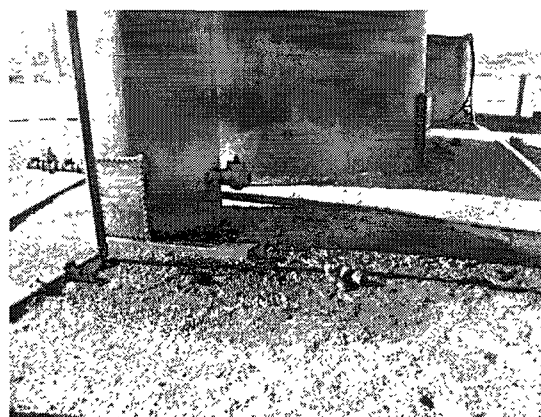
A release of heavy "tank bottom" oil occurred from a broken valve at the base of a separator and extends approximately 20 feet down slope. Results of laboratory and field analyses of soil samples recovered using a hand auger at depths of 0.5, 1.0, and 3.0 feet below the free liquid are provided on the table below:

TPH concentrations measured from near the surface at the Red-12 State No. 2 site exceeds the 1993 NMOCD Guideline levels but decreases to below the guideline levels at 3 feet below the surface. None of the measured hydrocarbon concentrations exceed the 2006 NMED Guideline levels. The fact that the concentrations of regulated constituents do not exceed NMED Guidelines allows us to conclude that the impacted soil does not represent a threat to fresh water or public health. The recommended corrective action for this site is:

1. Remove out-of-service vessels or repair all leaks
2. Excavate the upper 6-12 inches of earth within the spill footprint
3. Mix the excavated spill material with 2-5 parts clean soil
4. Use this blended soil for the construction of firewalls around tank batteries (use now or stockpile on site for future use)
5. Collect a composite sample of the blended soil to demonstrate that constituents are at concentrations that comply with NMOCD Rules and provide letter report to NMOCD.
6. At abandonment of the site the surface will be restored according to the landowner's specifications.

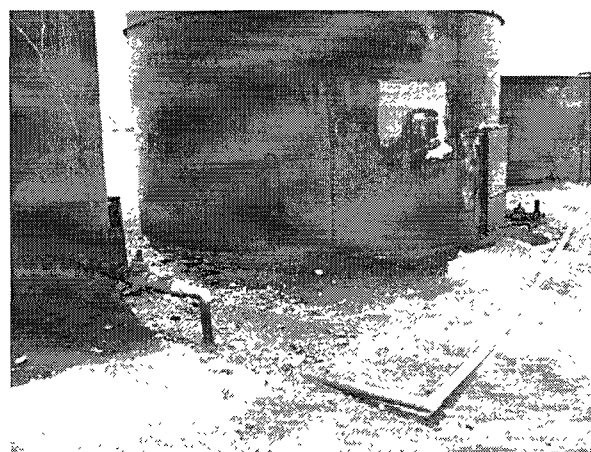
A release of heavy "tank bottom" oil occurred from leaks located at the base of a 500-bbl oil tank and a separator. The surface staining is present in an area of approximately 500 ft². A composite surface soil sample was recovered from the stained area and subsurface soil samples were recovered from two hand auger borings at depths of 1.0 and 2.0 feet below the free liquid. Laboratory analyses were performed to determine the concentrations of benzene, toluene, ethylbenzene, xylenes; and gasoline, diesel, and oil range hydrocarbons. Field screening and laboratory results are provided on the table below:

TPH concentrations measured from near the surface at the Red-12 State No. 3 site exceeds the 1993 NMOCD Guideline levels but decreases to below the guideline levels at 1 and 2 feet below the surface. None of the measured hydrocarbon concentrations exceed the 2006 NMED Guideline soil screening levels. The fact that the concentrations of regulated constituents do not exceed NMED Guidelines allows us to conclude that the impacted soil does not represent a threat to fresh water or public health. The recommended corrective action for this site is:

1. Remove out-of-service vessels or repair all leaks
2. Excavate the upper 1-2 feet of earth within the spill footprint
3. Mix the excavated spill material with 2-5 parts clean soil
4. Use this blended soil for the construction of firewalls around tank batteries (use now or stockpile on site for future use)
5. Collect a composite sample of the blended soil to demonstrate that constituents are at concentrations that comply with NMOCD

Rules and provide letter report to NMOCD

6. At abandonment of the site the surface will be restored according to the landowner's specifications.

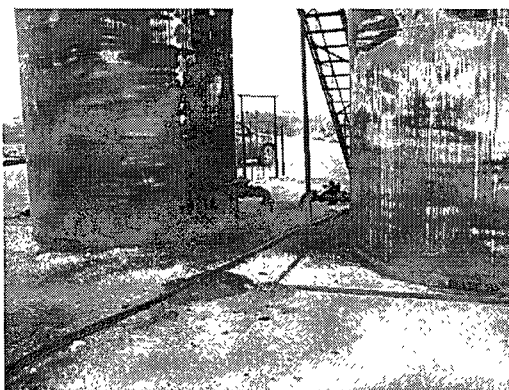
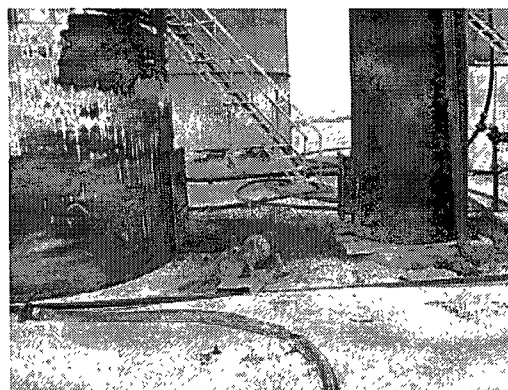
Historic spills within the tank battery have occurred resulting in an "asphalt-like" stained soil area of approximately 400 ft². A composite surface soil sample was recovered from the stained area and laboratory analyses were performed to determine the concentrations of benzene, toluene, ethylbenzene, xylenes; and gasoline, diesel, and oil range hydrocarbons. Laboratory results are provided on the table below:

TPH concentrations measured from near the surface at the Red-12 State No. 4 battery site exceed the 1993 NMOCD Guideline levels but none of the measured hydrocarbon concentrations exceed the 2006 NMED Guideline levels. The fact that the concentrations of regulated constituents do not exceed NMED Guidelines allows us to conclude that the hydrocarbon-impacted soil does not represent a threat to fresh water or public health. The recommended corrective action for this site is:

1. Repair all leaks
2. Excavate the upper 1-2 feet of earth within the spill footprint
3. Mix the excavated spill material with 2-5 parts clean soil
4. Use this blended-asphaltic soil for the construction of firewalls around tank batteries (use now or stockpile on site for future use)
5. Collect a composite sample of the blended soil to demonstrate that constituents are at concentrations that comply with NMOCD Rules and provide letter report to NMOCD
6. At abandonment of the site, disc hay and other organic material into hydrocarbon-impacted soil to open soil structure and permit infiltration of precipitation. Repeat tilling and addition of organic material or other soil amendments as necessary to meet landowner mandates for surface restoration and thereby eliminate the threat to the environment (i.e. soil and habitat) posed by the hydrocarbon-impacted soils

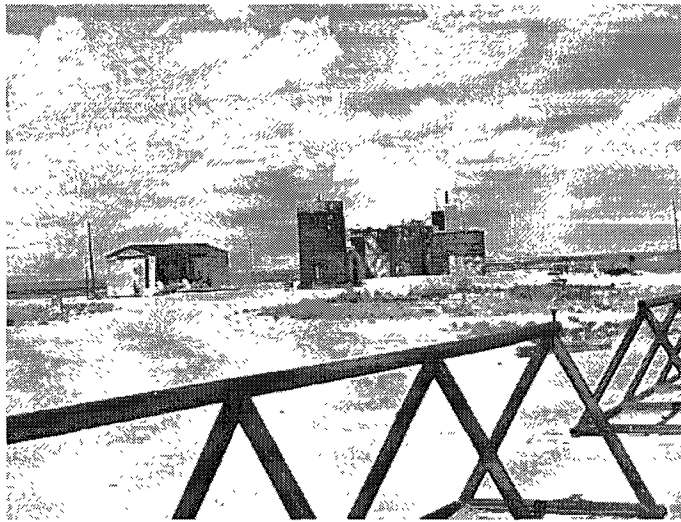
The tank battery is located on a topographically high area and much of the soil within the bermed area and the surrounding topographically low areas exhibit characteristics of one or more historic brine water releases. Three hand auger borings were installed in the low areas surrounding the tank battery in order to better characterize the extent of the chloride-impacted soil. Plate 2 is a site map drawn on a July 2005 satellite photograph that depicts the current extent of stressed vegetation, the location of the hand

auger borings, and the laboratory results from soil samples recovered at the site. It should be noted that the extent of the stressed vegetation observed during the inspection has changed since 2005. Some of the vegetation to the north and south has decreased while areas to the west appear to have recovered.

At the topographically low areas to the north and west of the tank batteries chloride concentrations in soil prevent re-vegetation. The vertical extent of the impacted soil could not be determined due to auger refusal. Further investigations at the Red-12 State No. 4 site will be conducted to verify the vertical extent of the chloride-impacted soil in order to determine the potential threat to ground water. Following the completion of these activities a final report will be submitted to the NMOCD.
