**CQA / CQC
REPORT**

**ENGINEERING CERTIFICATION REPORT
FOR
EVAPORATION POND 3 CONSTRUCTION**

**BASIN DISPOSAL, INC.
BLOOMFIELD, NEW MEXICO**

**Re: Basin Disposal Inc: [OCD Permit No. 1-0005]
Engineering Certification Report: Evaporation Pond 3 Construction [520.01.01]**

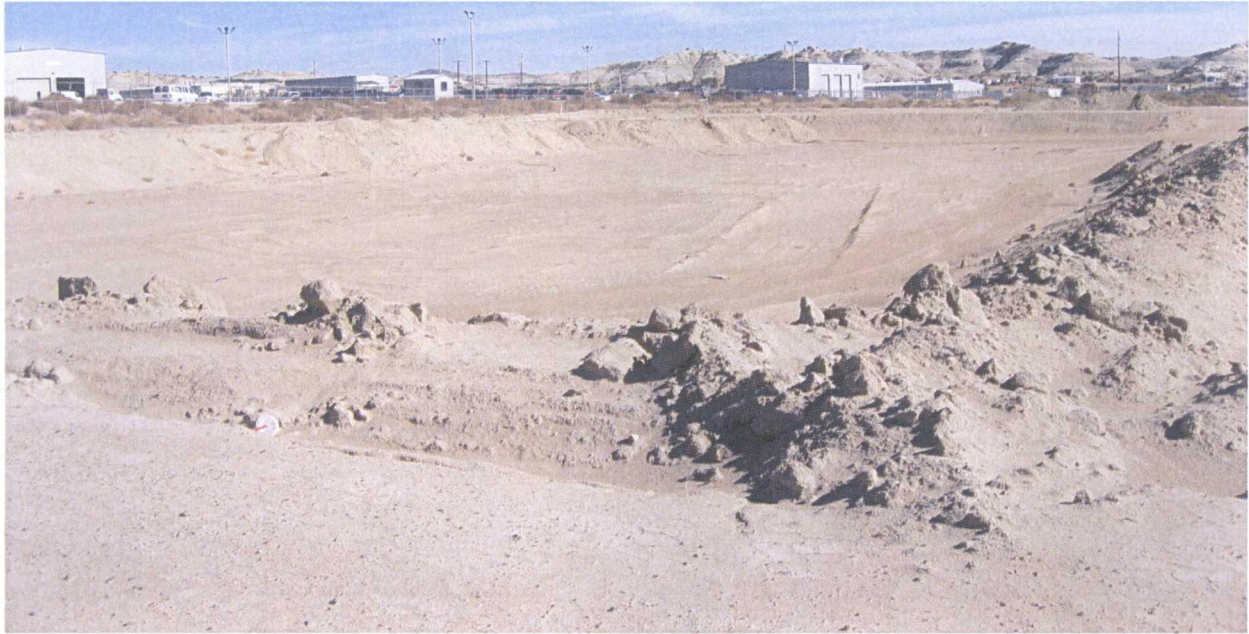
1. 11-13-08 Site conditions prior to Pond 3 construction

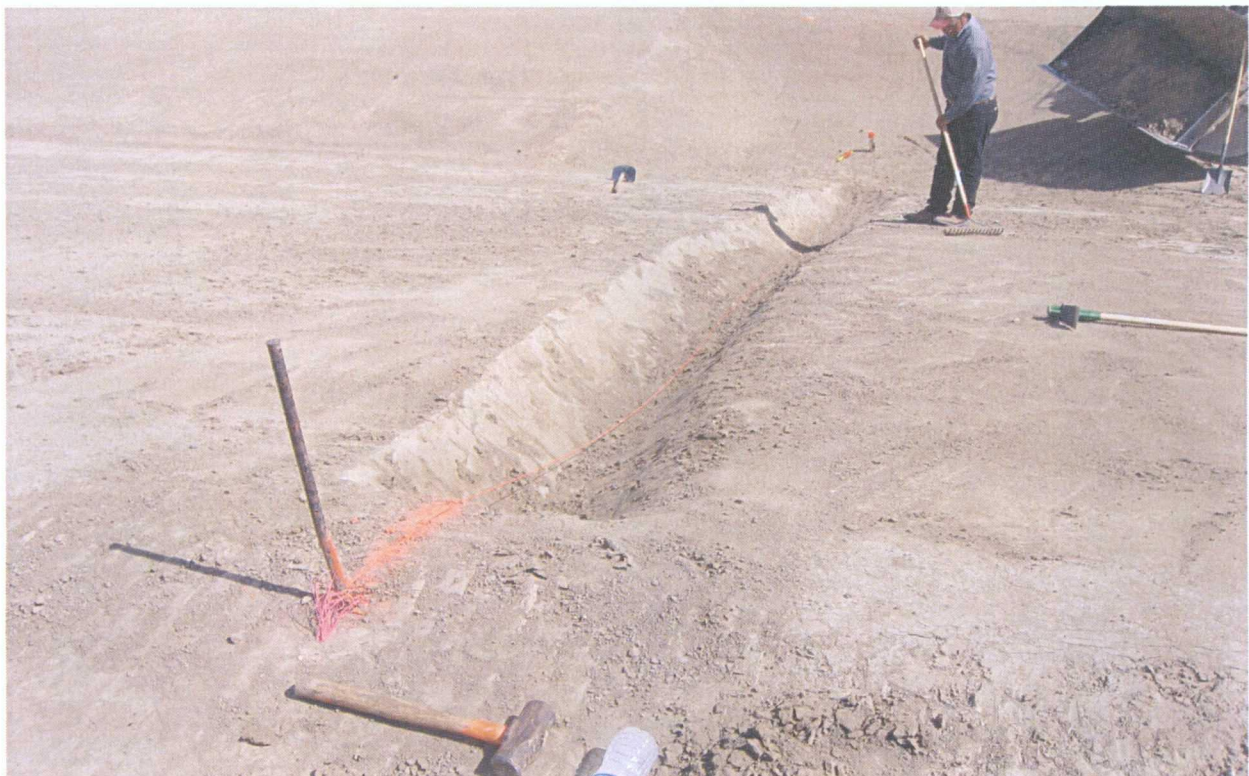
13. 6-15-09 Trench for leak detection riser pipe

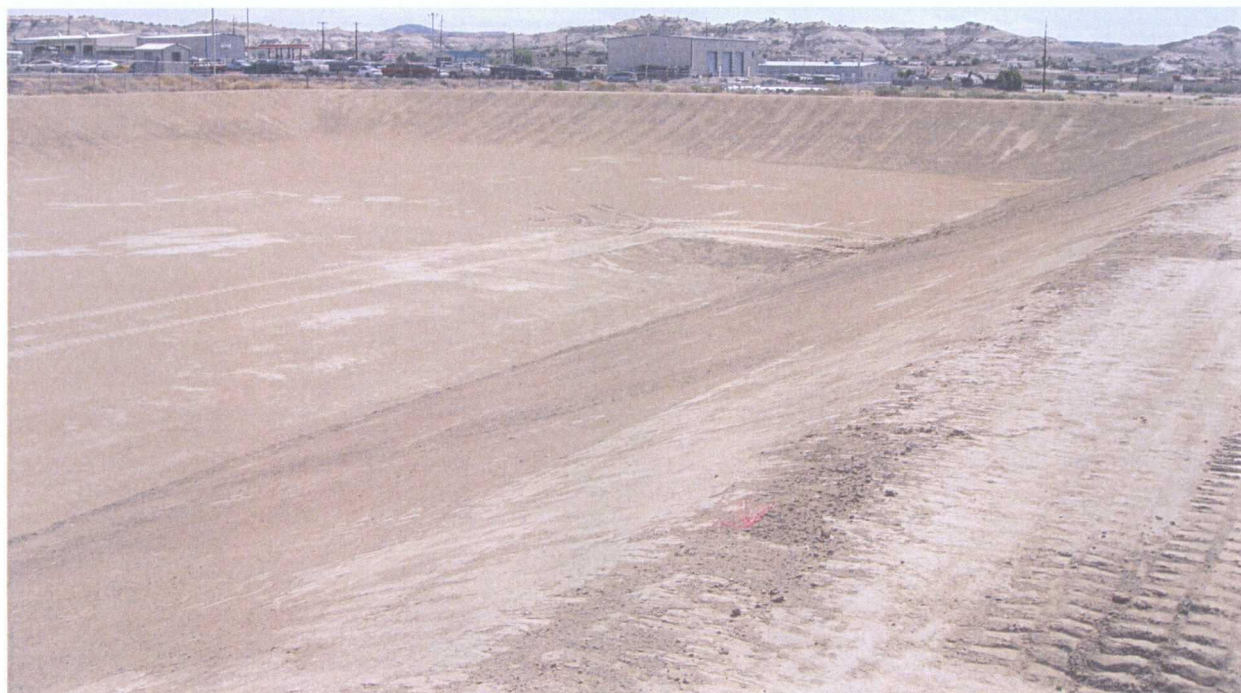
15. 6-15-09 Pond construction complete and ready for lining

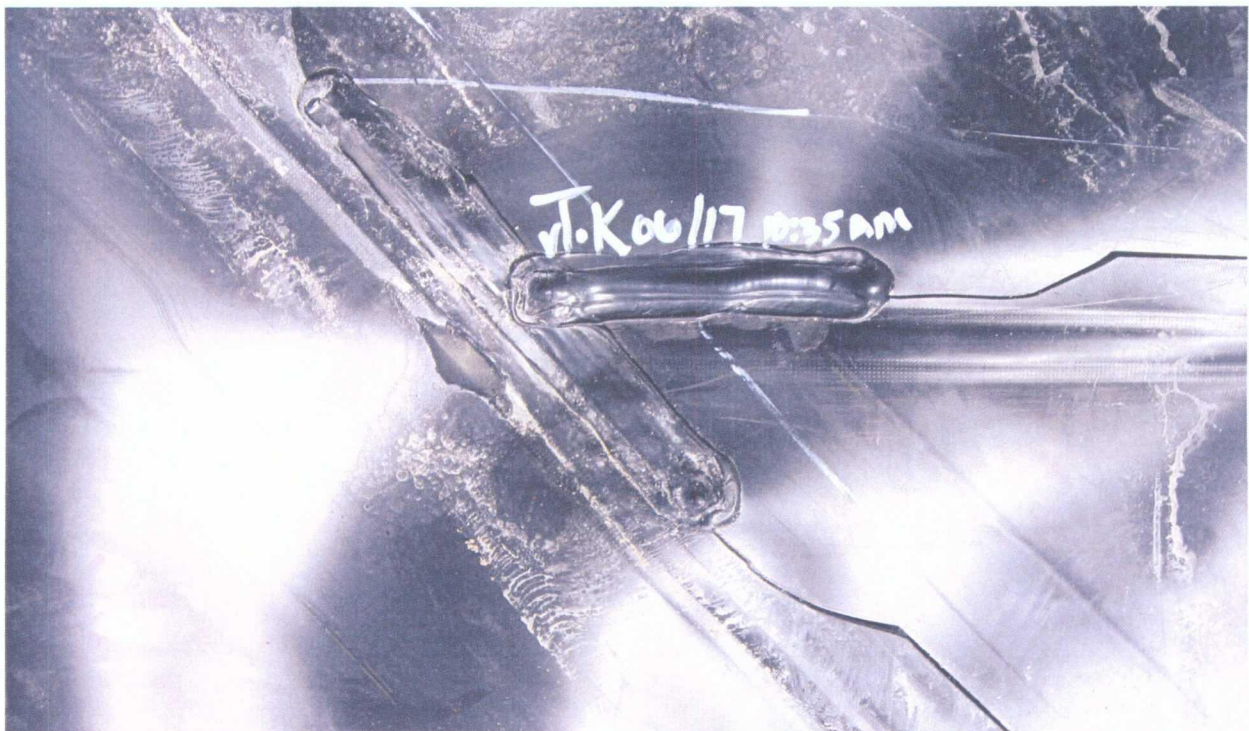
41. 6-17-09 "T" weld completed and vacuum tested

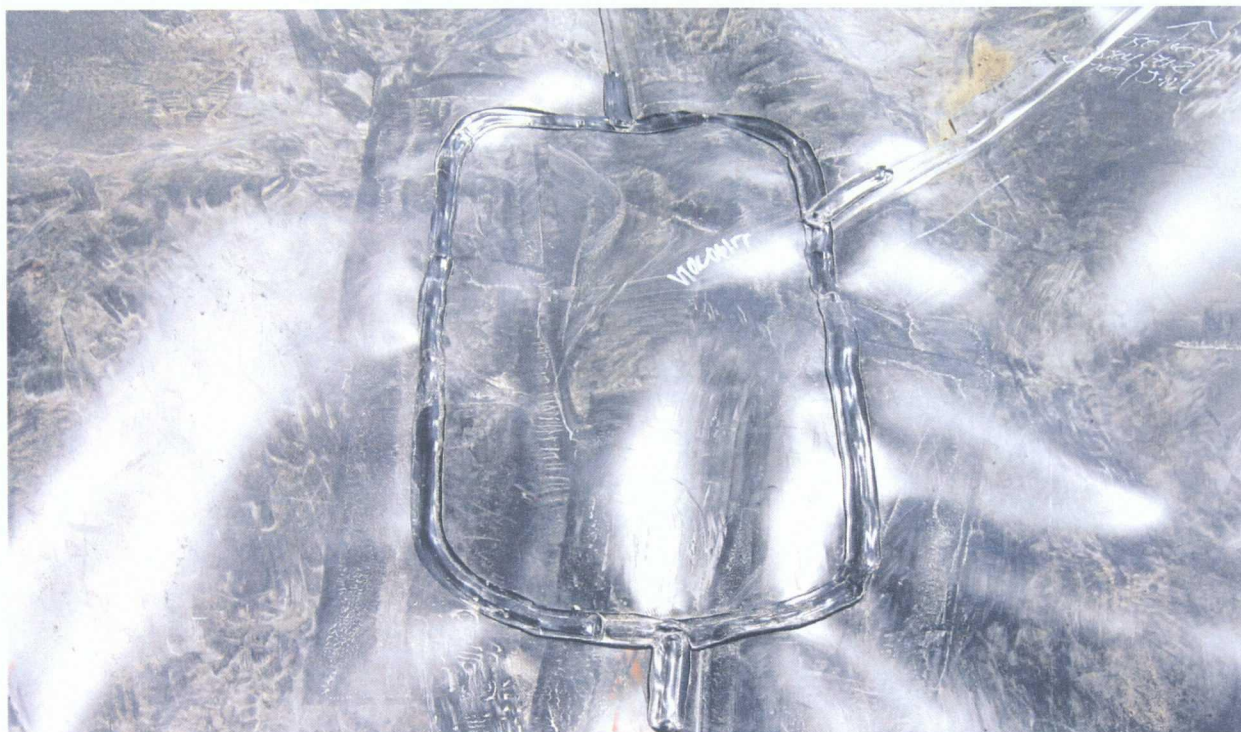
42. 6-17-09 Patch installed and vacuum tested

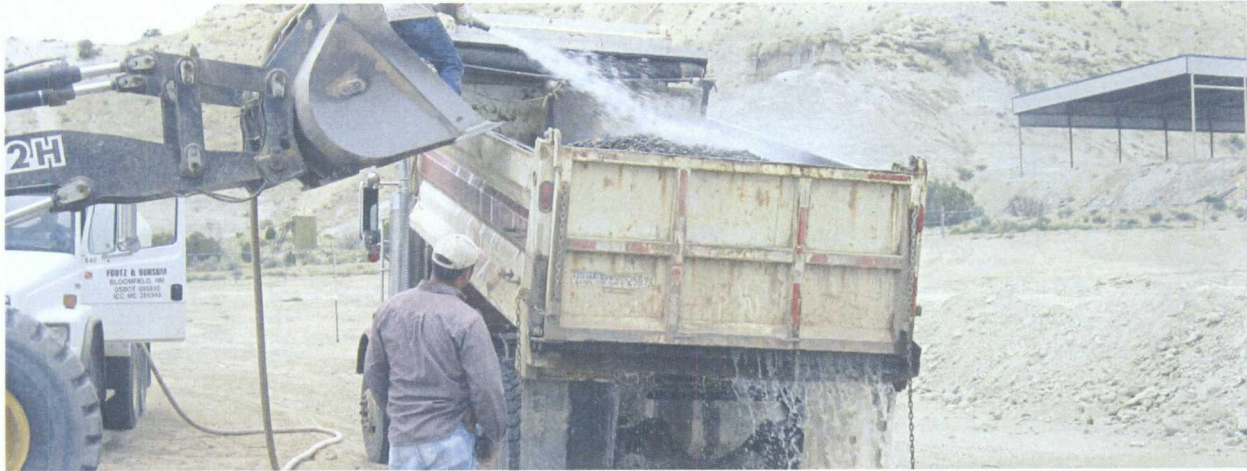
44. 6-17-09 Washing aggregate for leak detection sumps

Initial sieve analysis of the aggregate reported a 1% fines content. In communications with both the Contractor and the Site CQA Officer it was decided to wash the material and take a second sieve analysis. The material was washed using a water truck and the slightly elevated bed of a dump truck containing the aggregate. Once the sieve analysis was presented to the Site CQA Technician, the Site CQA Officer was contacted to discuss the issue of > 2% passing the ¾-inch sieve. After reviewing the second sieve analysis, the Site CQA Officer approved this material on the condition that the leak detection riser pipe be wrapped with geotextile material, to prevent the potential intrusion of material less than ½-inch in size. This decision was also based on the fact that materials smaller than the pipe perforations (i.e. ½") are less than 1% by weight. GEI's Site CQA Technician was on-site for the verification of this process, as documented in the **Field Log and Photographs** section of this report.

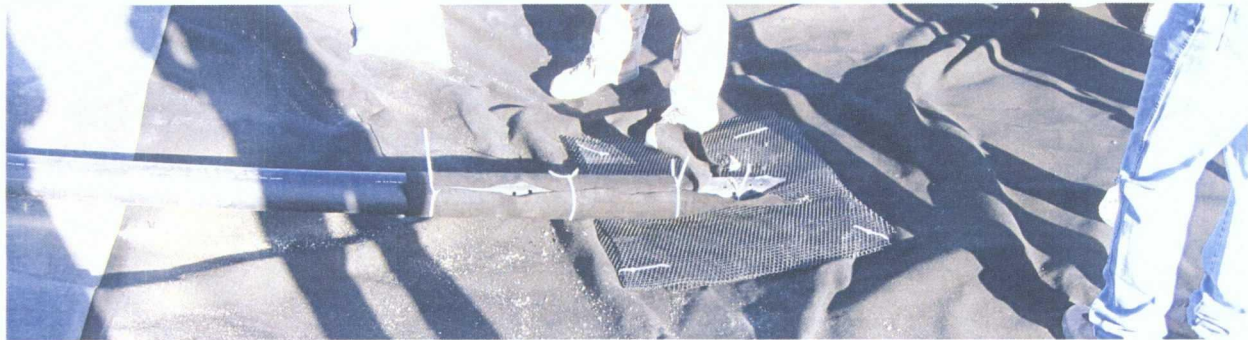
46. 6-18-09 Textile covering holes in leak detection riser pipe (textile pulled back to show holes underneath)

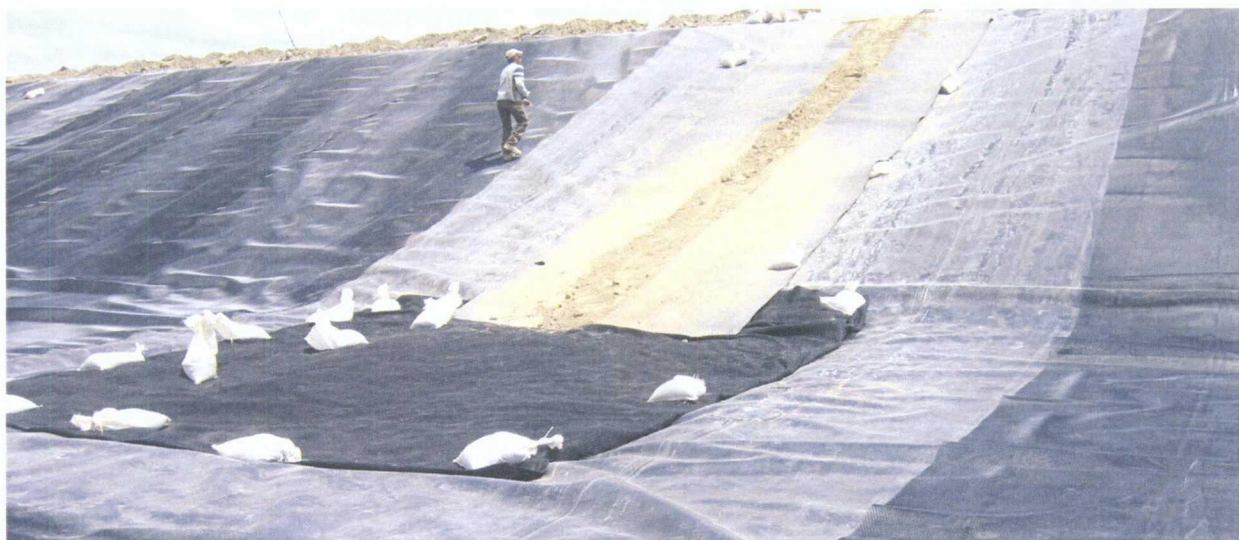
53. 6-18-09 Completed leak detection system

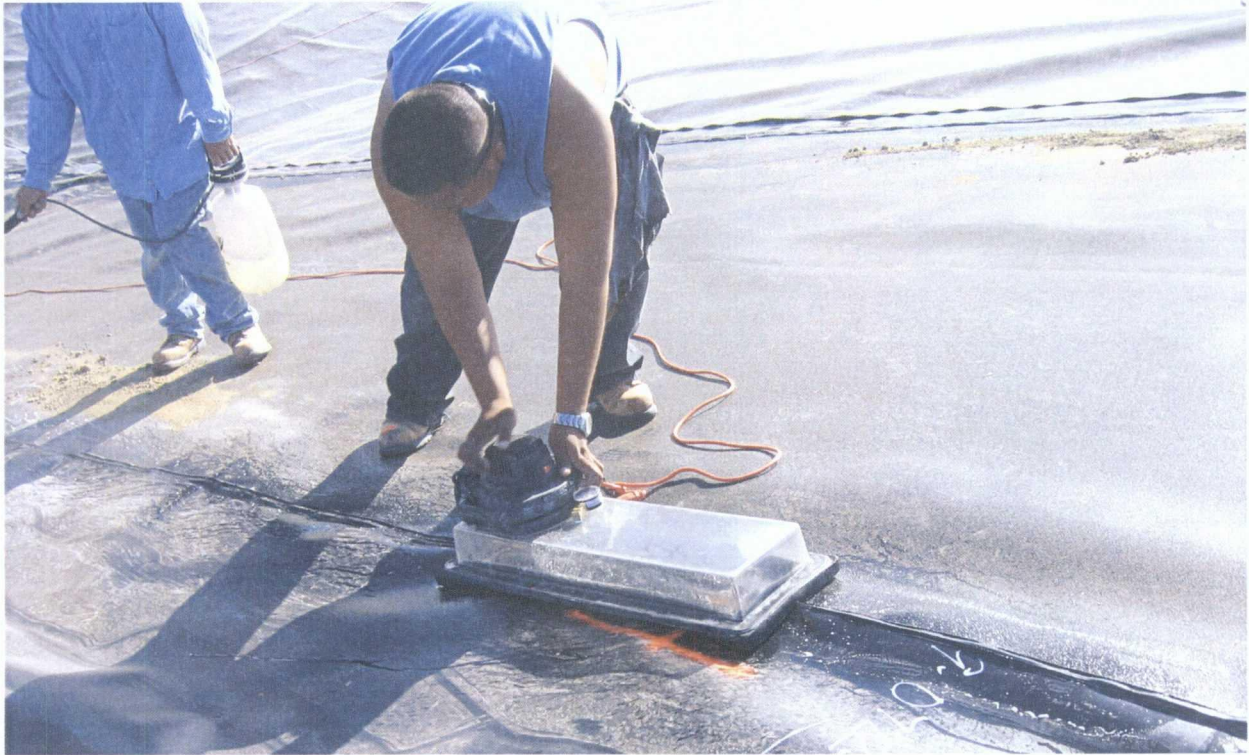
69. 6-24-09 Vacuum testing extrusion welds

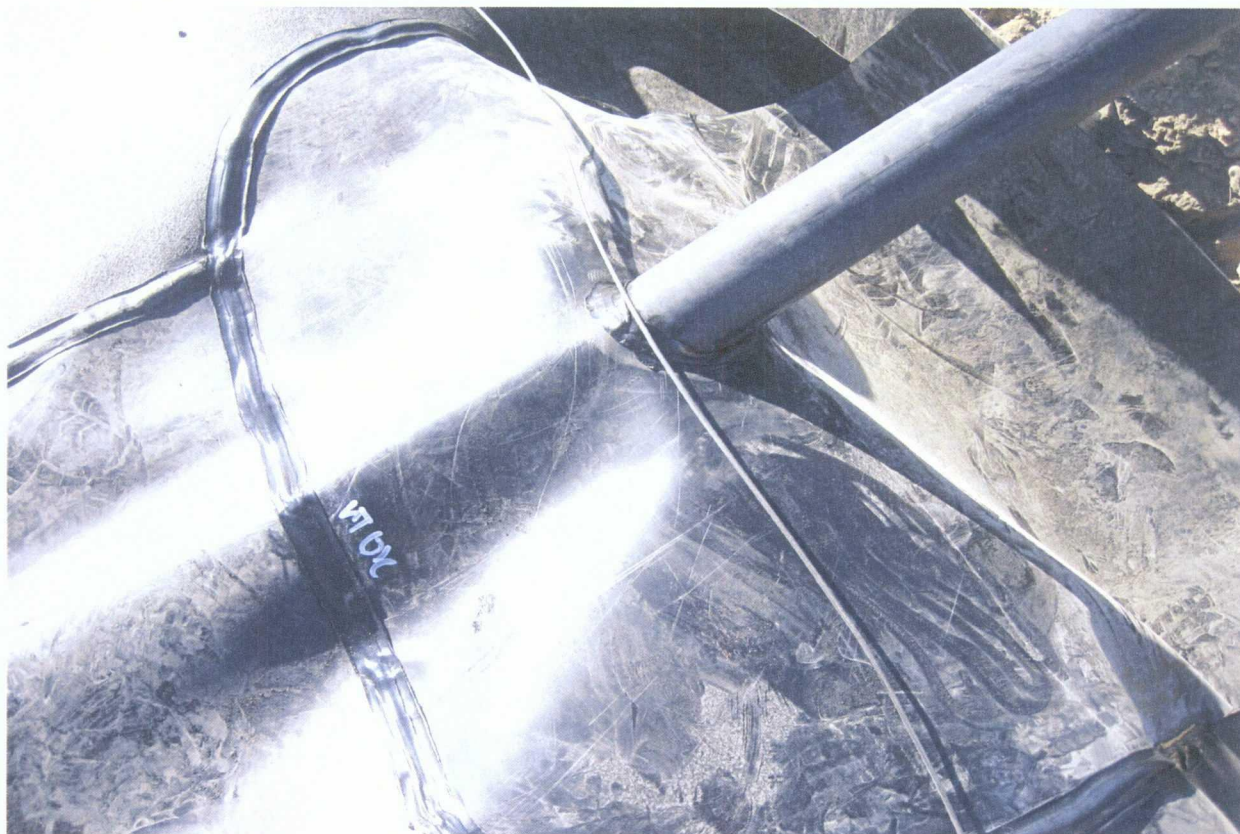
71. 6-24-09 Patch and pipe boot over leak detection riser pipe

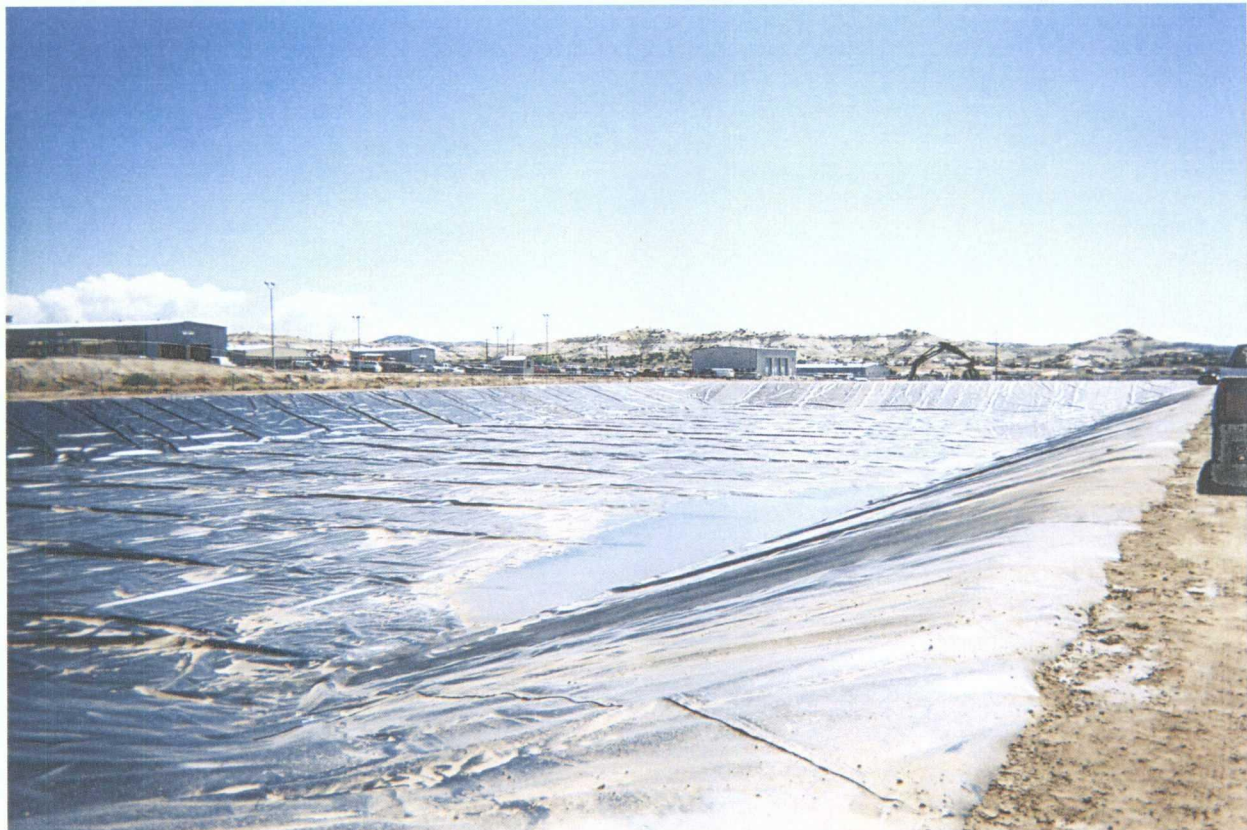
74. 6-29-09 Completed pond

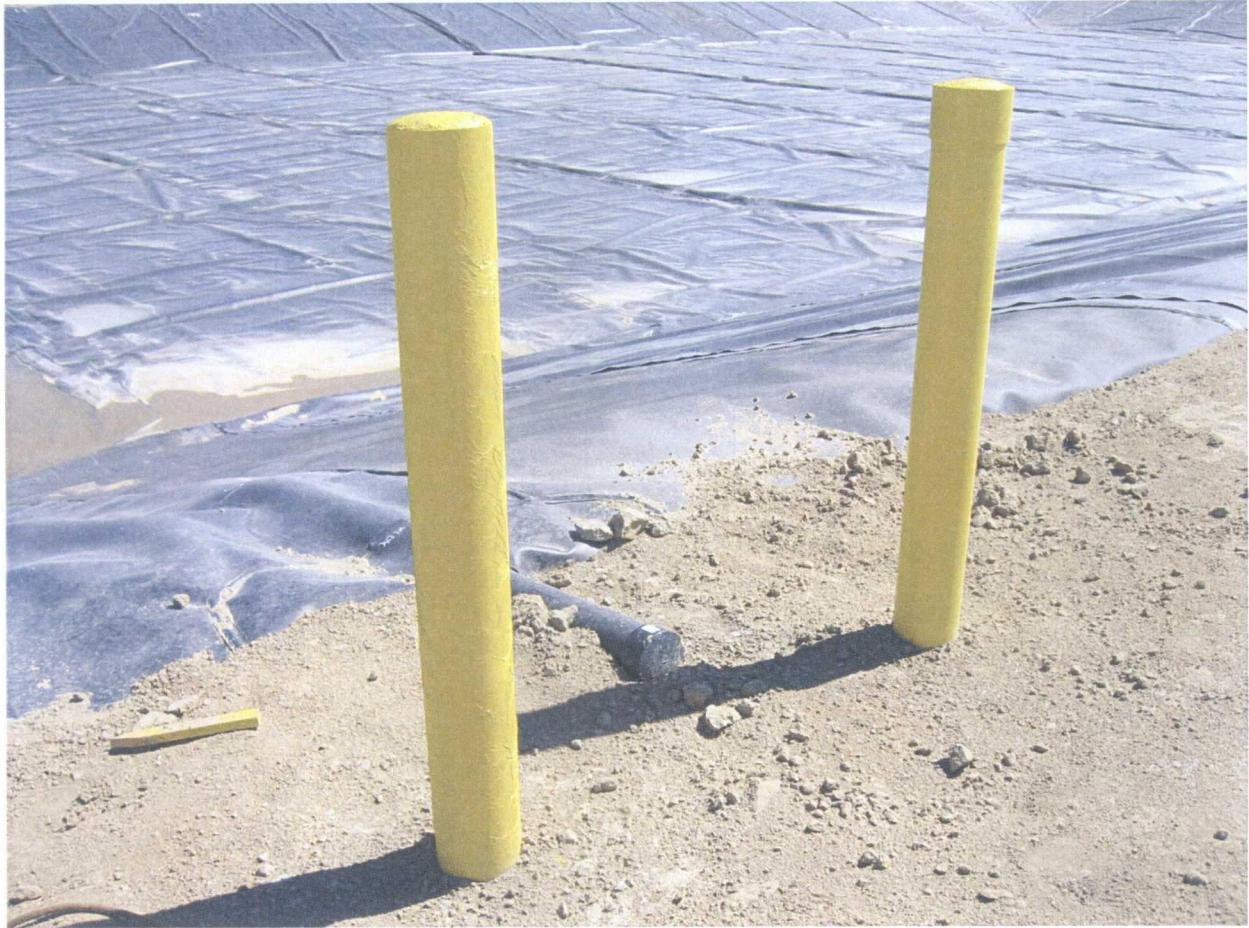
77. 7-28-09 Completed installation of Bollards protecting leak detection riser pipes.
