# **GW - 148**

# **INSPECTION**

**Re: Pump Mesa Compressor Station  
New Mexico Oil Conservation Division Inspection Report, GW-148  
NE/4, SW/4 Section 14, Township 31 North, Range 8 West, NMPM  
San Juan County, NM**

**Val Verde Gas Gathering L.P.  
Pump Mesa Compressor Station  
New Mexico Oil Conservation Division Inspection Report, GW-148**

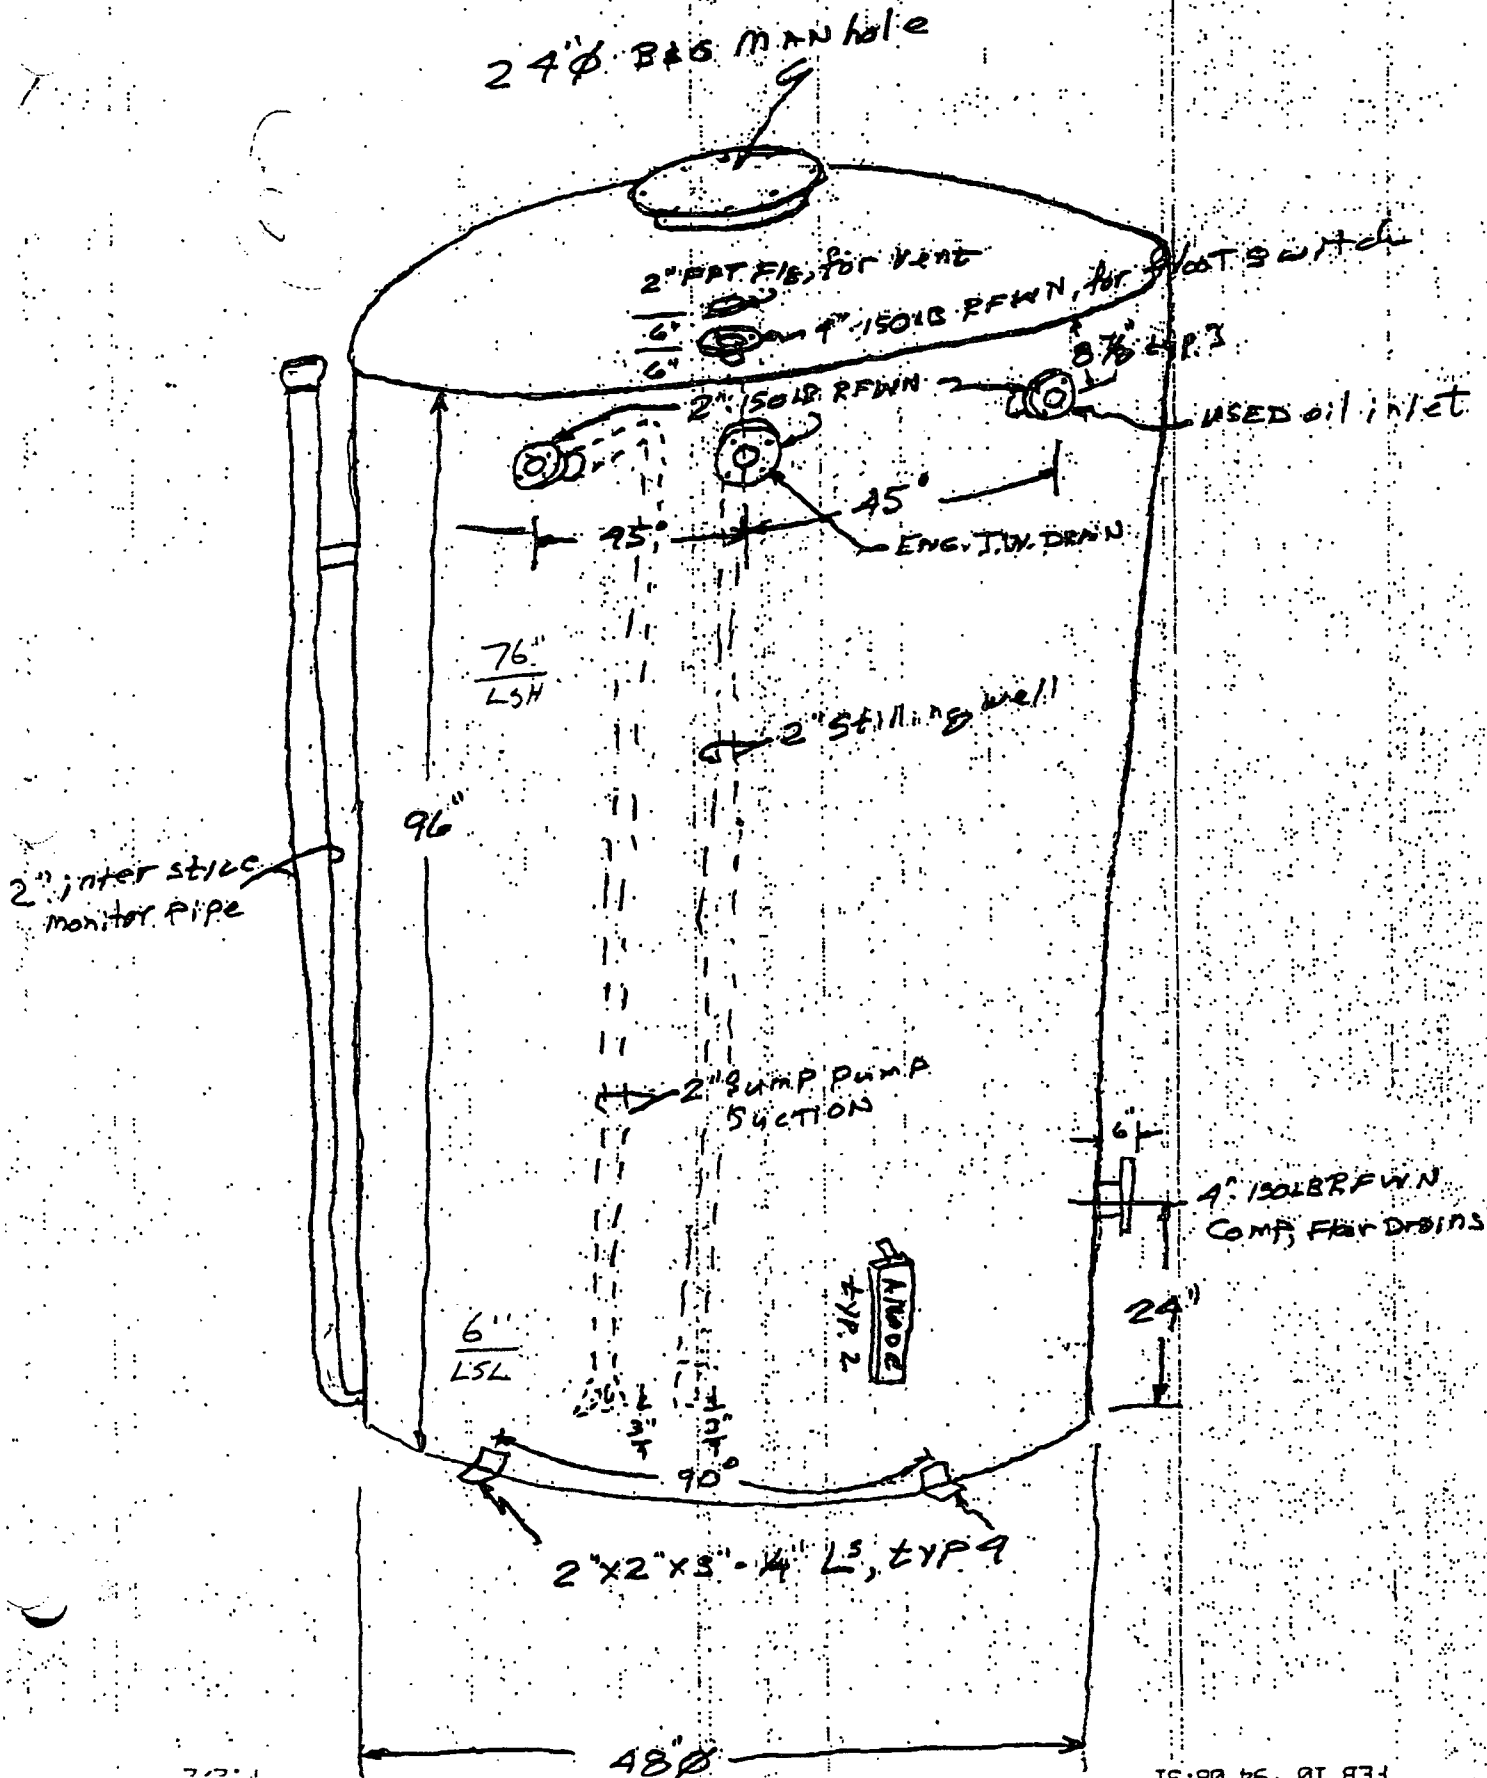
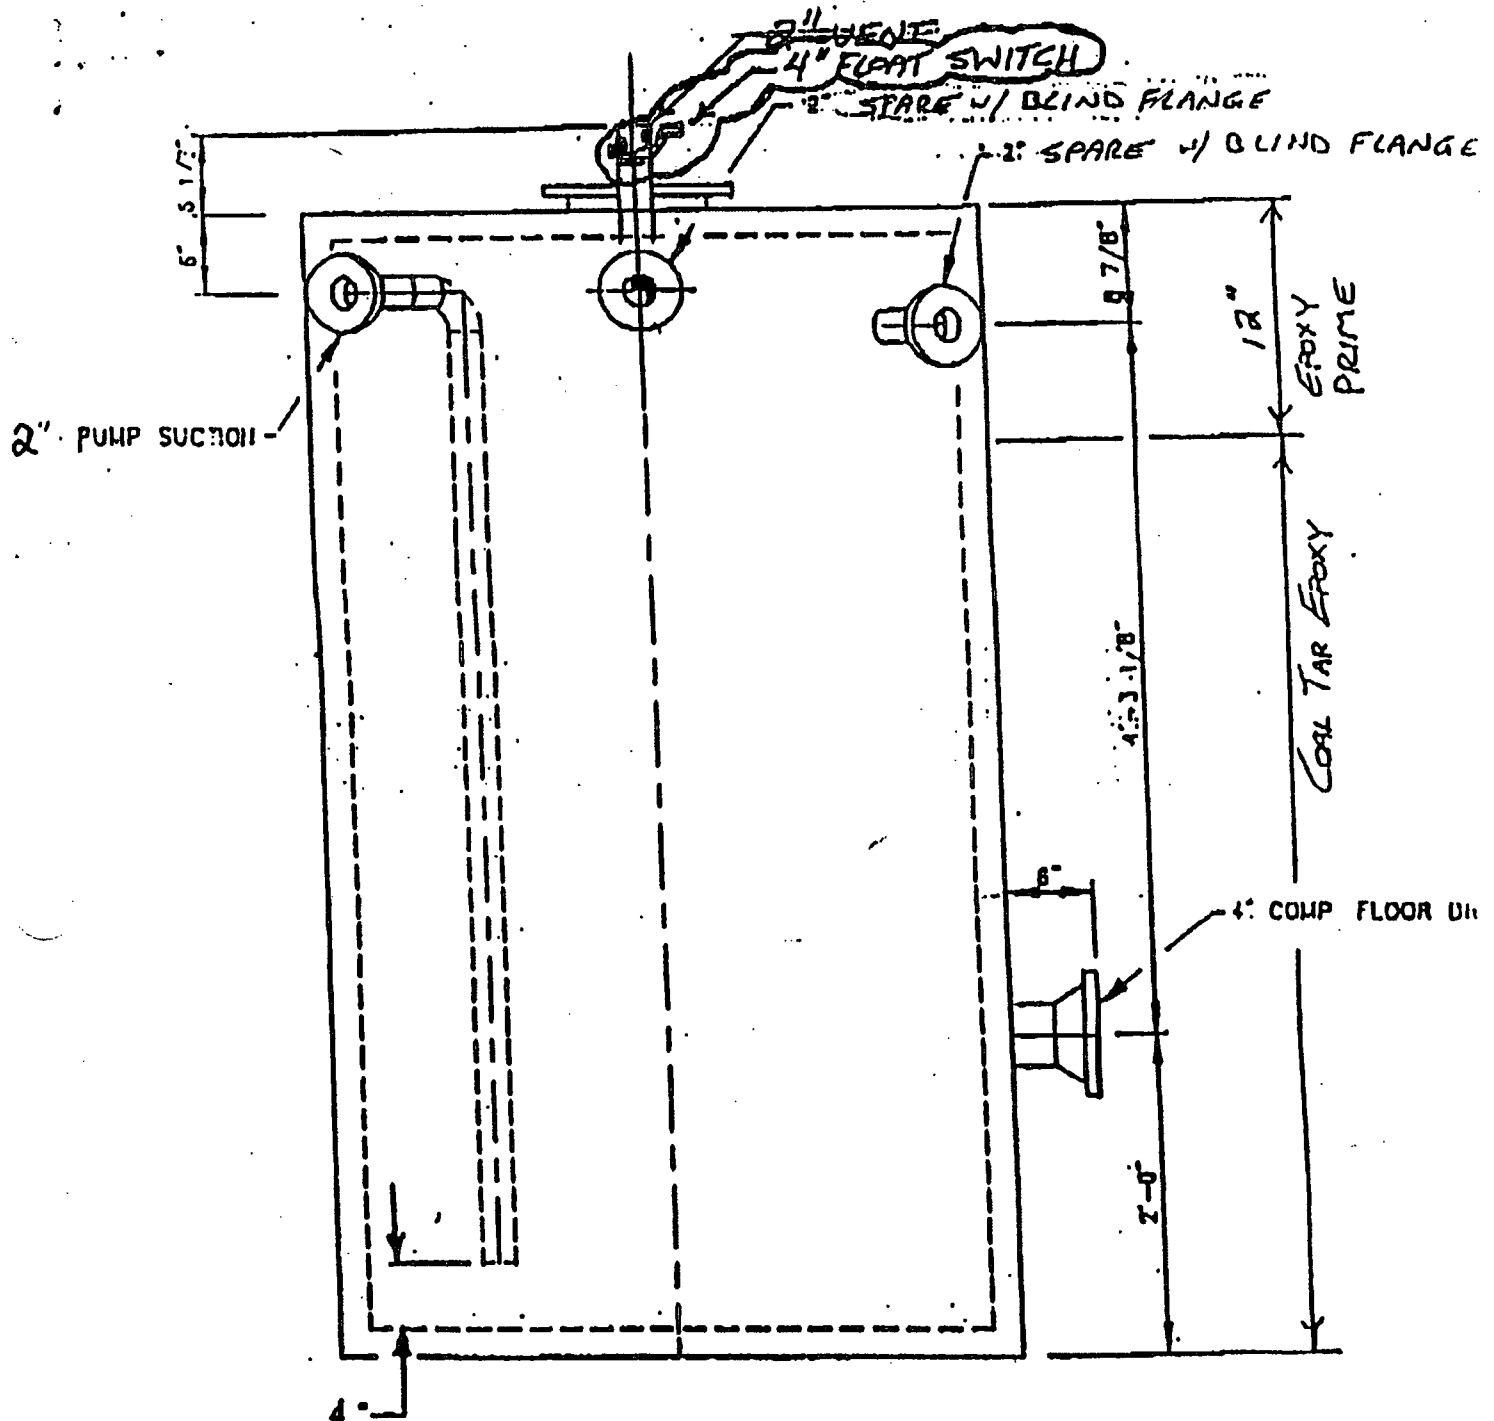
# Pump Mesa Sump

Response: Both BGTs noted in photos 1 & 6 are similarly designed and are double walled with electronic leak detection that is checked and documented on a monthly basis. Please find the attached construction specification (Attachment A) for the below grade tanks. These below grade tanks have an alarm that actuates if liquids are detected in the interstitial space between the primary tank and secondary wall. Monthly inspections are also conducted to determine the integrity of the sub-grade tank, please find a copy (Attachment B) of a recent representative inspection.
