GW - ___032____

Giant Ciniza Refinery Evaporation Pond & Aeration Lagoon Follow-up Inspection January 4, 2007

Giant Ciniza Refinery Fire Inspection Follow-up of 10/05/06 Alkylation Unit Fire October 11, 2006

OCD Ciniza Refinery Evaporation Pond 2 Corrective Action Inspection May 10, 2006

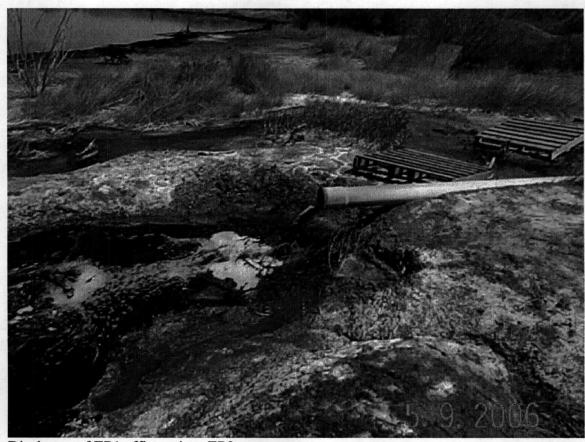
Discharge of EP1 effluent into EP2

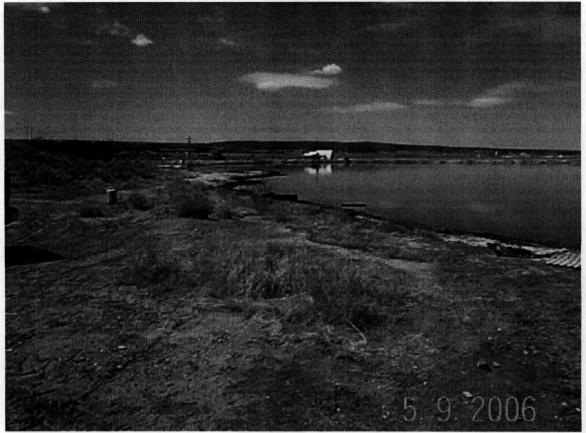
Looking southward from NE side of EP2 along eastern shoreline. Eastern shoreline is estimated to be about 300 ft. long.

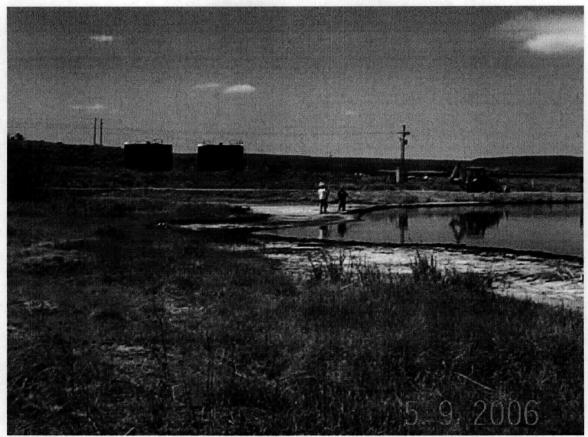
Looking southward from mid-point along east side of EP 2 shoreline at scraped waste along shoreline and workers preparing for a lunch break.

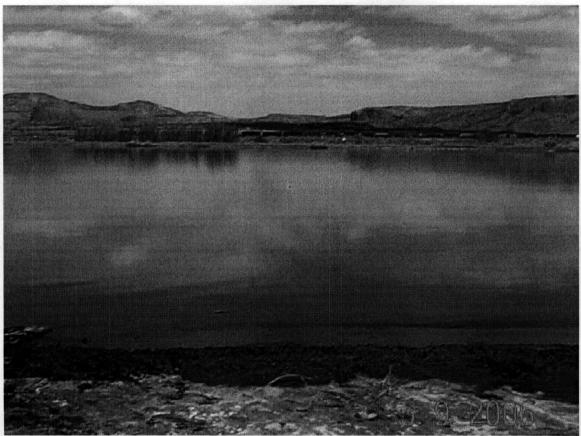
Looking westward from east side middle section of EP2. Scraped waste on shoreline in foreground. Notice clean shoreline conditions on west side of pond.

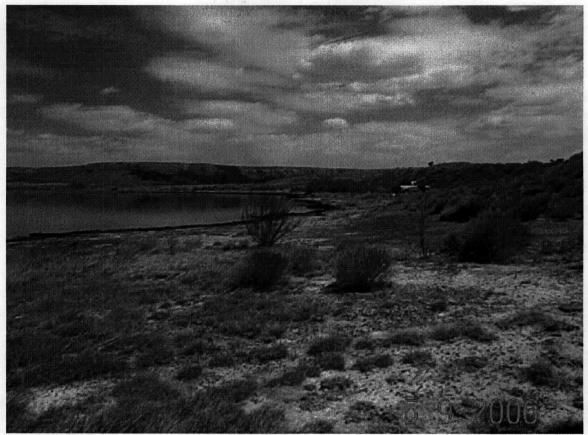
Looking northward from SE side of pond along east side of EP 2 shoreline. Eastern shoreline is estimated to be about 300 ft. long.

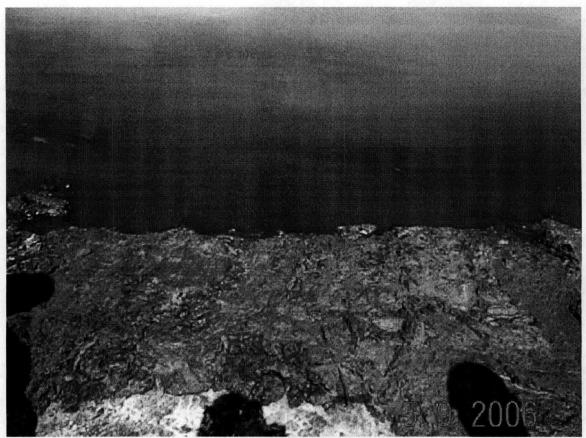
Contractors are digging with long scrapers by hand at least 4 inches deep from at least 2 feet inside of pond scraping waste outward over shoreline. Anticipated volume of waste expected from soil cleanup is expected to be greater than 200 ft³ or 7.4 yd³ as the shoreline will end up being scraped during the waste removal process.

Corrective action required to clean up oil from evaporation ponds. Giant has vacuum trucks working to remove oil from treatment system.

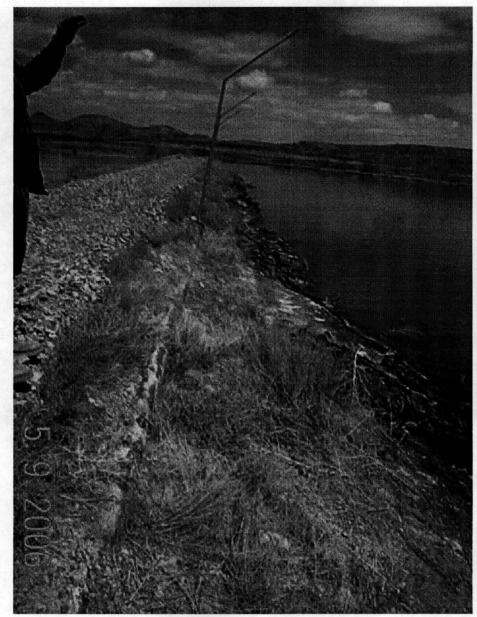
Looking northward from SW of EP2 along shoreline.

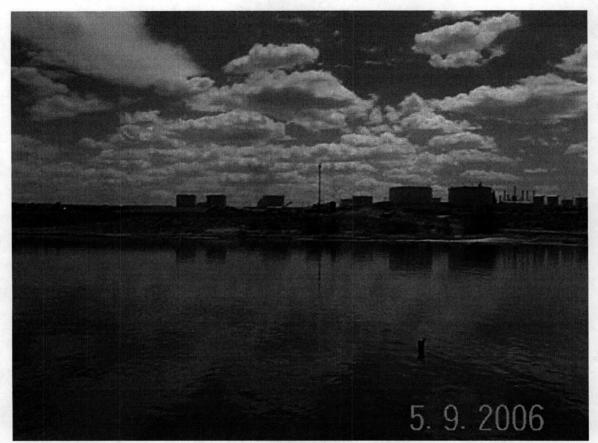
Looking eastward from center west shoreline of EP2 back toward refinery.

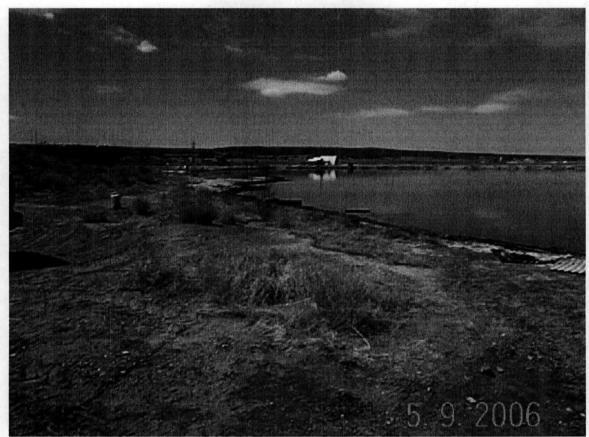
Looking southward from NE point along EP2 shoreline. Eastern shoreline is estimated to be about 300 ft. long.

Oil in Evaporation Ponds 1 & 2 that needs to be cleaned up.
