GW - 164

INSPECTION

RE: Sump Integrity Test Results and Retrofit Plan
Wood Group ESP, Inc., Hobbs Test Facility (GW-164)
8426 North Dal Paso, Hobbs, New Mexico 88240

RE: Sump Closure
Wood Group ESP, Inc., Hobbs Test Facility (GW-164)
8426 North Dal Paso, Hobbs, New Mexico 88240

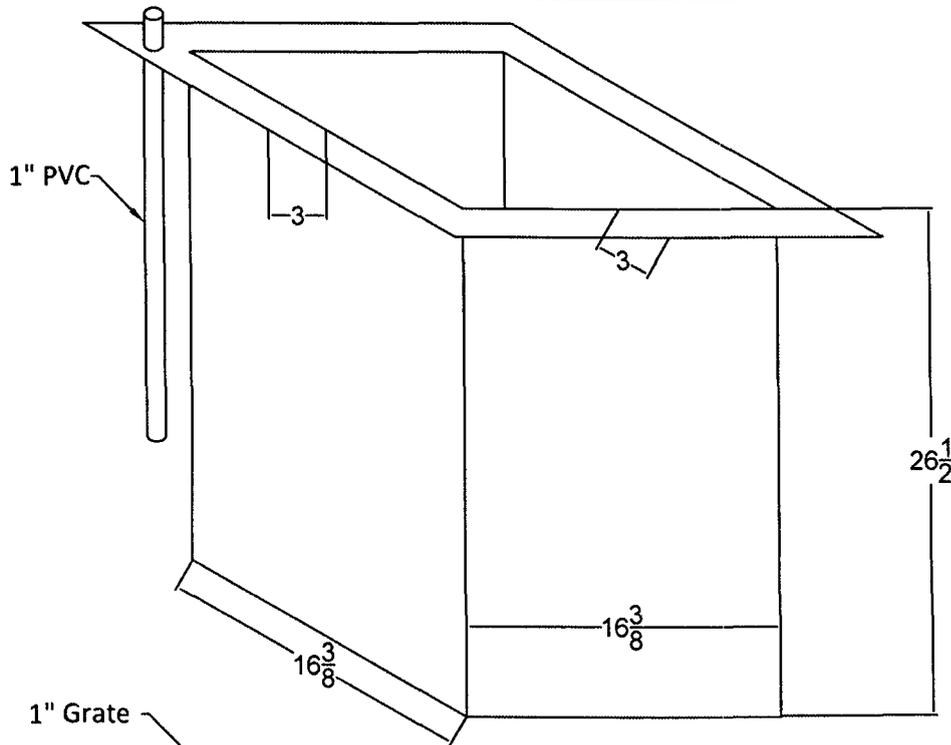
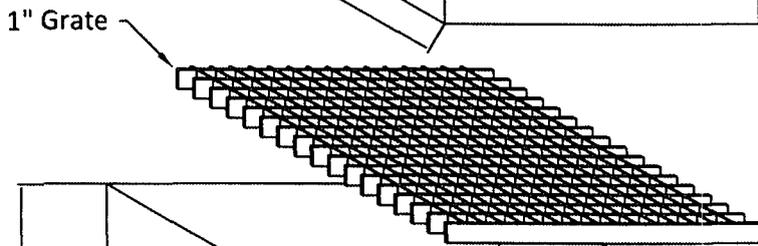
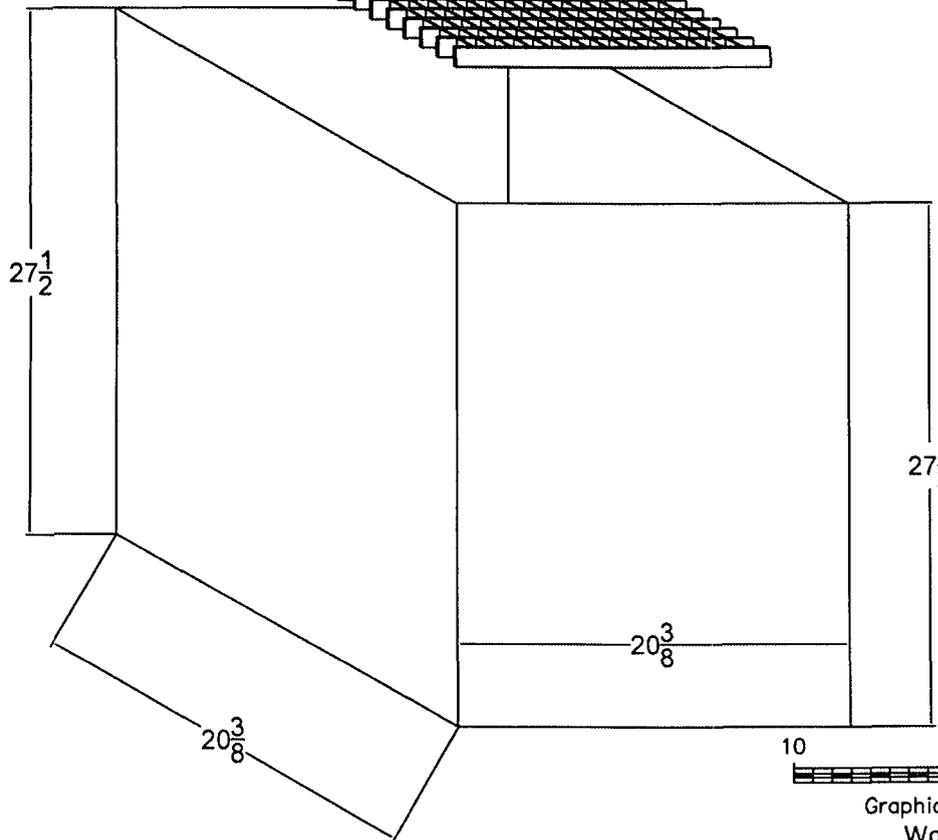
Figure 4 - Wash Bay Sump

The wash bay sump was constructed of concrete with a fiberglass liner. The fiberglass liner measured approximately 16 $\frac{3}{8}$ x 16 $\frac{3}{8}$ x 26 $\frac{1}{2}$ inches and recessed into the concrete containment and sealed with silicon caulking. The bottom of the fiberglass liner was flush with the concrete floor. The fiberglass liner is not equipped with leak detection to allow monitoring of the space between the fiberglass liner and concrete containment. The fiberglass liner is not

in compliance with existing OCD rules due to the lack of leak detection and the bottom of the liner being flush with concrete floor.

WGESP proposes to retrofit the south drain and wash bays sumps to comply with OCD rules (NMAC 19.15.17.11). WGESP will install a 1-inch thick ~~steel grate~~ in the bottom of the concrete containment to provide space to monitor leakage from the fiberglass liner. An inspection tube will be built into the new fiberglass liner for monitoring leakage between the liner and concrete containment. The upper surface between the fiberglass liner and concrete will be sealed with silicon caulking. WGESP will submit a report, including photographs, to the OCD once the retrofit work is completed. Figure 3 and Figure 4 present the proposed retrofit schematics for the south drain and wash bay sumps, respectively.

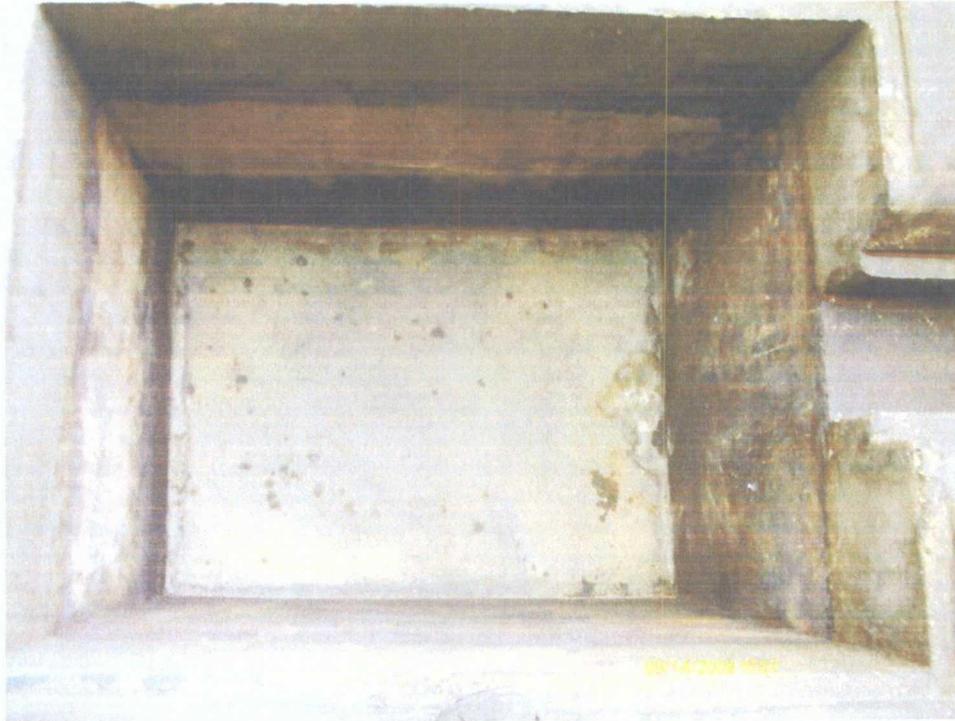
The concrete containment was marked prior to filling and the fluid level remained substantially unchanged during the test. The hydrostatic test results confirm that the integrity of the concrete containment was not compromised. Photographs 1 through 3, presented in Appendix B, represent the south drain sump testing.

1. South Drain Sump after Cleaning

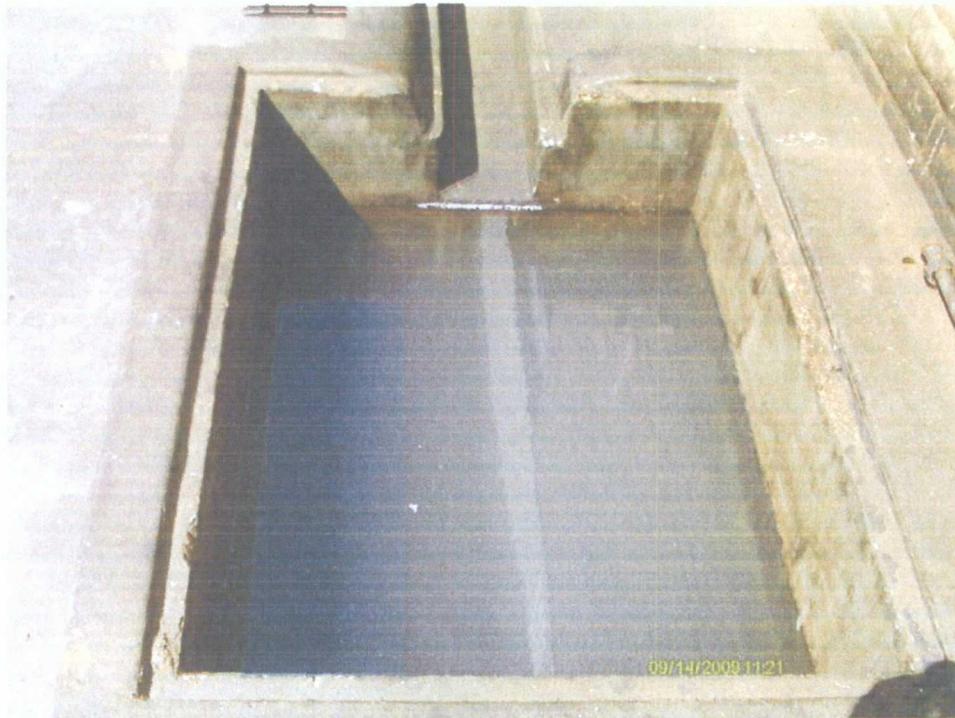
The fiberglass liner was damaged during recent efforts to remove the line and miscommunication of OCD procedural hydrostatic test requirement. Facility personnel cleaned and photographed the concrete containment before hydrostatic testing. On September 14, 2009, facility personnel filled the concrete containment, near full, with fresh water to begin the hydrostatic test. The test began at 11:21 am on September 14, 2009 and was concluded at 11:22 am on September 15, 2009.

2. Begin South Drain Sump Hydrostatic Test.

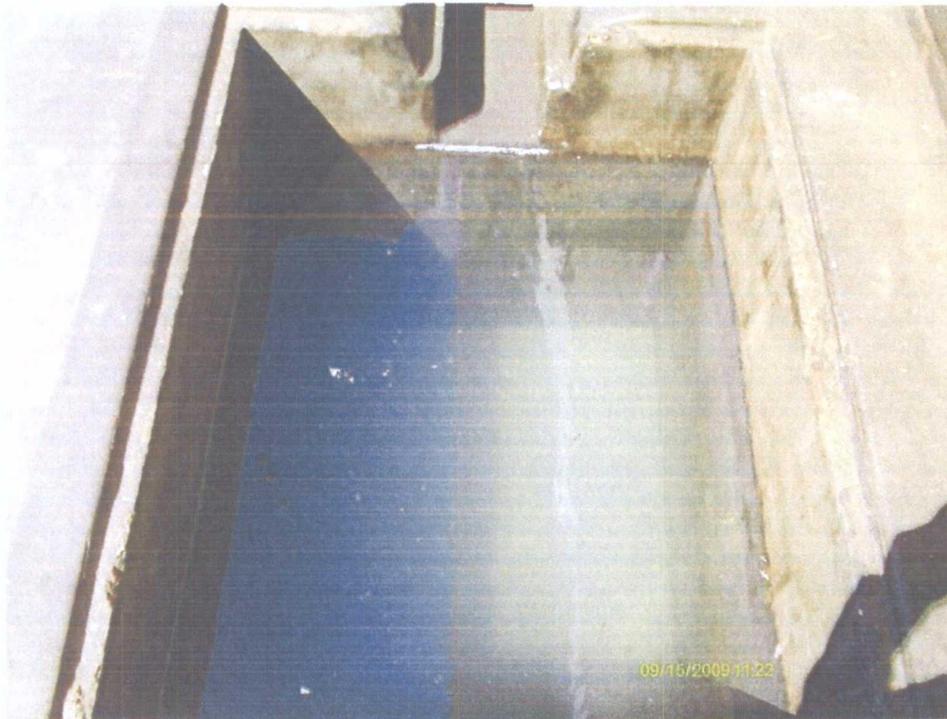
3. End South Drain Sump Hydrostatic Test.

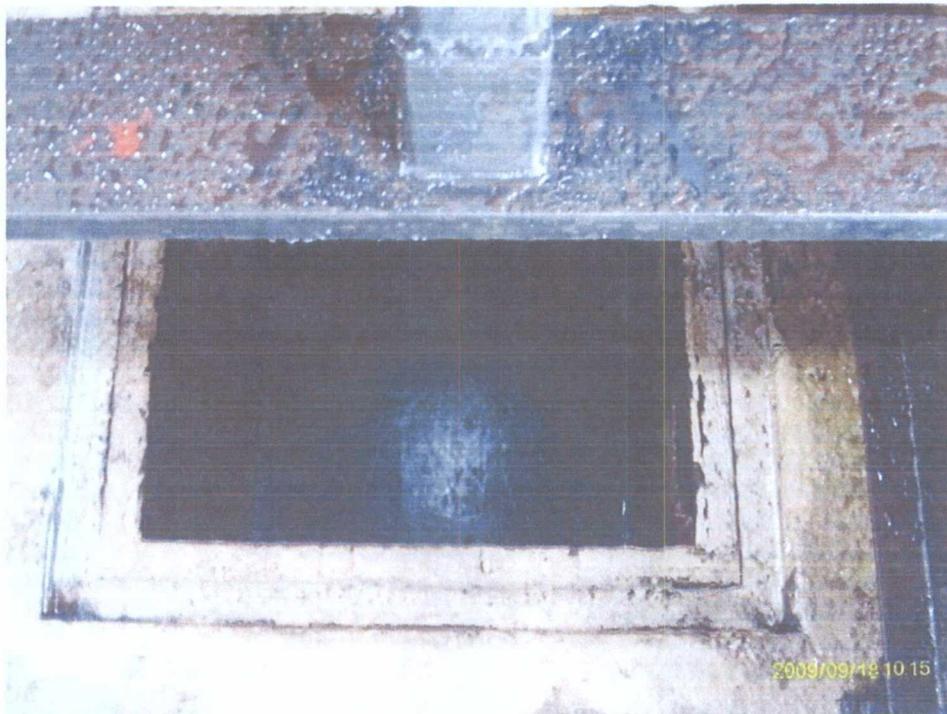
Facility personnel cleaned and photographed the fiberglass-lined sump prior to conducting the hydrostatic test. The fiberglass liner was visually inspected for cracks and holes and none were found. On September 18, 2009, facility personnel filled, near full, the fiberglass liner with fresh water to begin the hydrostatic test. The test began at 10:29 am on September 18, 2009 and was concluded at 10:31 am on September 19, 2009. The fiberglass liner was marked prior to filling and the fluid level remained substantially unchanged during the test. This concludes that the integrity of the fiberglass liner was not compromised. Figure 2 presents the sump location. Figure 4 presents the sump dimensions. Photographs 4, 5 and 6, presented in Appendix B, represent the wash bay sump.

4. Wash Bay Sump after Cleaning.

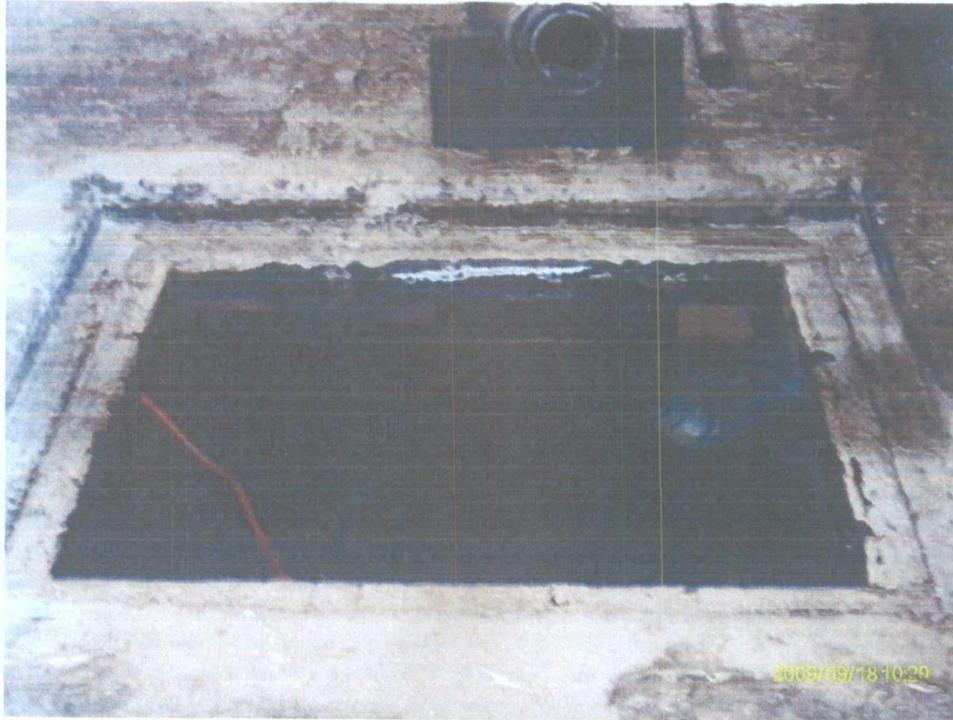
5. Begin Wash Bay Sump Hydrostatic Test.

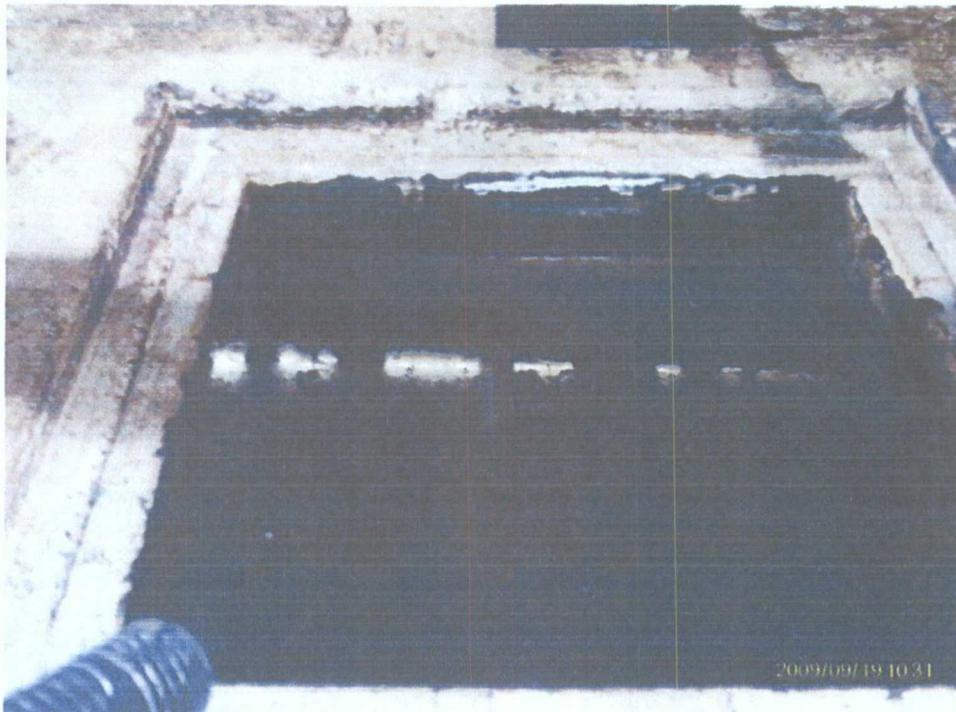
Based on the results of the hydrostatic testing, observations of the sump conditions, and concurrence by our consultant LAI, WGESP concludes there was no potential for any significant release and the integrity of the south drain and wash bay sumps was not compromised.

6. End Wash Bay Sump Hydrostatic Test.

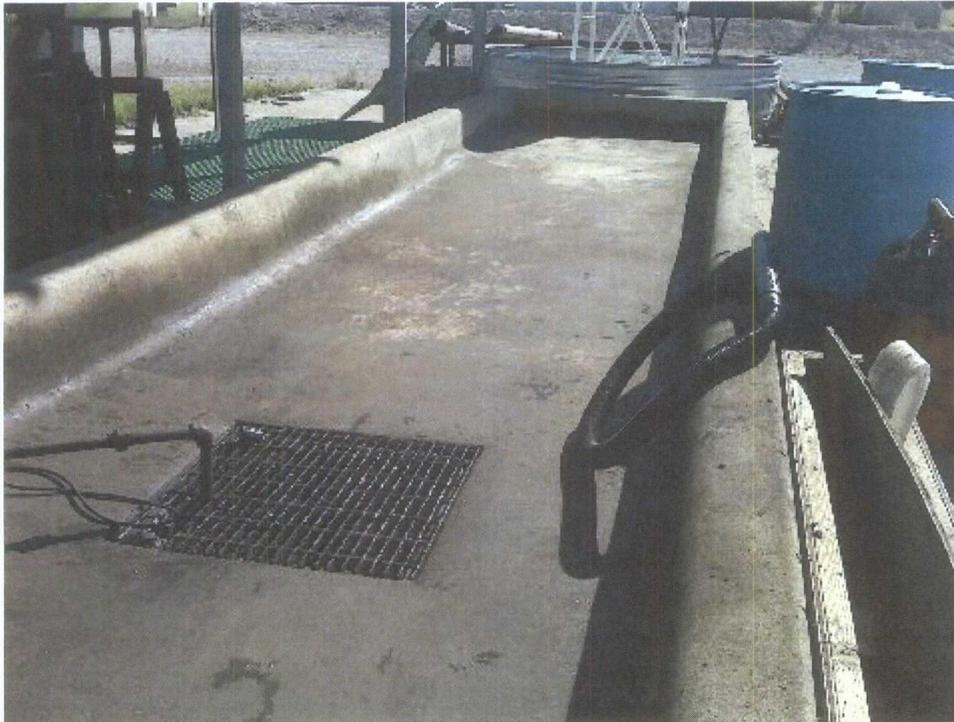
Viewing south Covered Drum Storage Containment with sump before closure.

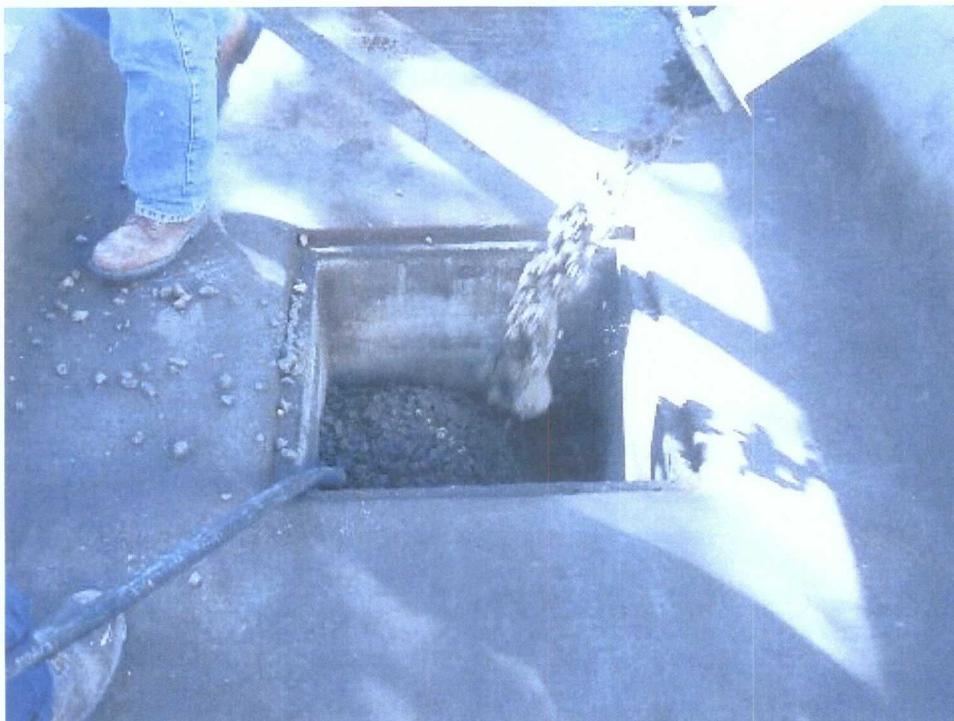
View of the cementing the Covered Drum Storage Containment Sump.

On November 3, 2009, LAI personnel, Michelle Green observed cementing of the Covered Drum Storage Area Sump, Covered East Containment Sump and the Southeast Containment Sump. Custom Mobile Concrete was contracted by Big Boys LLC to prepare the cement mixture onsite. The cement mixture was added to each sump. A pneumatically energized hand-held vibrating rod was placed in the freshly poured cement. The rod vibrated the cement mixture to remove any air pockets and push suspended gravel downward to provide a finished surface. The surface of the concrete was tamped, floated and made flush with the existing surface.

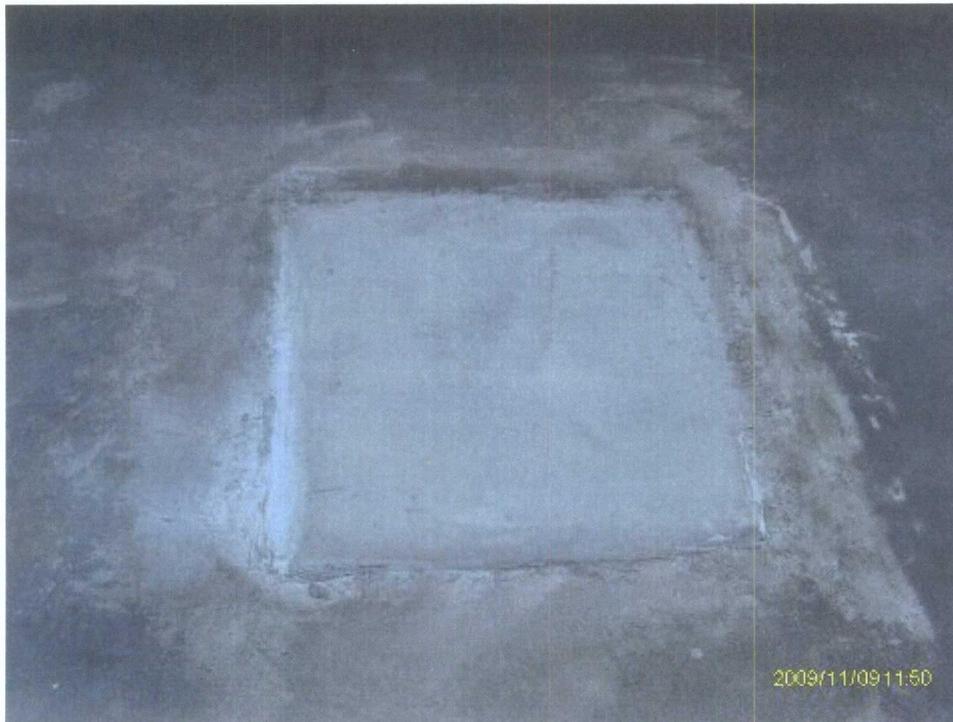
View of former sump filled with cement in Covered Drum Storage Area.

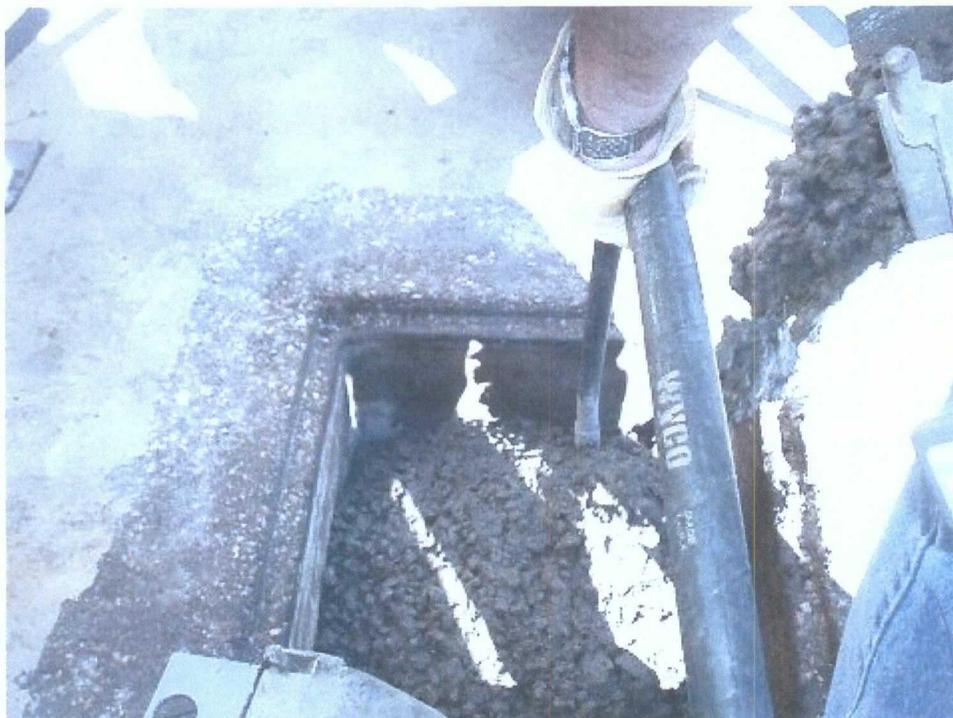
View of the Southeast Containment Sump being filled with cement.

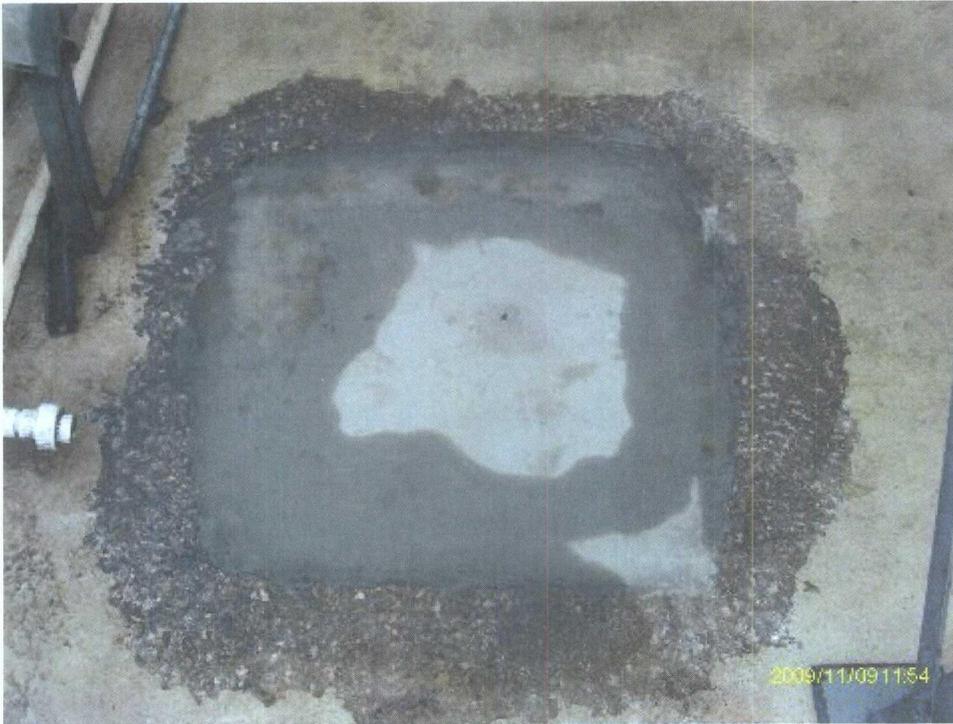
View of former sump filled with cement in Southeast Containment.

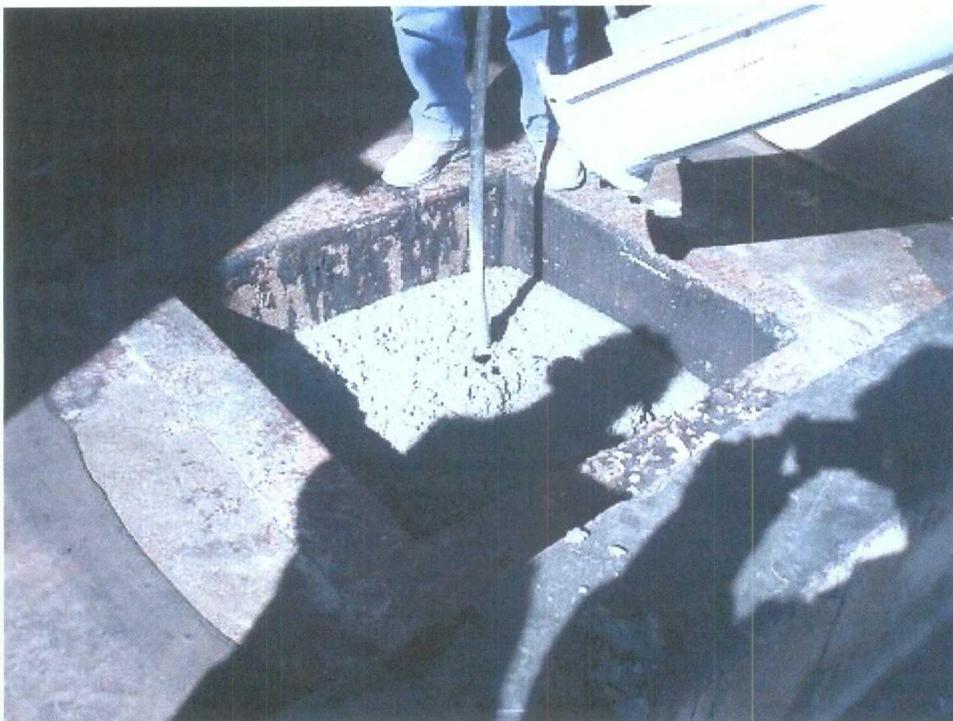
View of the Covered East Containment Sump being filled with cement.

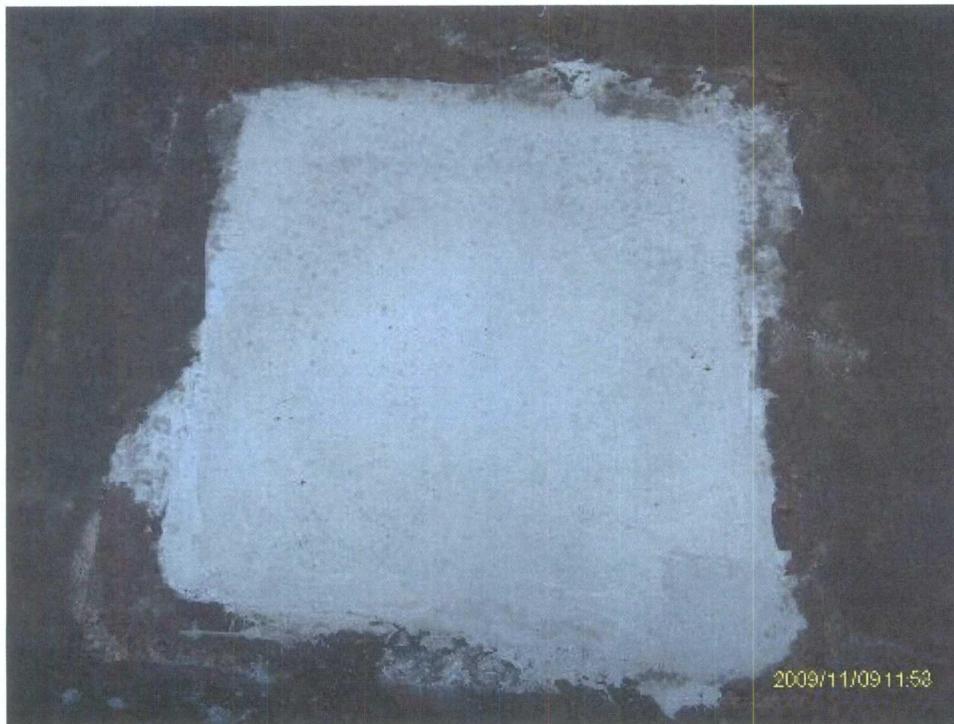
View of former sump filled with cement in Covered East Containment.

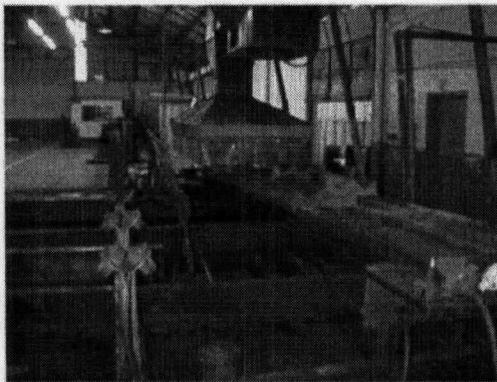
#2 Pump clean out area. HCL acid, & steam is used in the process.

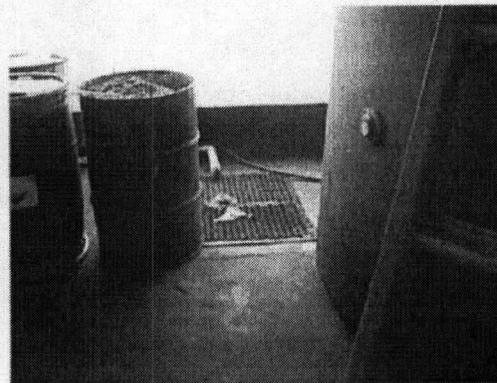
OLD CONCRETE SUMP IN WASTE WATER TREATMENT AREA DO NOT HAVE SECONDARY CONTAINMENT.

#5 Wastewater treatment area sump is concrete construction, no secondary containment. Area is covered and bermed.

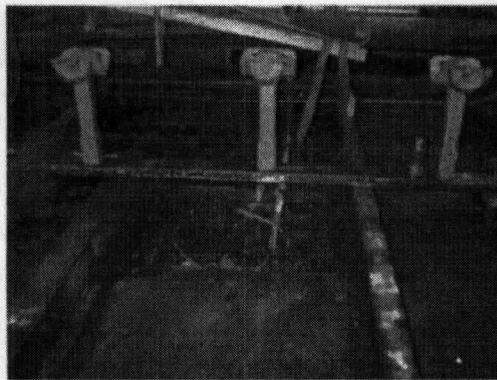
#3 pump clean out sump. Primary is FG tank secondary is concrete. Wastewater is pumped to waste water treatment area.

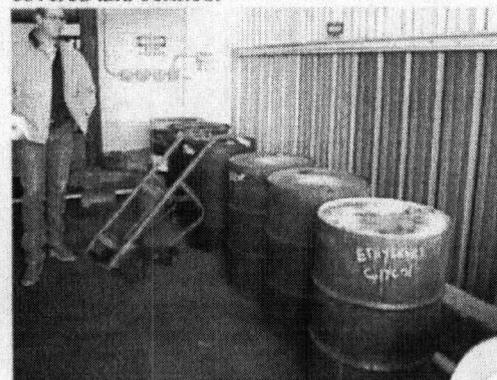
#6 Waste water treatment area. Chemical storage. Oils, Xylene, & Ethylene Glycol.

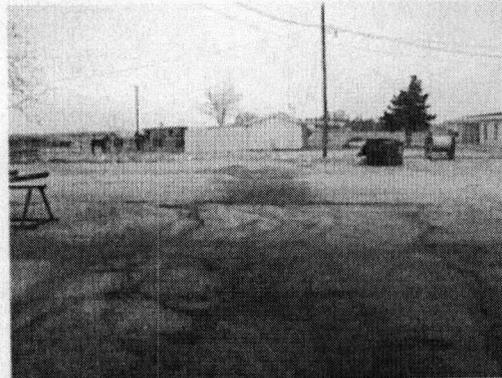
VISIBLE CONTAMINATION NOTED IN SOUTH PAD AREA,
DRUM STORAGE AREA EAST OF SHOP AND YARD AREA
PICTURES # 10, 13 + 14

#10 Concrete pad south of shop area. Visible contamination running off of pad. Picture looking south. Background shows nearby residence.

- ESP NEEDS TO RE-SUBMIT WASTE STREAM FLOW DIAGRAM
- INSTALL PAD & CURBS IN AREAS WHERE RUN-OFF IS OCCURRING.
- ESP WILL BE REQUIRED TO SUBMIT SOIL CLEAN-UP PLAN

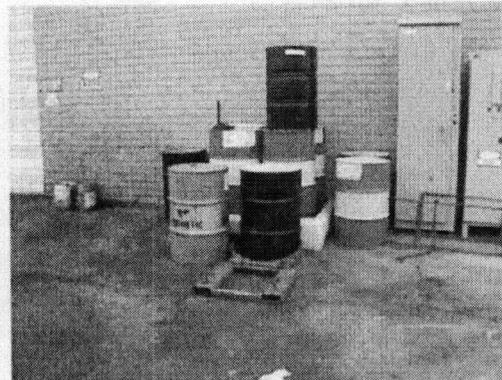
DRUMS LOCATED OUTSIDE KEEP PROPER CONTAINMENT
PICTURES 11, 12 + 13

#11 Chemical drum storage.

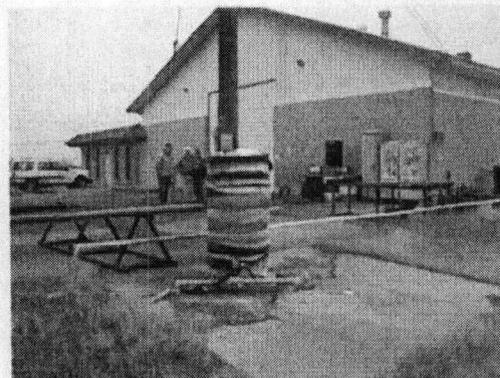
#12 ESP Water well located southeast of shop.

OCD WILL REQUIRE WELL TO BE TESTED AS DISCHARGE PLAN CONDITION.

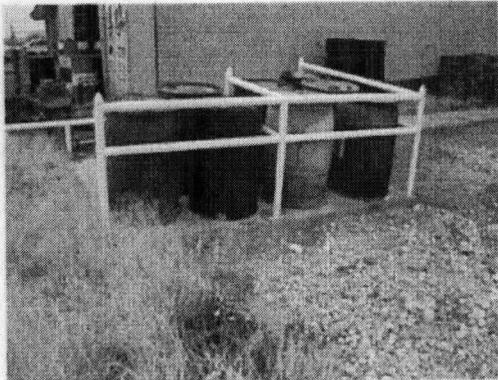
#13 Drum storage -no containment. Visible contamination on ground.

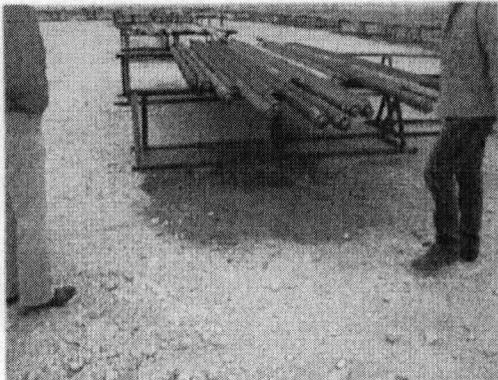
#14 ESP yard area, pump and motor storage area. Visible contamination on ground
