COG Operating
RJU Injection Line Leak
Section 34, T17S, R29E, Unit A
32 47.701 104 03.233

Re: Work Plan for the COG Operating LLC., RJU Injection Trunk Line, Unit A, Section 34, Township 17 South, Range 29 East, Eddy County, New Mexico. (API 30-015-03765)

Table 1
COG Operating LLC.
RJU Inj. Line Leak
EDDY COUNTY, NEW MEXICO

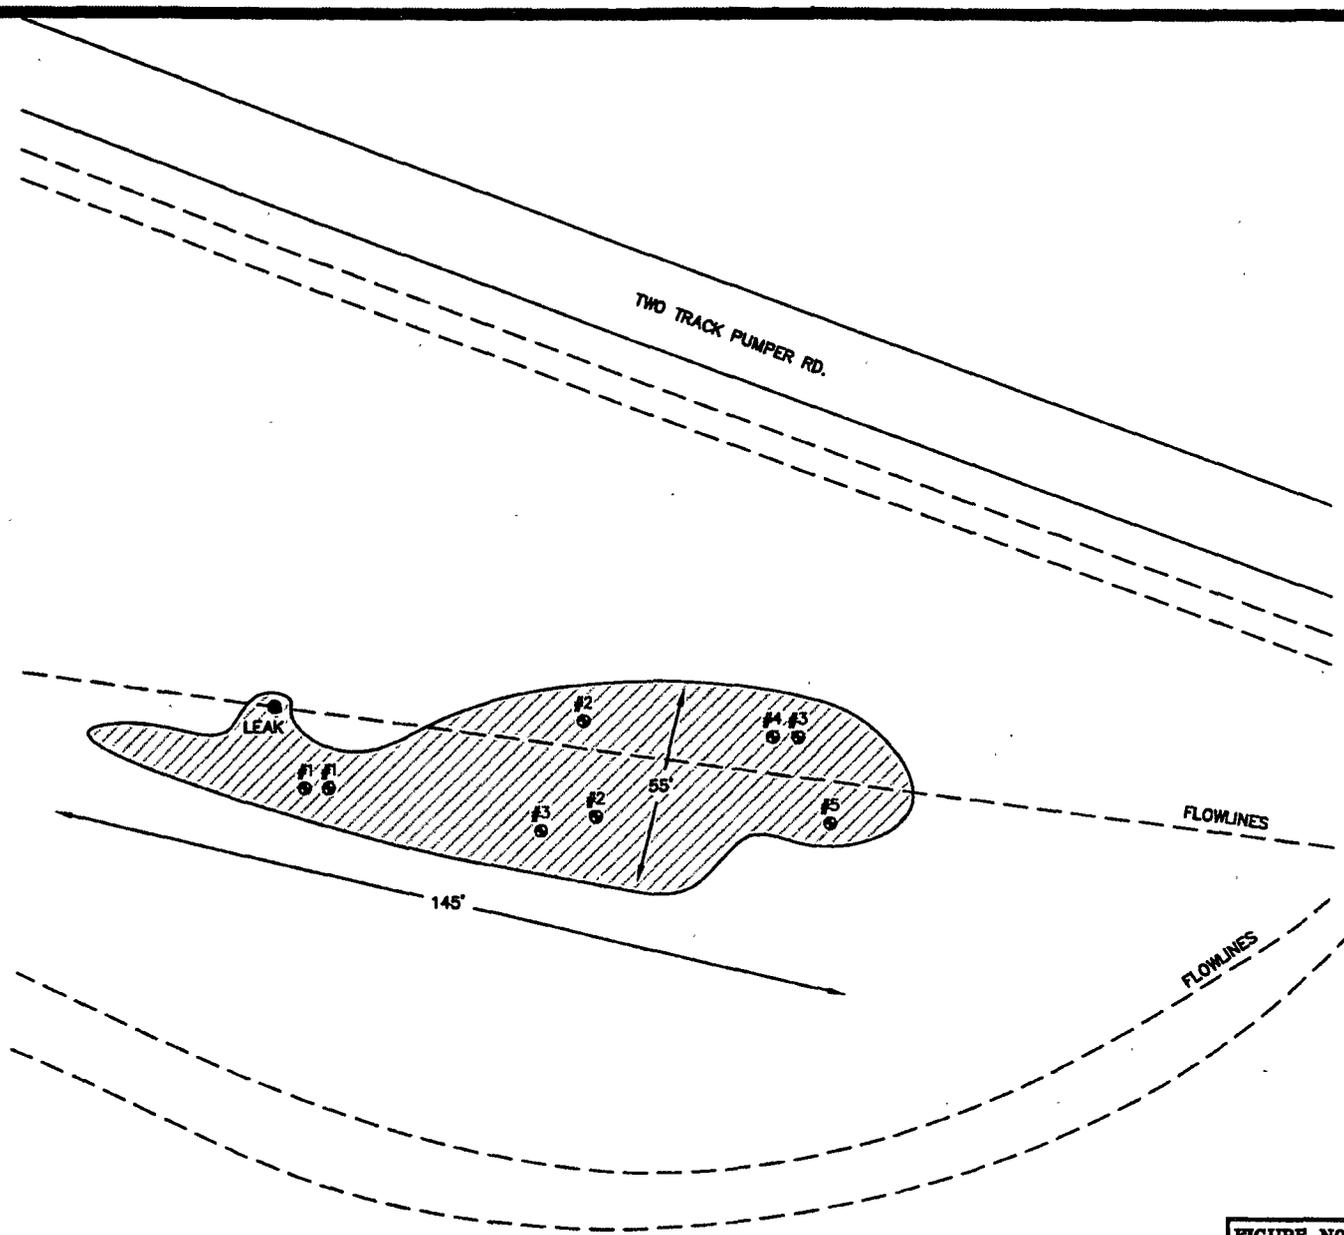
FIGURE NO. 3
EDDY COUNTY, NEW MEXICO
COG OPERATING LLC
RJU INJECTION TRUCK LINE LEAK
TETRA TECH, INC. MIDLAND, TEXAS

On April 22, 2010, Tetra Tech personnel inspected and sampled the spill area. The spill area measured approximately 40' x 145', which ran along the injection line. A total of five (5) auger holes (AH-1 through AH-5) were installed using a stainless steel hand auger to assess the impacted soils. Select samples were analyzed for TPH analysis by EPA method 8015 modified, BTEX by EPA Method 8021B and chloride by EPA method 300.0. Copies of laboratory analysis and chain-of-custody documentation are included in Appendix C. The results of the sampling are summarized in Table 1.

On June 30, 2010, Tetra Tech personnel supervised the installation of three (3) boreholes (SB-1 through SB-3) utilizing an air rotary rig to define the chloride impact. The soil boring locations are shown on Figure 3. The borings were installed in the vicinity of the previous auger holes. The boreholes were extended to a maximum depth of 30 feet below surface, with samples collected at 2 to 3 foot intervals for the first 10 feet and 5 foot intervals thereafter, and submitted to the laboratory for chloride analysis. Copies of laboratory analysis and chain-of-custody documentation are included in Appendix C. The results of the sampling are summarized in Table 2.

- SPILL AREA
- SAMPLE LOCATIONS
- SOIL BORING LOCATIONS

proposes to excavate the impacted soil (spill foot print) to a depth of approximately 10.0' below surface. The proposed excavation depths are shown in Table 2. Tetra Tech personnel will supervise the removal of impacted and transported to CRI for proper disposal. The excavated area will then be backfilled with clean soil to grade.

Since the impacted area is in the native sand dunes, the proposed excavation depths may not be reached due to wall cave ins, safety concerns for lines, equipment operators as well, as other onsite personnel. As such, Tetra Tech will excavate the soils to the maximum extent practicable. If the depths are not reached, a 40 mil liner will be installed at depth of 4' to 5' below surface to cap the impacted area.
