**From:** Tavarez, Ike [Ike.Tavarez@tetrattech.com]  
**Sent:** Friday, January 07, 2011 9:54 AM  
**To:** Bratcher, Mike, EMNRD  
**Cc:** Pat Ellis; Joshua Russo  
**Subject:** COG - GJ West COOP #125 Work Plan Approval Request  
**Attachments:** COG - GJ West COOP #125 Work Plan .pdf; COG - GJ West COOP #125 Figures.pdf

COG Operating  
GJ West COOP #125  
Section 28, T17S, R29E  
State Land  
Eddy County, NM  
32.80022 104.07126

## Report Type: Work Plan

**Re: Work Plan for the COG Operating LLC., GJ West COOP Unit #125,  
Unit P, Section 28, Township 17 South, Range 29 East, Eddy  
County, New Mexico.**

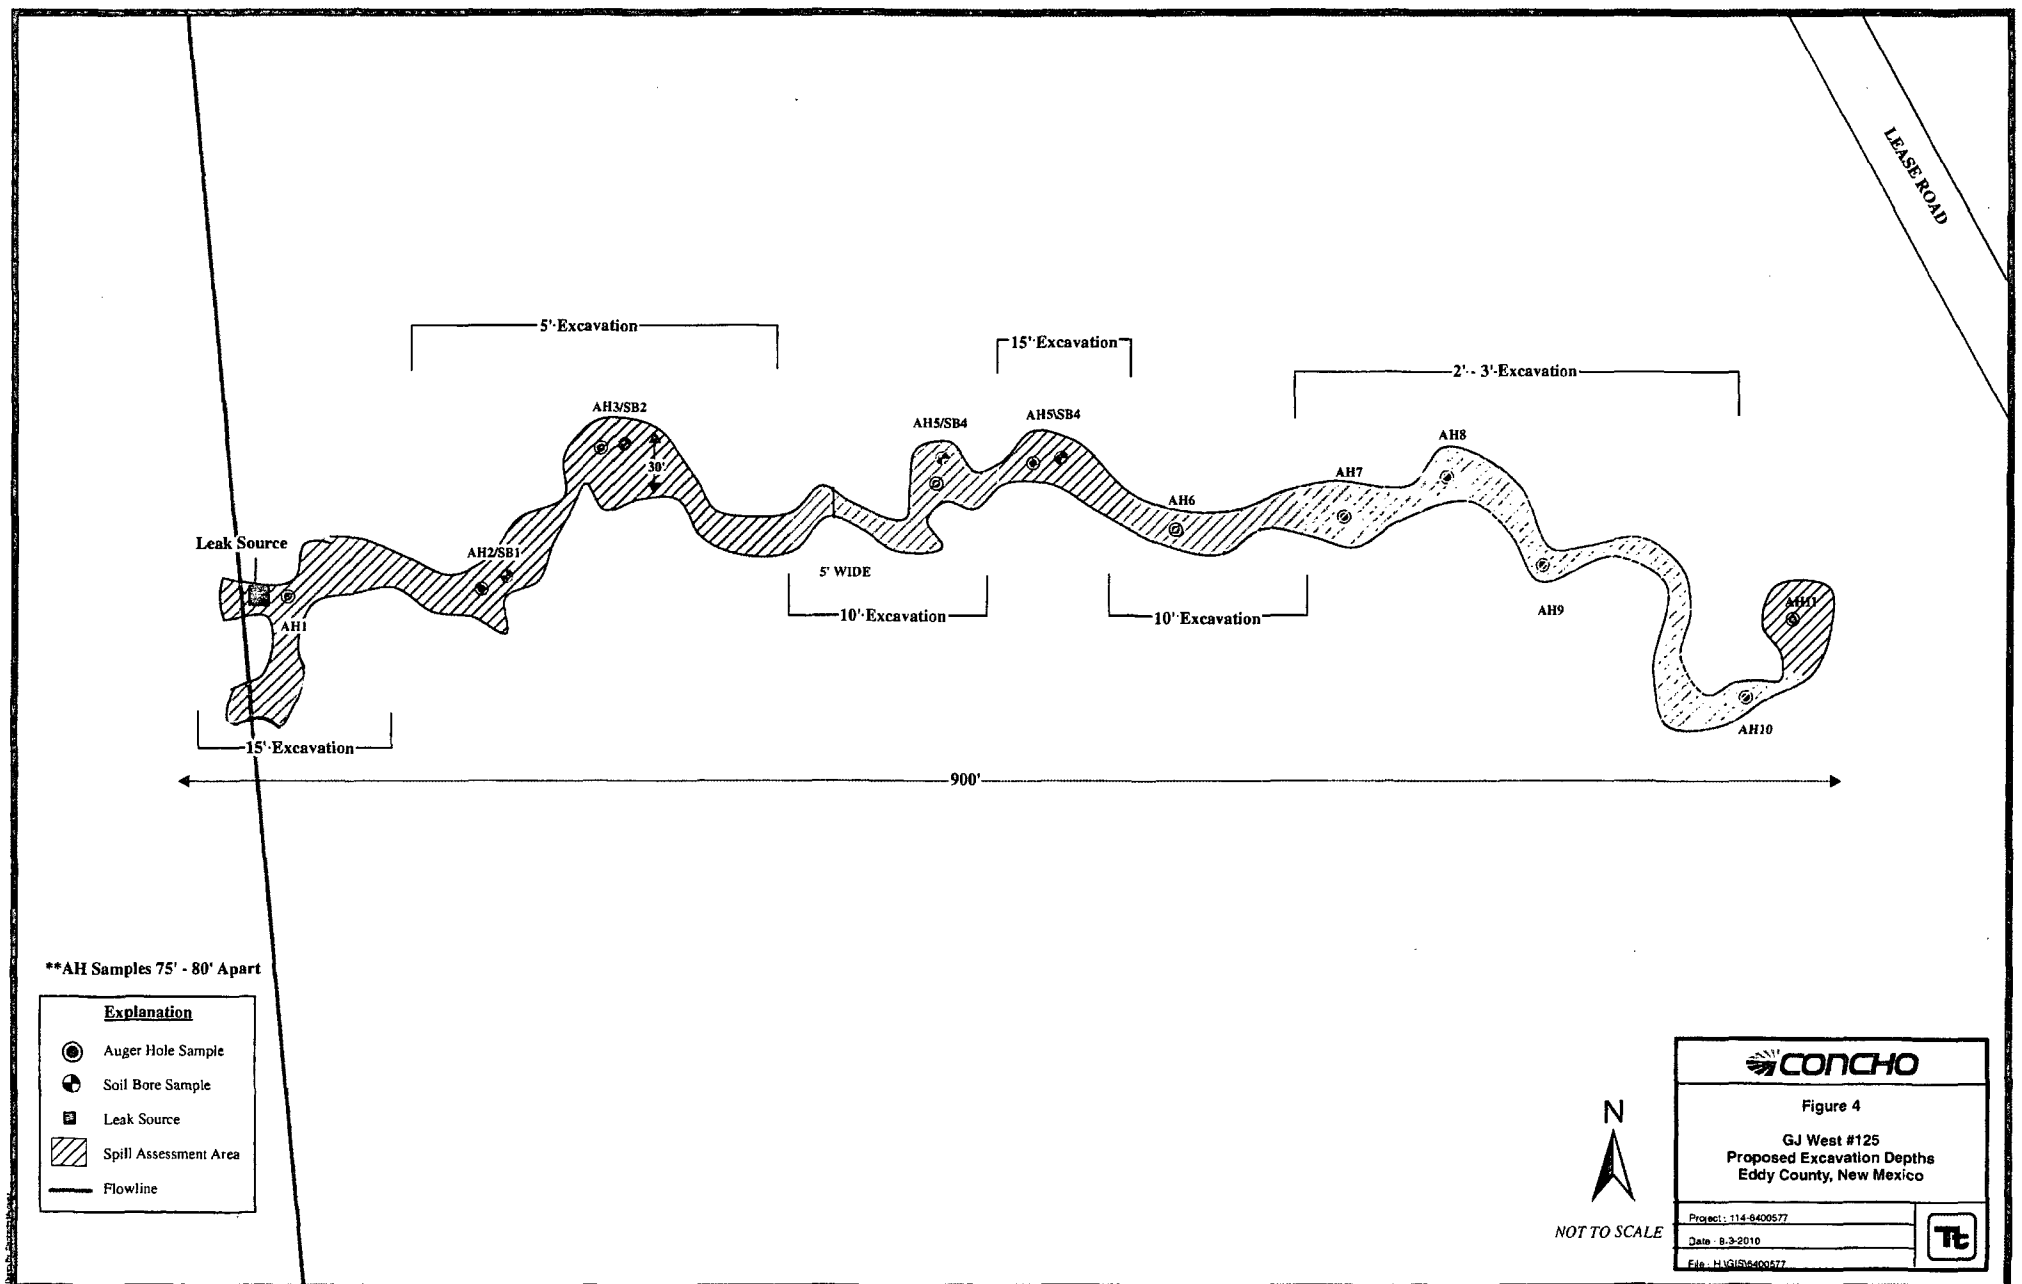
Figure 4	
GJ West #125 Proposed Excavation Depths Eddy County, New Mexico	
Project: 114-8406577	
Date: 8-3-2010	
File: H:\GIS\8406577

Referring to Table 1, the areas of auger holes (AH-1, AH-2, AH-4, AH-5, AH-7, AH-8 and AH-9) exceeded TPH RRAL at depths ranging from 1' to 7' below surface and all were vertically defined. Auger hole (AH-1) exceeded the total BTEX from surface to a total depth of 7' below surface and declined below the RRAL at 8' below surface.

Elevated chloride concentrations were detected in the majority of the auger hole locations. All of the auger holes were vertically defined, except for AH-1, AH-2, AH-4 and AH-5. On the auger holes defined, the chloride impact depths ranged from 2' to 9' below surface. The remaining auger holes were not vertically defined and required additional delineation.

COG proposes to excavate and removal of impacted material as highlighted (green) in attached Table 1. Once the areas are excavated to the appropriate depths, the excavation will be backfilled with clean soil.

The goal of the remediation is to establish surface growth and to reduce the environmental liabilities for the protection of the groundwater. For growth, a minimum of 4.0' of impacted soil will be removed from the spill area, if necessary. Concerns exist regarding a deep excavation plan. Since the impacted area is in the native sand dunes, the proposed excavation depths may not be reached due to wall cave ins and safety concerns for onsite personnel. In addition, impacted soil around oil and gas equipment, structures or lines may not be feasible or practicable to be removed due to safety concerns. As such, Tetra Tech will excavate the soils to the maximum extent practicable. If the depths are not reached, a 40 mil liner will be installed at depth of 4' to 5' below surface to cap the impacted area.

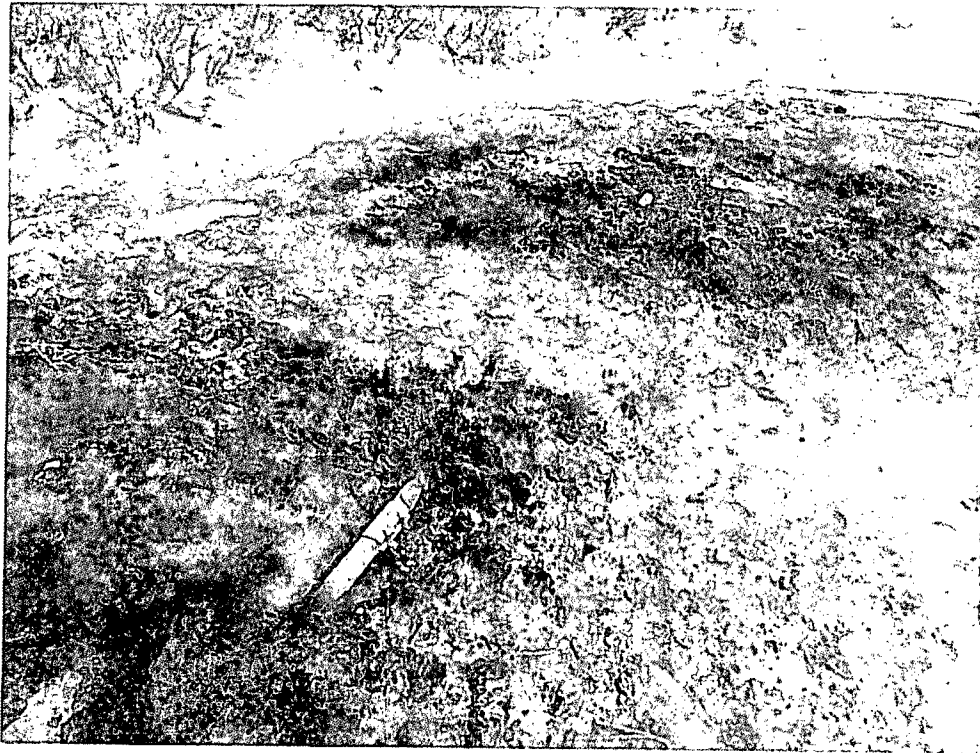
The cause of this release was due to a ruptured flowline. The flowline has been repaired and put back into service.

Source of spill (8/6/10)

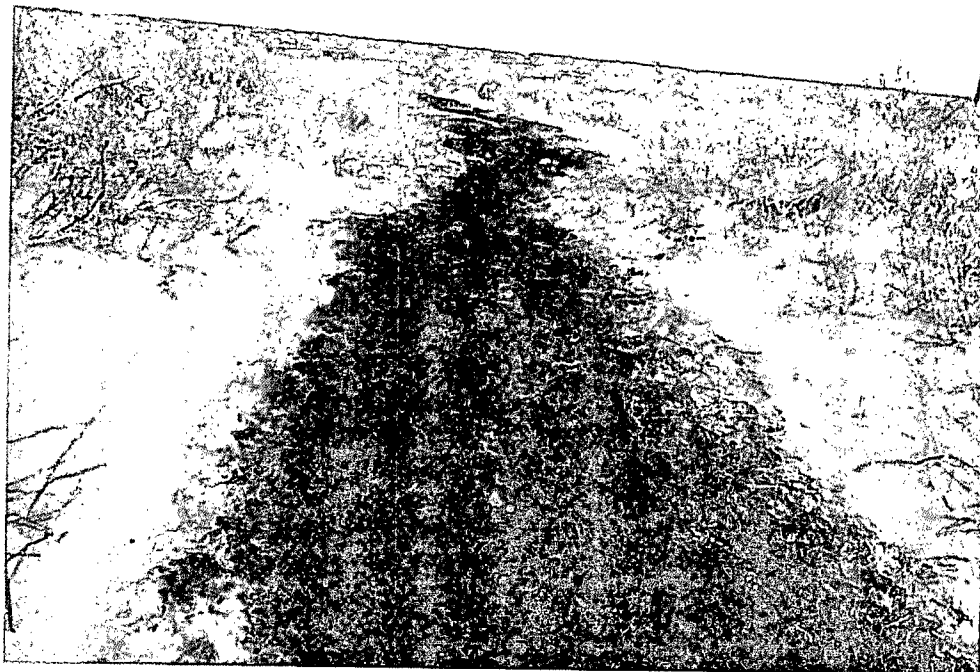
View East – Spill migrated along native draw (8/6/10)

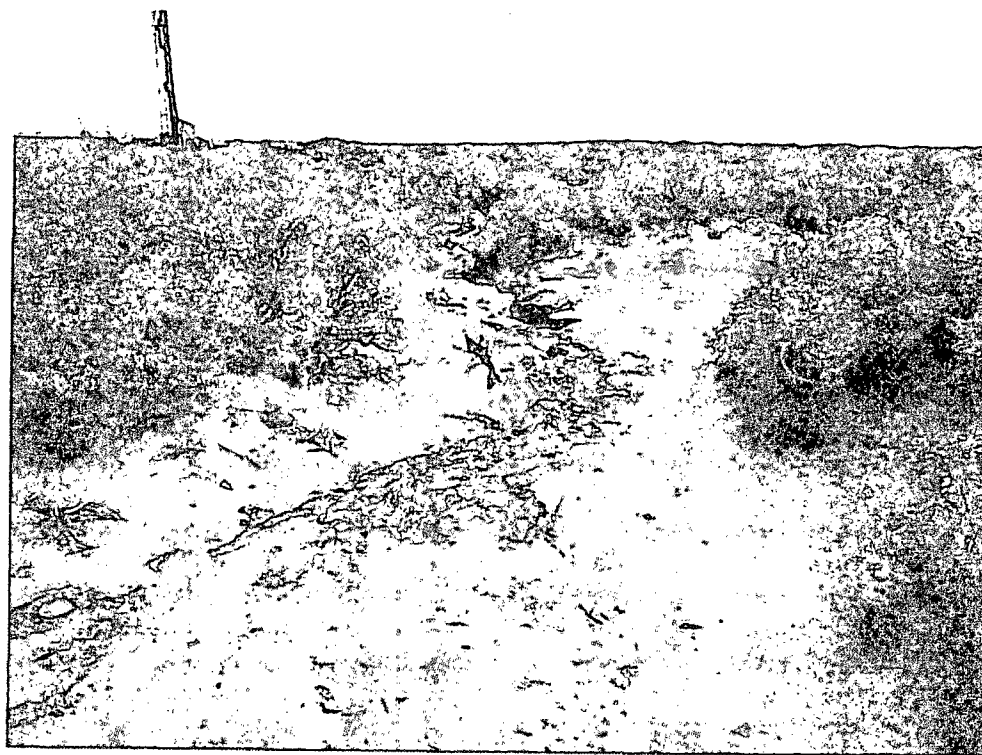
View west near AH-10 Spill tapered off dramatically
