Fasken Oil and Ranch, LTD.

**Denton SWD Emergency Pit Overflow
Closure Report**

**Unit Letter D, Section 13 of Township 15 South,
Range 37 East, Lea County, New Mexico**

August 10, 2010

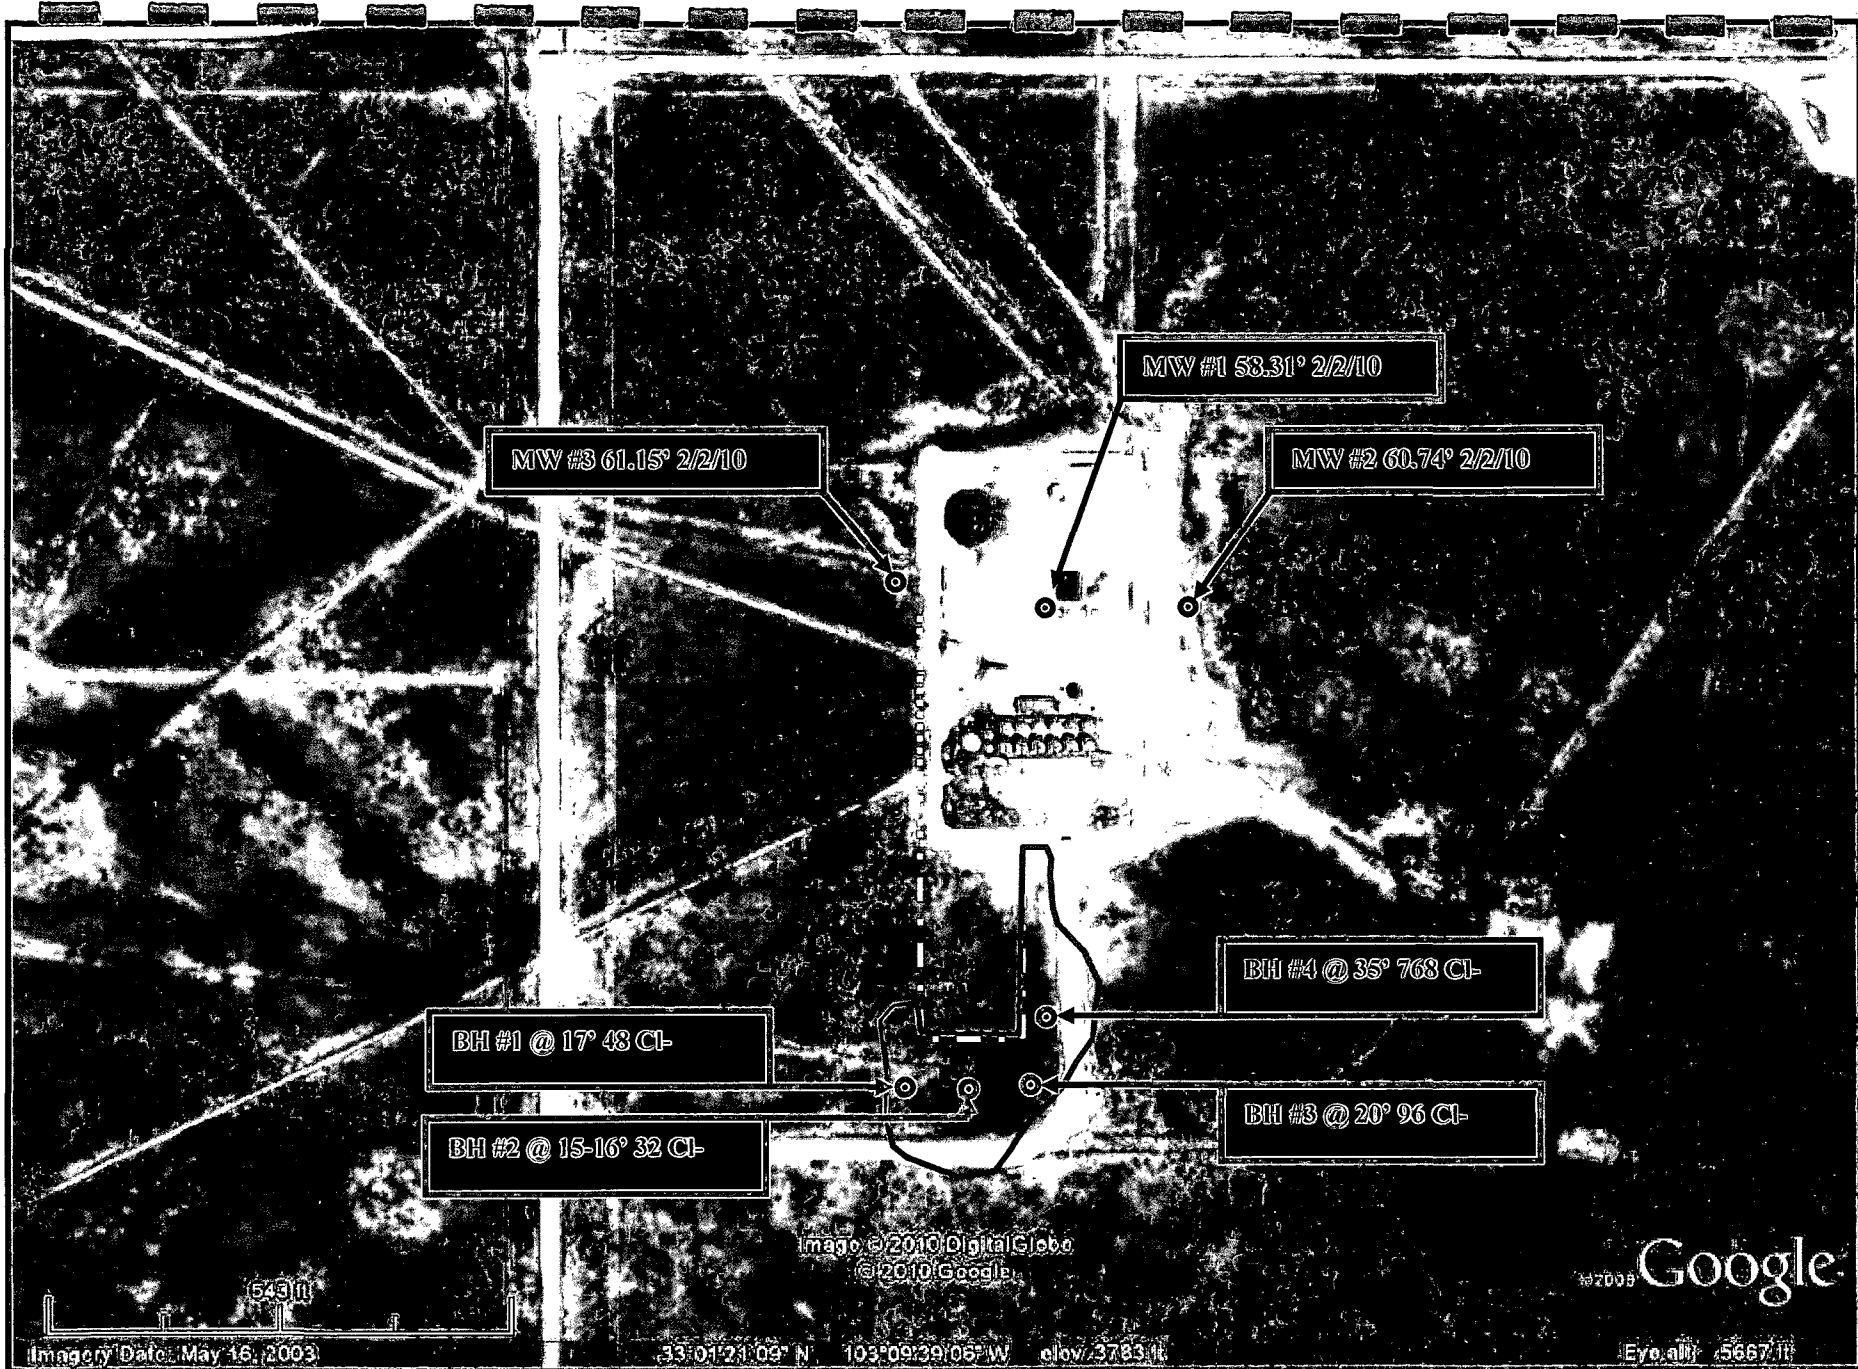
Figure 2
Site Plan

MW #3 61.15° 2/2/10

MW #1 58.31° 2/2/10

MW #2 60.74° 2/2/10

WW#1: 96 CI-

WW#2: 32 CI-

WW#3: <16 CI-

WW#4: 32 CI-

WW#5: 48 CI-

WW#6: <16 CI-

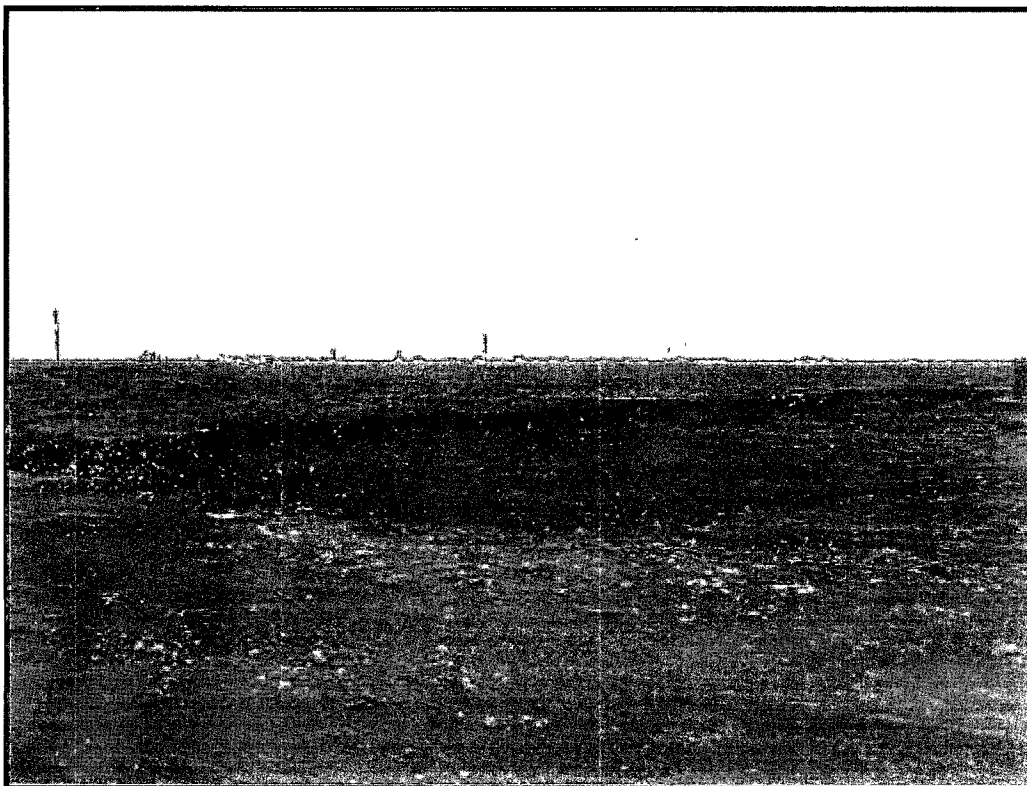
Excavated area facing northwest

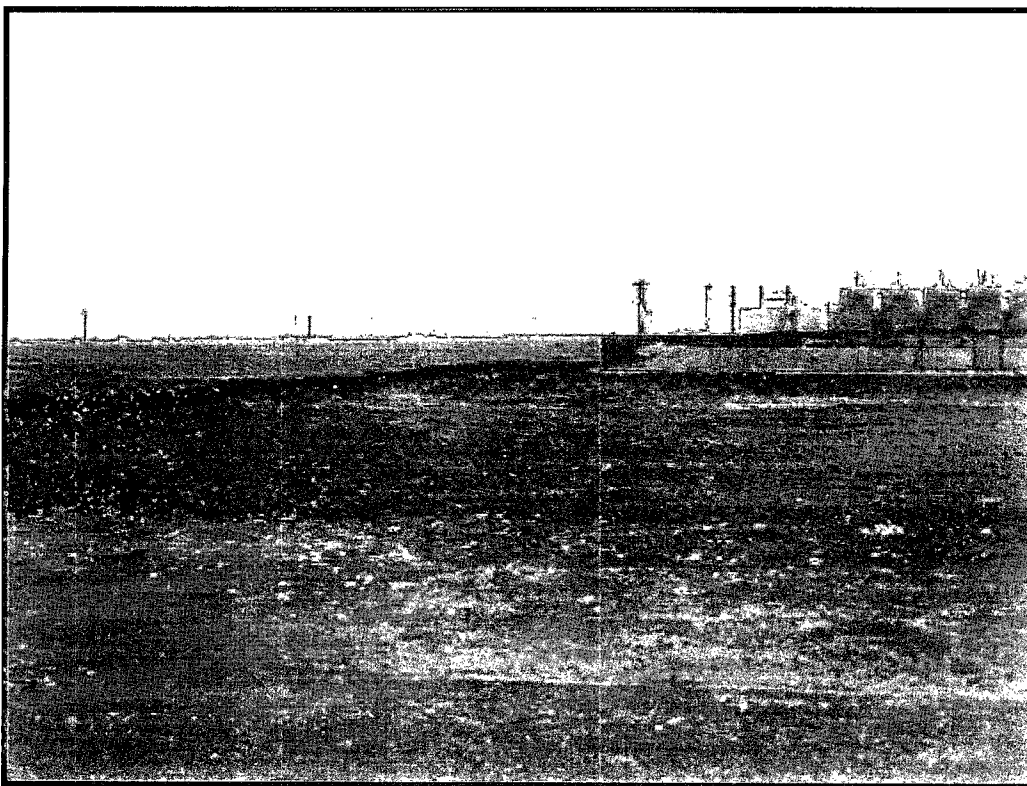
Excavated area facing north

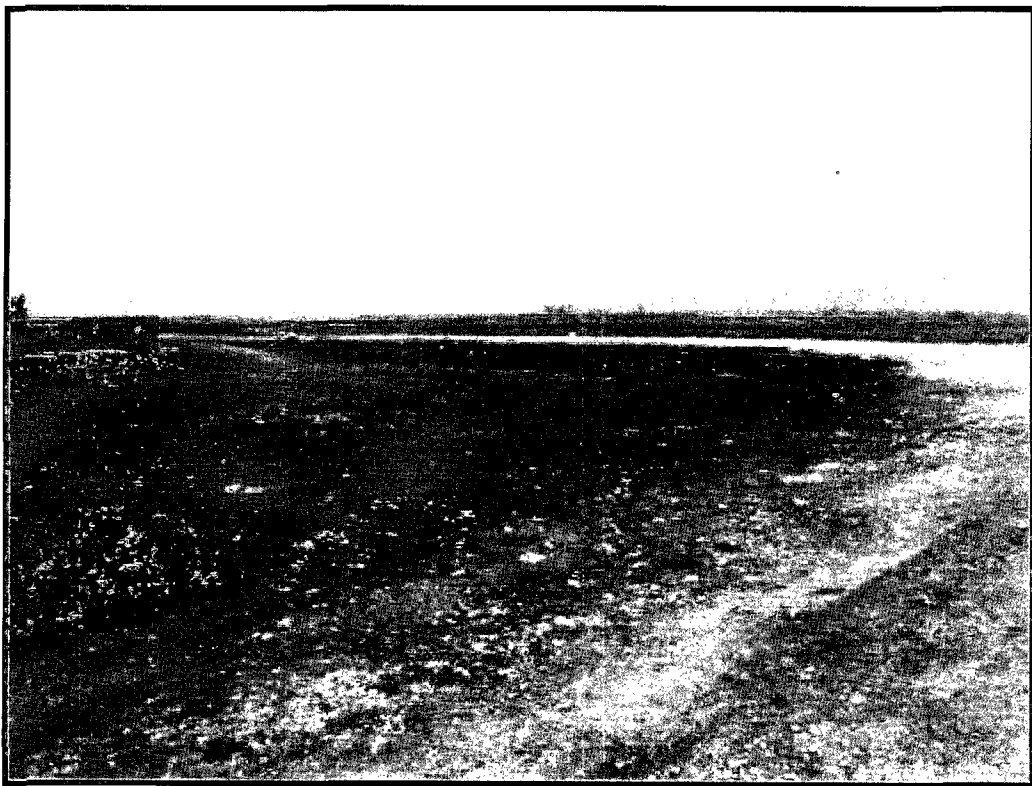
Excavated area facing east

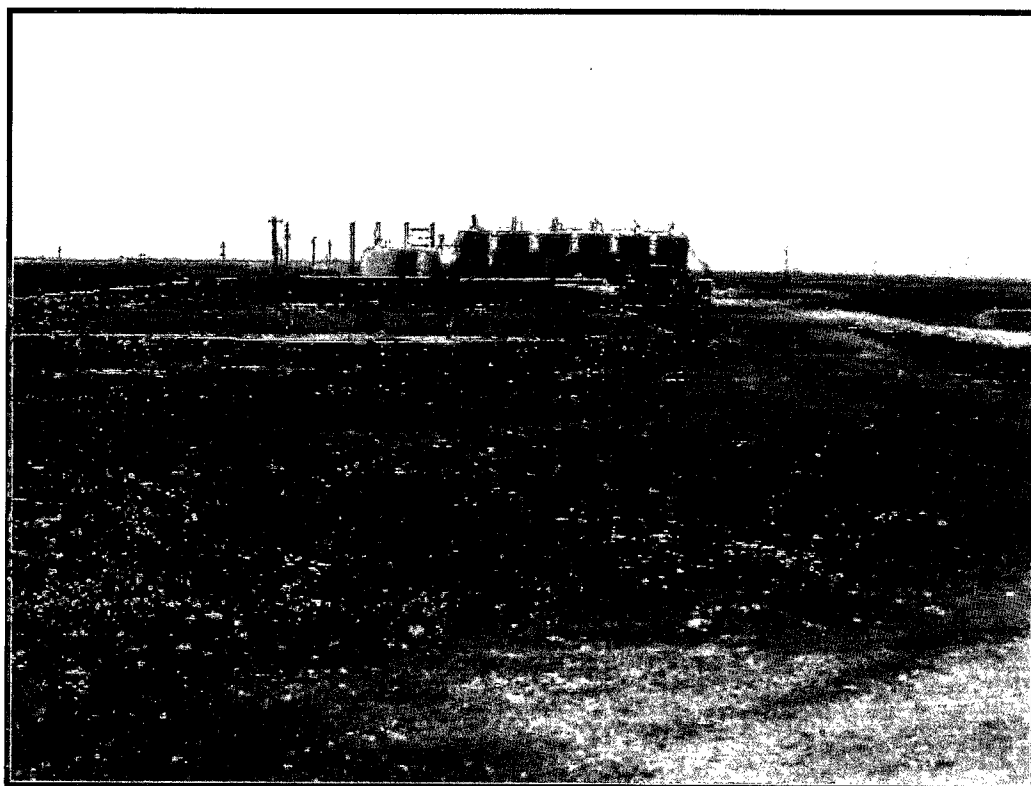
Excavated area facing north

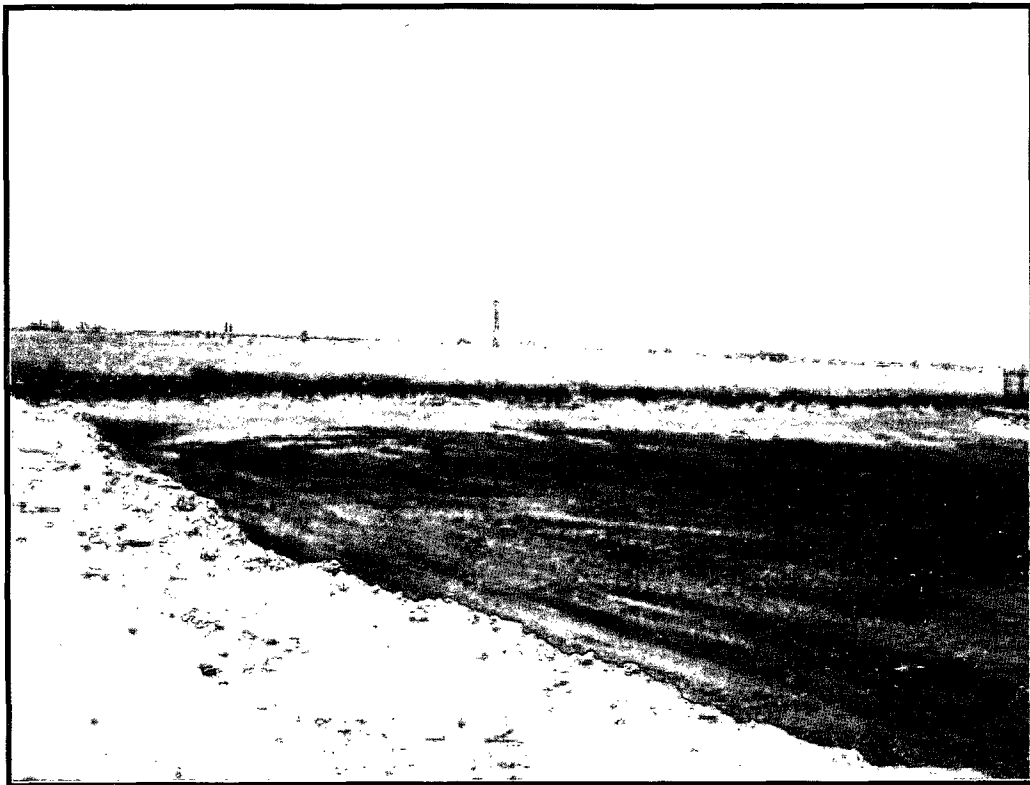
Excavation padded with top soil facing west

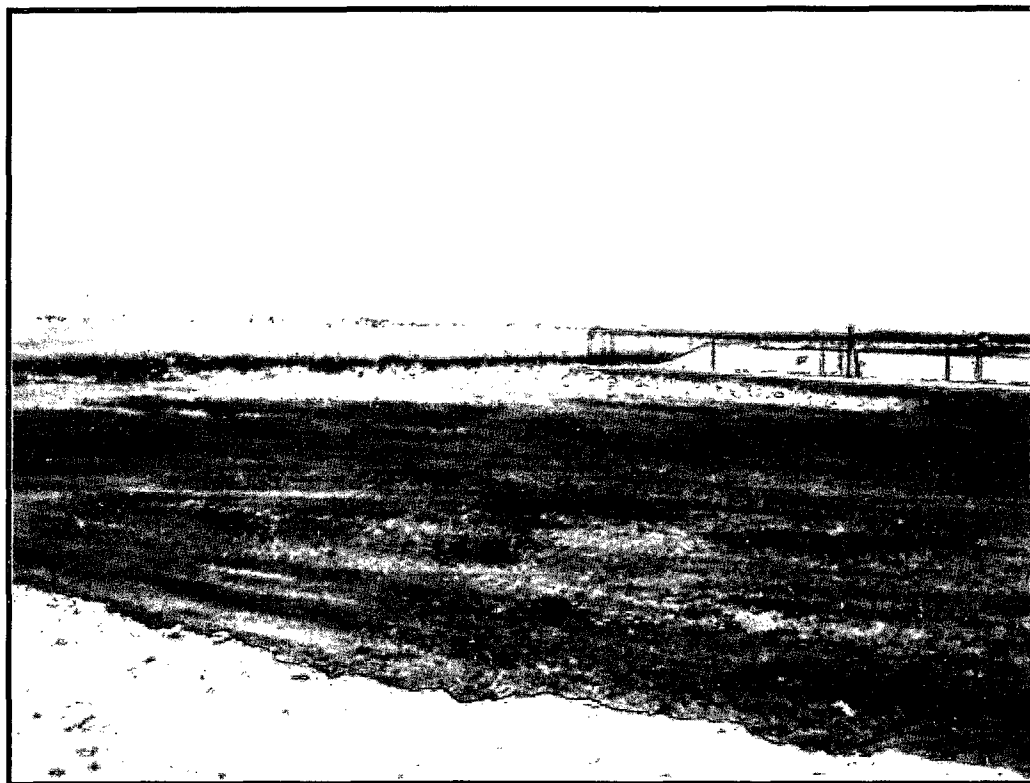
Excavation padded with top soil facing northwest

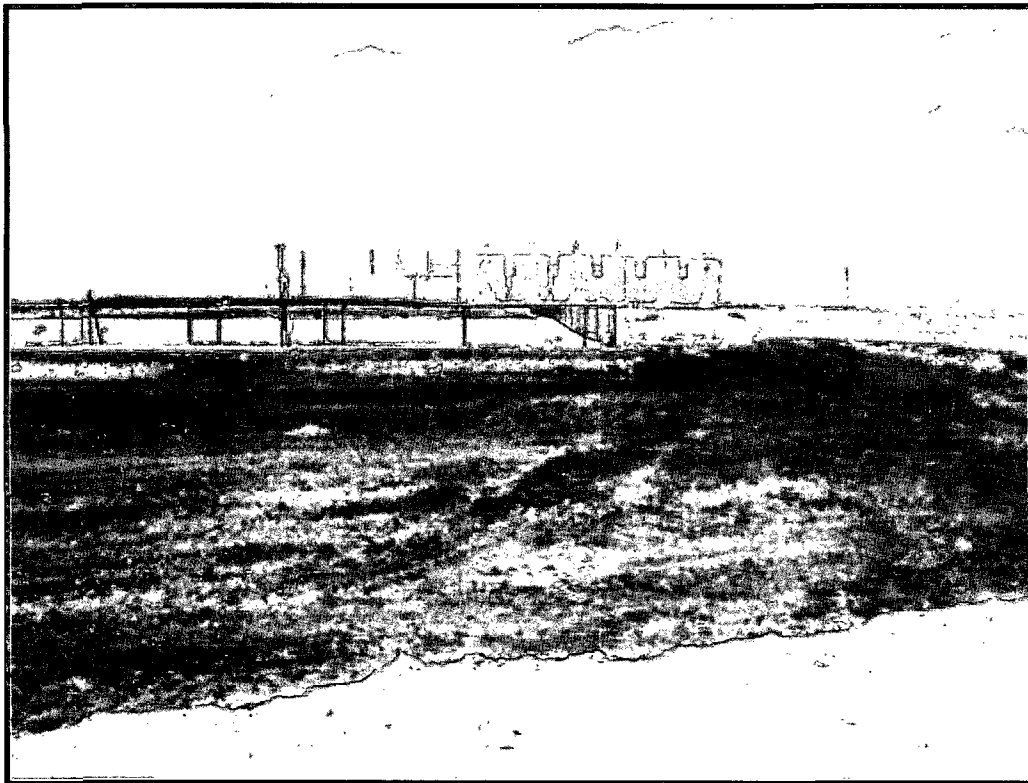
Excavation padded with top soil facing north

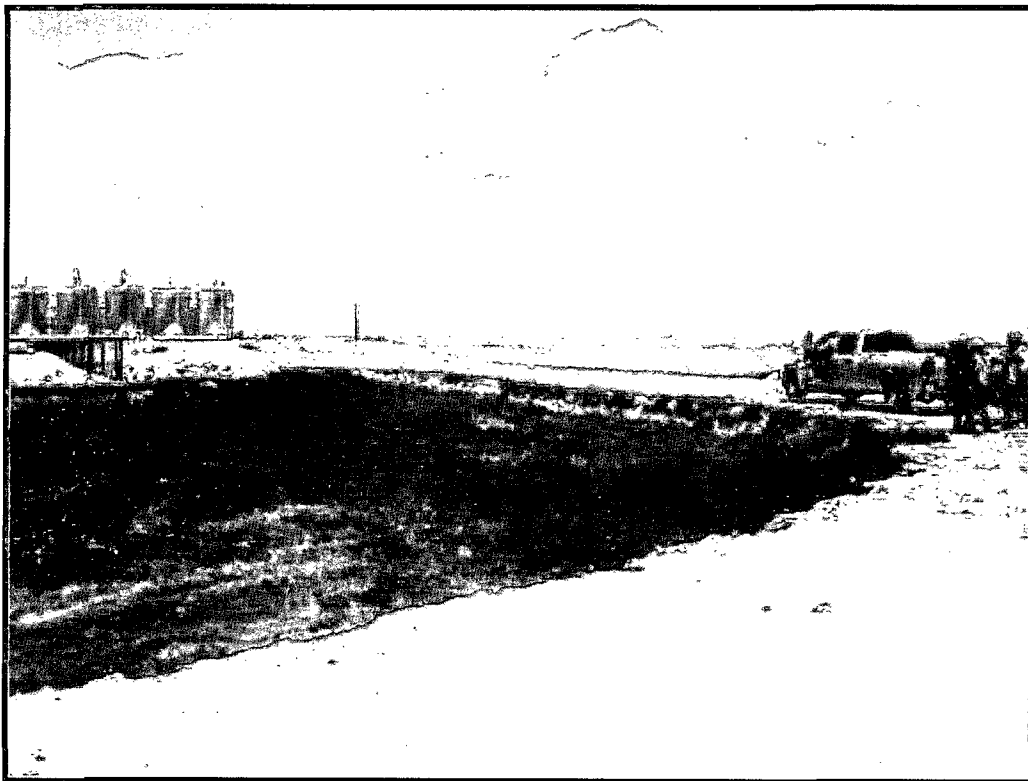
Excavation padded with top soil facing northeast

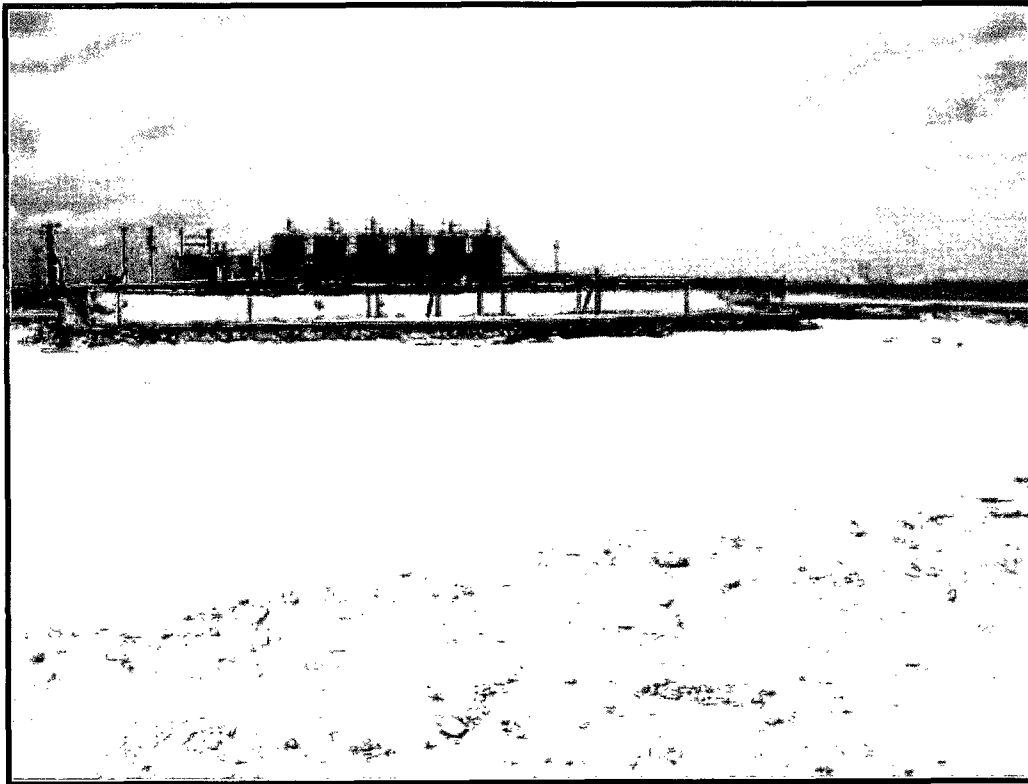
Excavation with 20 mil liner installed facing north

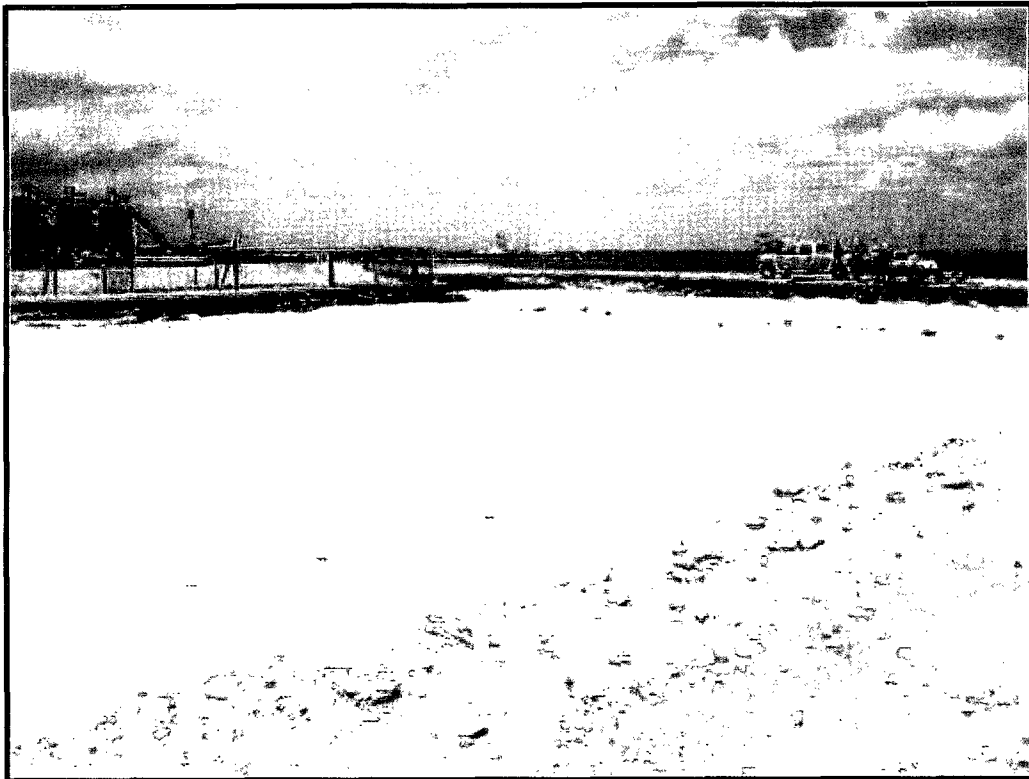
Excavation with 20 mil liner installed facing northeast

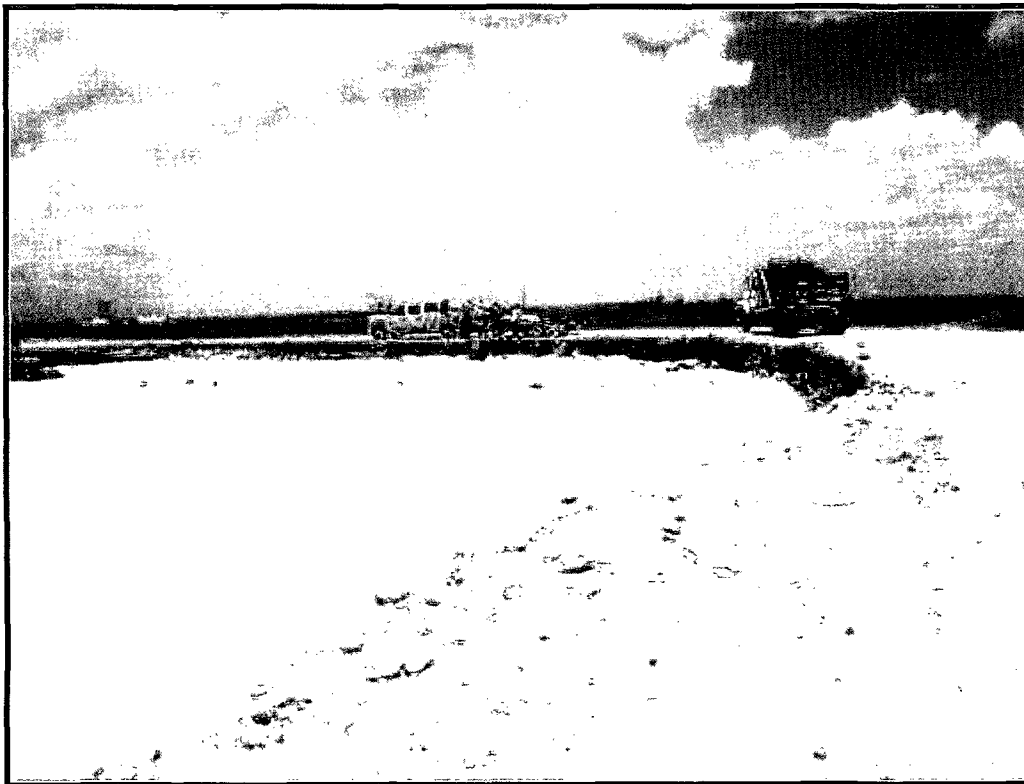
Excavation with 20 mil liner installed facing east

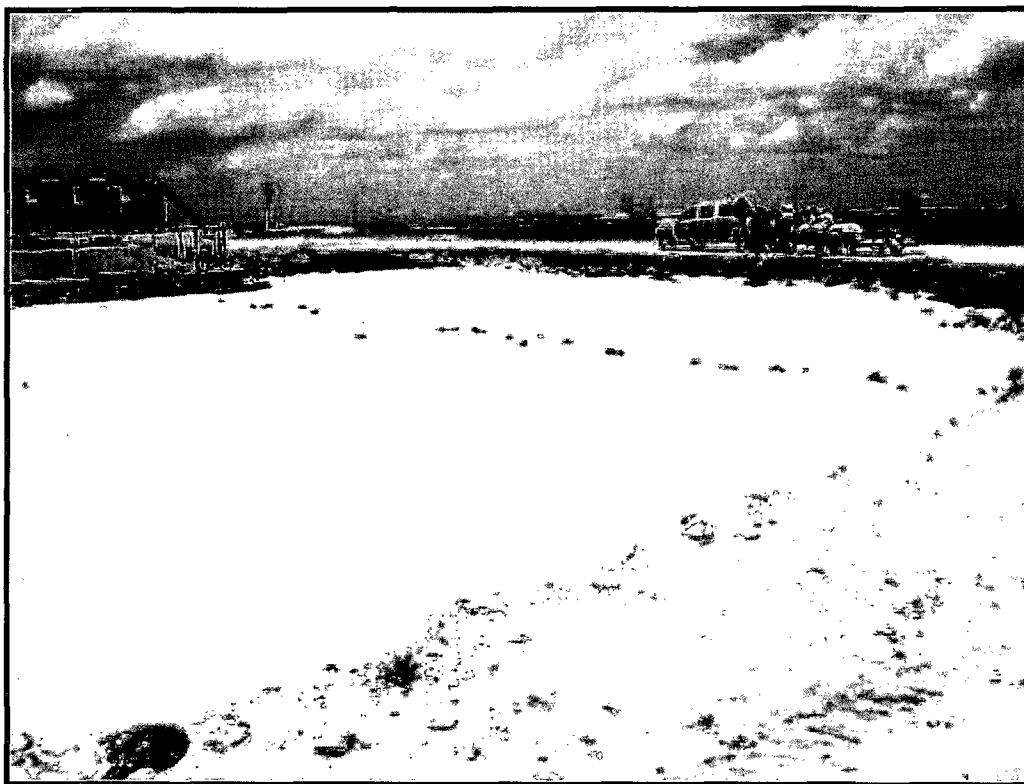
Excavation with 20 mil liner installed facing northeast

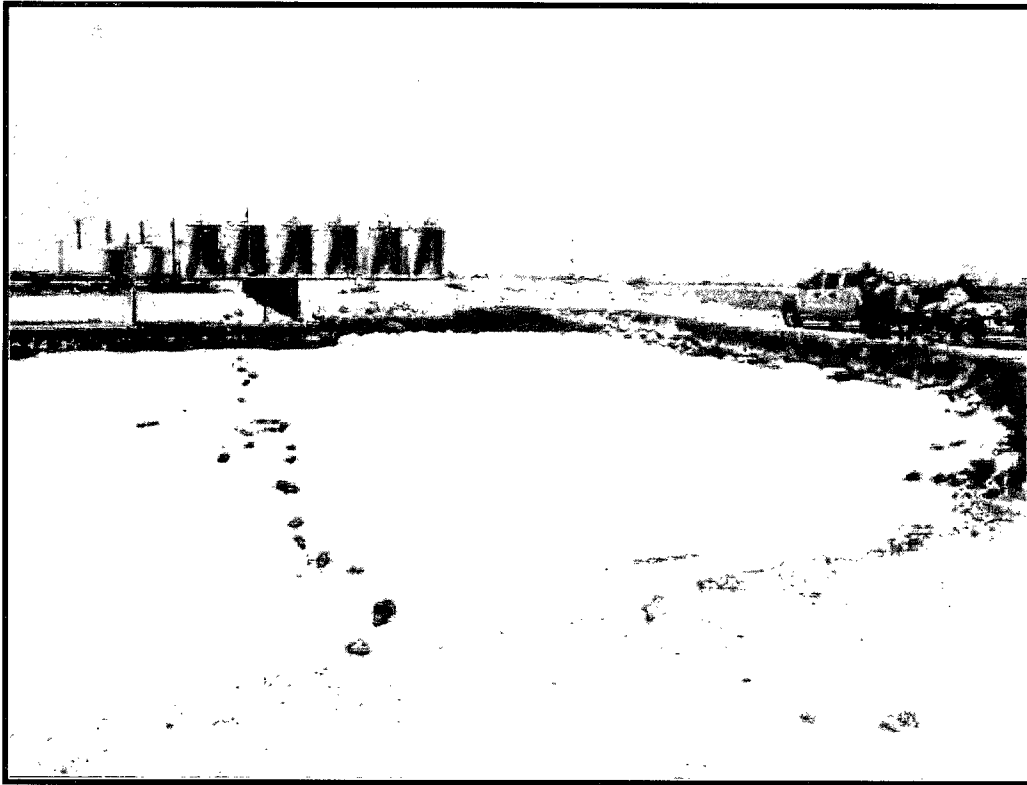
Excavation with 20 mil liner installed facing north

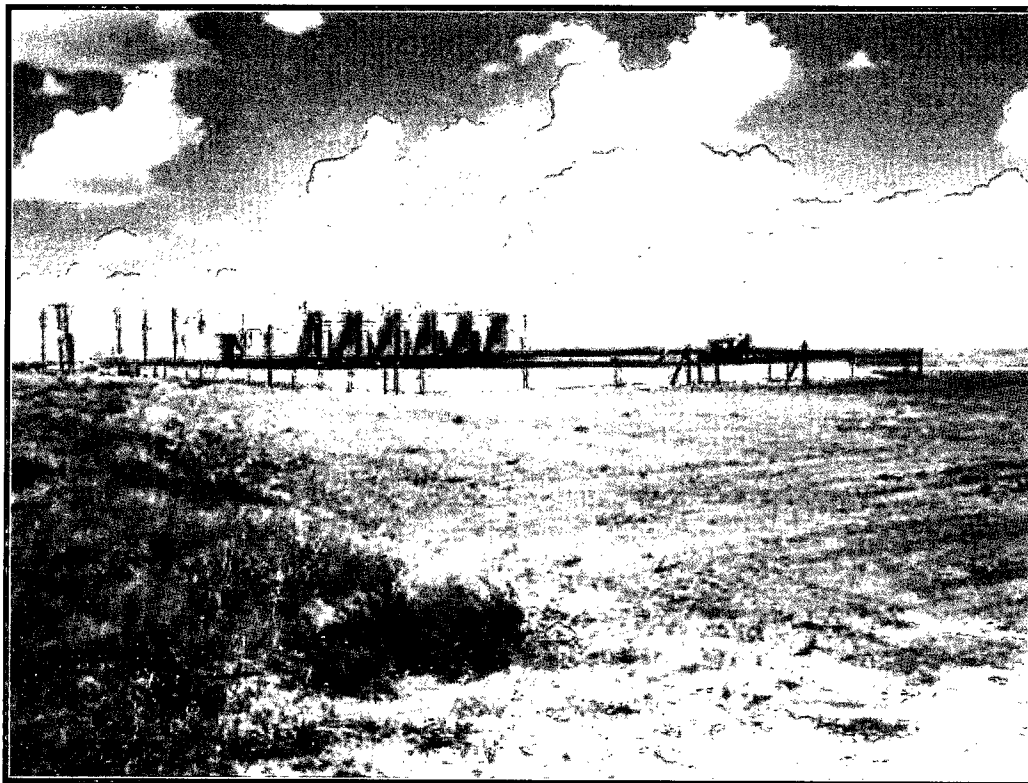
Backfilled excavation facing northeast

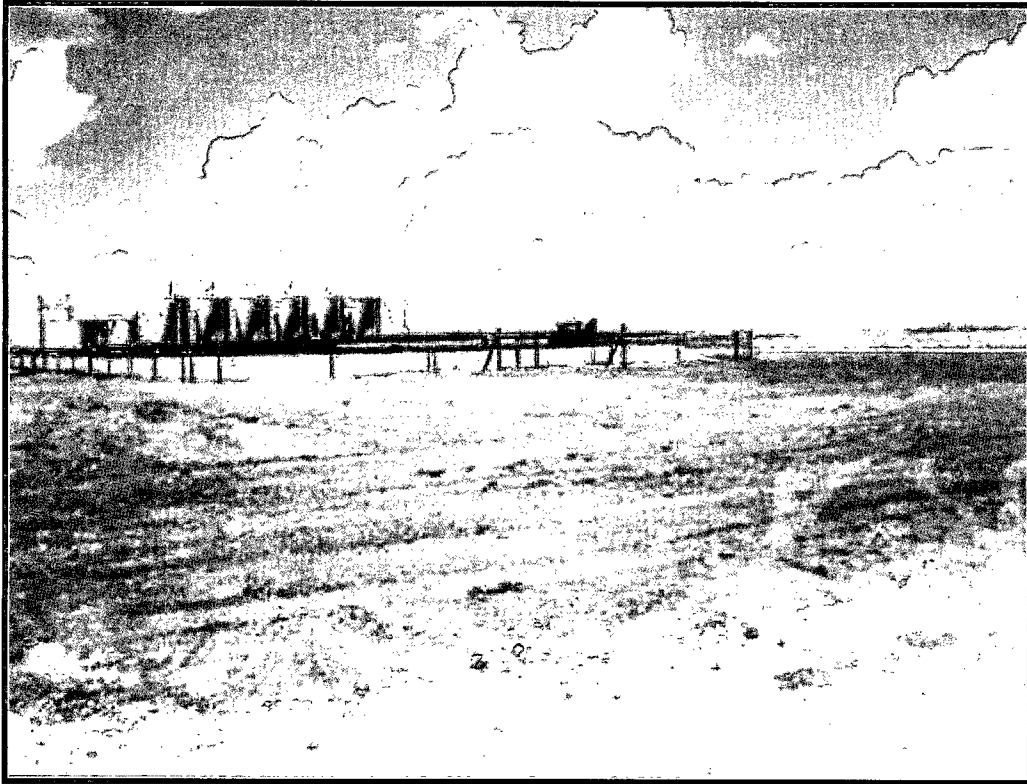
Backfilled excavation facing northeast

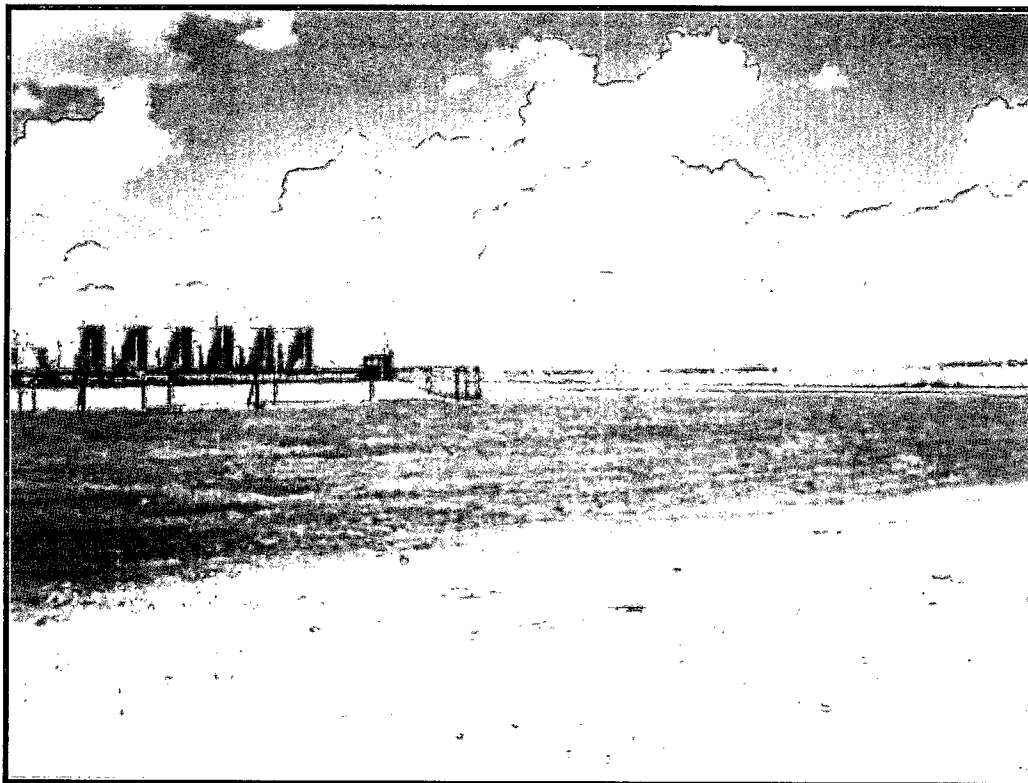
Backfilled excavation facing northeast

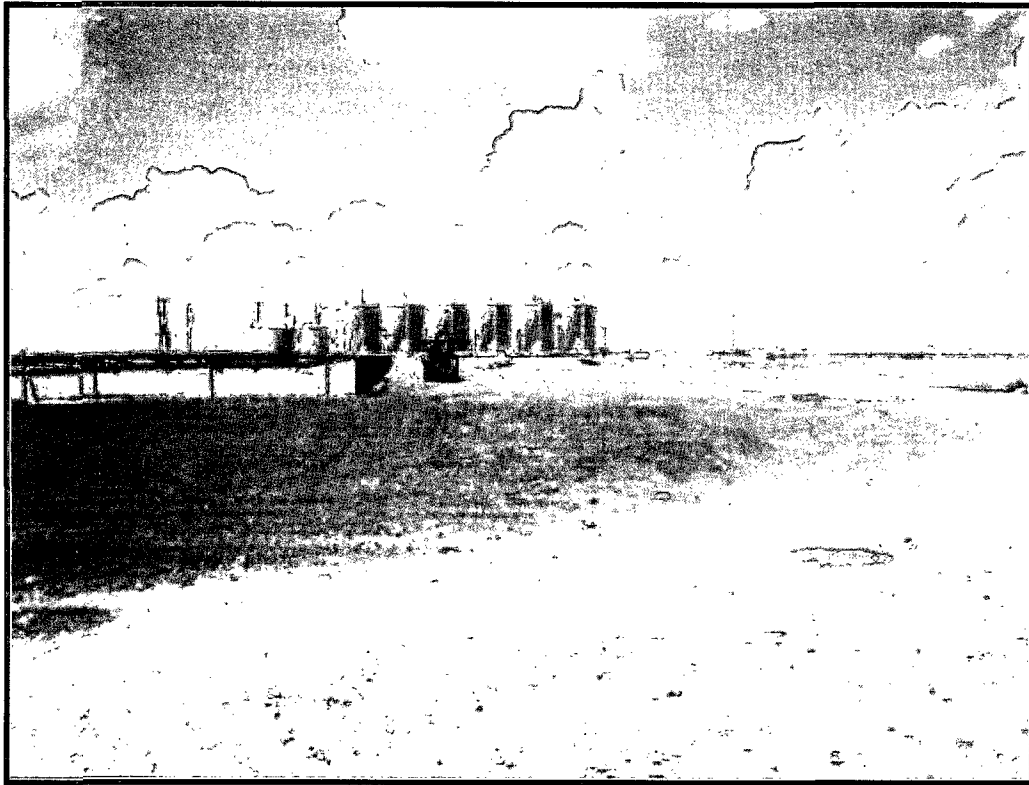
Backfilled excavation facing north

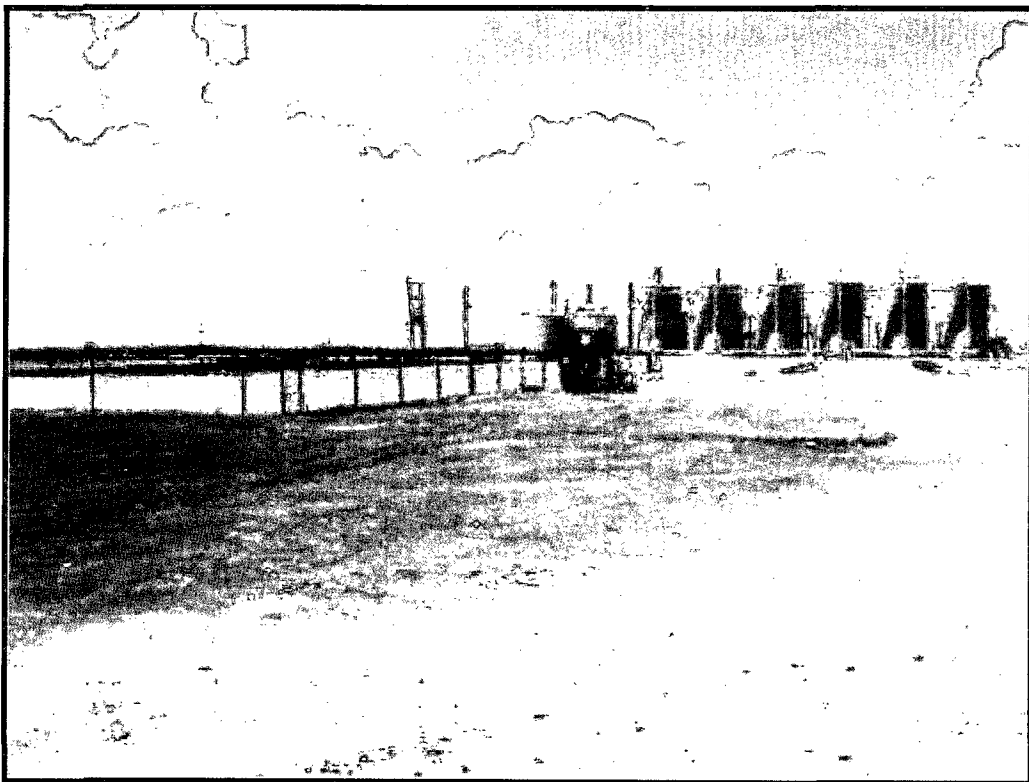
Backfilled excavation facing north
