# Whitten Ranch Sinkhole

Case Study: Evaporites and out of formation waters and their potential for sinkhole development

Oil Conservation Division  
Case No \_\_\_\_\_  
Exhibit No 6

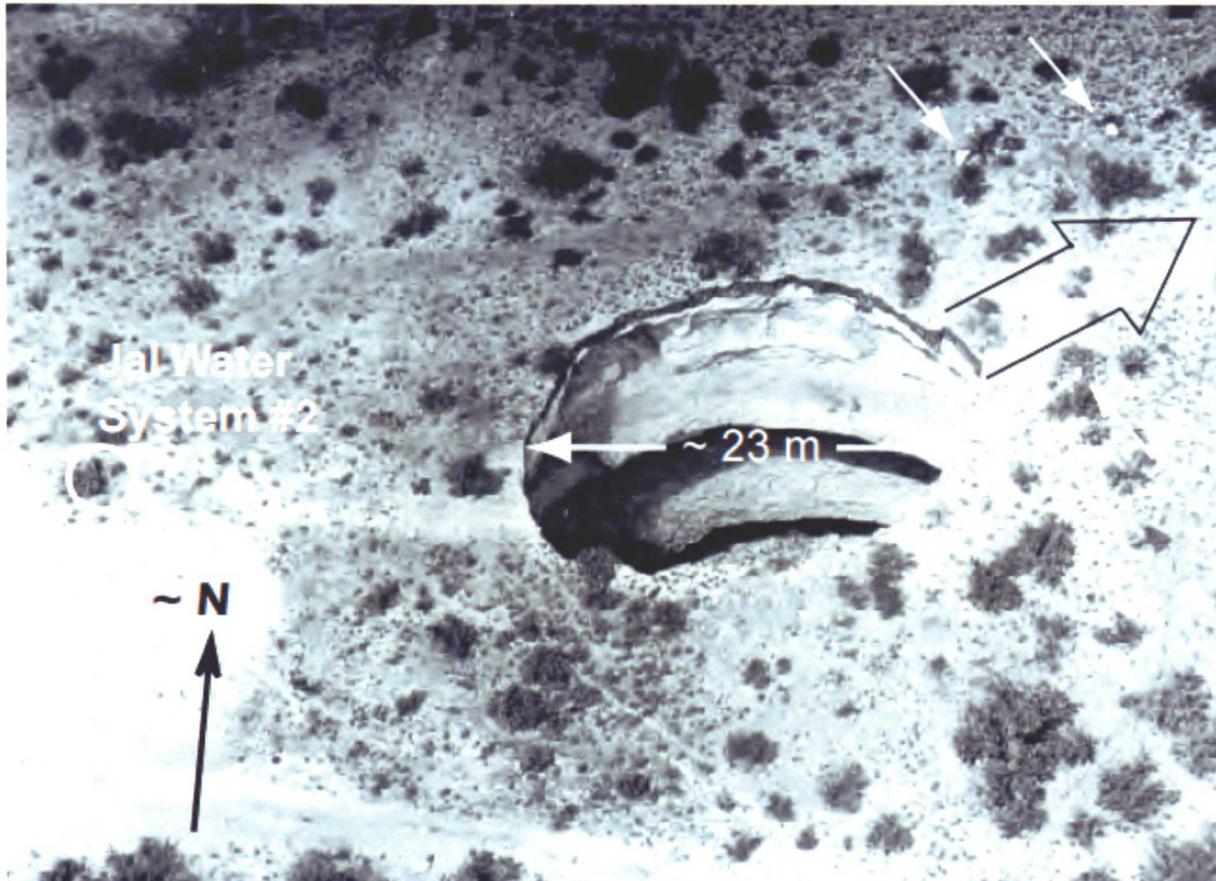
*Oblique aerial photograph*

- Sinkhole formed in a catastrophic collapse in late 1998
- Sinkhole developed above deeper Ochoan evaporite sequence
- Locally modest casing requirements through the evaporites and water-flood operations with out-of-formation waters increase risk of karstification
- Jal #2 water system #2, drilled in 1967 and had a series of collapsed casing issues throughout its life which could have provided a conduit for shallow or deep water reservoirs to transport to the evaporites and result in dissolution of the
- Natural origin cannot be ruled out, but circumstantial evidence favors faulty wellbores as a significant causal agent for water migration
