Release Notification and Corrective Action

Name GP II ENERGY, INC.	Contact Elaine McCarty
Address P. O. Box 50682, Midland, Tx. 79710	Telephone No. (915) 684-4748 EXT 5
Facility Name Langlie Jal Unit	Facility Type Injection Plant

**GP II ENERGY, INC
P. O. BOX 50682
MIDLAND, TX. 79710
Supplement to C 141**

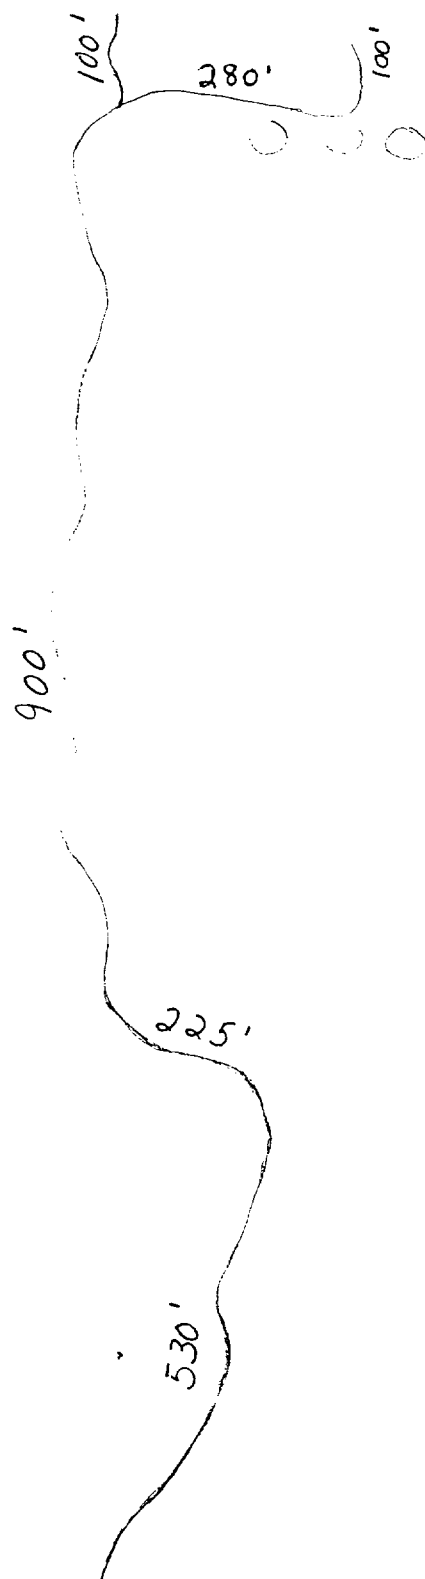
From tank site which is located in south west corner of injection plant area, fluid ran 280' west, 100' north, 900 south, 225' east and 530' south. See map.

Fluid was picked up by vacuum truck. All contaminated dirt and caliche was hauled away by Sundance Services. Clean dirt and caliche was brought in and spread in appropriate areas.
