**Legacy Reserves
Chamberlain TB**

**Investigation &
Remediation**

**INVESTIGATION
AND REMEDIATION REPORT
Chamberlain Flow Line Leak
and Historic Contamination
#1RP-2391**

LAI Project No. 12-0126-01

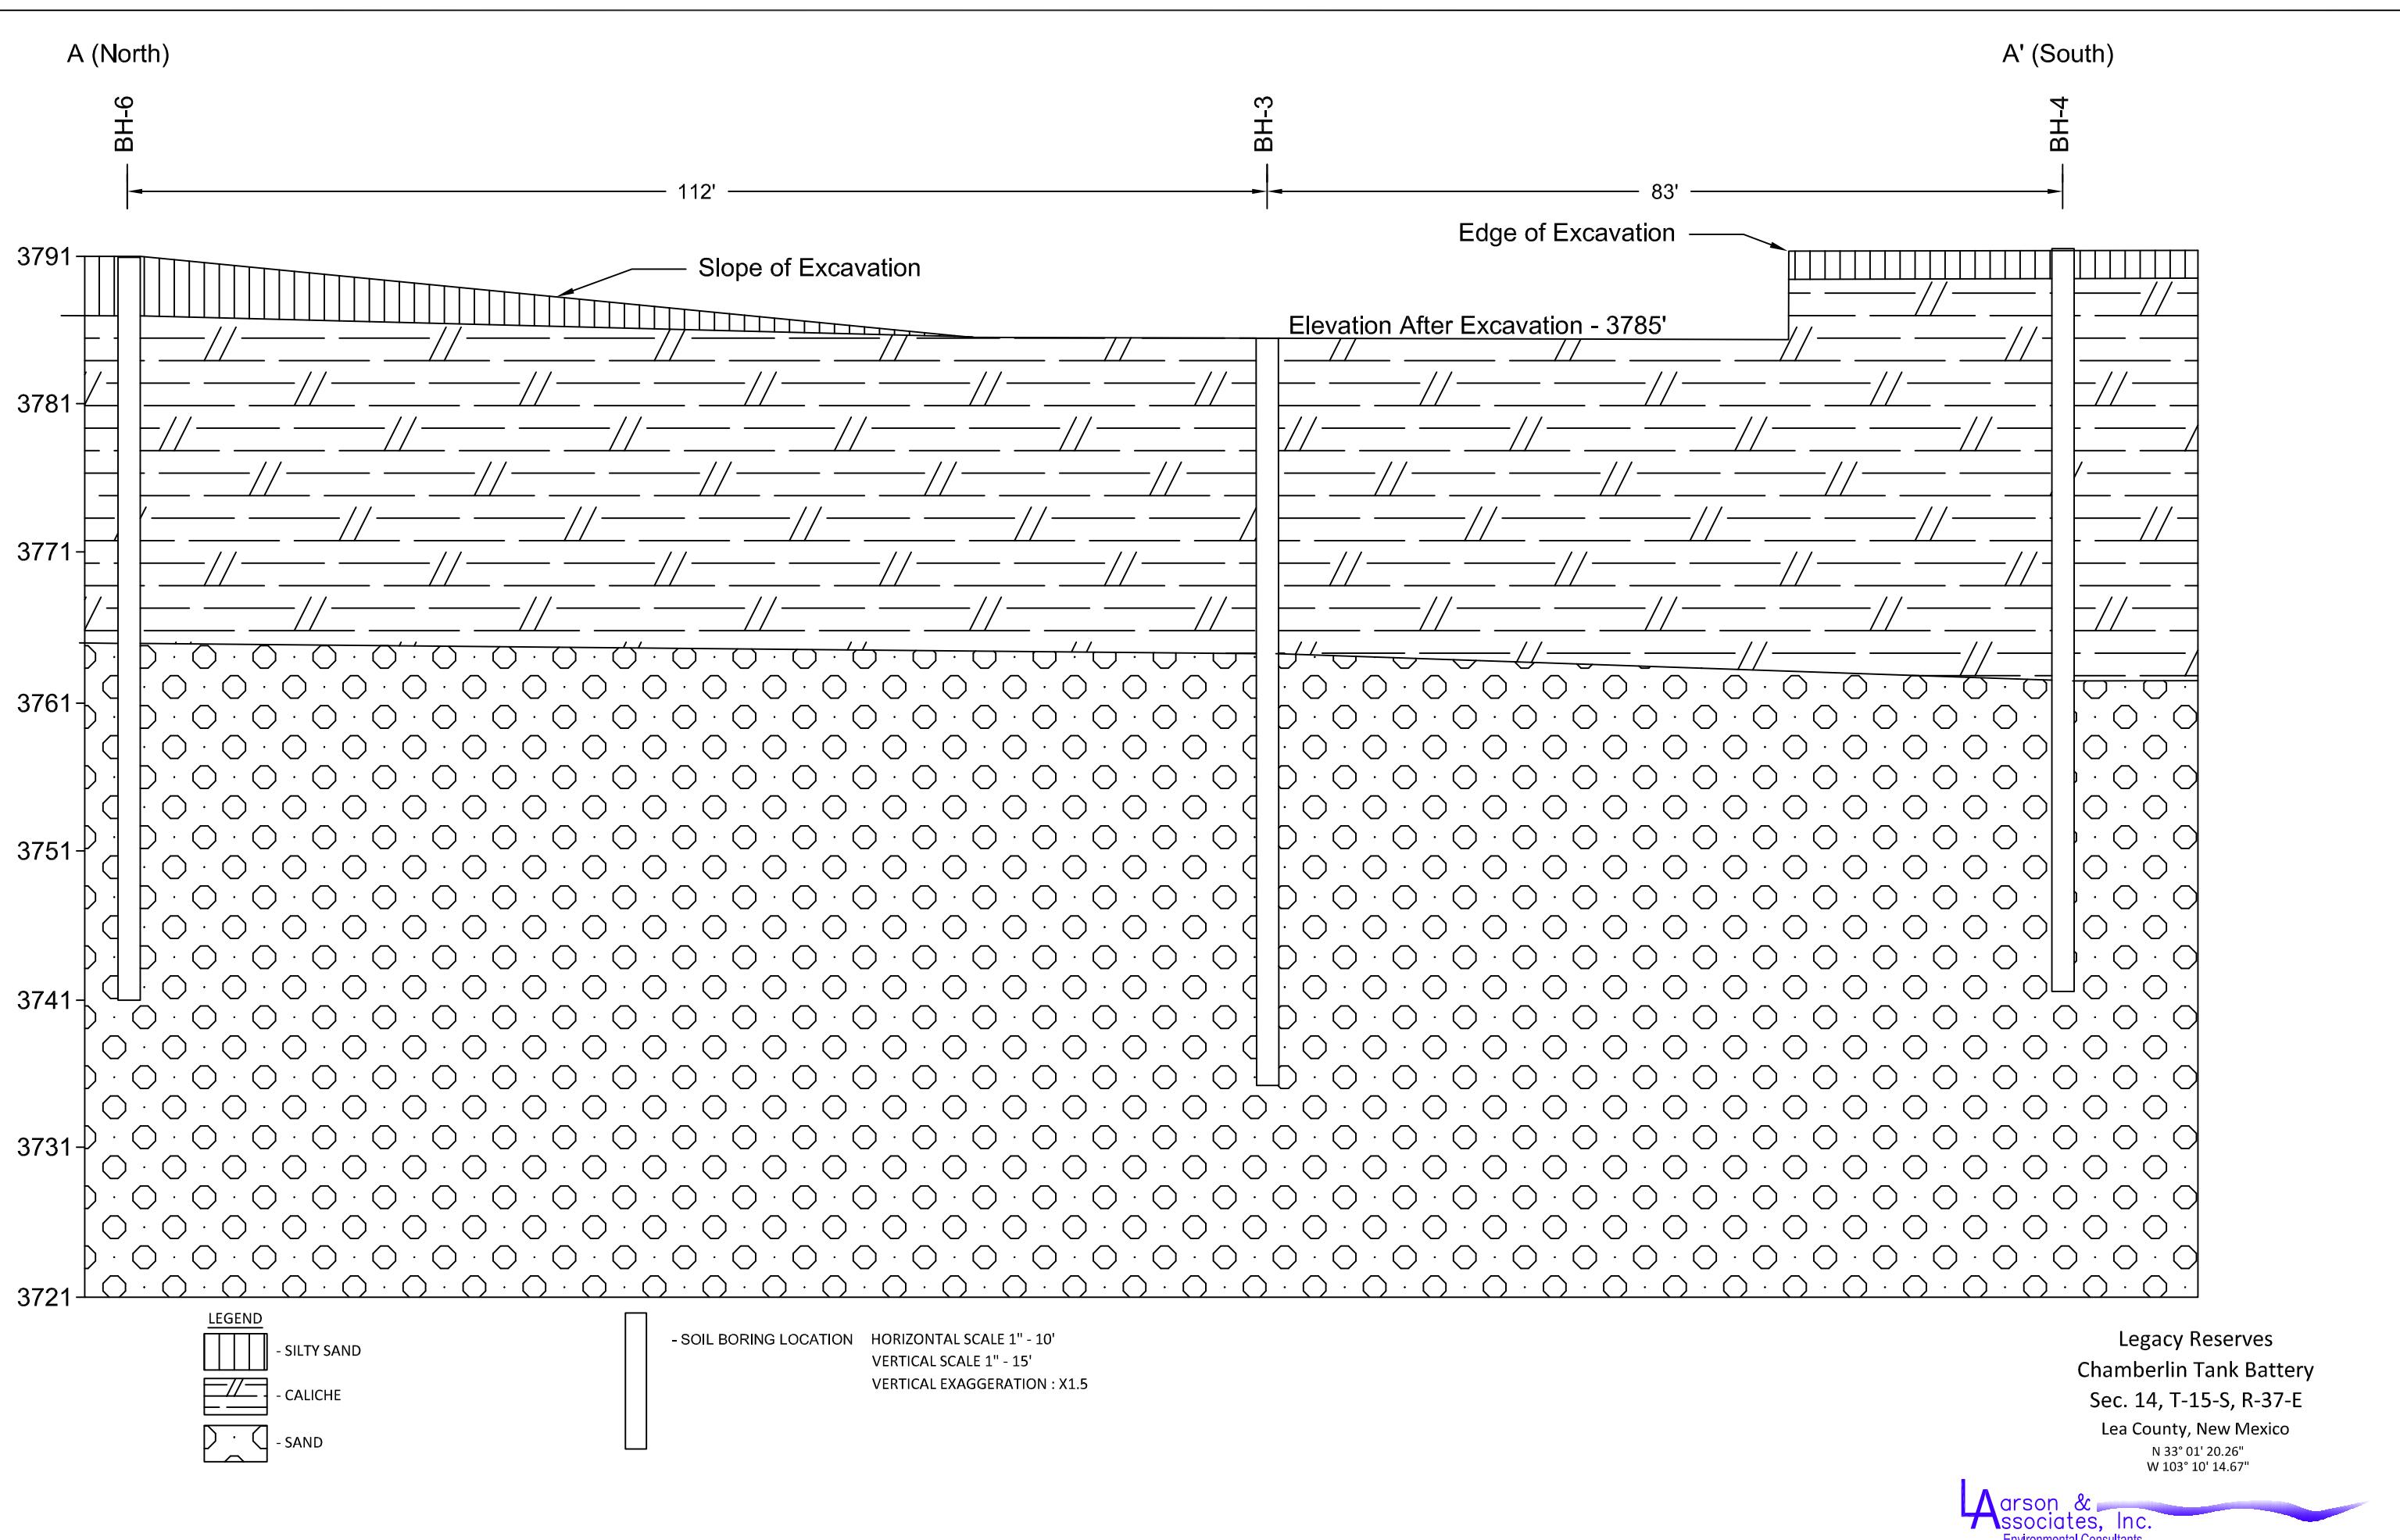
Figure 4 - Geological Cross Section Map A-A'

LAI personnel supervised installing a temporary monitoring well (TMW-1) about 100 feet southeast of the Site where groundwater was encountered in the Ogallala formation at approximately 62 feet bgs. The Triassic-age Chinle formation is the lower confining unit for the Ogallala formation and occurs at a depth of approximately 120 feet bgs according to well records from the New Mexico Office of the State Engineer (OSE). A well used for livestock watering is located about 1,600 feet southeast of the Site. The regional groundwater flow direction is to the southeast (Nativ, 1988). The groundwater potentiometric surface is depicted on the north (A) to south (A') and west (B) to east (B') geological cross sections presented on Figure 4 and Figure 5, respectively.

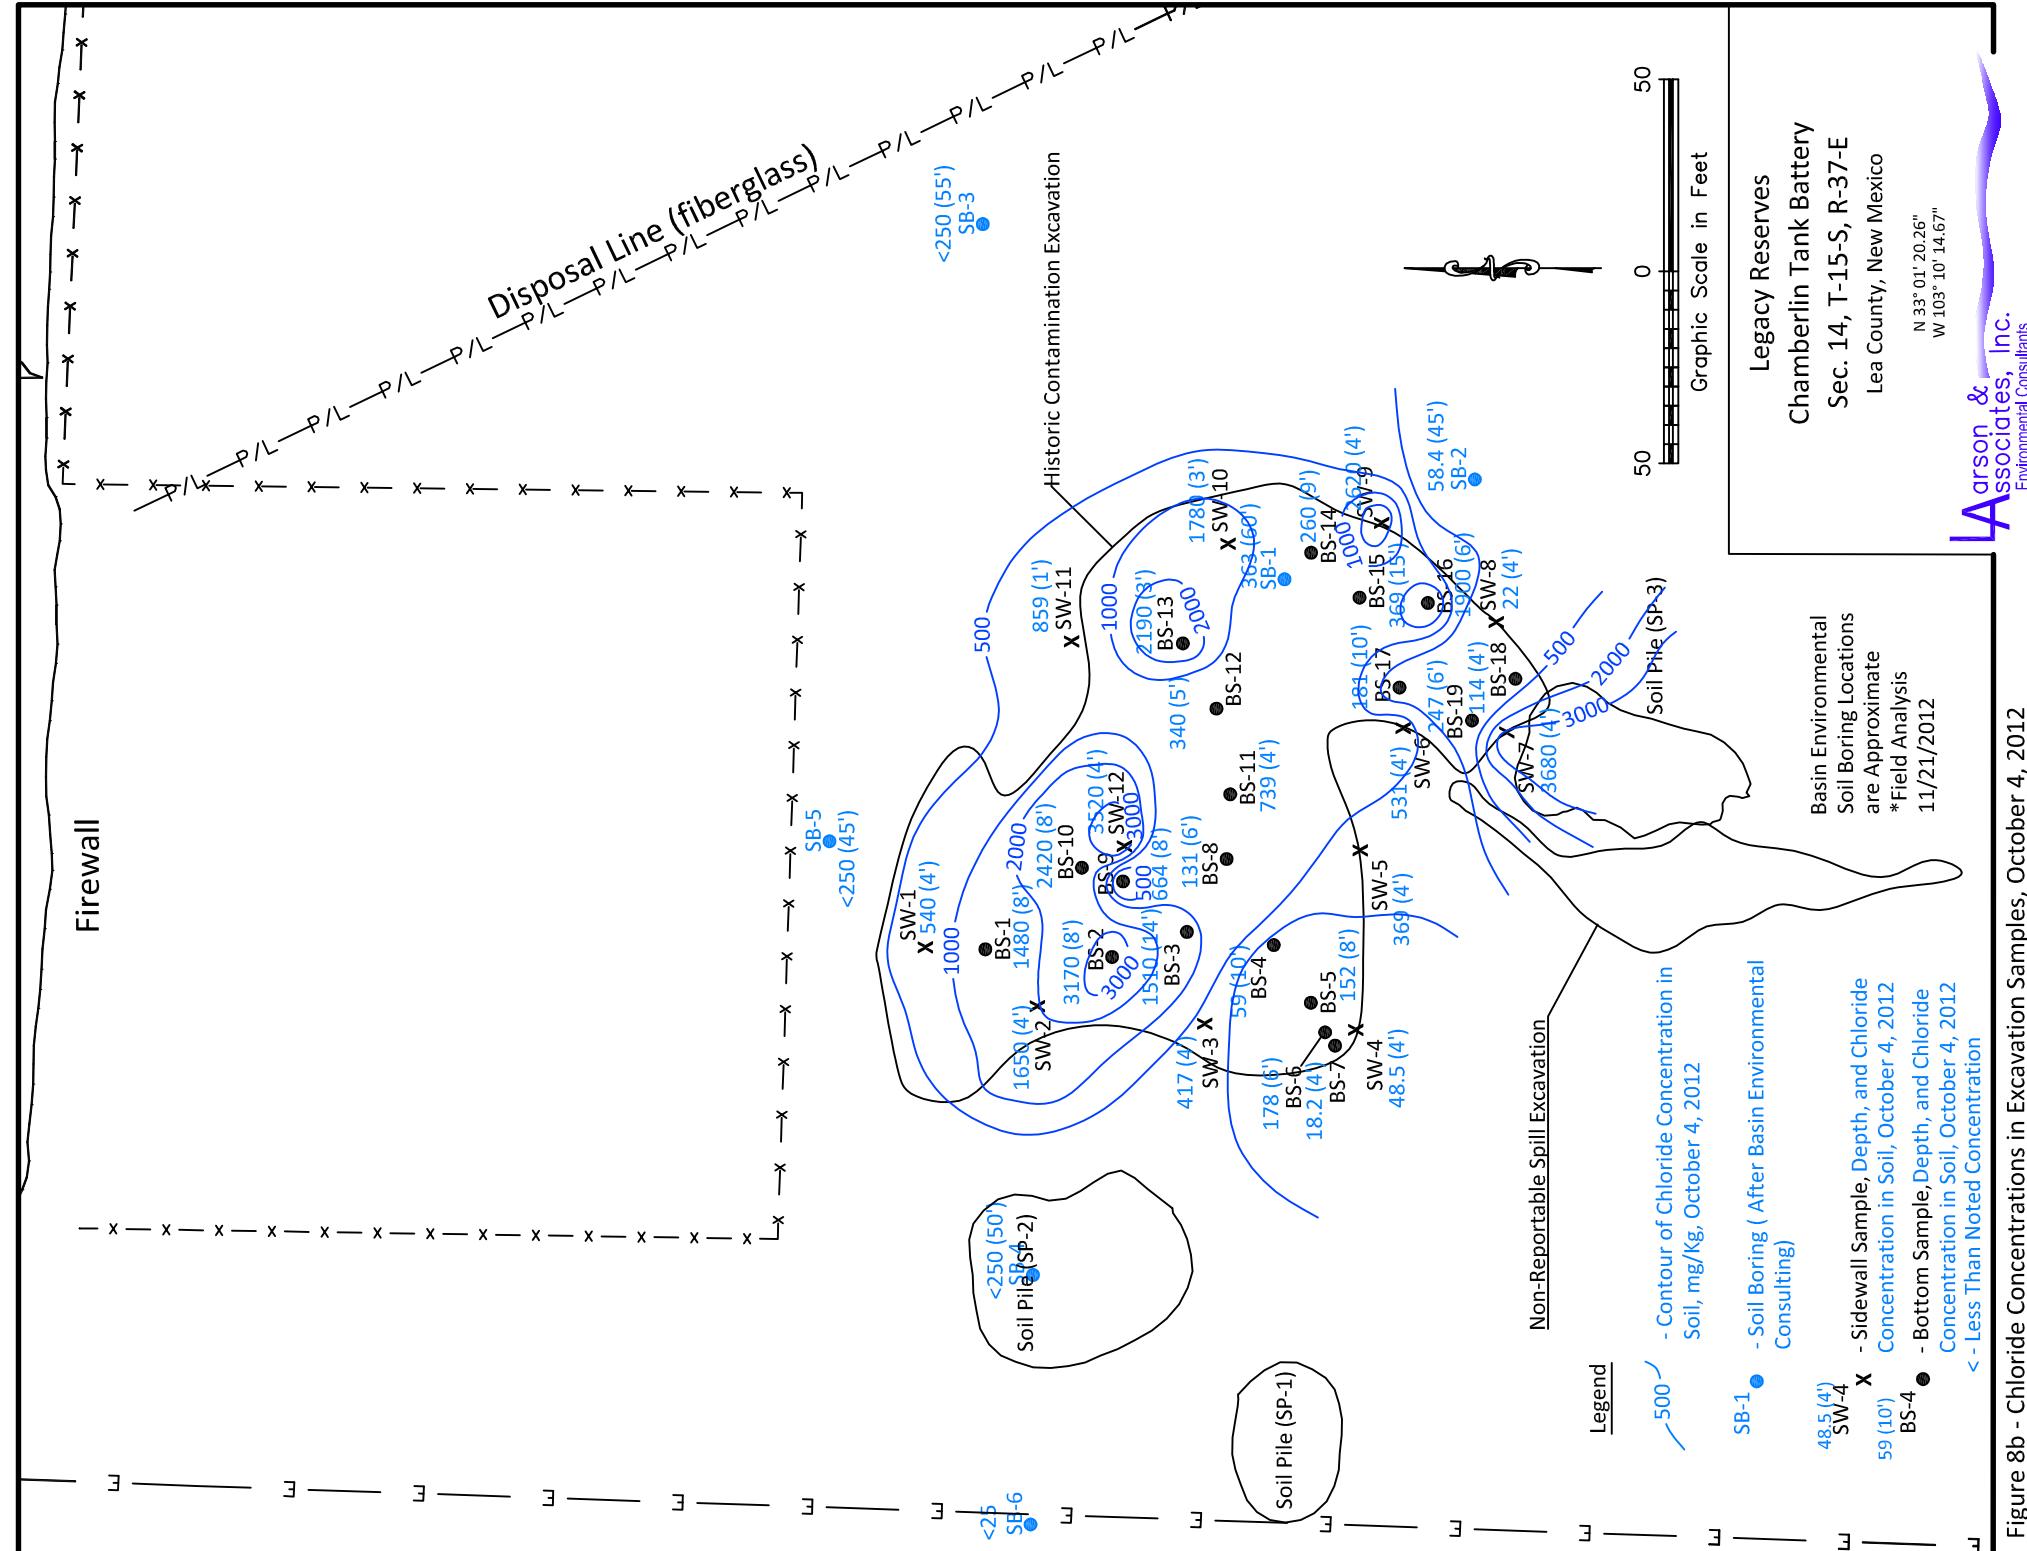
Figure 8b - Chloride Concentrations in Excavation Samples, October 4, 2012

Referring to Figure 8a, TPH was above the OCD recommended cleanup level in the bottom samples except BS-19 (23.8 mg/Kg). Chloride in the bottom samples ranged from 59 mg/Kg (BS-4) at approximately 10 feet bgs to 3,170 mg/Kg (BS-2) at approximately 8 feet bgs (Figure 8b). The extent of TPH and chloride were not delineated. Benzene was below the MDL and BTEX was below the OCD recommended cleanup level. Approximately 1,900 cubic yards of soil was hauled to the Jay Dan Landfarm, LLC. Appendix C presents photographs.

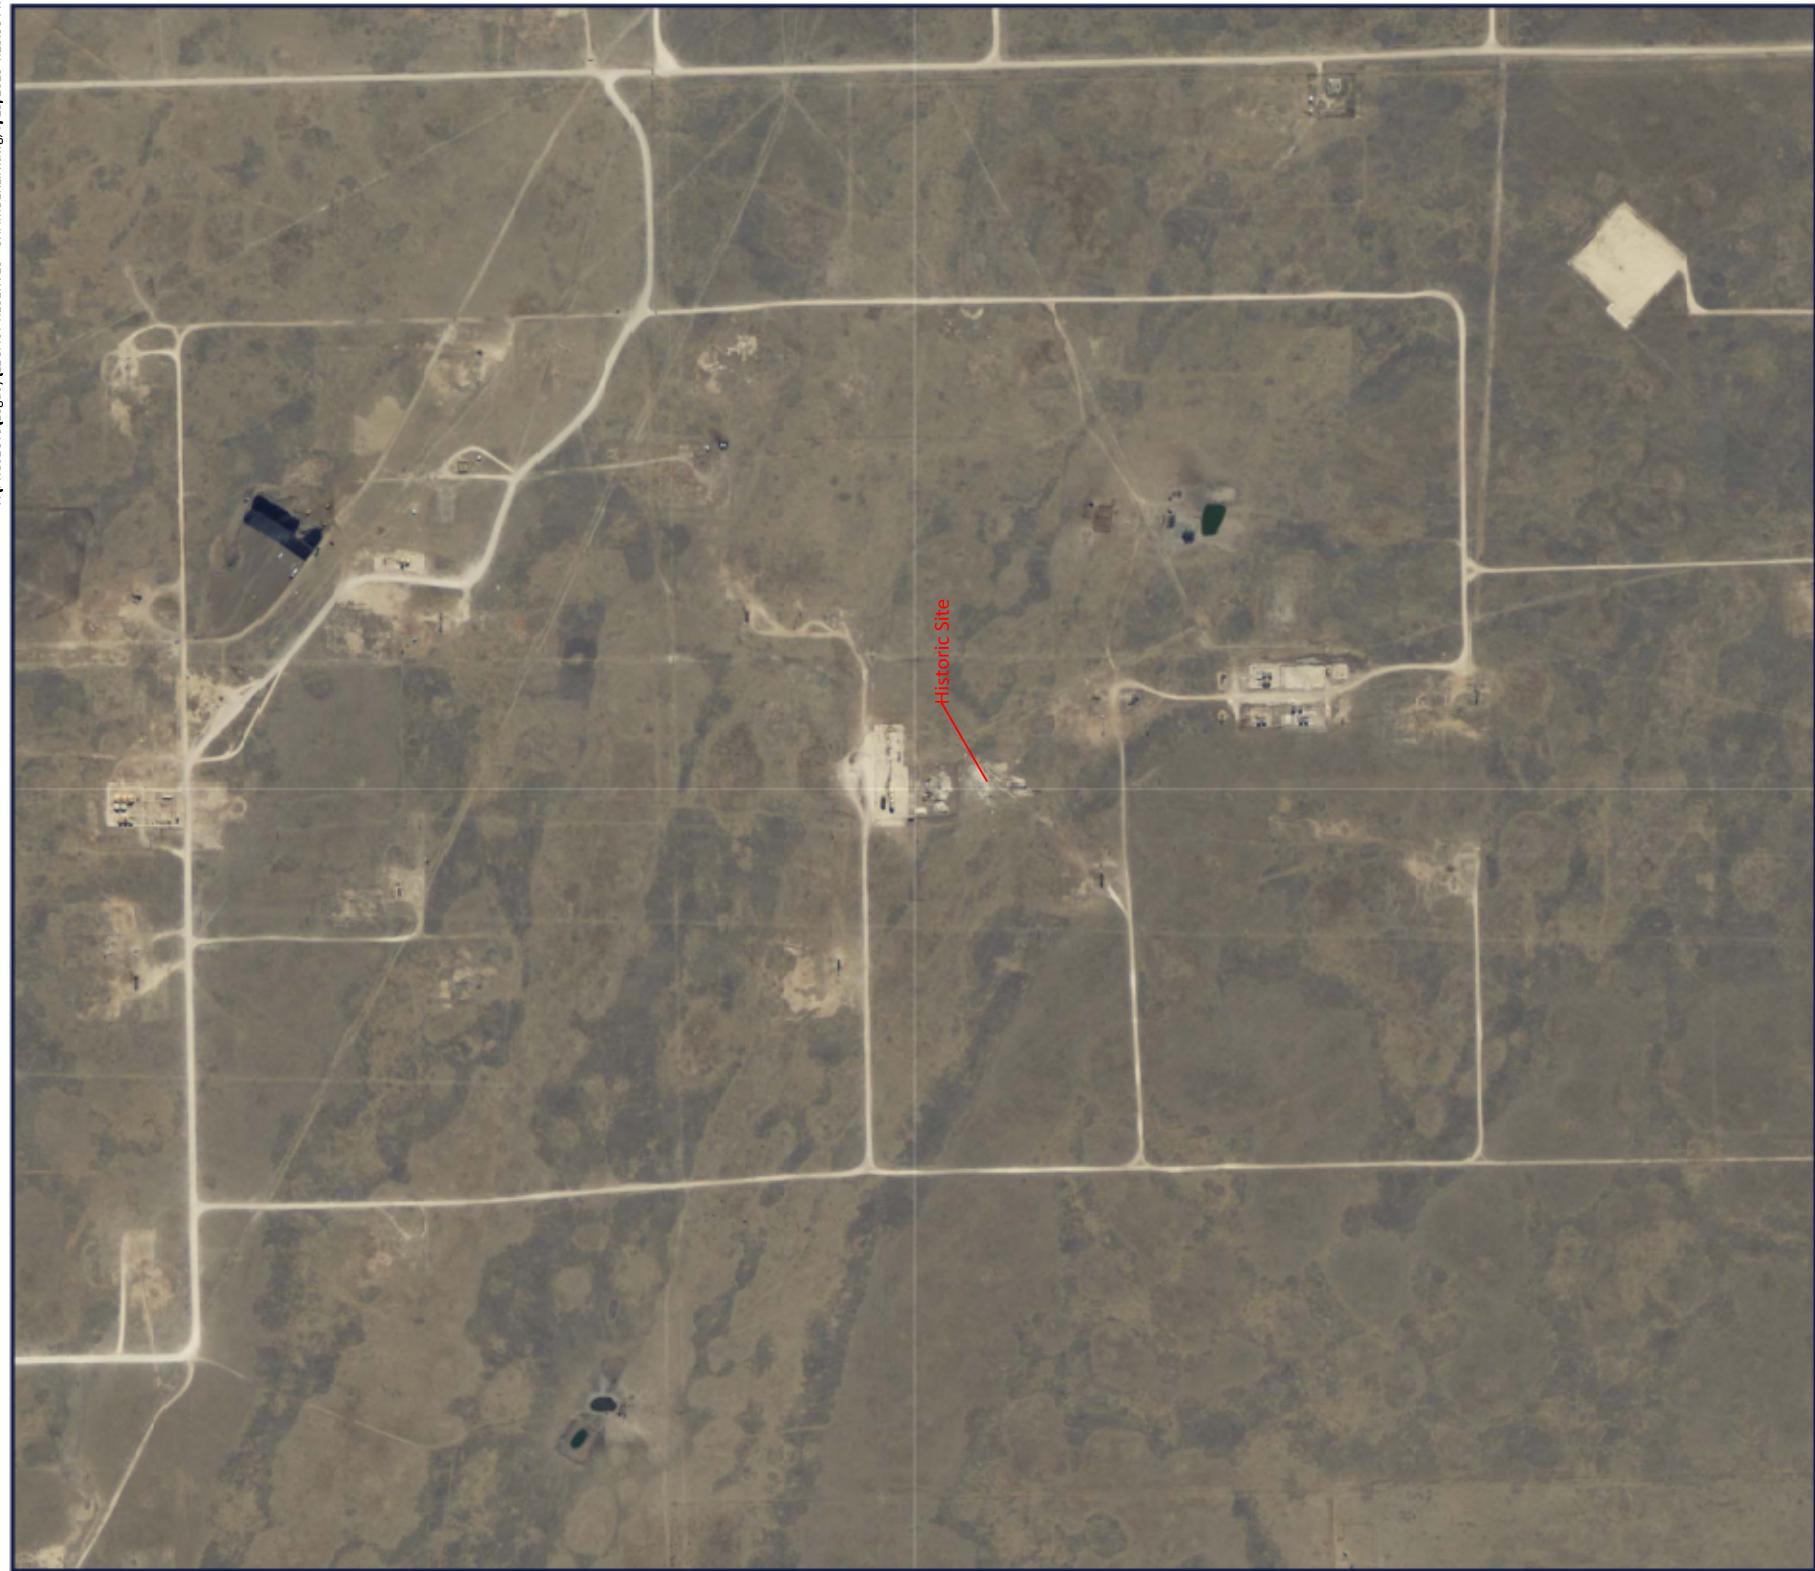
This 2011 color photograph has a scale of 1" to 700'. The photograph depicts the Site condition following the initial excavations in 2009. The photograph shows evidence of surface scarring from prior operations or releases at the Site. The surrounding area is similar to what was observed during the current investigation and remediation.

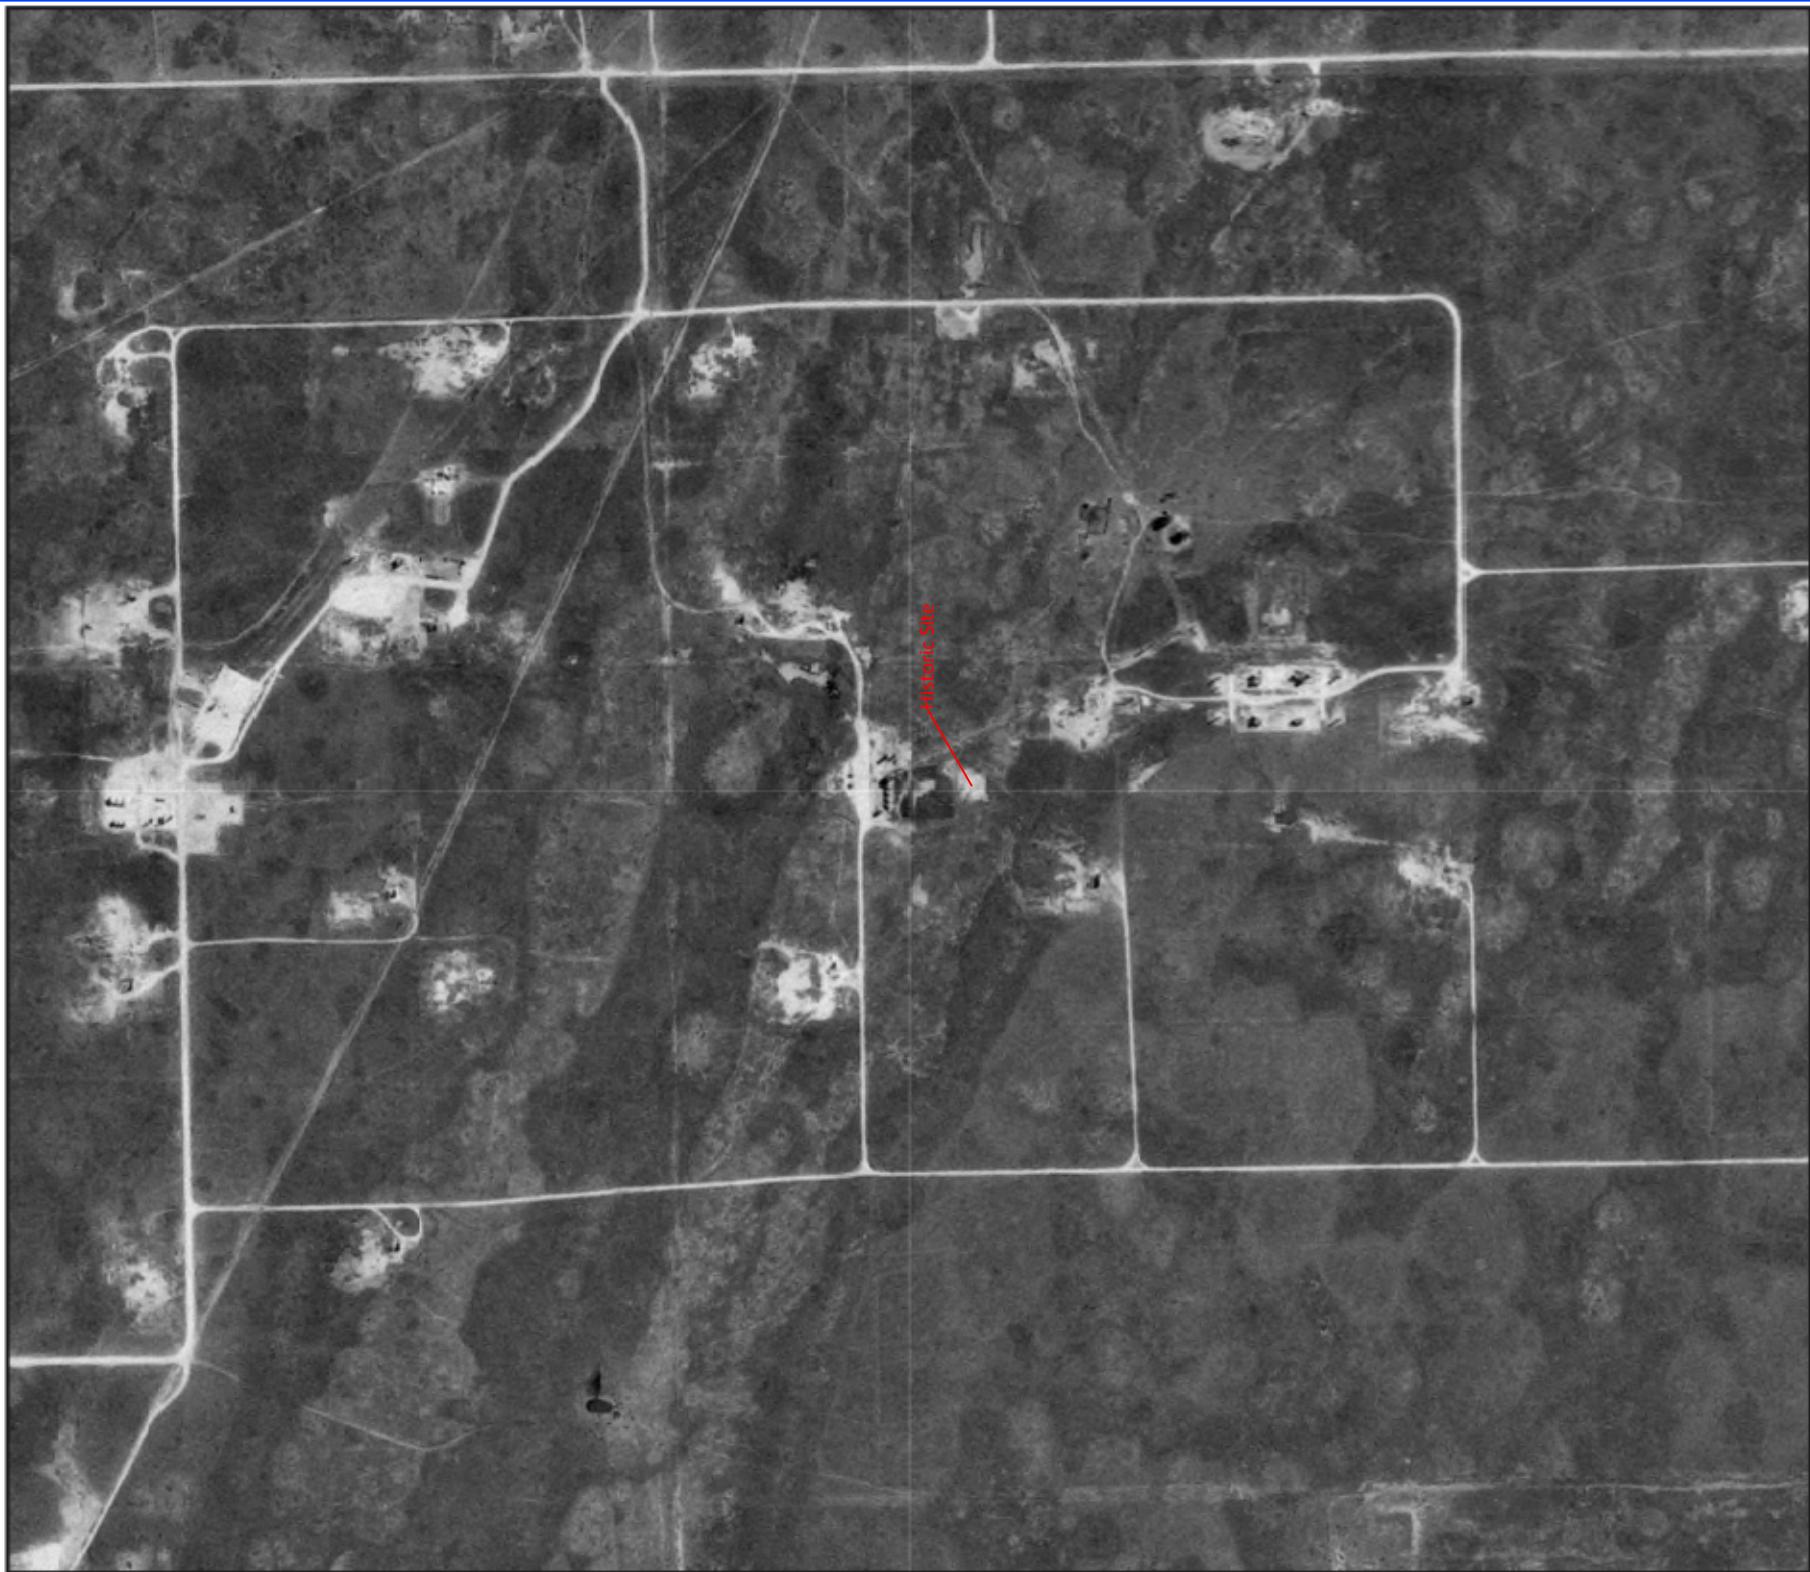
SITE: LEGACY - CHAMBERLIN
SOURCE: USGS
DATE: 1996
COUNTY: LEA, NM
SCALE: 1" = 700'

This black and white photograph was taken in 1996, and has a scale of 1" to 700'. This photograph shows evidence of scarring from previous operations or releases at the Site. Adjoining properties to the north, south, east, and west are in similar configuration observed during the current investigations and remediation.

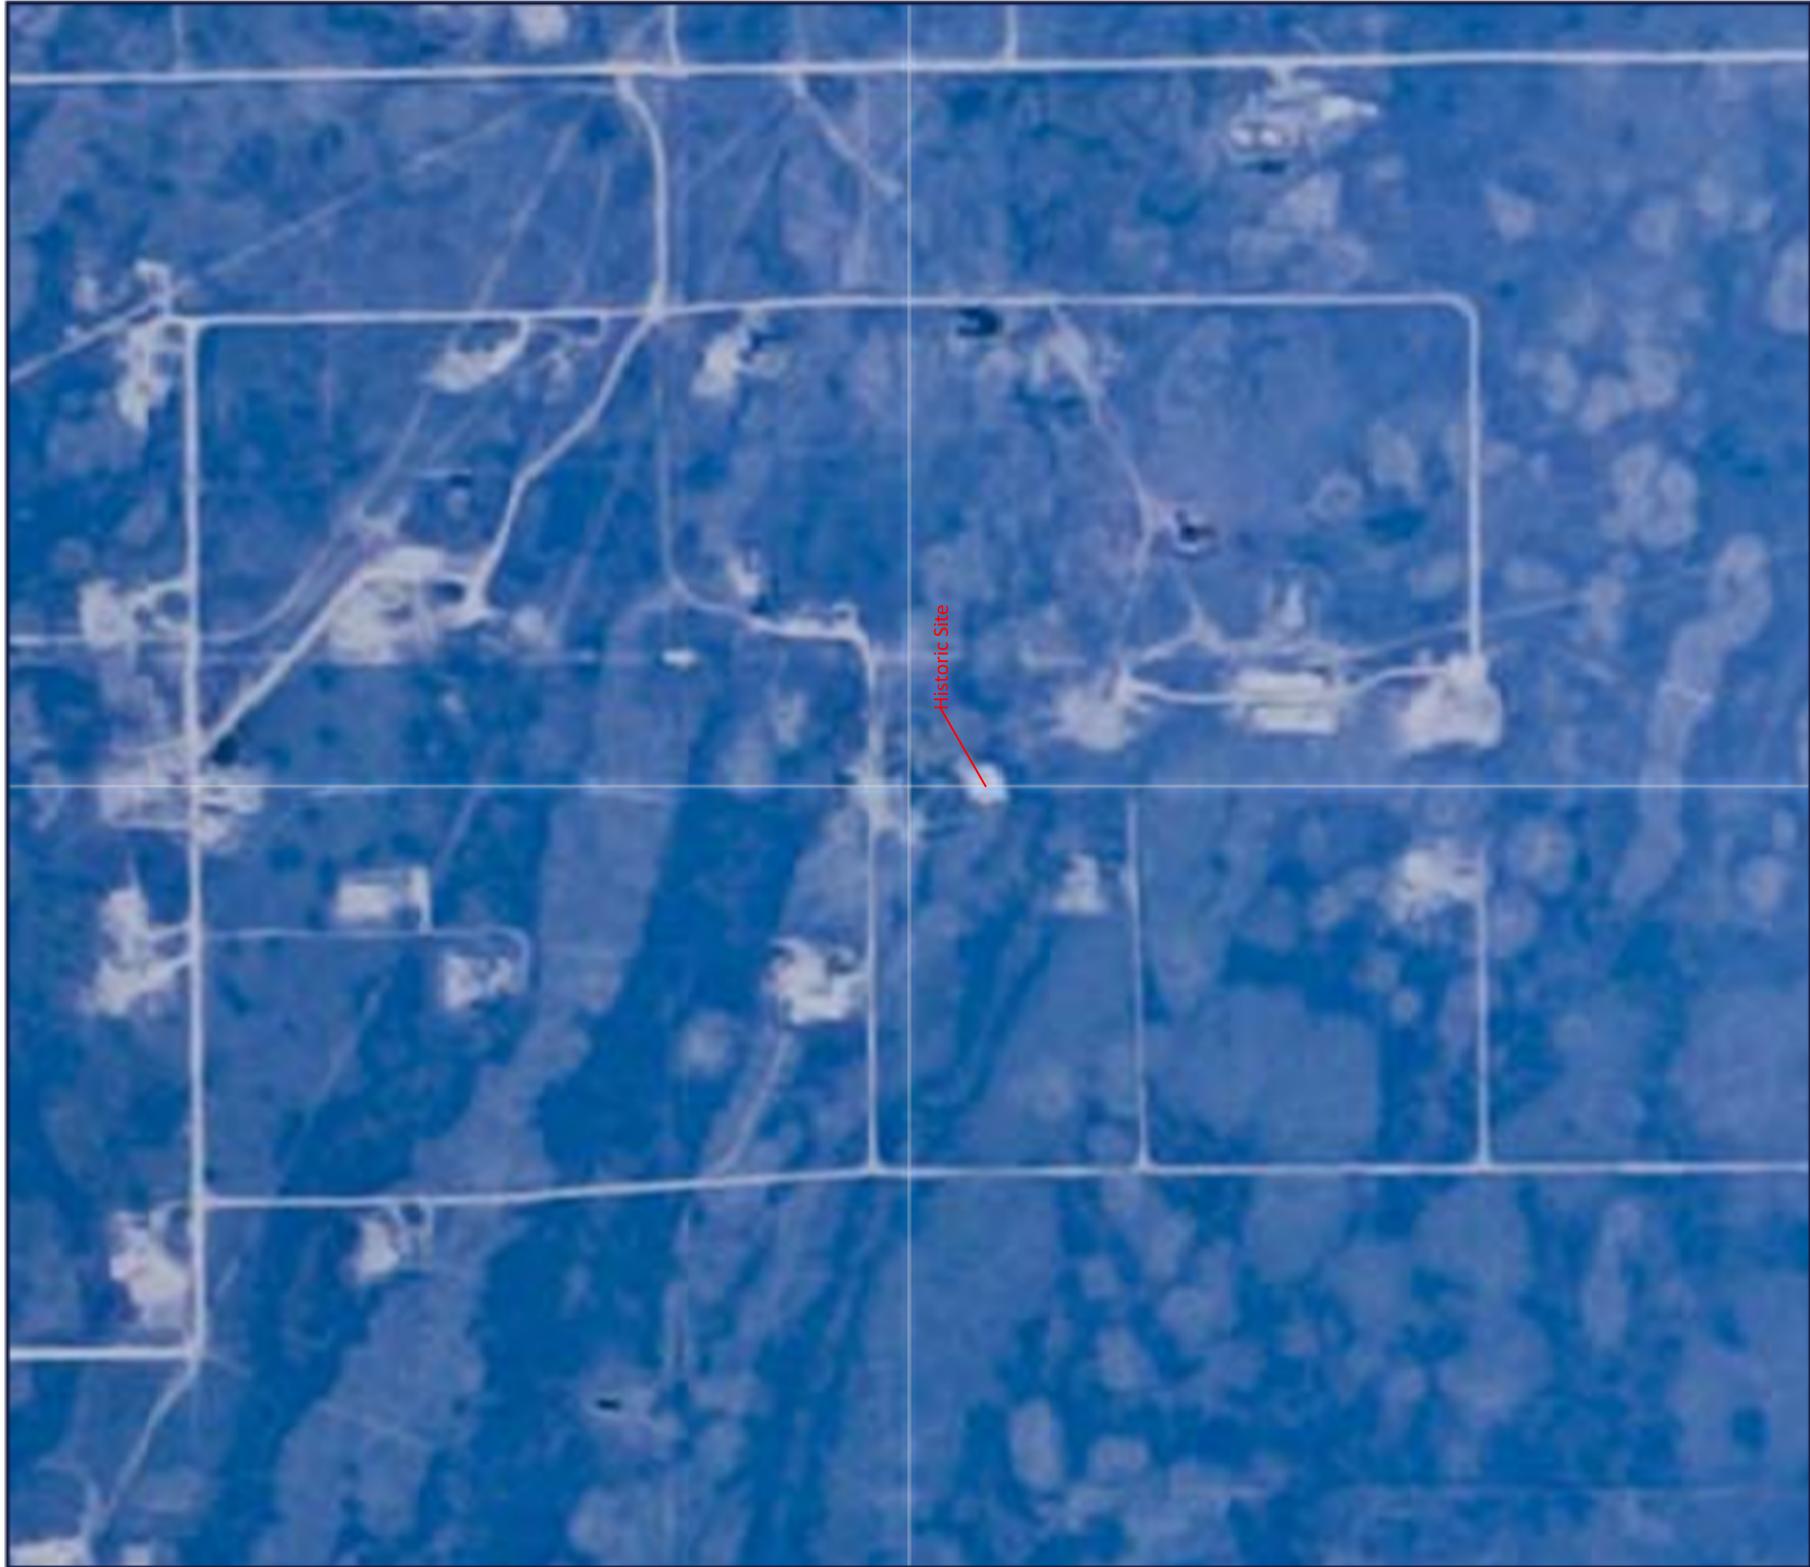
SITE: LEGACY - CHAMBERLIN
SOURCE: USGS
DATE: 6-3-1983
COUNTY: LEA, NM
SCALE: 1" = 700'

This color photograph was taken on June 3, 1983, and has a scale of 1" to 700'. The photograph shows evidence of scarring from previous operations or releases at the Site. The square shape of the scarring suggests that release was from a pit. The adjoining properties to the north, south, east, and west are in similar configuration observed during the current investigations and remediation.

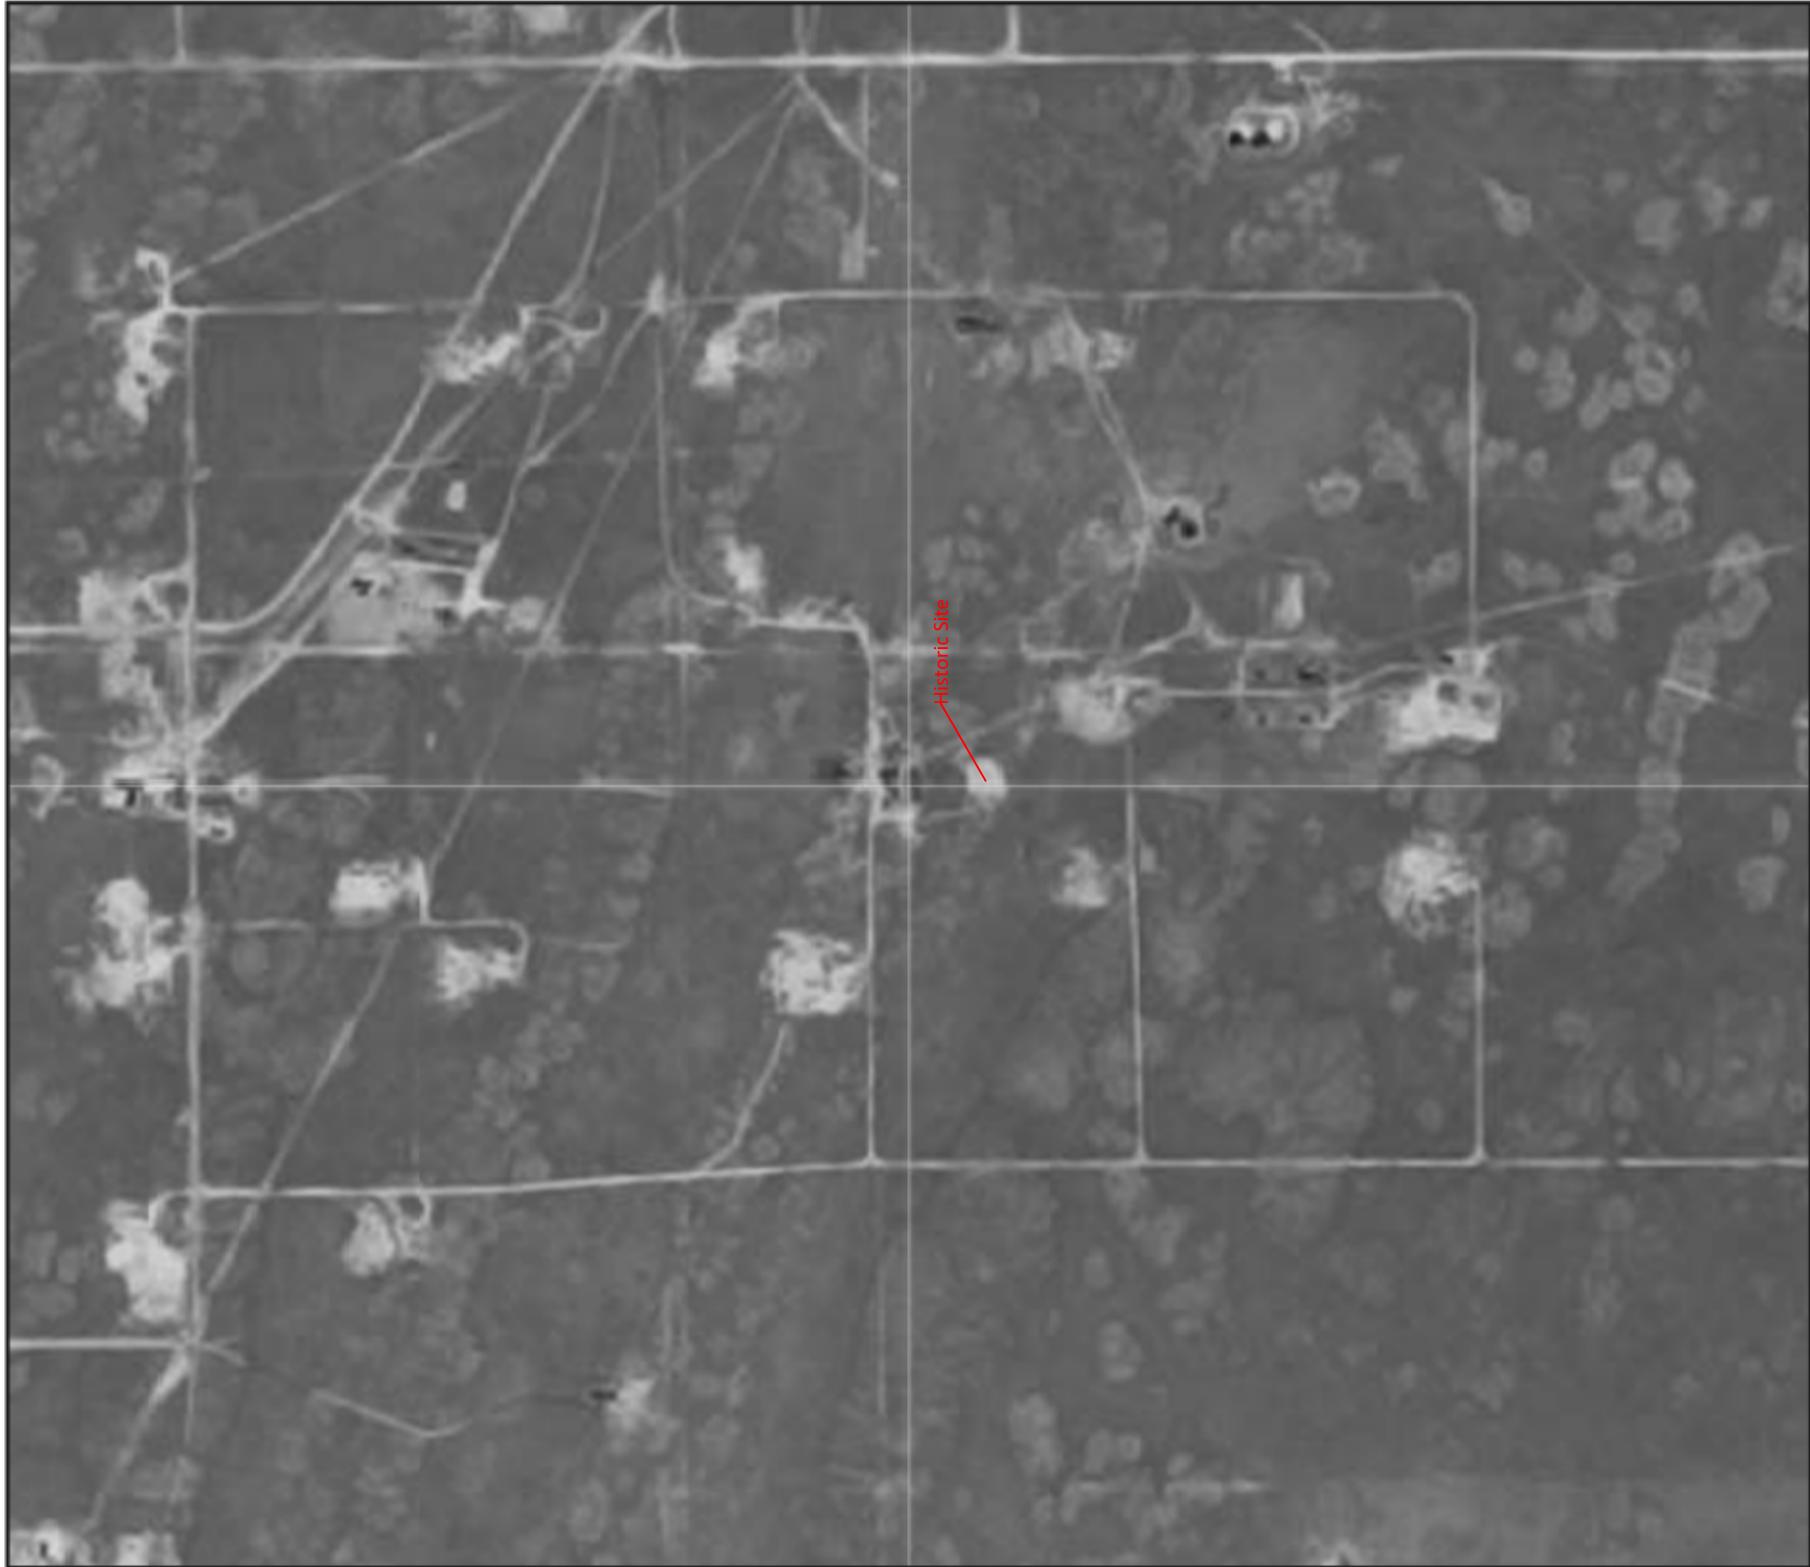
SITE: LEGACY - CHAMBERLIN
SOURCE: USGS
DATE: 11-17-1978
COUNTY: LEA, NM
SCALE: 1" = 700'

This black and white photograph was taken on November 17, 1978, and has a scale of 1" to 700'. The photograph shows the Site in similar condition observed in the earlier photograph (June 3, 1983) with the square shape being more pronounced. The square shape of the area suggests that the Site was the location of a pit.

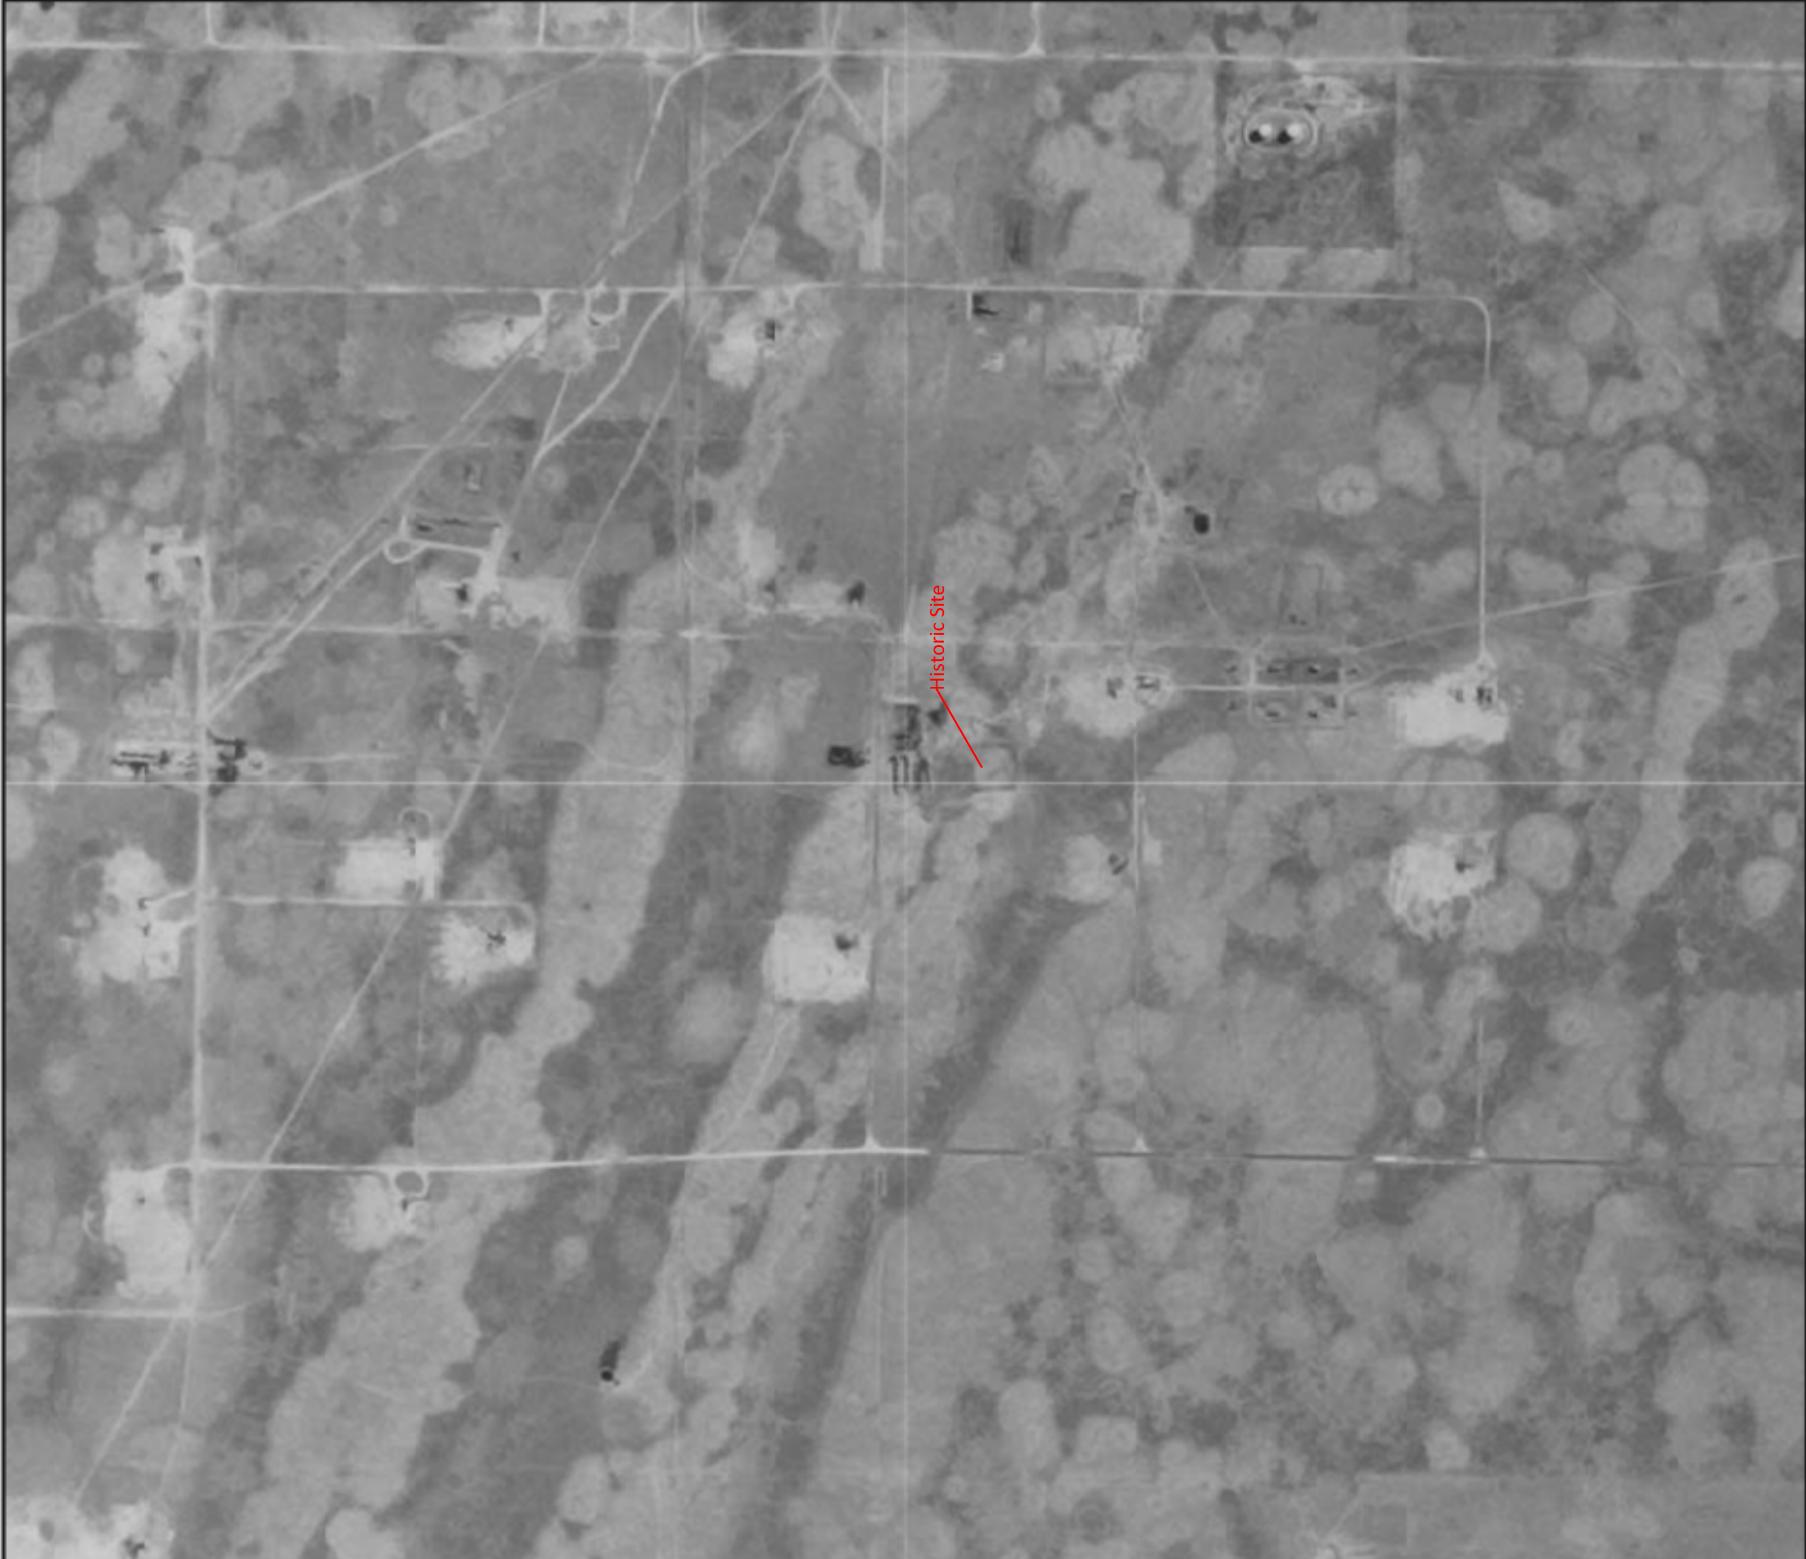
This black and white photograph was taken on February 8, 1968, and has a scale of 1" to 700'. This photograph depicts the Site in similar condition observed in the earlier photograph (November 17, 1968) with a square shape that suggests the release was a pit that was covered. This is further supported by the presence of corner post which suggests the area was fenced.
