Mallon 33 Fed #4

REMEDIATION WORK PLAN

1RP-3592

RE: Cimarex, Mallon 33 Fed #4 – Remediation Work Plan
UL/H, Section 33, T19S, R34E
API No. 30-025-34114

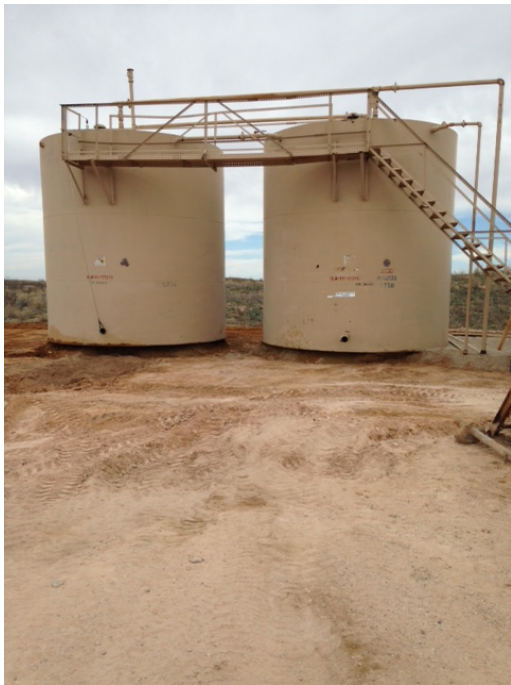
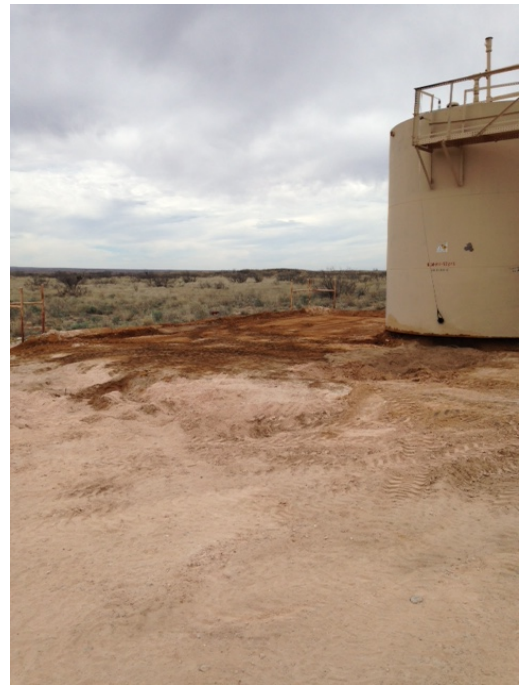
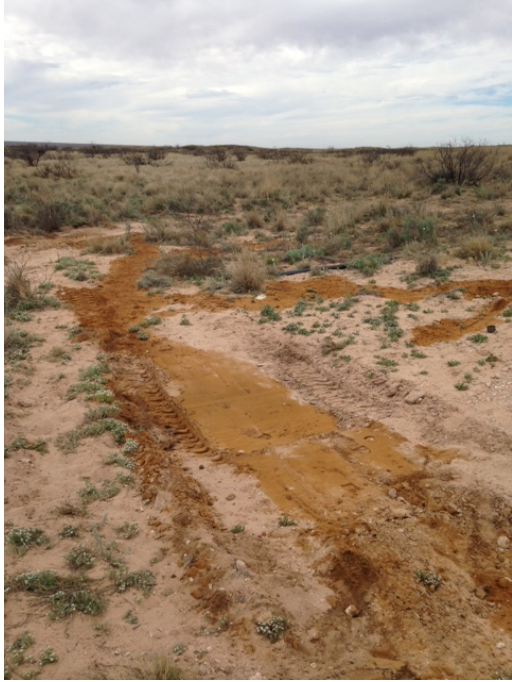
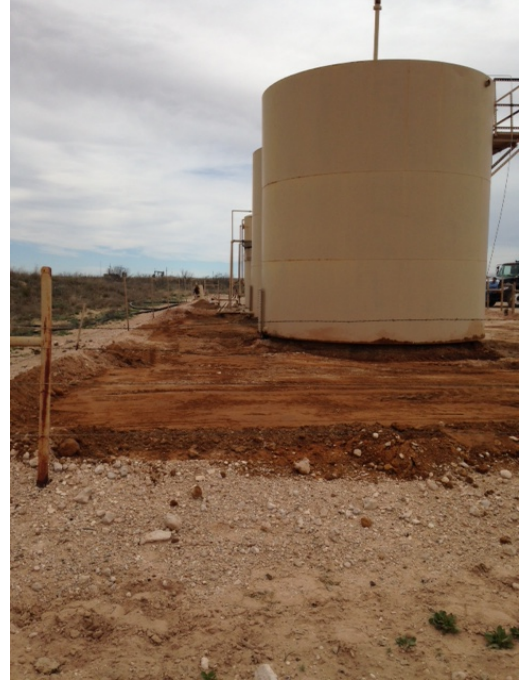
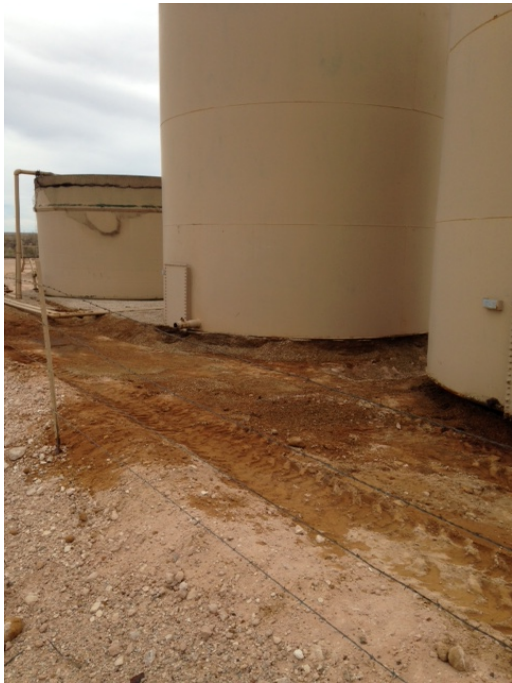
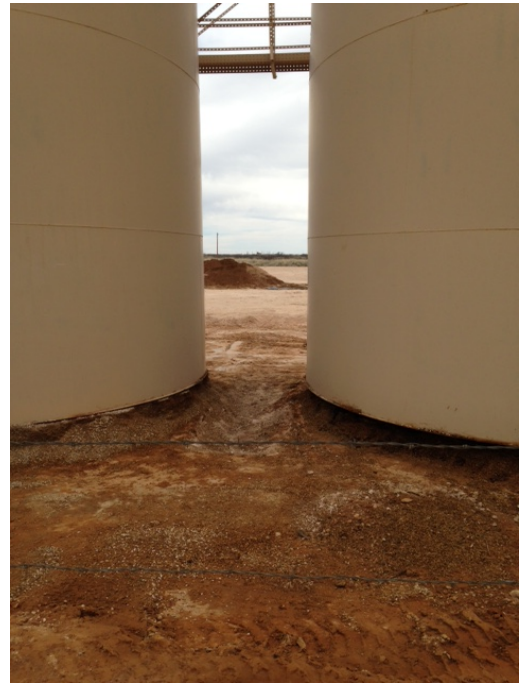
PHOTO PAGE

The site is located north of highway 62/180 NM, in Lea County. The leak site resulted from a hole developing in the bottom of a steel oil tank. The impacted area is inside an unlined firewall of the battery and a small area south into the pasture. Approx. 255 bbls of produced water was released, and 25 bbls recovered. A C-141 was submitted to the NMOCD on April 6th, 2015. The C-141 is attached.

Remove 1'to 2' bgs of the contaminated soil inside the bermed facility. Haul all contaminated material to an approved NM state disposal. New caliche will be used to backfill the excavation in the battery. In the pasture 2' BGS will be removed. Backfill will be done by pushing the surrounding sand into the excavation and re contouring. We will re seed using a BLM approved seed mix.

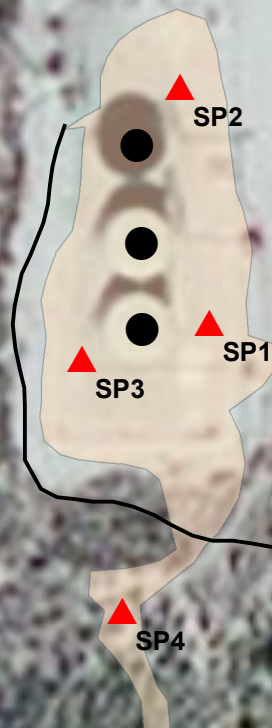
Site Diagram

Spill Area:
4,628 sq. ft.
