Release Notification and Corrective Action

IRP-03469

***Attachment for Final C-141 Closure Report for Grand Banks 1RP-03469
AUR#14 Well Site:***

Grand Banks-AUR #14 Oil Well Pad
OCD 1RP-03469
UL I-Sec 2-Ts16s-R32E
Aerial Plot Plan of Original Spill Footprint
Annotated by Price LLC-Oct 10, 2015

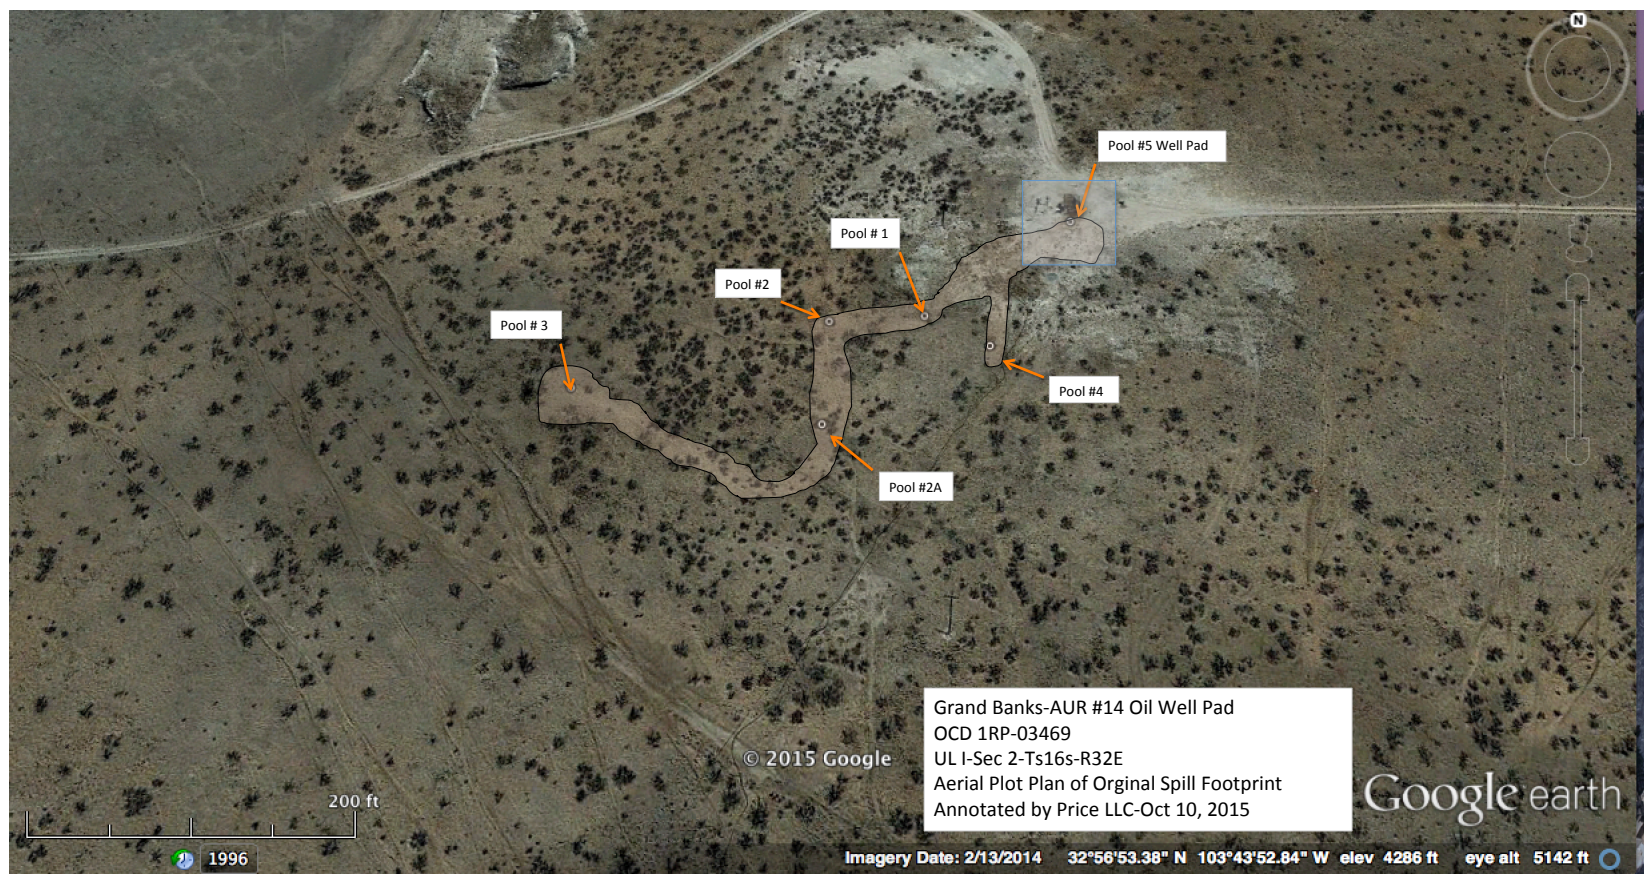
Background: On December 14, 2014 Grand Banks had a 90-barrel release of crude oil near the AUR#14 wellhead. The oil spilled on the pad and ran off in sheet flow fashion until it entered a series of small erosional features and flowed approximately 400-500 ft., stopping in a small depressed low lying area where it pooled.

There were six areas that were singled out and concentrated on; these were marked as Pool #1, 2, 2A, 3, 4 and 5. The field test results are compiled in an excel spreadsheet and attached hereto for reference. Theses locations are also marked on the aerial plot plan.

Due to the site location and sensitivity of a nearby playa lake, immediate emergency response actions were taken by removing approximately 160 yards of oily saturated soils. The soils were disposed of at the OCD permitted Gandy-Marley Landfill. See attached aerial plot plan depicting the original spill footprint and sample points.

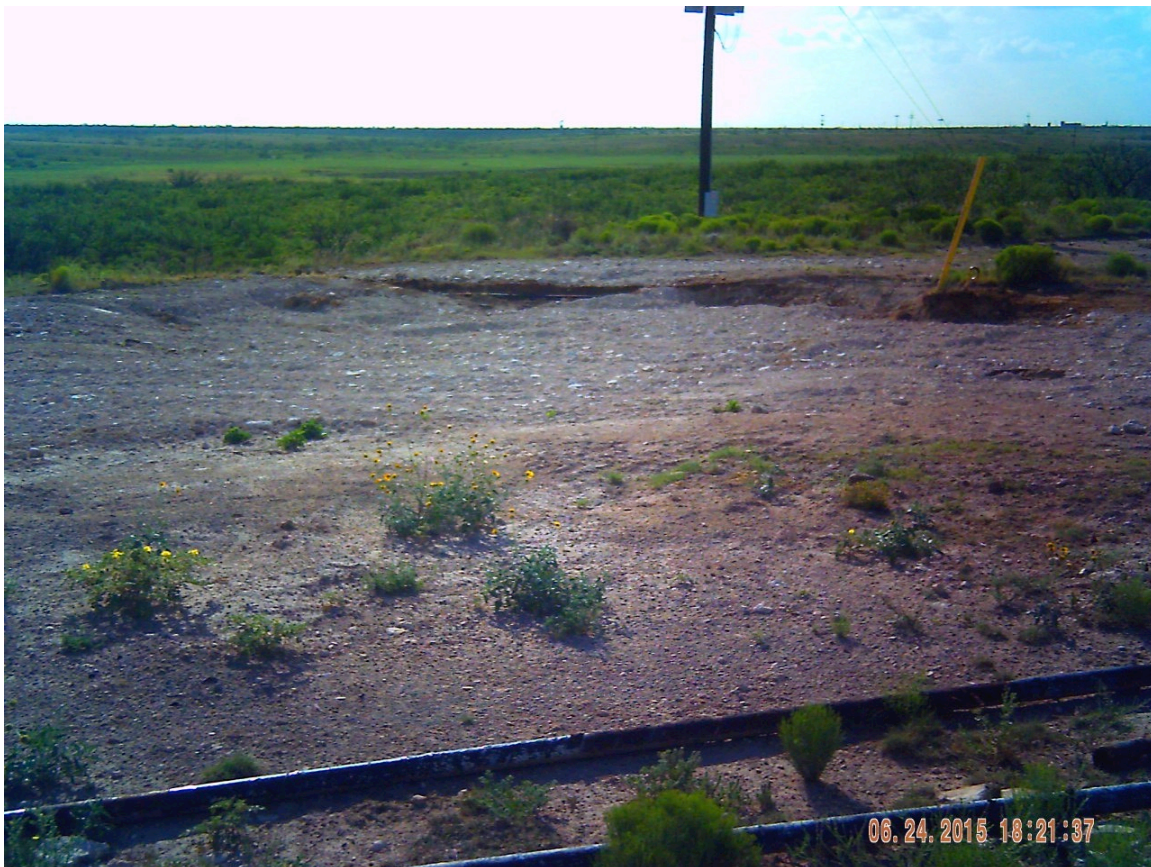
Pool #5 Pad Area Looking West, background shows Playa Lake and Cattle Pond.-
This area was excavated to remove oily stained soil and sampled.

June Site Inspection and Additional Work: Price LLC re-inspected the site in June of 2015 and a decision was made to remove additional soils predominantly from the Pool #3 and Pool #5 areas, and some minor visually contaminated soils from the other areas, including Pool #2. Approximately 60 yards of contaminated soils were excavated and hauled to the Gandy-Marley Landfill. Caliche backfill was brought back in to rebuild the pad area and to install a berm to prevent future runoff. See attached the June excavation photos showing the additional excavated areas of concern.

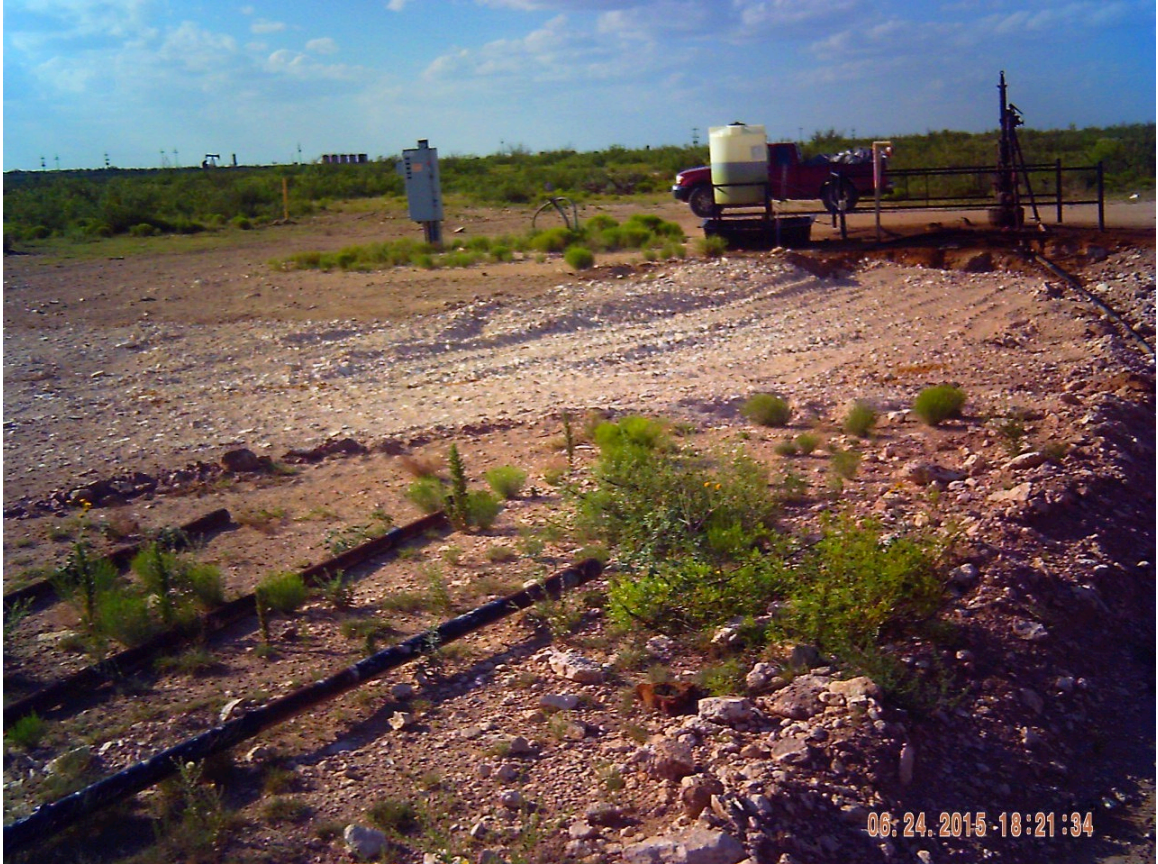
Pool #5 Area and wellhead-A composite bottom hole sample was collected and sent to Lab for confirmation.

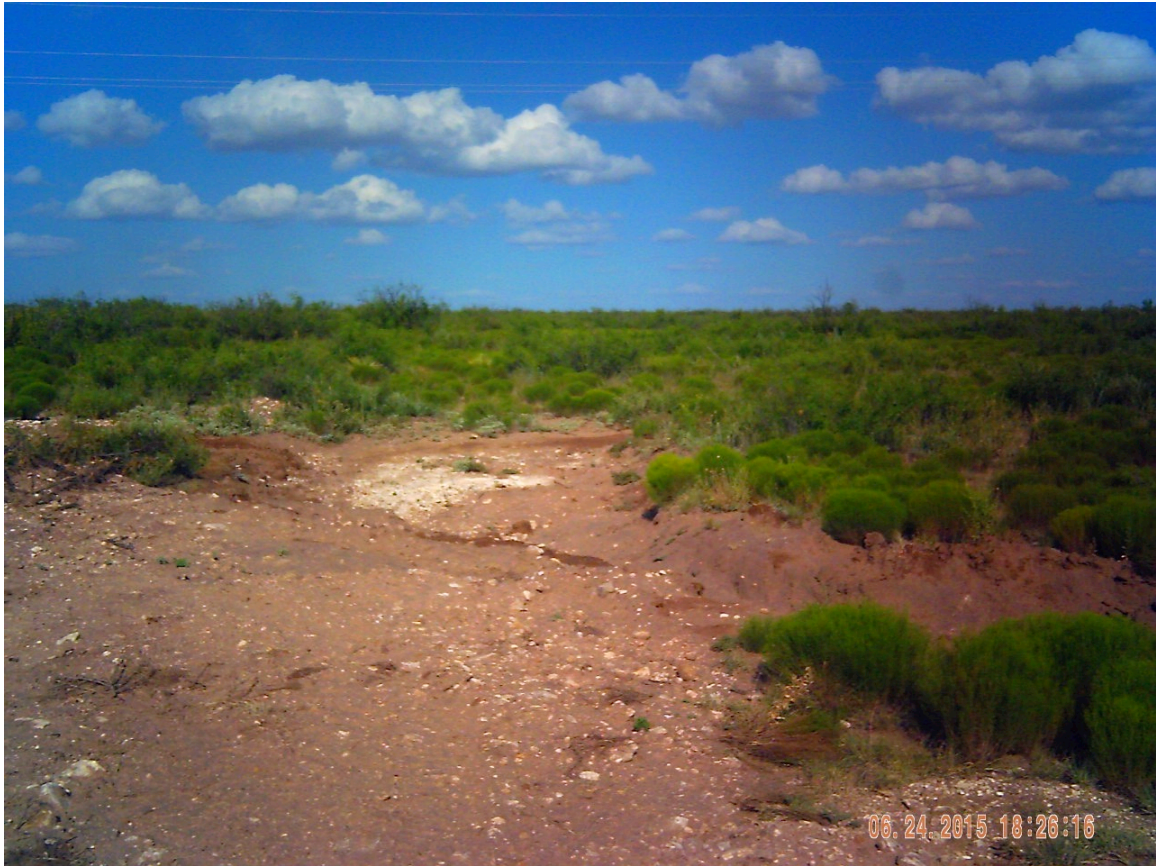
Pool 2 & 2A drainage area after excavation. Area was screened with Field Test and all were below guideline criteria.

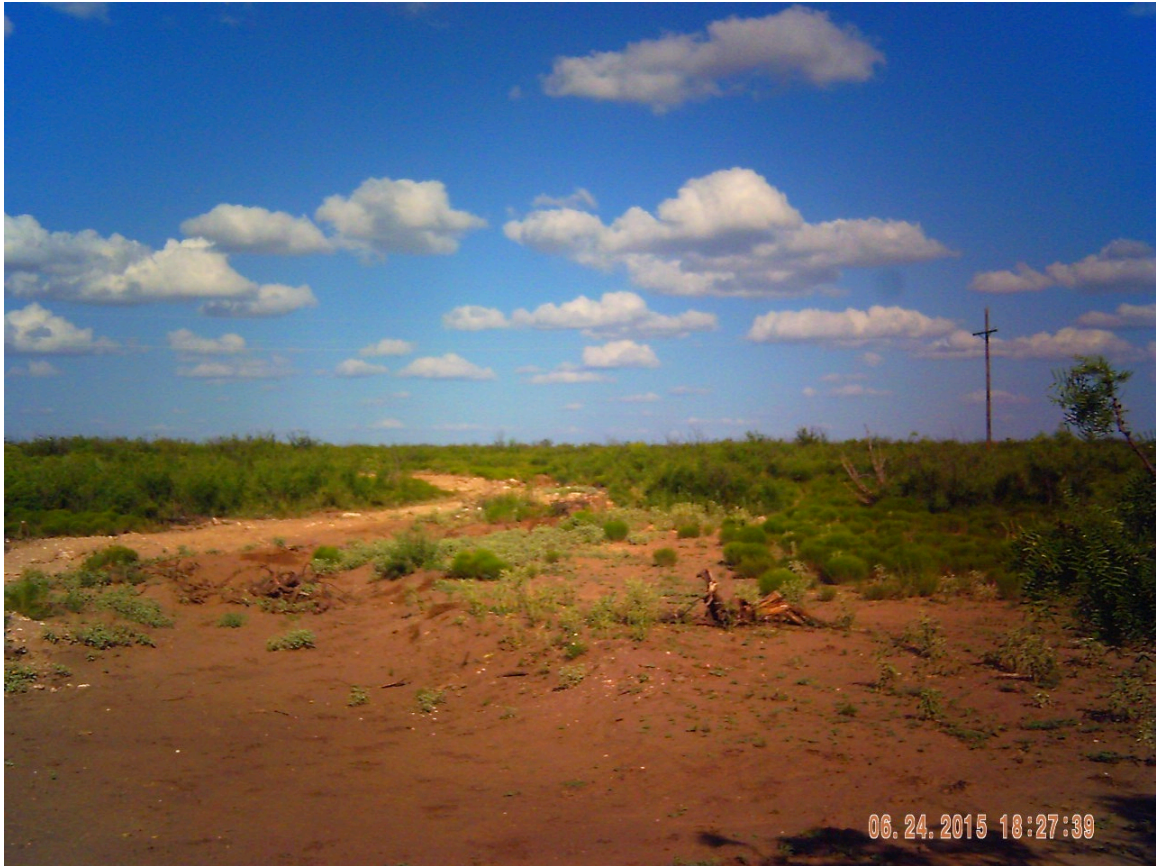
Pool #3 depressed area where oil flow stopped. Area has been excavated and re-sampled and sent to Lab for confirmation. Foreground shows drainage path.

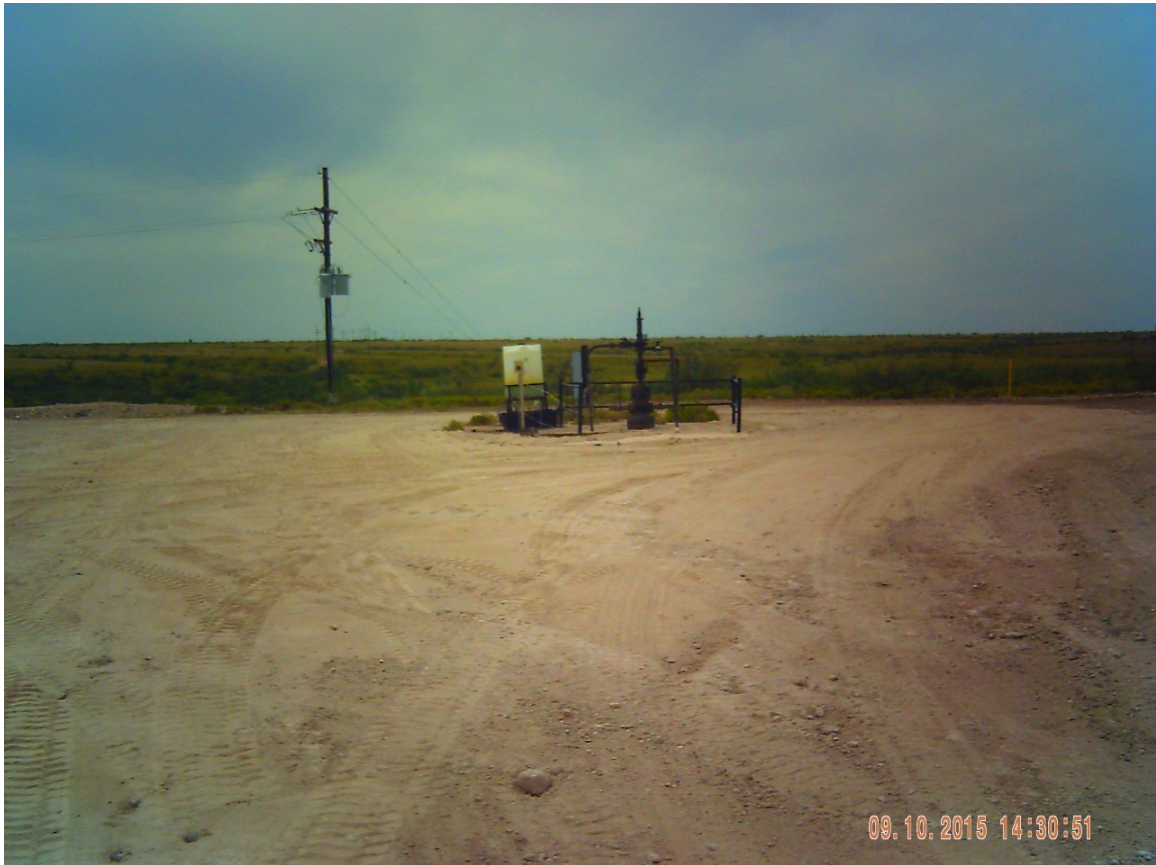
Pool #5-Well Pad Re-built-looking North.

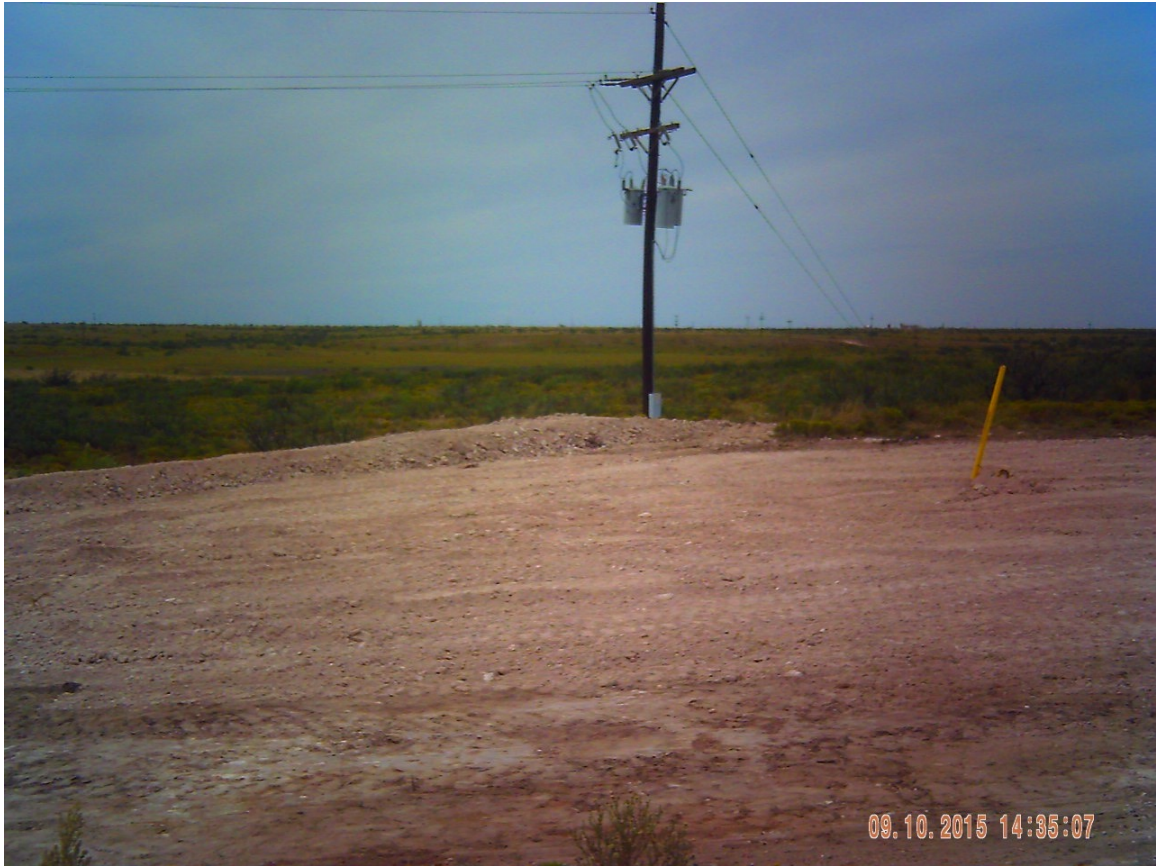
Well Pad-Showing New Runoff Berm-Looking SW.

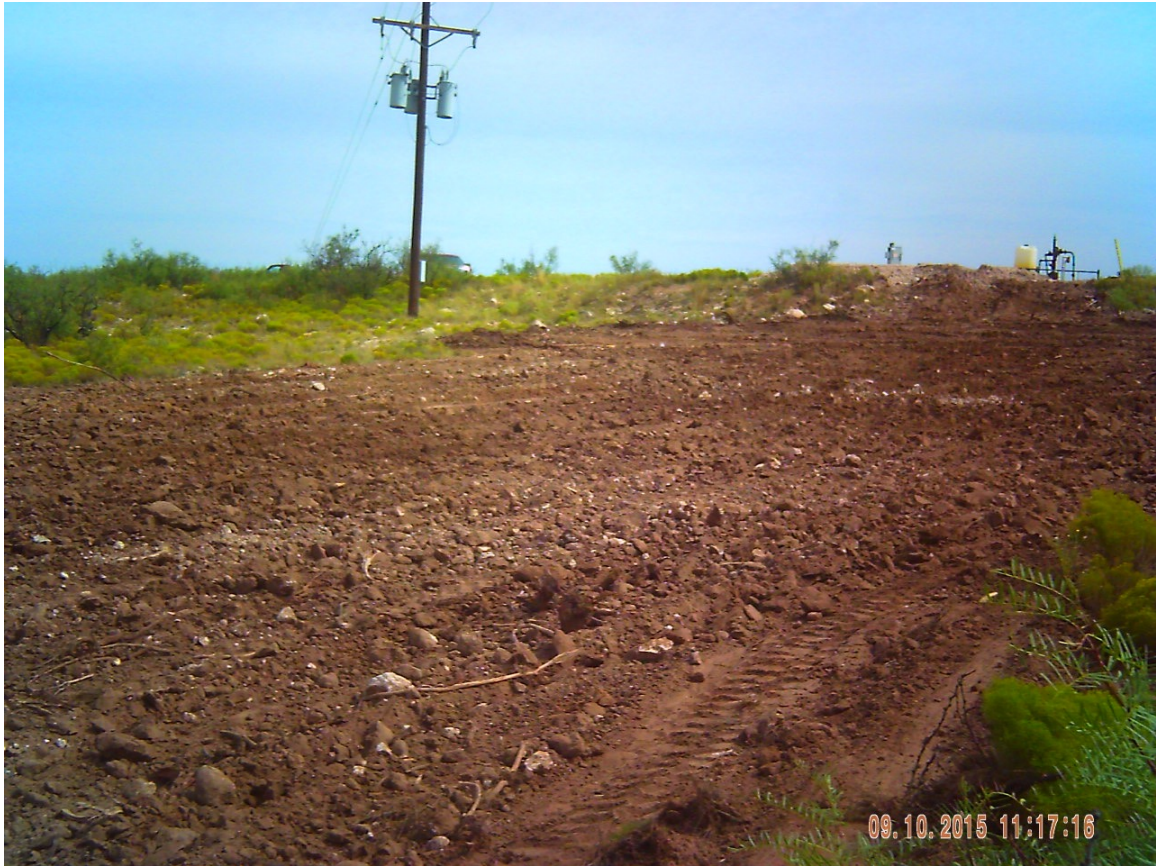
Pool #1 Area-plowed, disked and fertilizer application-Looking East with well pad in background.

The final step including plowing, disking and applying a winter (Hold Over) conditional fertilizer, (8-8-8).

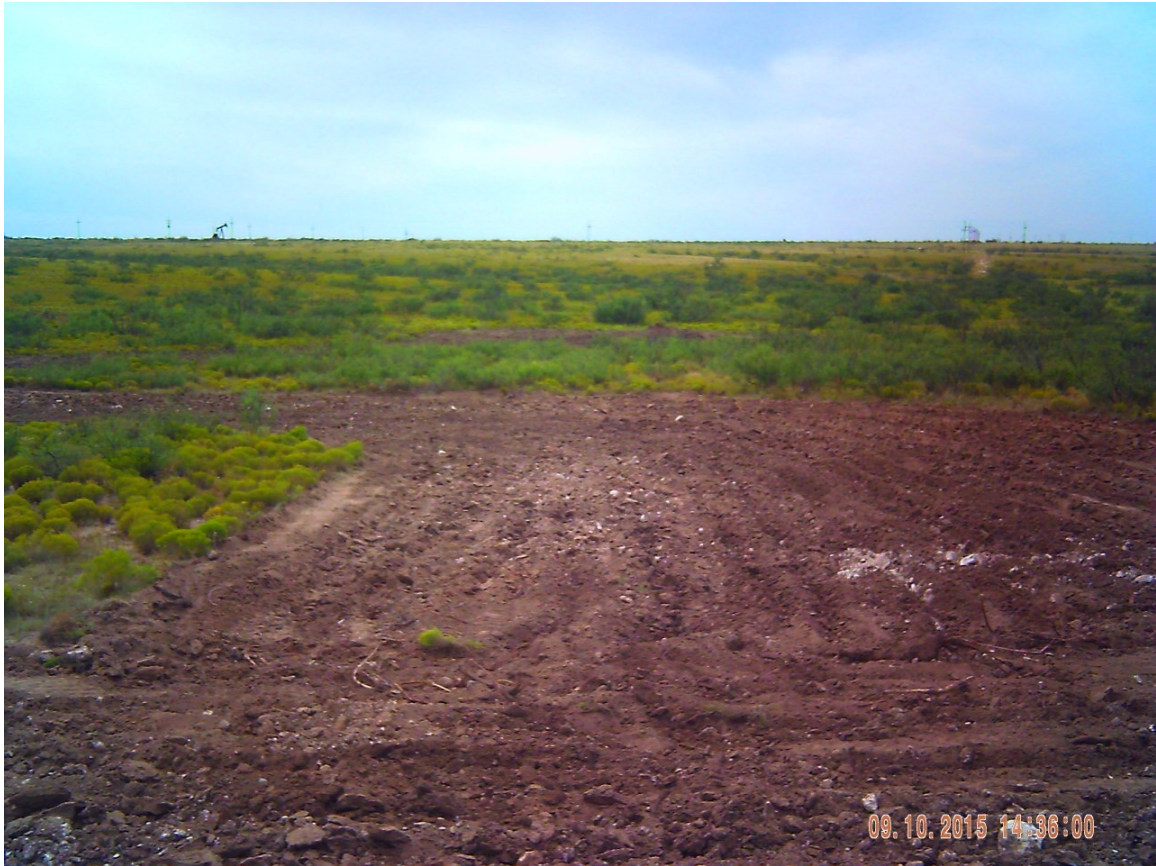
Standing on West end of well pad-looking SW- Area plowed, disked and fertilized.
