**FORMER DIESEL  
DISPENSER SYSTEM**

Re: Response to APPROVAL WITH MODIFICATIONS  
REVISED ACCELERATED CORRECTIVE MEASURES COMPLETION REPORT  
FORMER DIESEL DISPENSER SYSTEM, SEPTEMBER 2015  
Western Refining Southwest, Inc. – Bloomfield Terminal  
EPA ID# NMD089416416

**APPENDIX C**  
**Former Diesel Dispensing System Decommissioning**  
**Western Refining – Bloomfield Terminal**

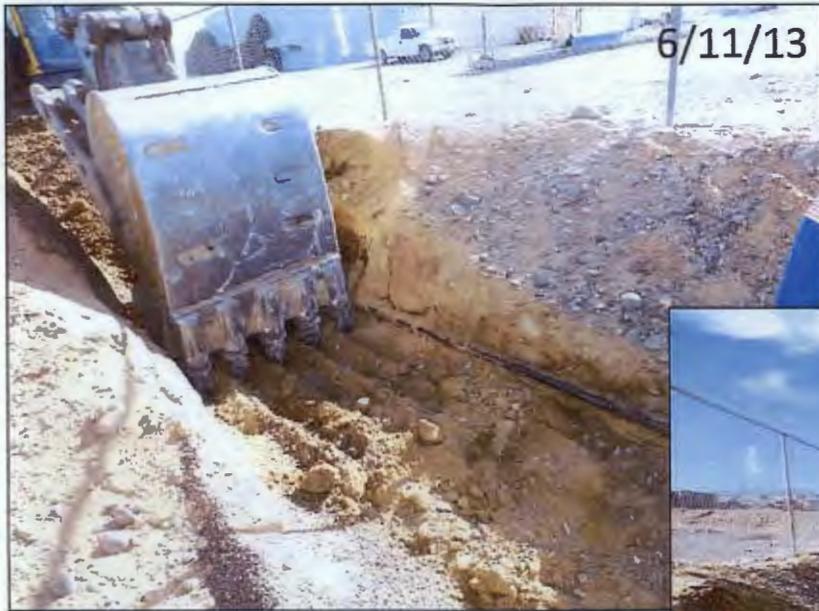
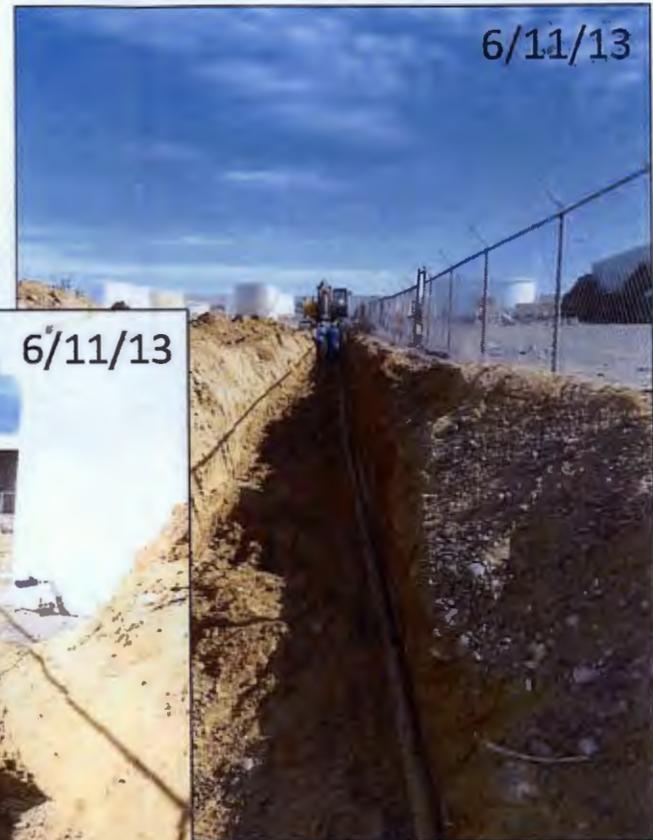
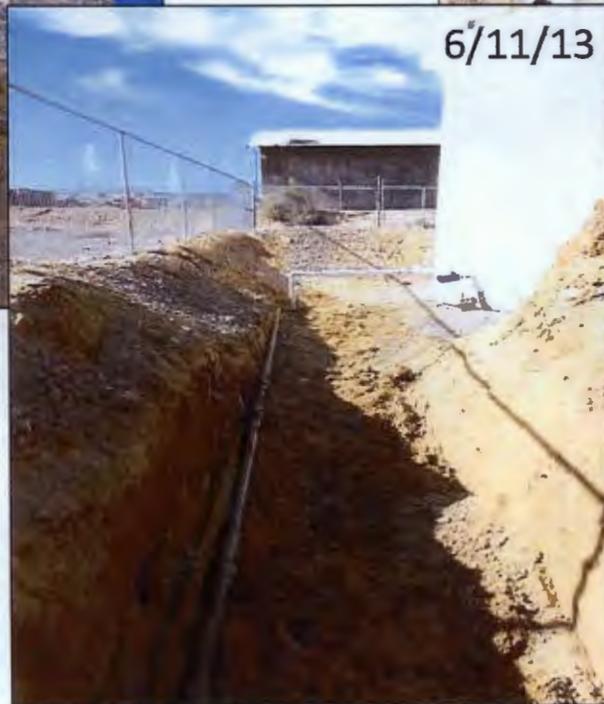
These photos capture the fuel supply piping excavation trench which runs north and south. There was no visual indicators of leaks along the supply piping, which connected the diesel supply tank to the dispenser area. The supply line appeared to be intact.

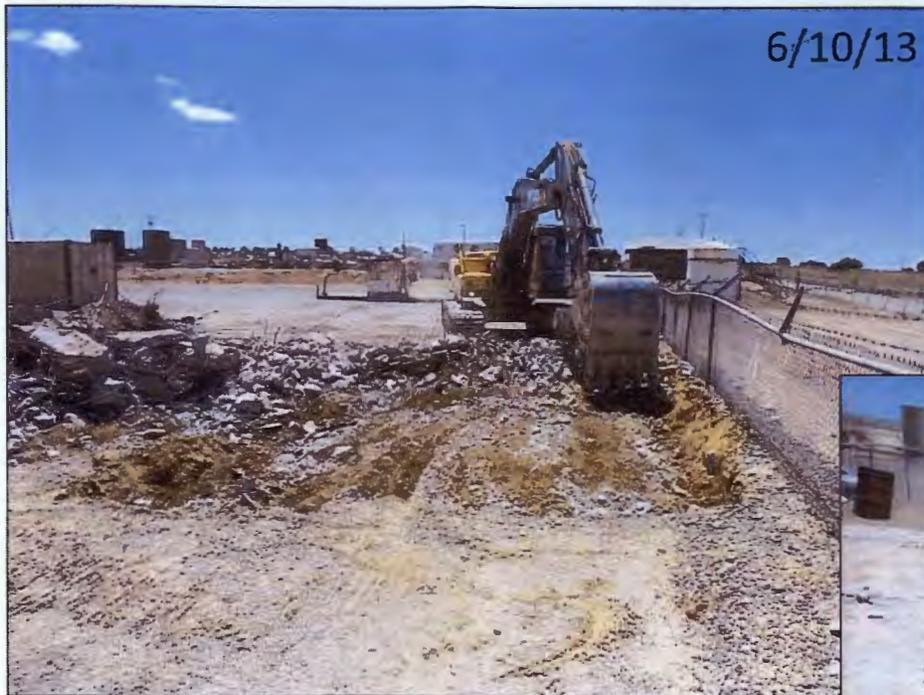
← The concrete pad at the fueling dispenser pump area was removed in order to begin the excavation of impacted soil. This picture is facing south.

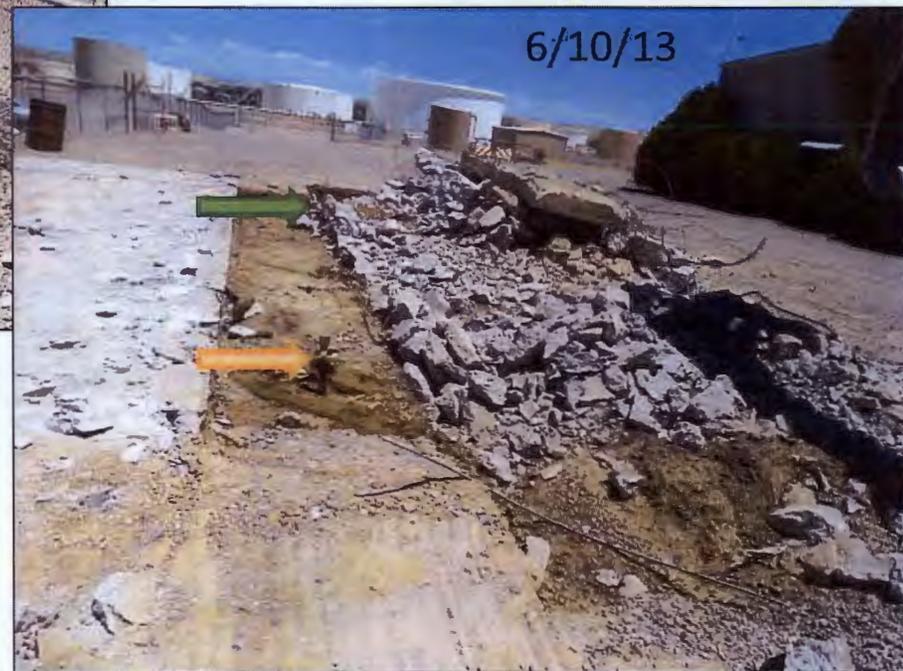
→ Depicted in this photo are the fueling supply piping stick-ups at dispenser locations. This photo facing north shows the former location of the fueling pumps. The green arrow in the picture shows the former location of the north dispenser and the orange arrow in the photo designates the former location of the south dispenser.

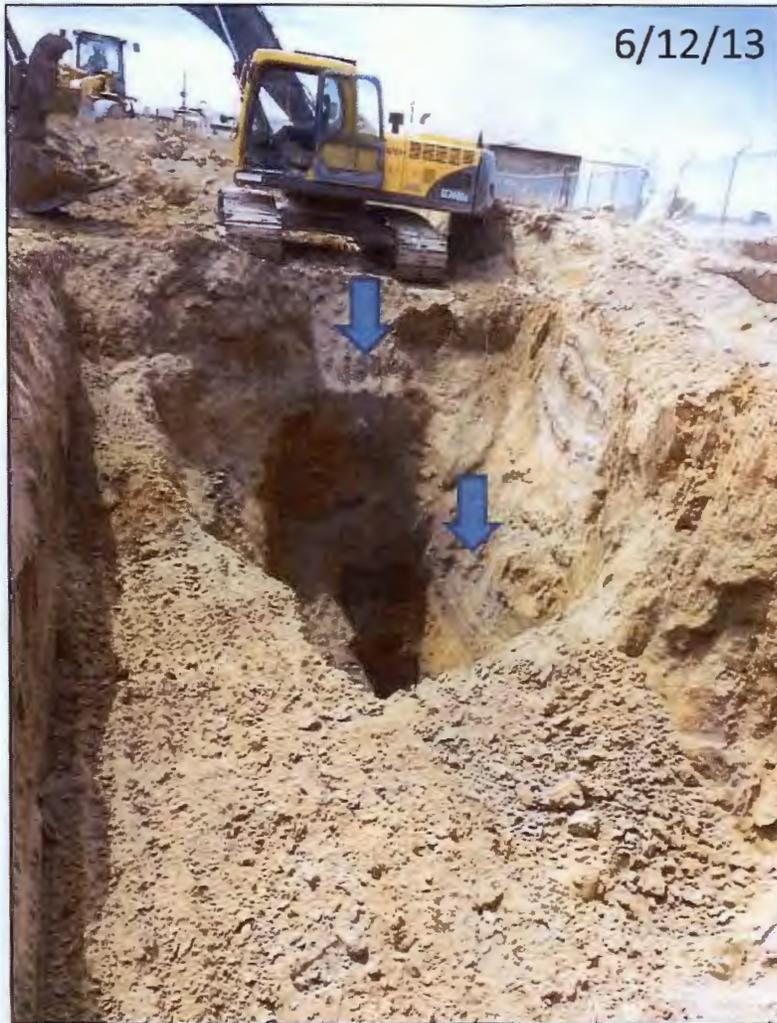
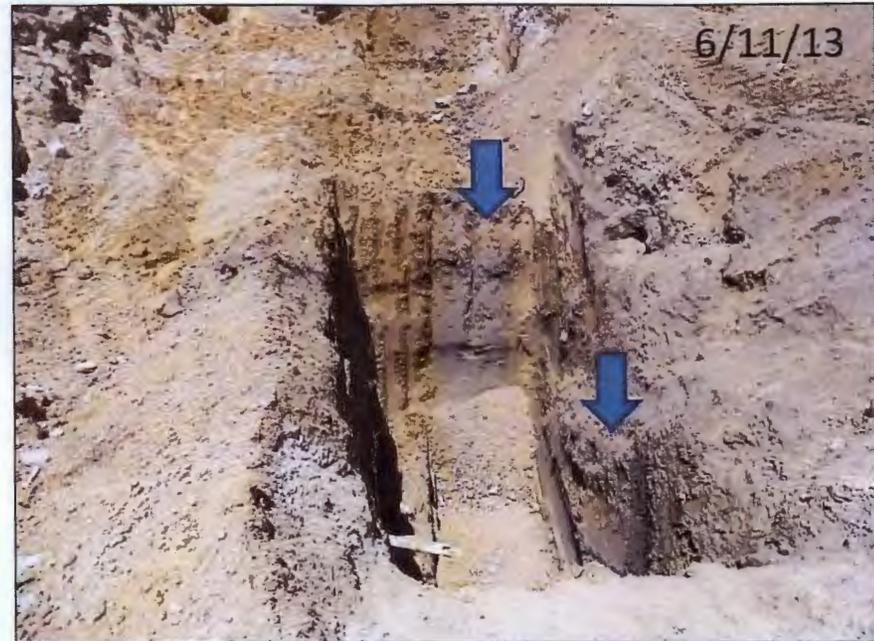
Soil samples were collected below the fueling dispenser area between June 12, 2013 and June 14, 2013. Based on visual field observations, it was determined that most of the impacted soil was located within the vicinity of the south fueling dispenser pump. A sample was collected below the south dispenser at a depth of approximately 28

These photos facing south show localized impacts within the vicinity of the south dispenser pump. The area of contamination extended vertical and is designated by the arrows in the pictures.

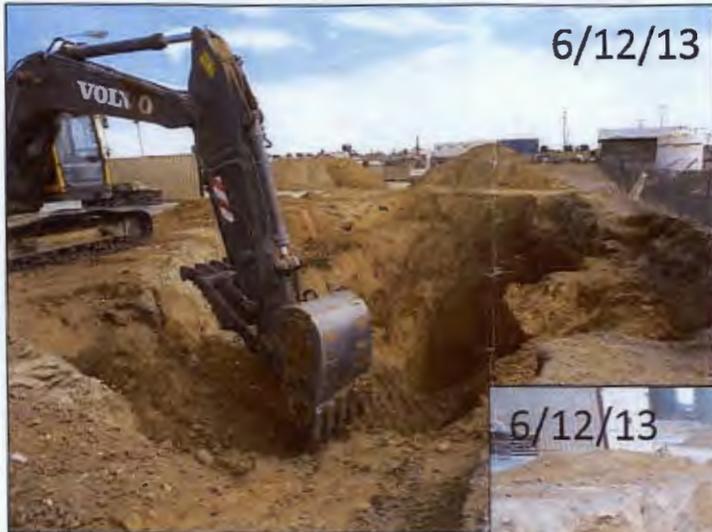
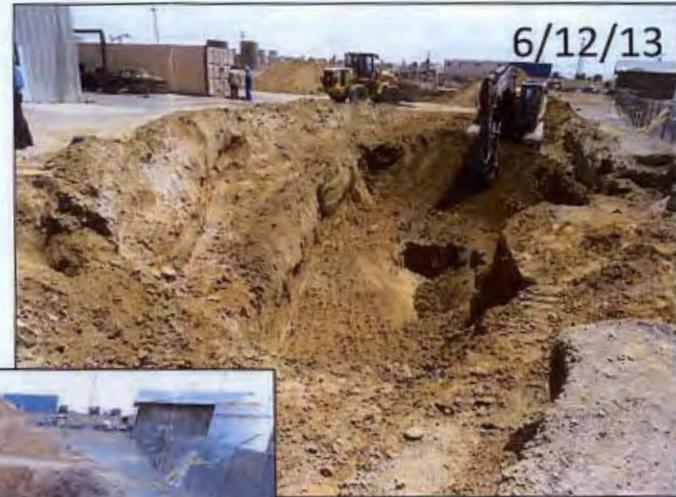
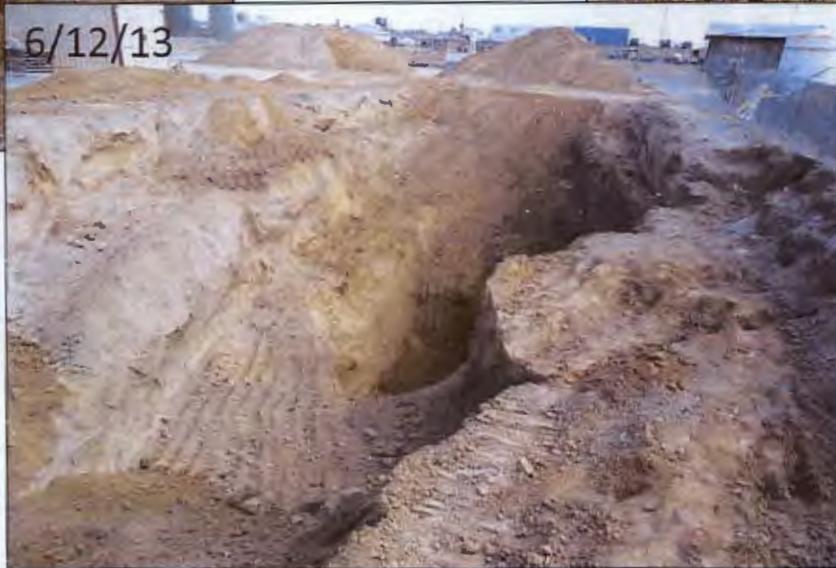
These photos facing south of the excavation show the benching that was required to extend the vertical reach of the excavator.
