AP - 111

**SUMMARY REPORT
EVAPORATION POND
REPAIRS (2)**

12/17/2015

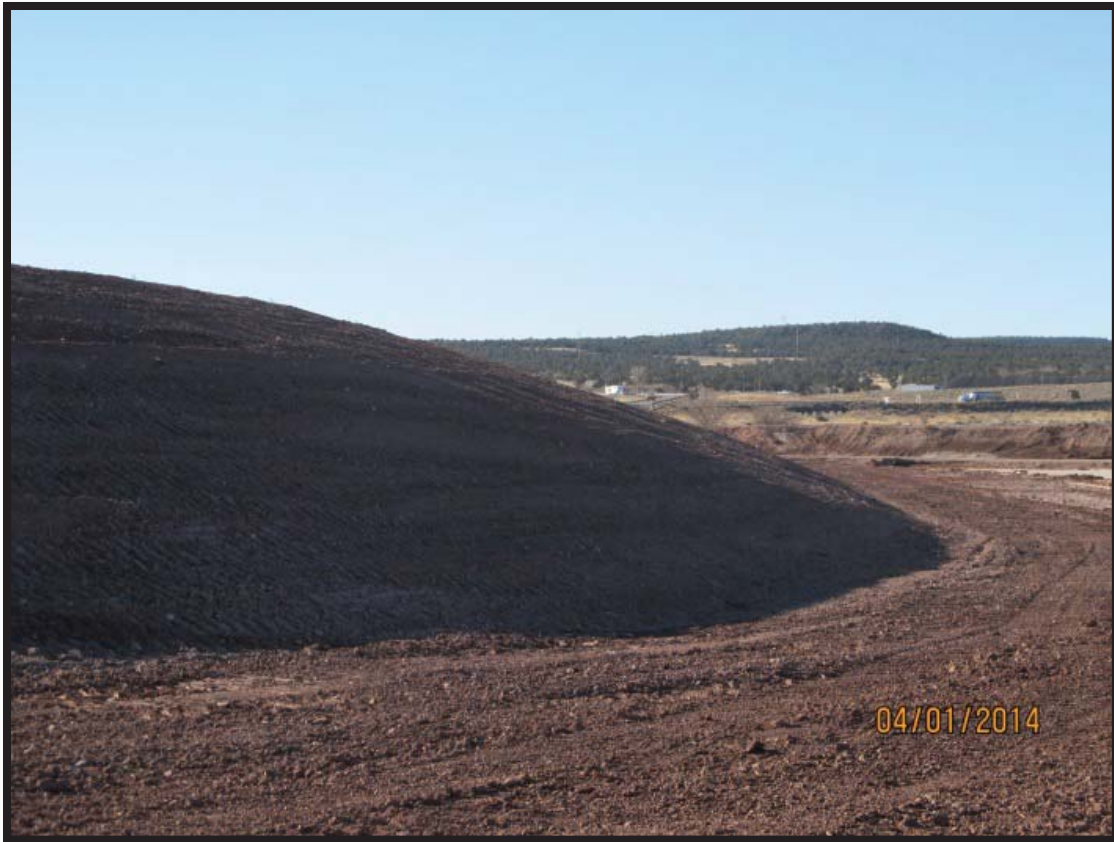
Photo #1: Pond 6 Northwest Corner After Fill Placement - Looking South

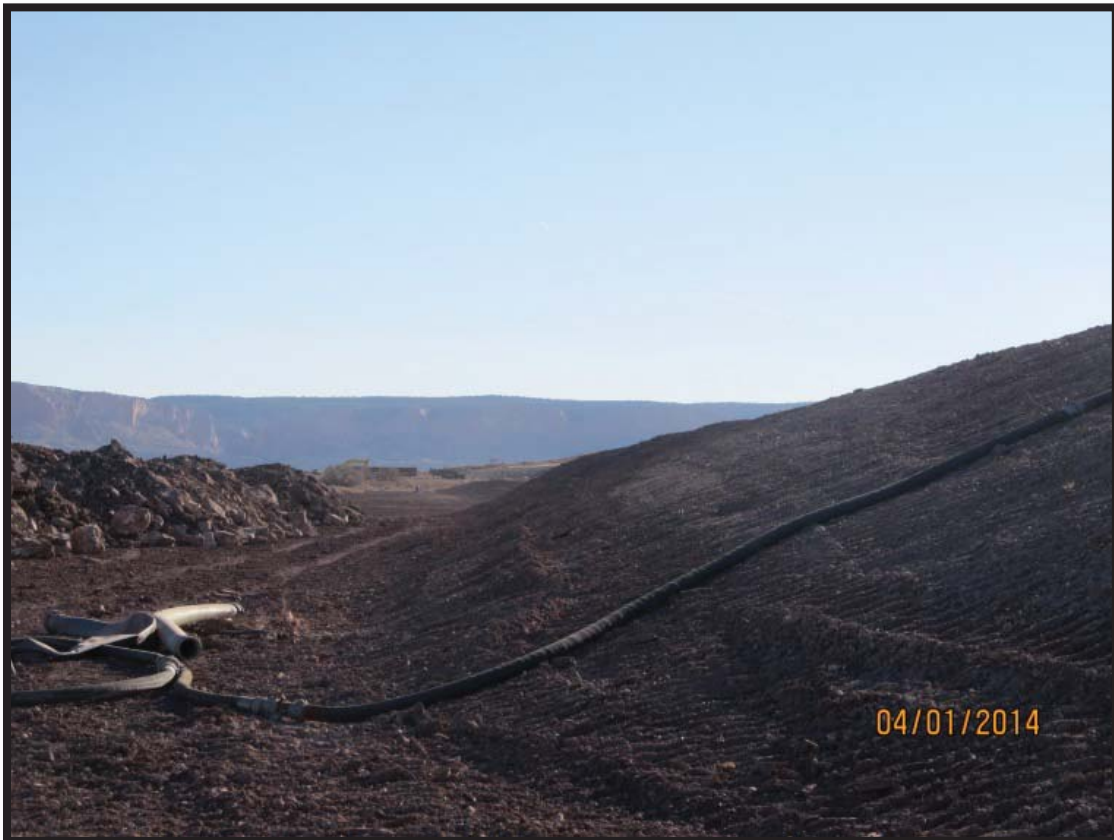
Photo #2: Pond 6 Northwest Corner After Fill Placement - Looking North

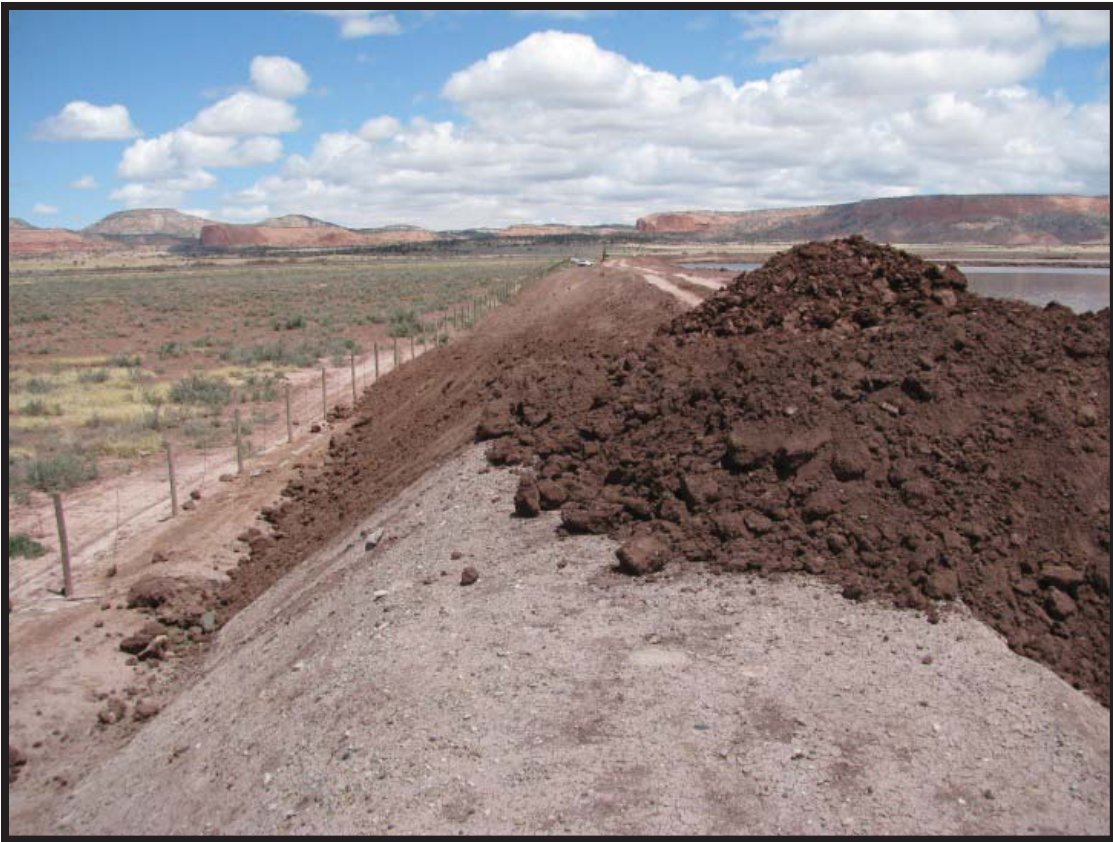
Photo #3: Pond 7/8 West Berm Under Construction - Looking North
(Note how the new crest alignment is shifted to the east)

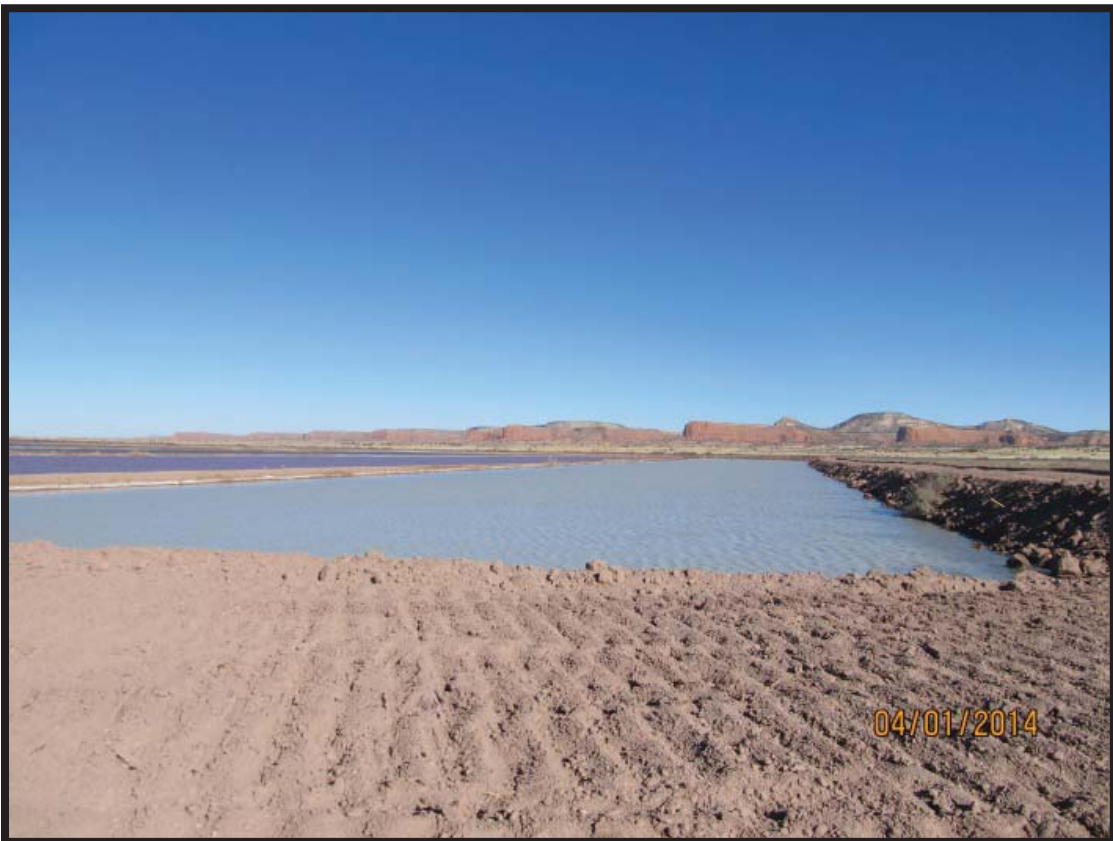
Photo #4: Pond 11 South Berm Construction Complete - Looking North

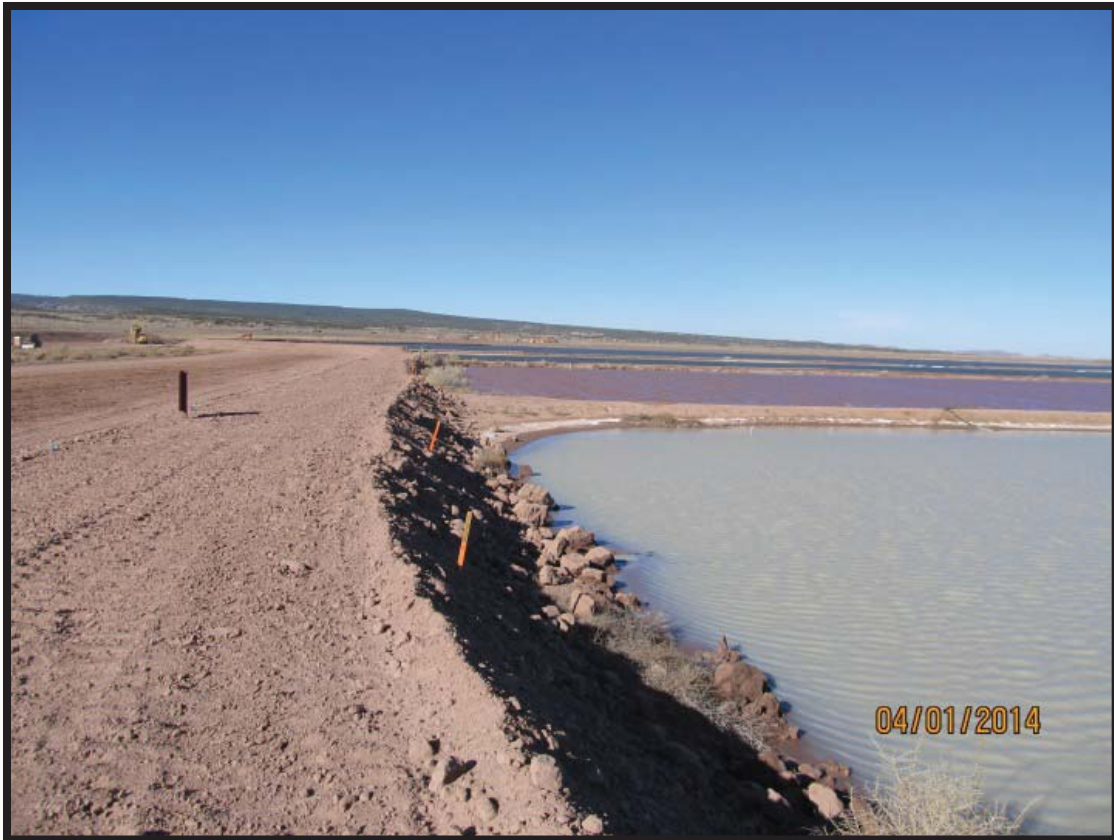
Photo #5: Pond 12A South Berm Construction Complete - Looking West

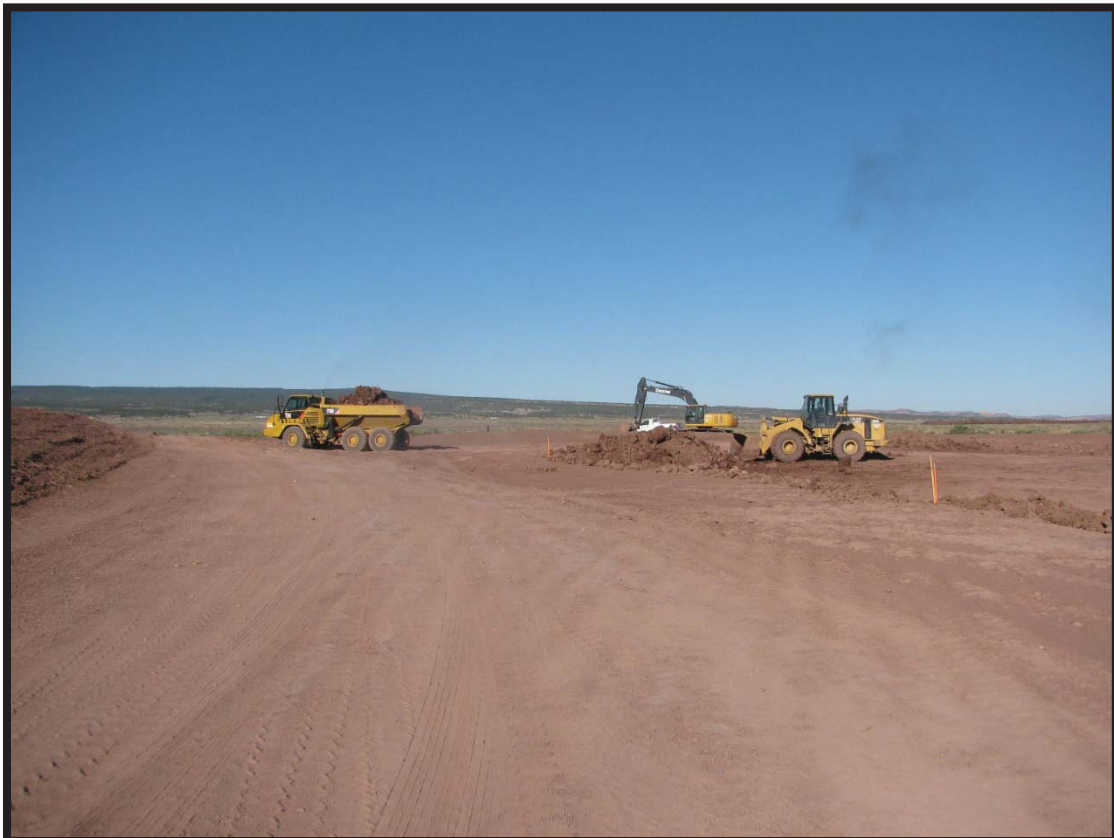
Photo #6: Borrow area north of Pond 11 – Looking West

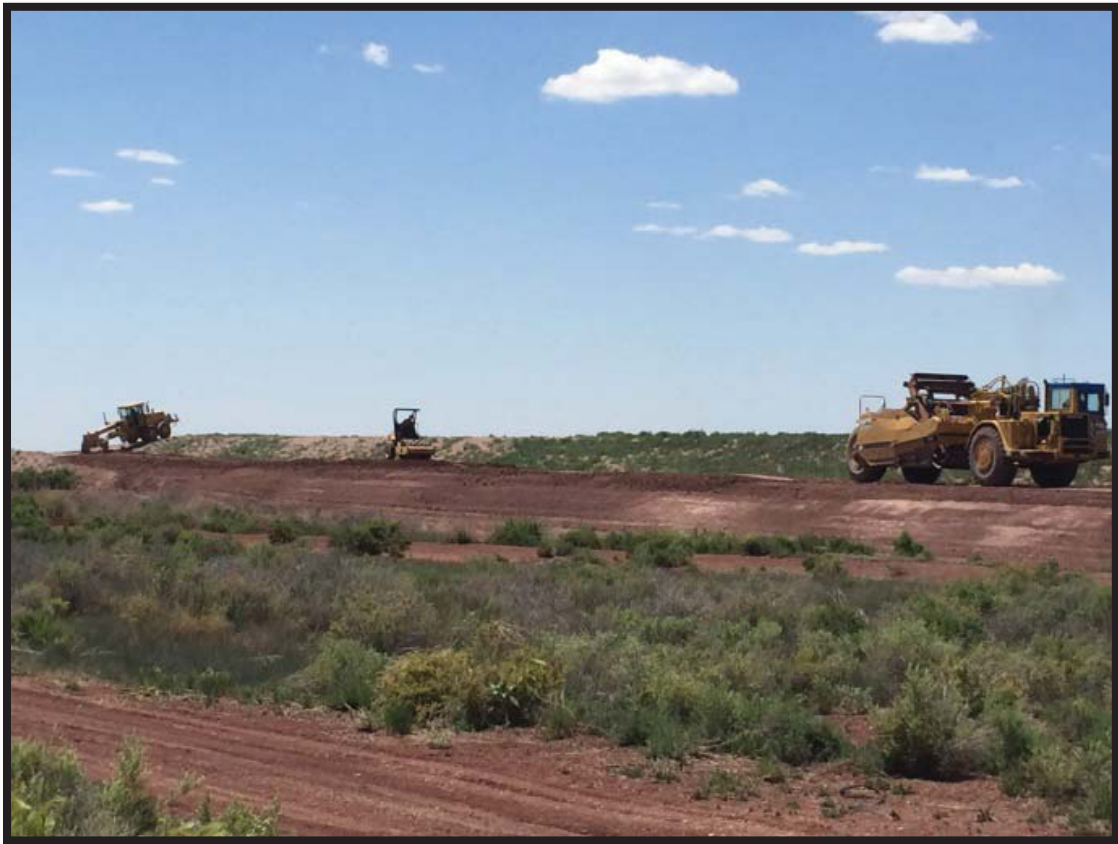
Photo #7: Pond 5 North Berm Under Construction, Nearly Complete - Looking East

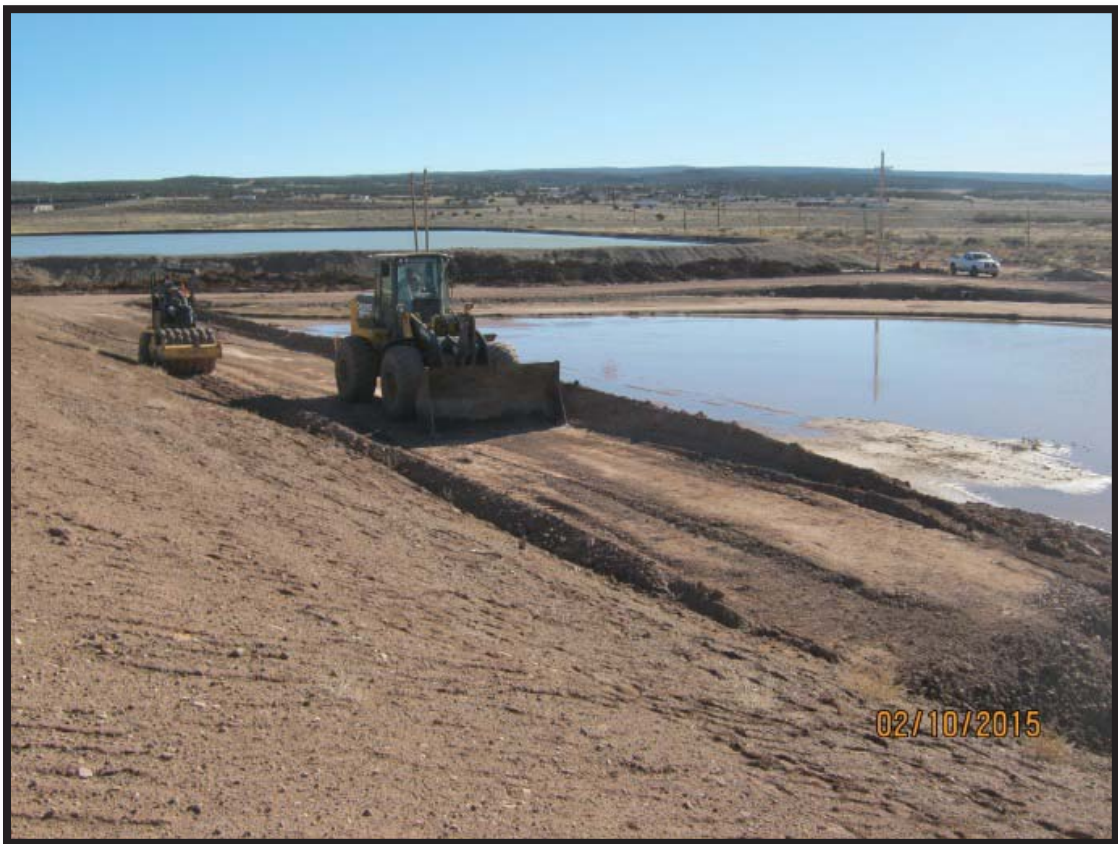
Photo #8: Pond 6 West Berm Under Construction - Looking South

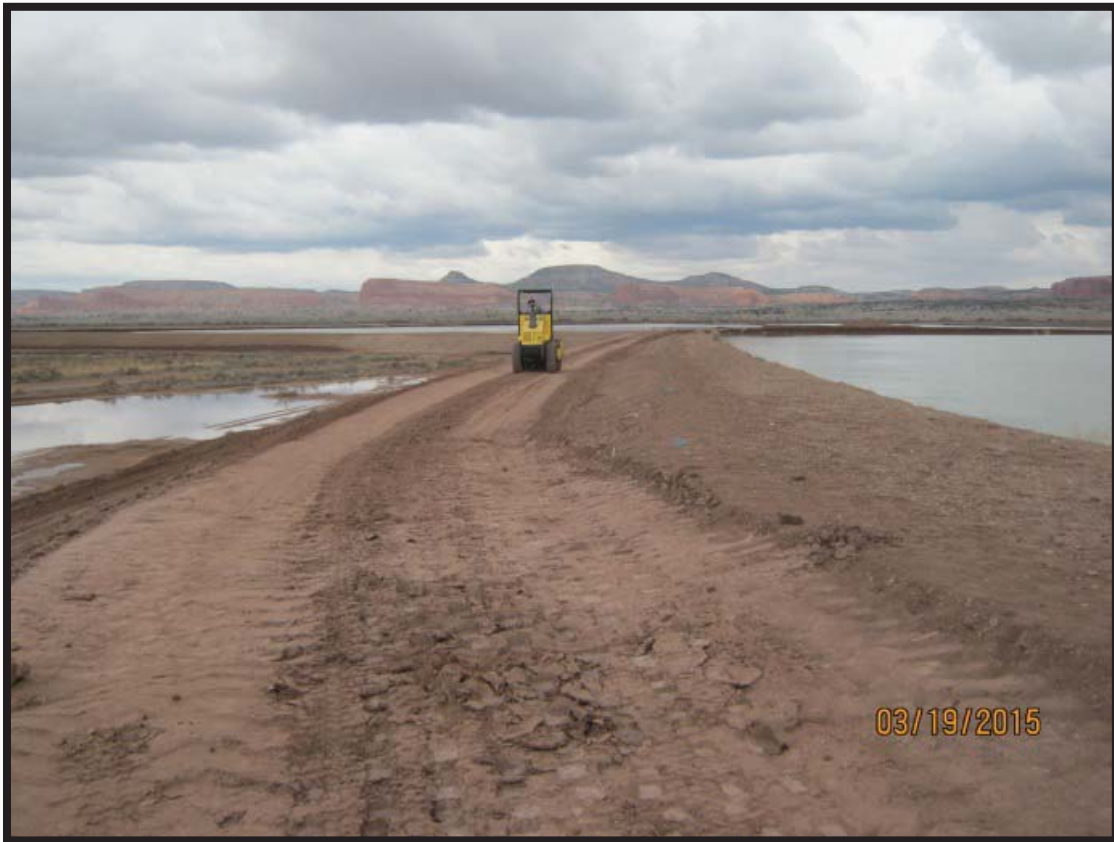
Photo #9: Pond 6 West Berm Under Construction, Nearly Complete - Looking North

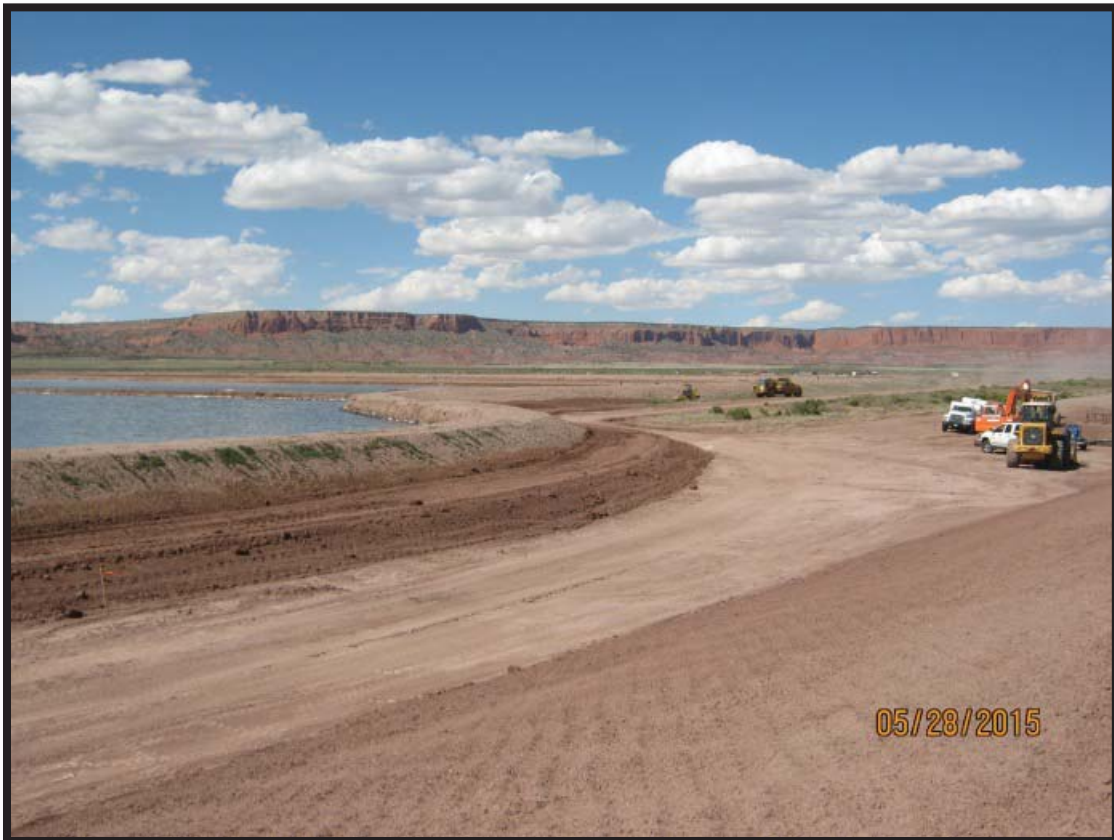
Photo #10: Pond 7/8 and Pond 11 South Berms Under Construction - Looking Northeast

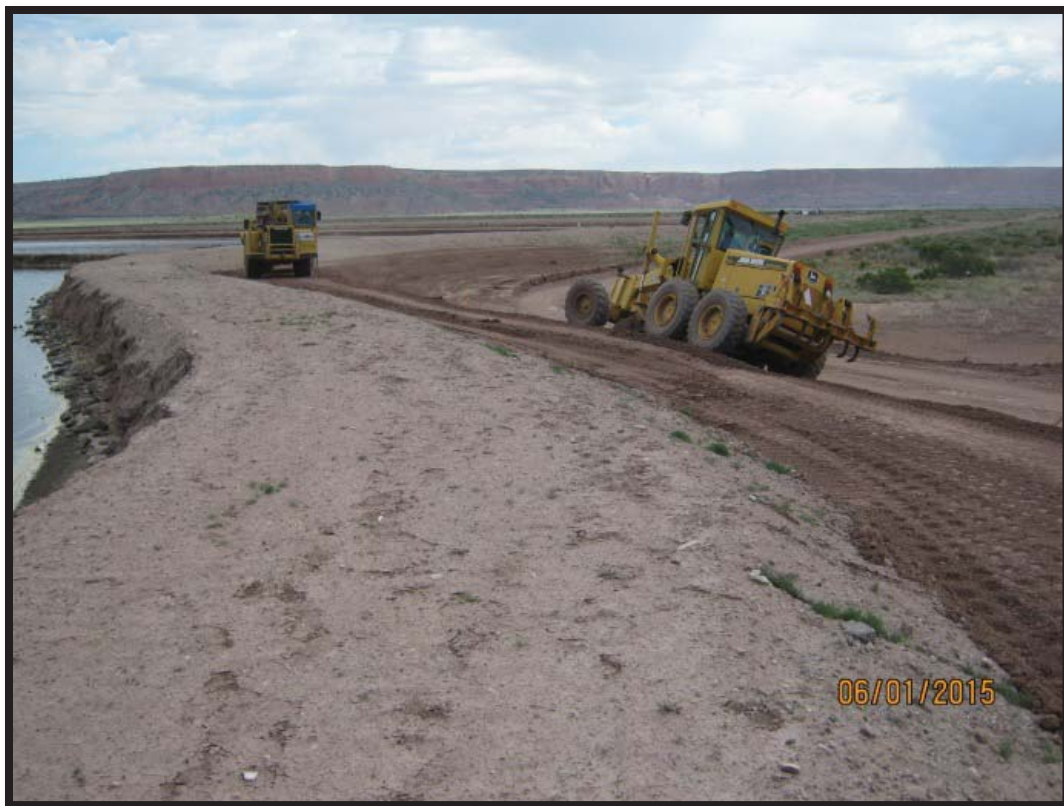
Photo #11: Pond 7/8 and Pond 11 South Berms Under Construction, Nearly Complete - Looking Northeast

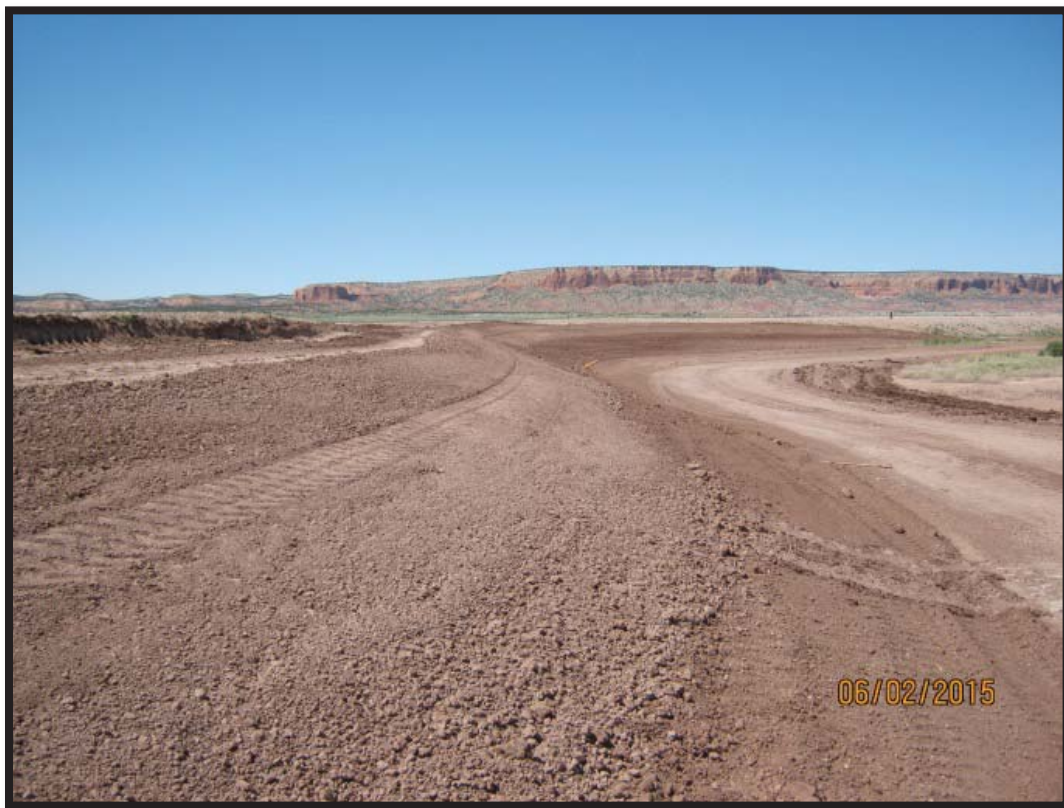
Photo #12: Pond 7/8 and Pond 11 South Berms Under Construction, Nearly Complete - Looking Northeast

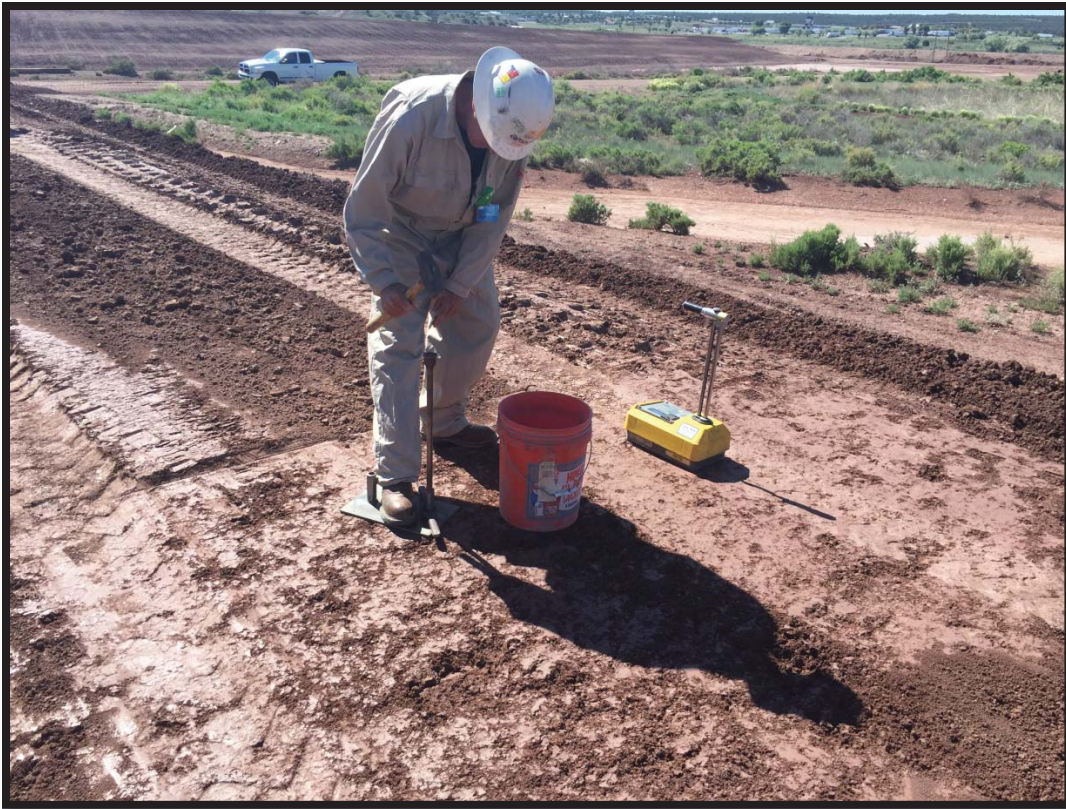
Photo #13: Density Testing Pond 7/8 with repaired Pond 6 in the background

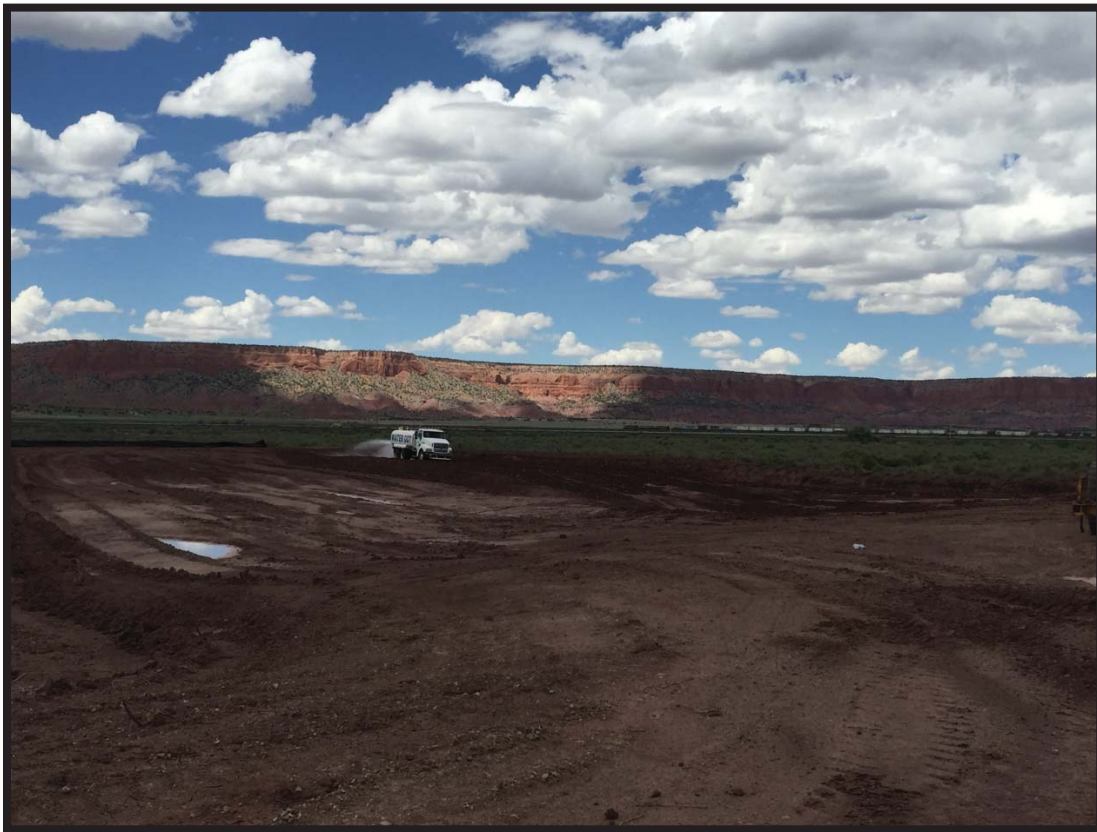
Photo #14: Moisture conditioning soil in the borrow area.

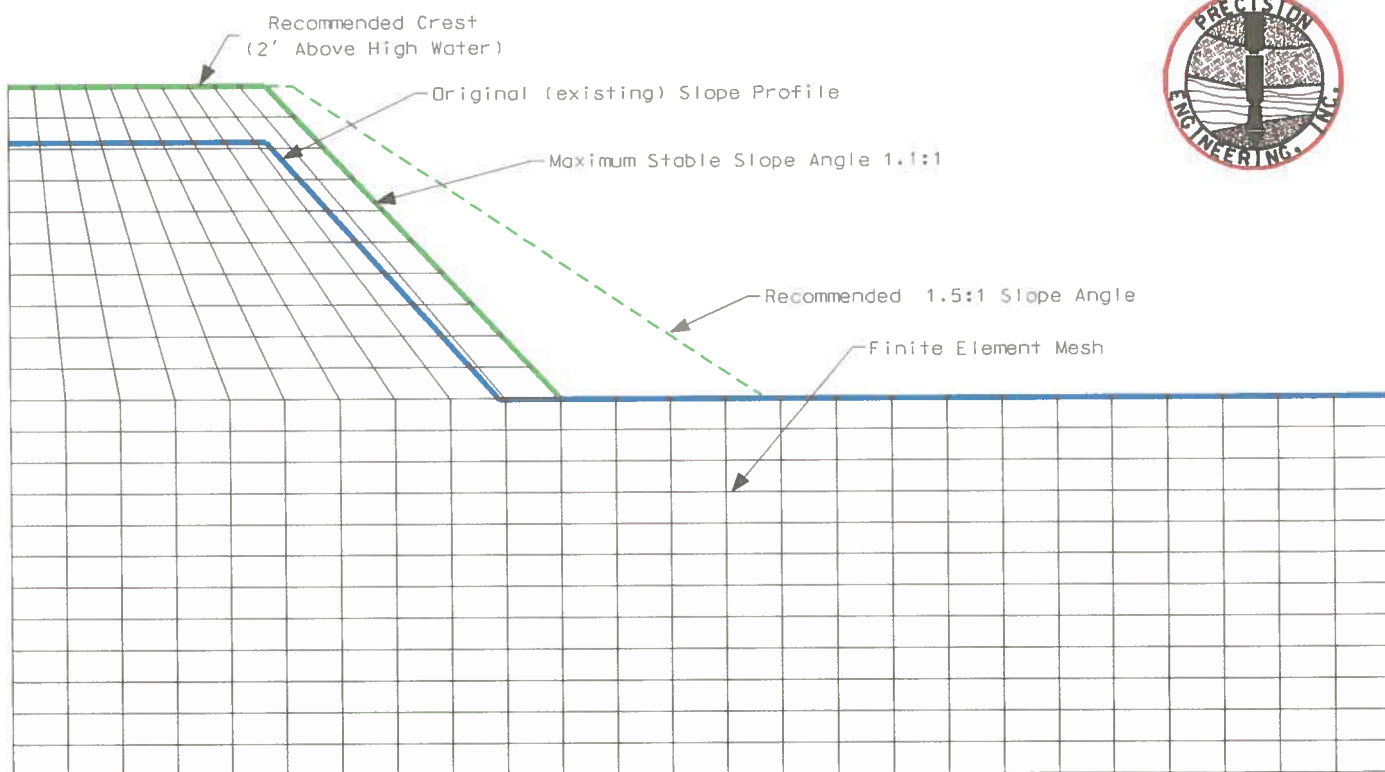
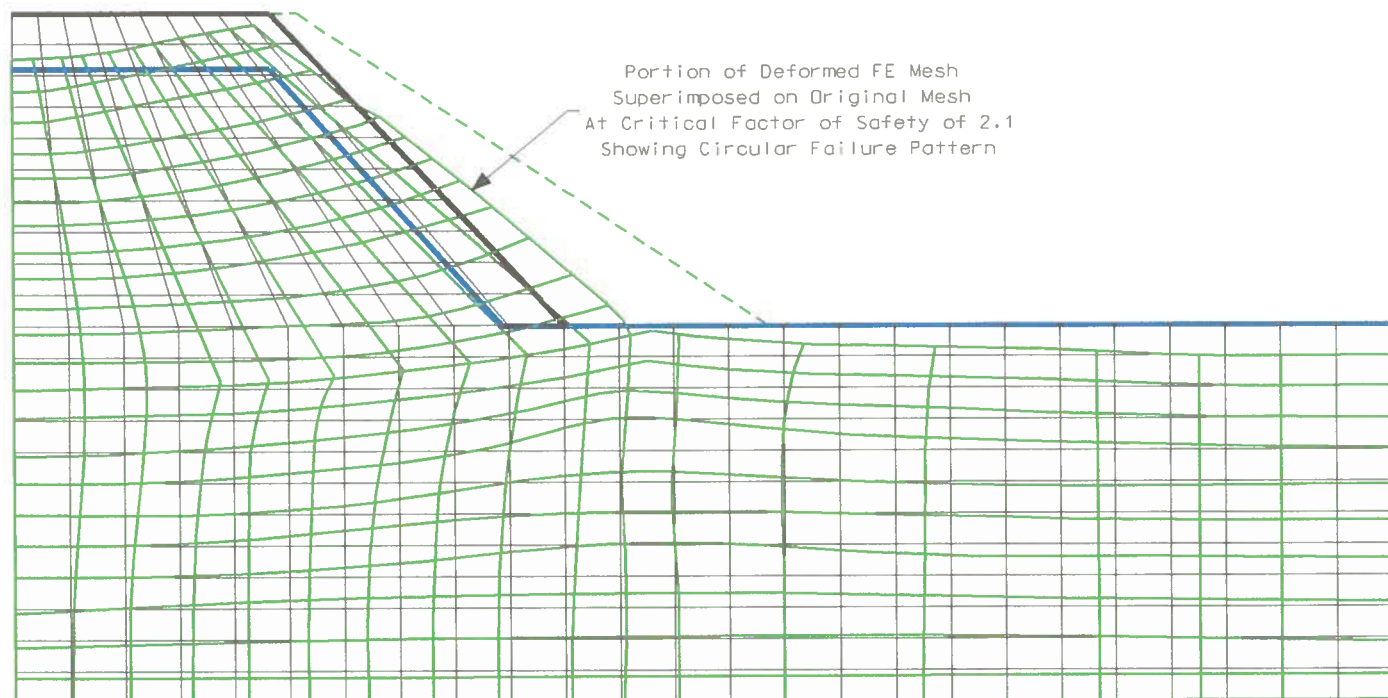
Figure 2 - Section 12

Analysis indicates that when the elevation of the top of the outside containment berms are elevated approximately two (2) feet the minimum factor of safety against failure is 2.1. This minimum critical section is represented by Section 12 on the west side of the ponds (see boring plan). The failure mechanism and associated factor of safety is illustrated in Figure 2.

Critical Section and Failure Mechanism After Elevating and Reshaping Containment Berms

It is recommended that the berm elevations be adjusted to be two (2) feet above the maximum anticipated water level elevation. It is recommended that the minimum width of the top of the containment berms be ten (10) feet. For structural stability, the side slopes of the berms should not exceed their present slope angle after the addition of material to raise the crest elevation. It is recommended, however, that the slope angles not exceed an angle having a horizontal to vertical ratio of 1.5:1. This typically flatter slope angle will resist the development of erosion channels on the exterior face of the berms.

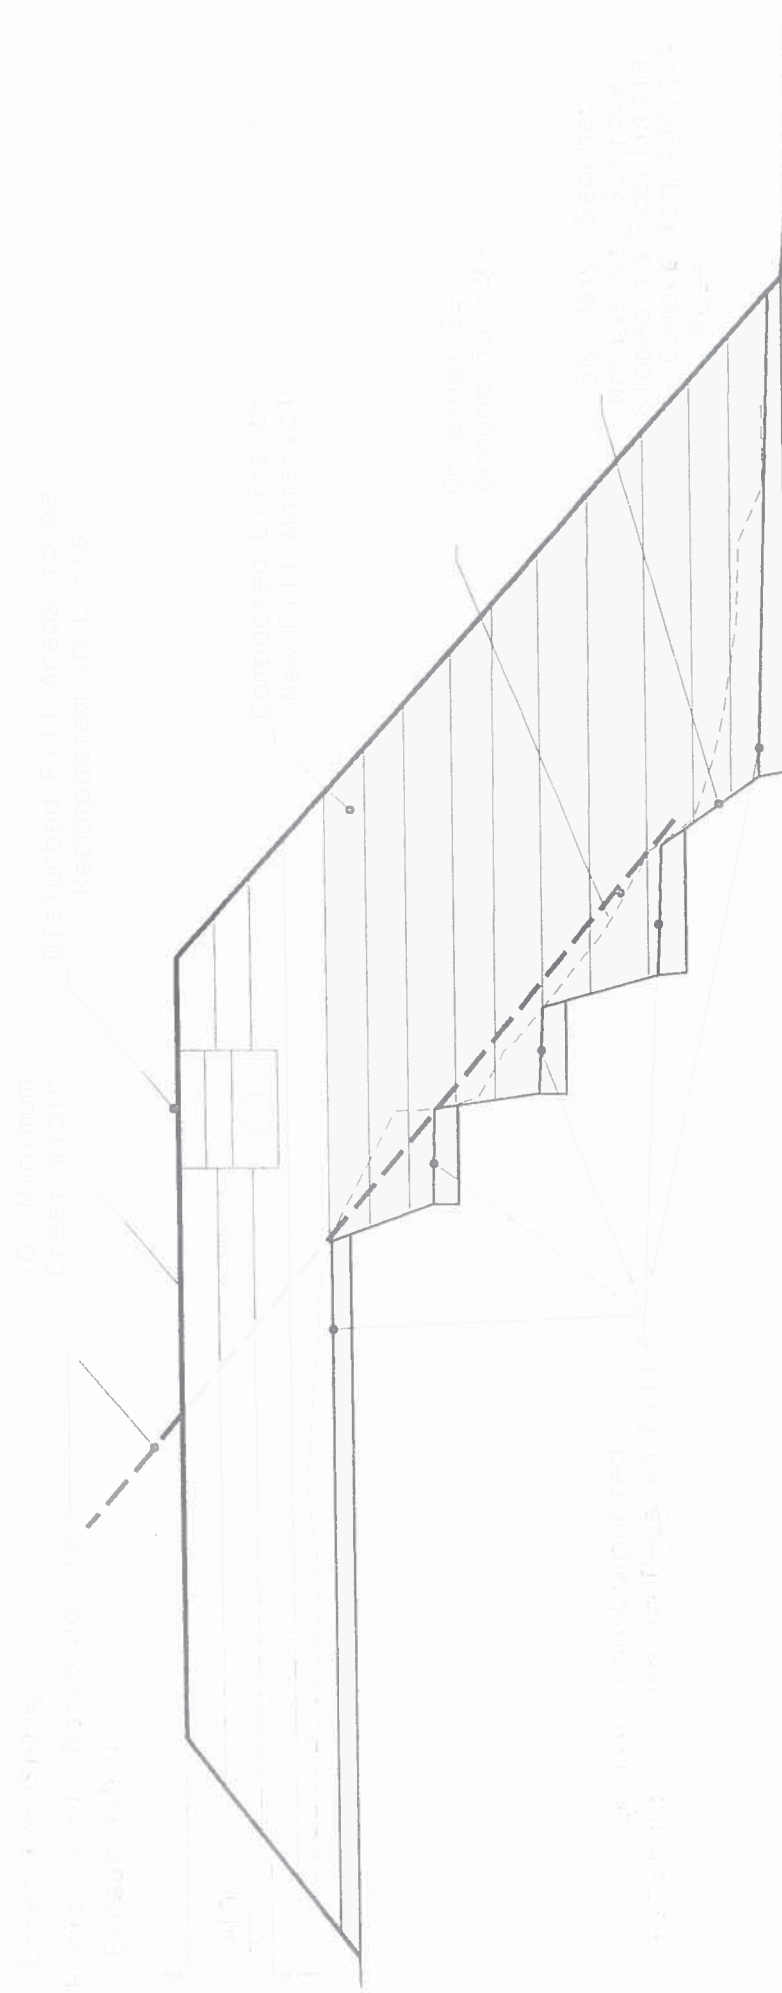
Figure 1

General Fill Placement on Existing Slopes

Soil placed on the berms should be keyed into the berms to provide the maximum strength. The side slopes of the existing embankments should be benched to create a horizontal surface for fill construction. This will provide structural interlock with the existing material. All new fill should be placed and compacted in lifts on the benched surfaces. Keys should be cut in the excavated slope to form horizontal benches as nearly level as is reasonable. Each bench should not exceed thirty-six (36) inches in elevation change to avoid stress concentrations within the fill. Bench cut faces may be sloped steeply to facilitate compaction adjacent to the cut face.

Fill should be placed and compacted beginning at the slope toe and progress to the top of the berm to allow for a more homogeneous new fill section. The berm will be more stable if the new slope section is constructed prior to adding height to the berms. The intent of this recommendation is illustrated in Figure 1.
