Terracon

Re: Energy Transfer Company's Jal #3 Gas Plant – Contingency Tank
Summary of Field Activities
Section 33, Township 24 South, Range 37 East
Terracon Project No. AR167205

Attachment #1 – Topographic Map

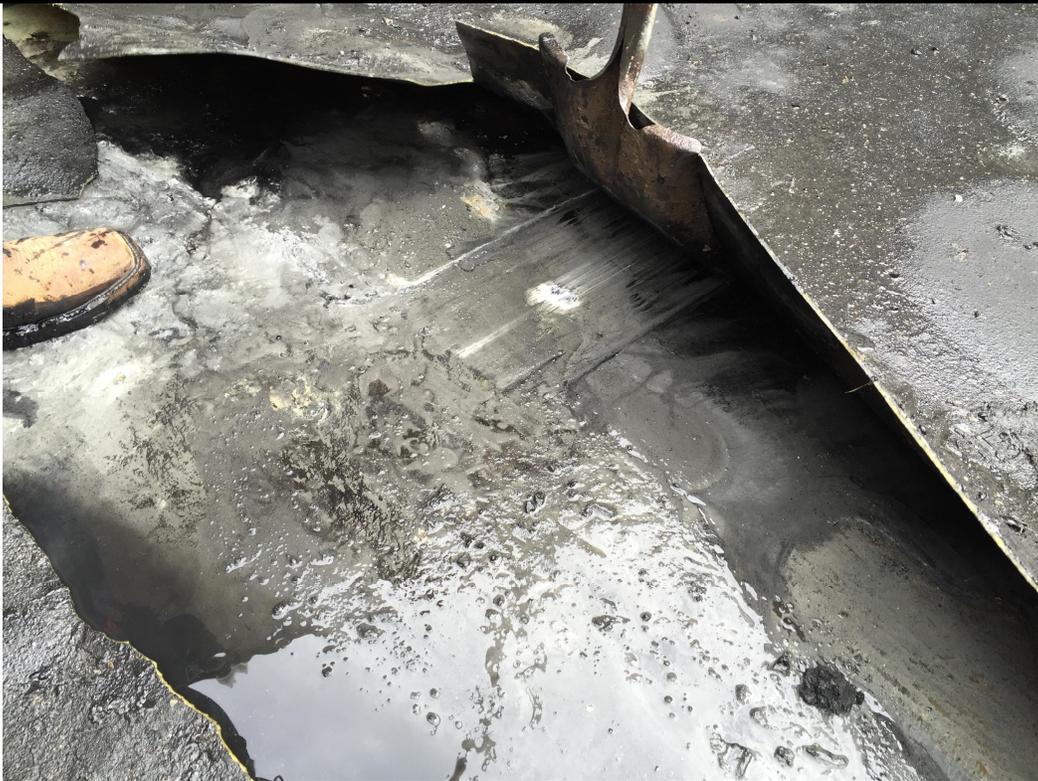
PHOTO 1: View of tank floor including rubber liner and mastic.

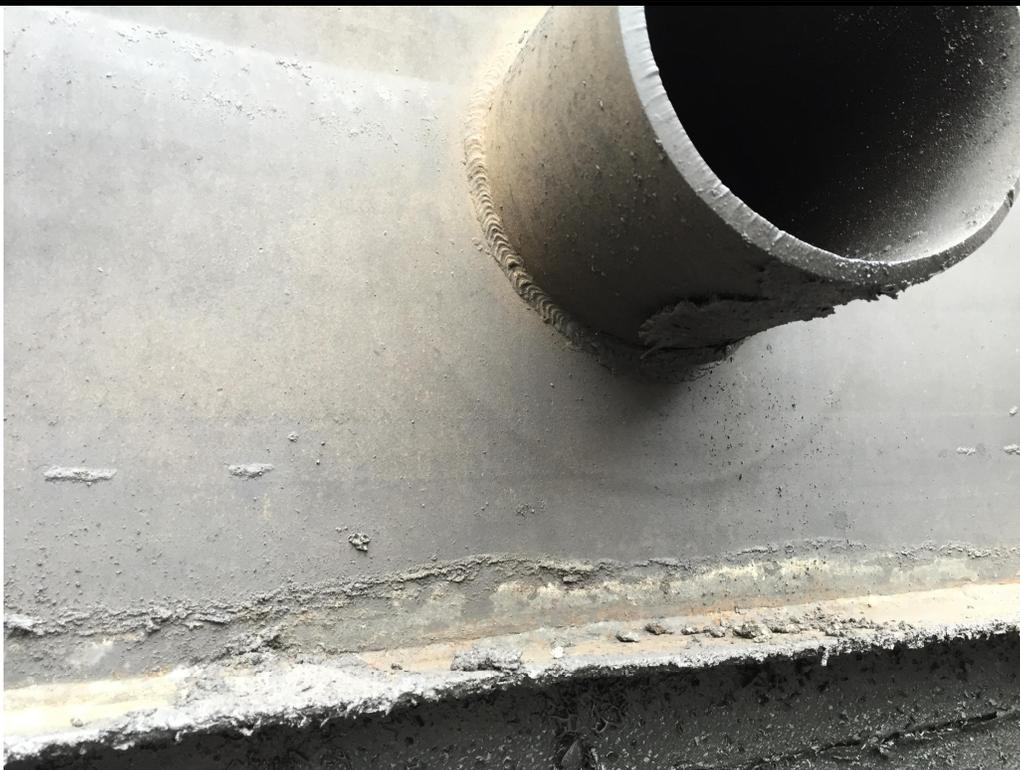
PHOTO 2: View of welded seam on tank inlet.

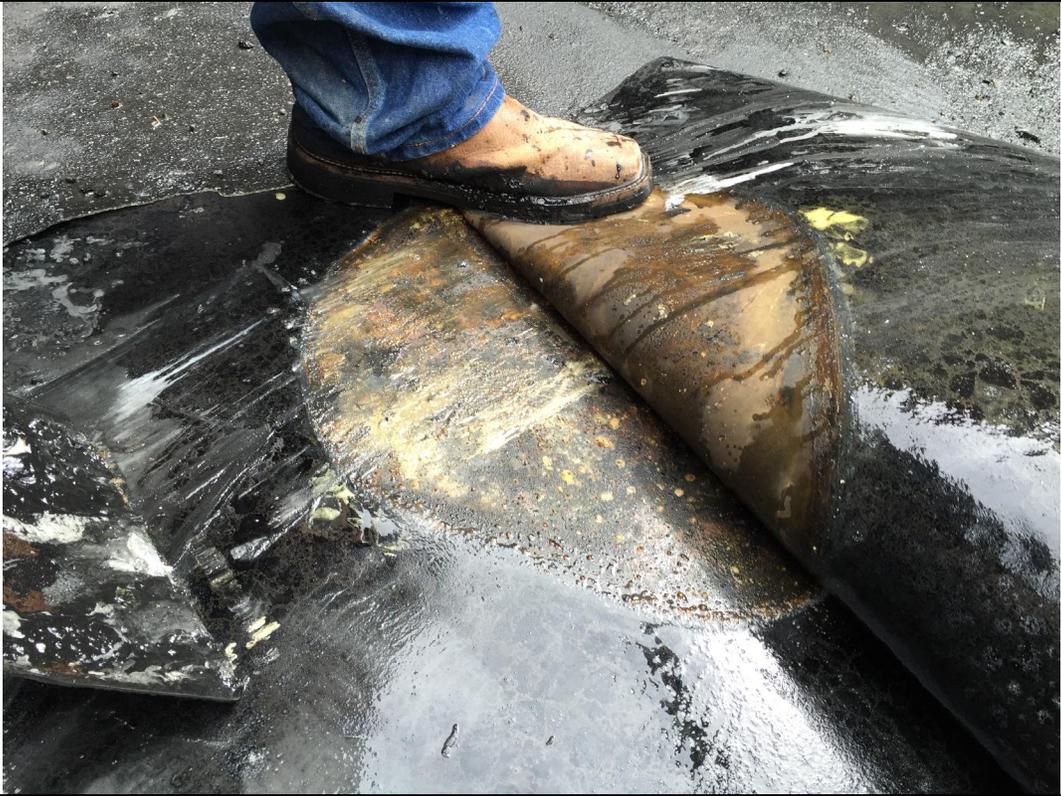
PHOTO 3: View of tank floor including rubber liner and mastic.

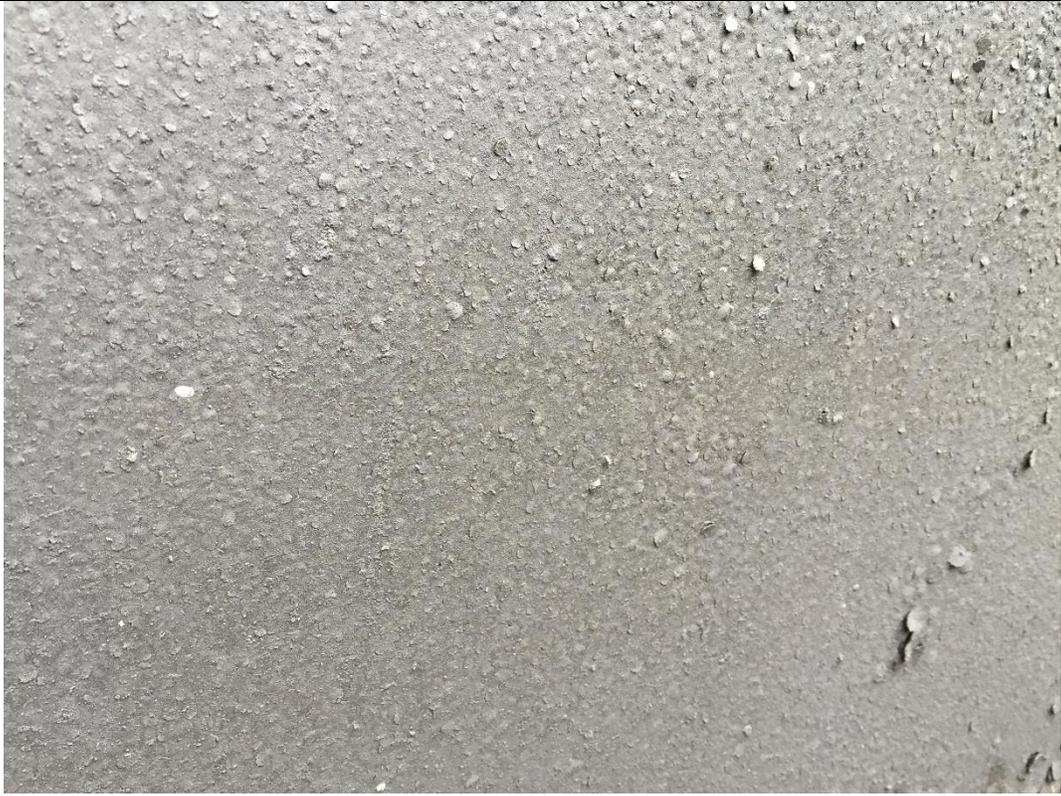
PHOTO 4: View of upper portion of tank wall above the rubber liner.

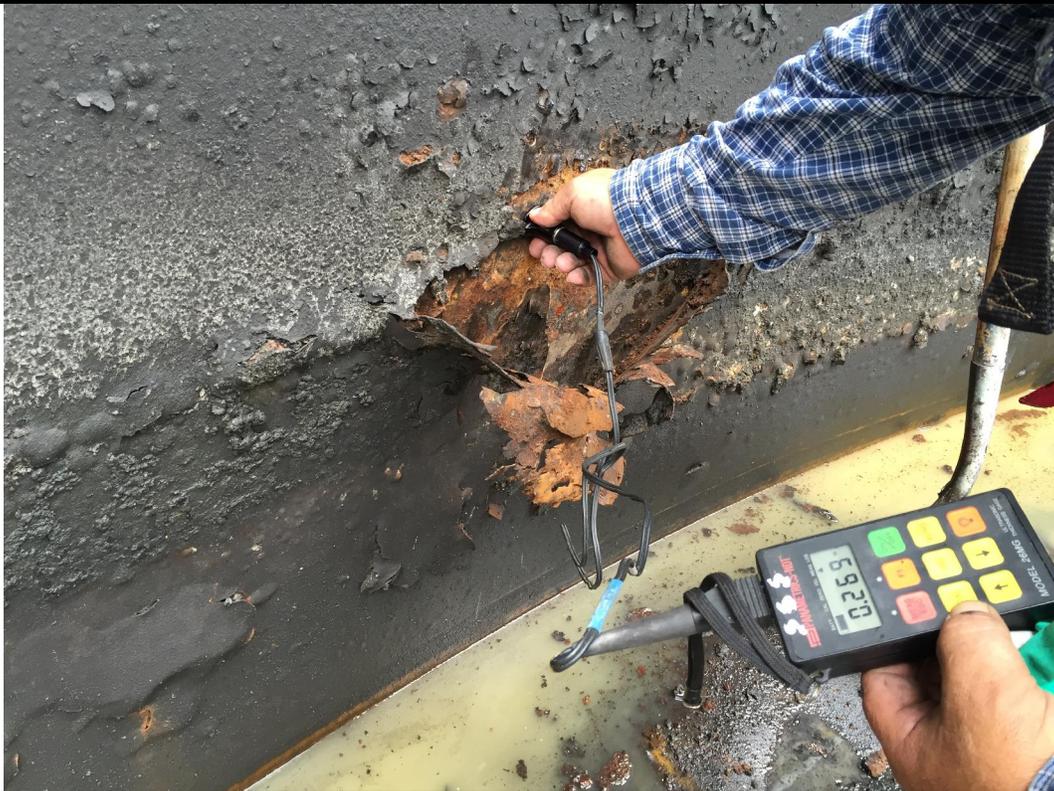
The UTM survey included measuring the thickness of the steel in ten locations on the floor and/or sides of the tank utilizing an ultrasonic thickness gauge. Special attention was given to gauging areas exhibiting evidences of rust and/or scaling. UTM readings ranged from 0.232 inches to 0.290 inches with the mean of 0.262 inches and a mode of 0.250 inches. Areas exhibiting thicknesses over ¼-inch are inferred to be a result of lamination. UT measurements are summarized in the following table:

PHOTO 5: View of UTM survey of inferred "worse case" area.

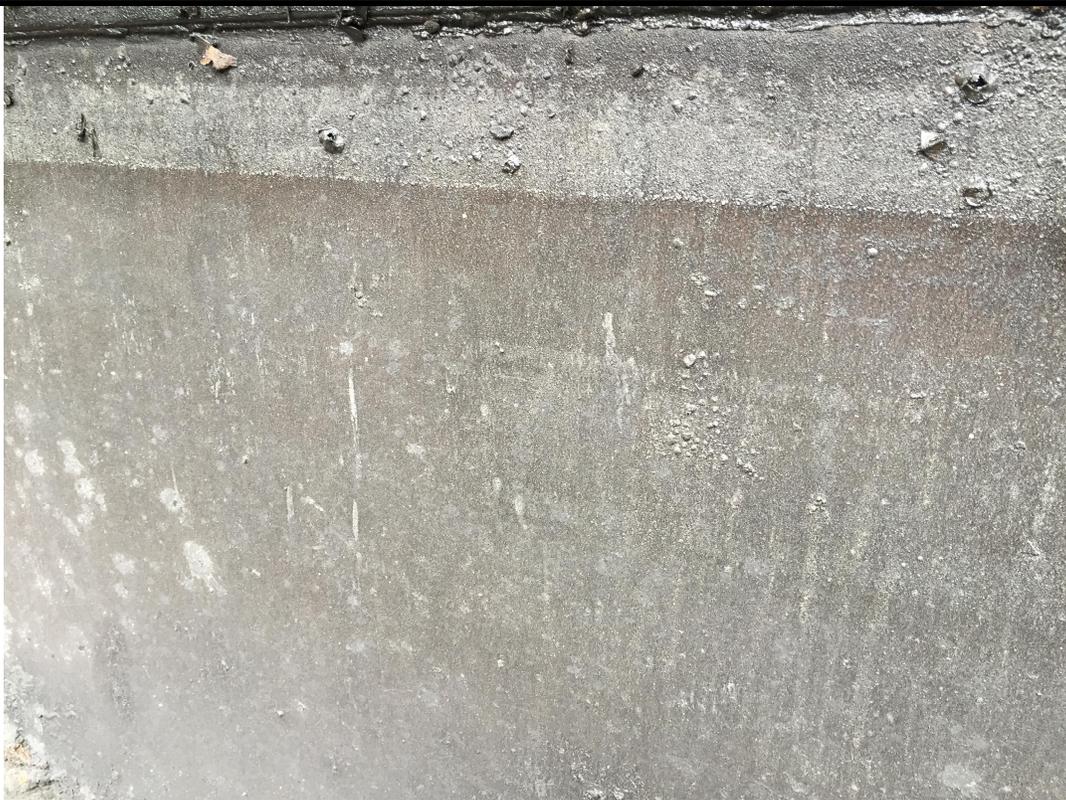
PHOTO 6: View of upper portion of tank wall above the rubber liner.

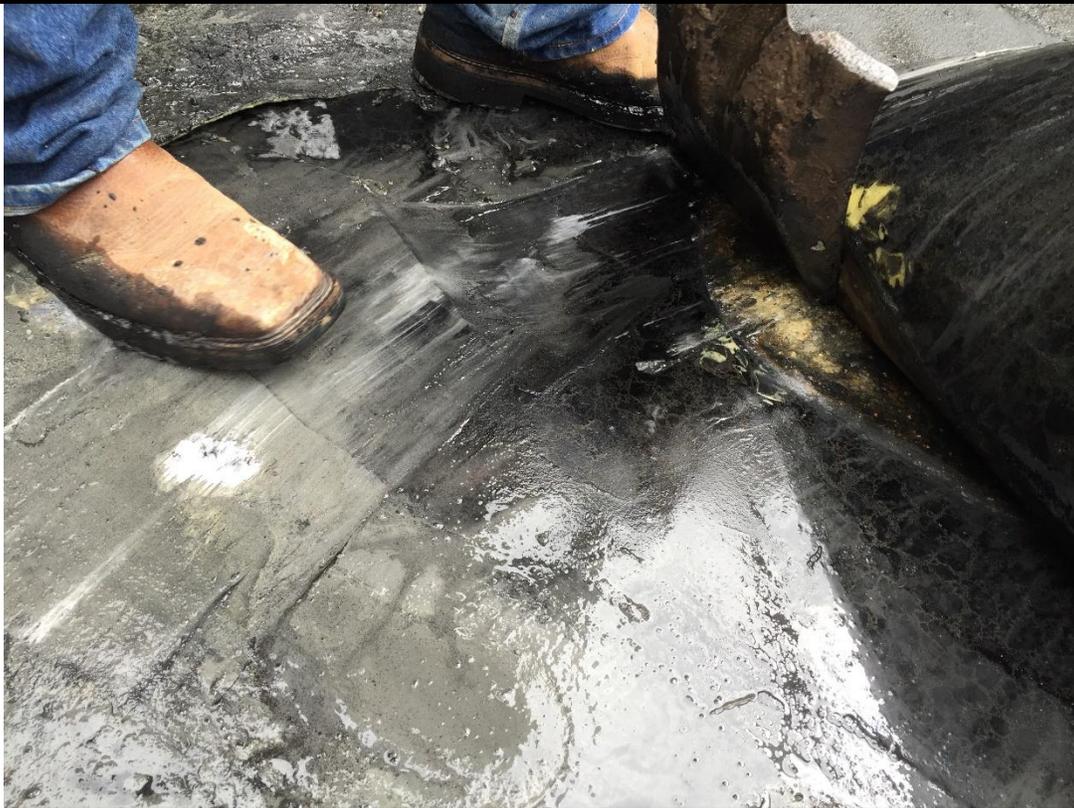
PHOTO 7: View of tank floor beneath rubber liner.

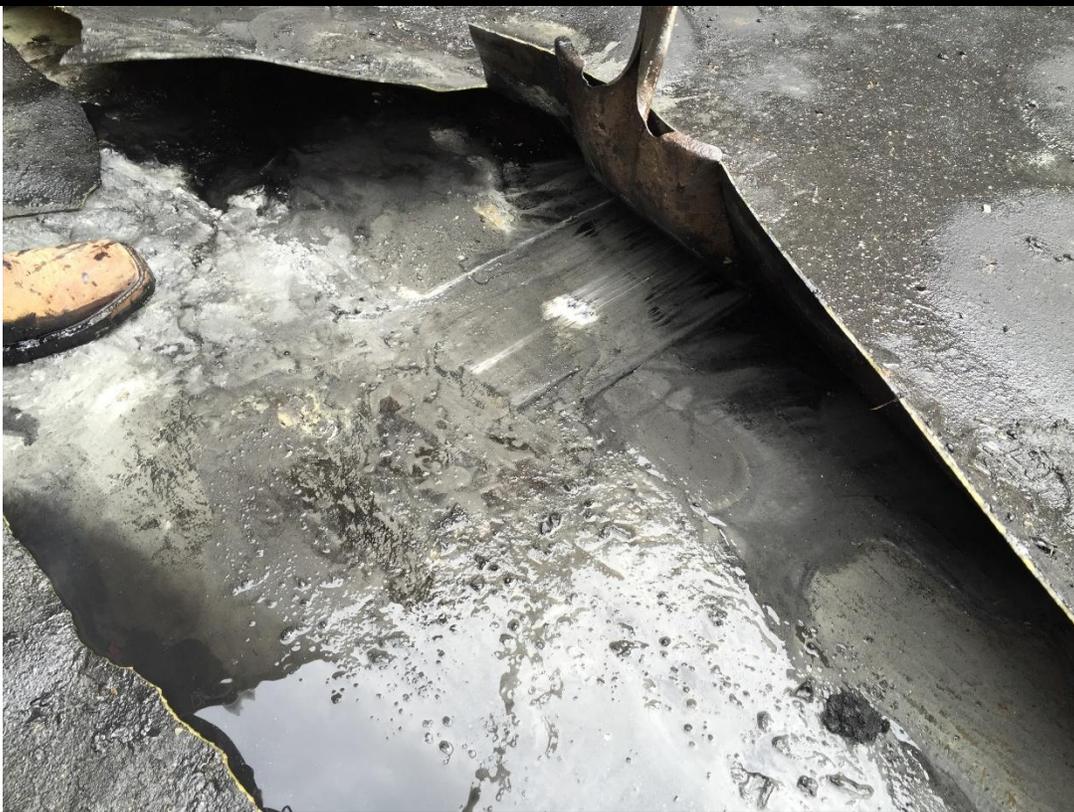
PHOTO 8: View of tank floor beneath rubber liner.

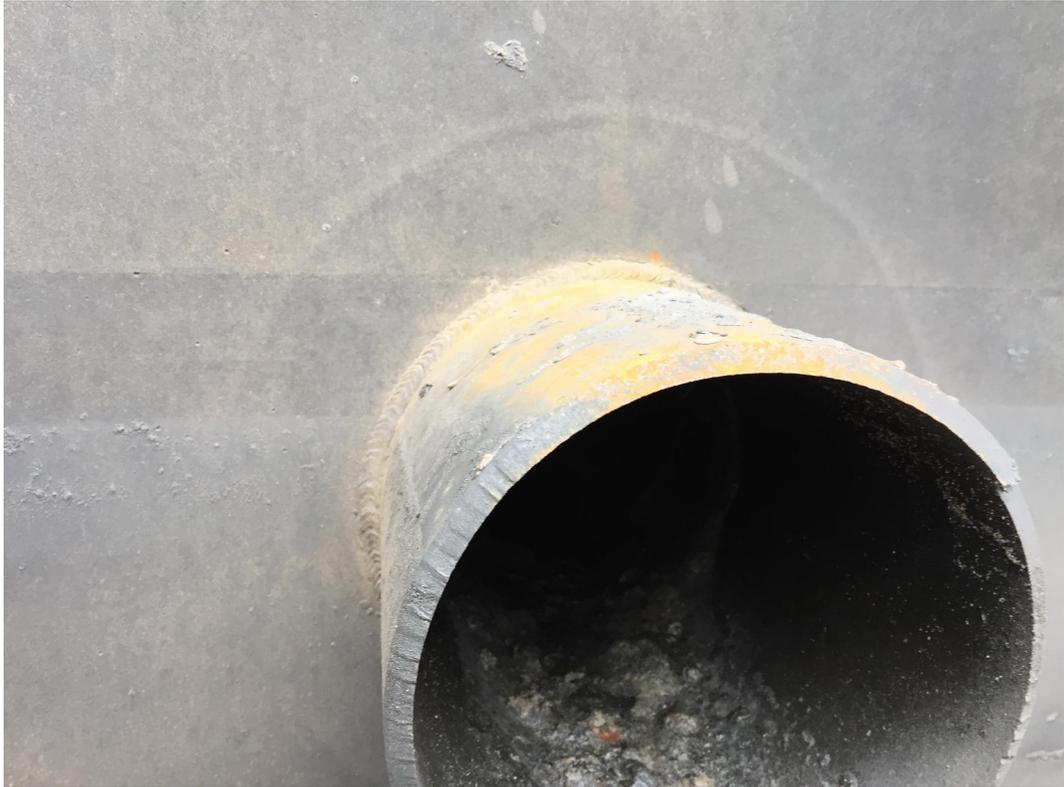
PHOTO 9: View of welded seam on tank inlet.

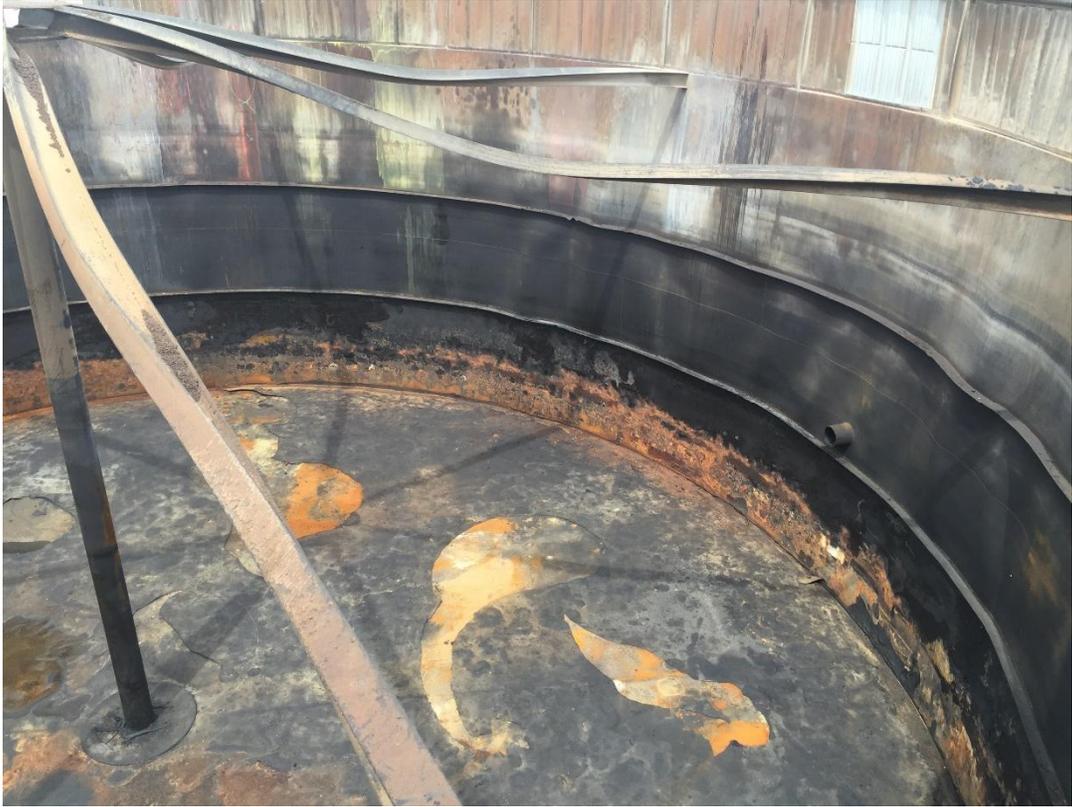
PHOTO 10: View of the floor of the tank after cleaning activities and inspection.

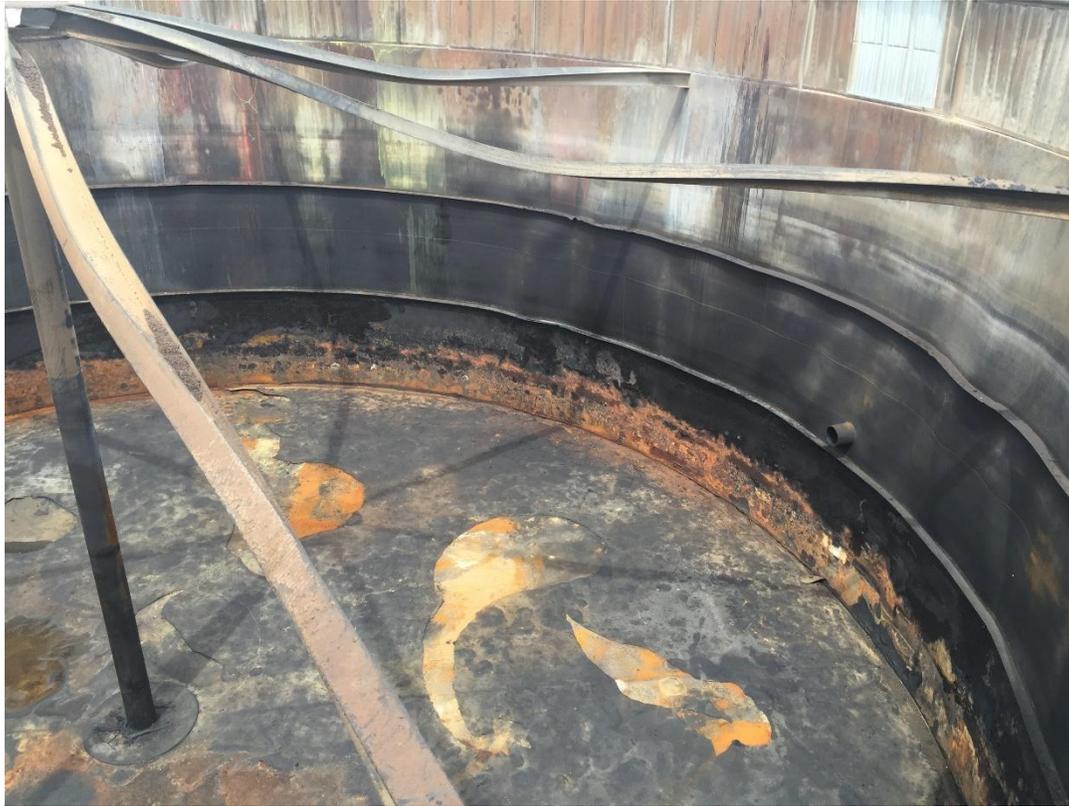
PHOTO 11: View of the floor of the tank after cleaning activities and inspection.

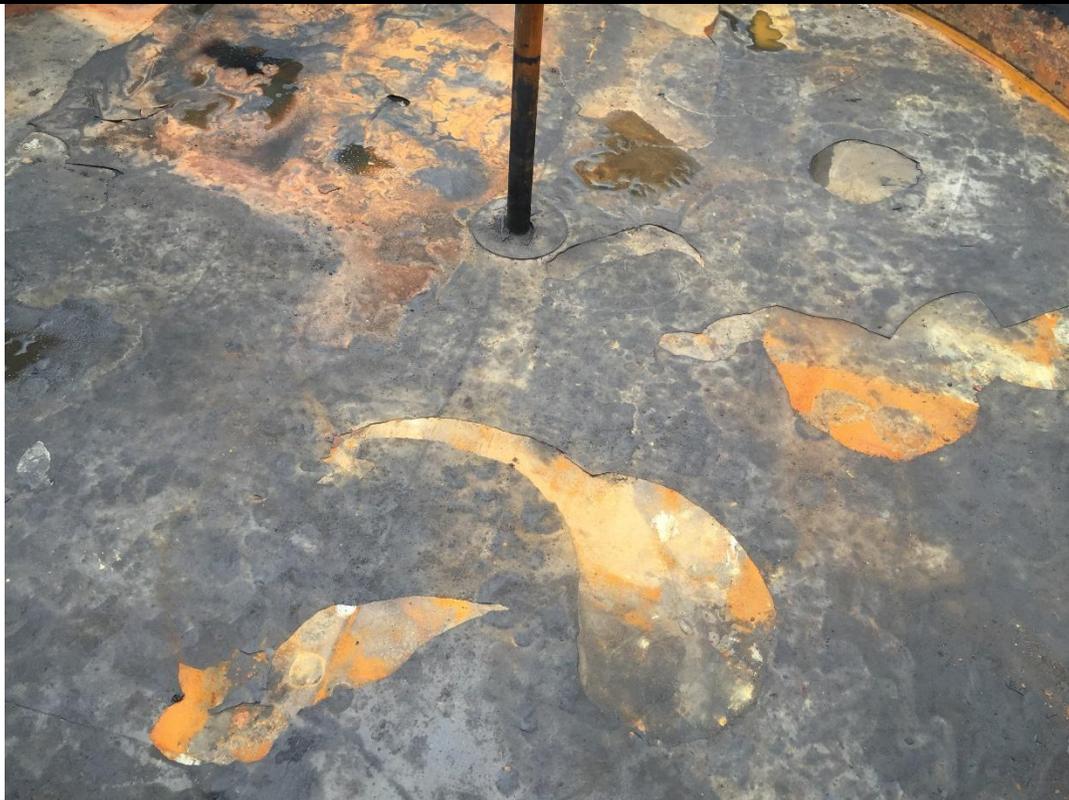
PHOTO 12: View of the floor of the tank after cleaning activities and inspection.
