AP - 111

**EVAPORATION
POND REPAIRS
REV. 1 (2 of 4)**

2017

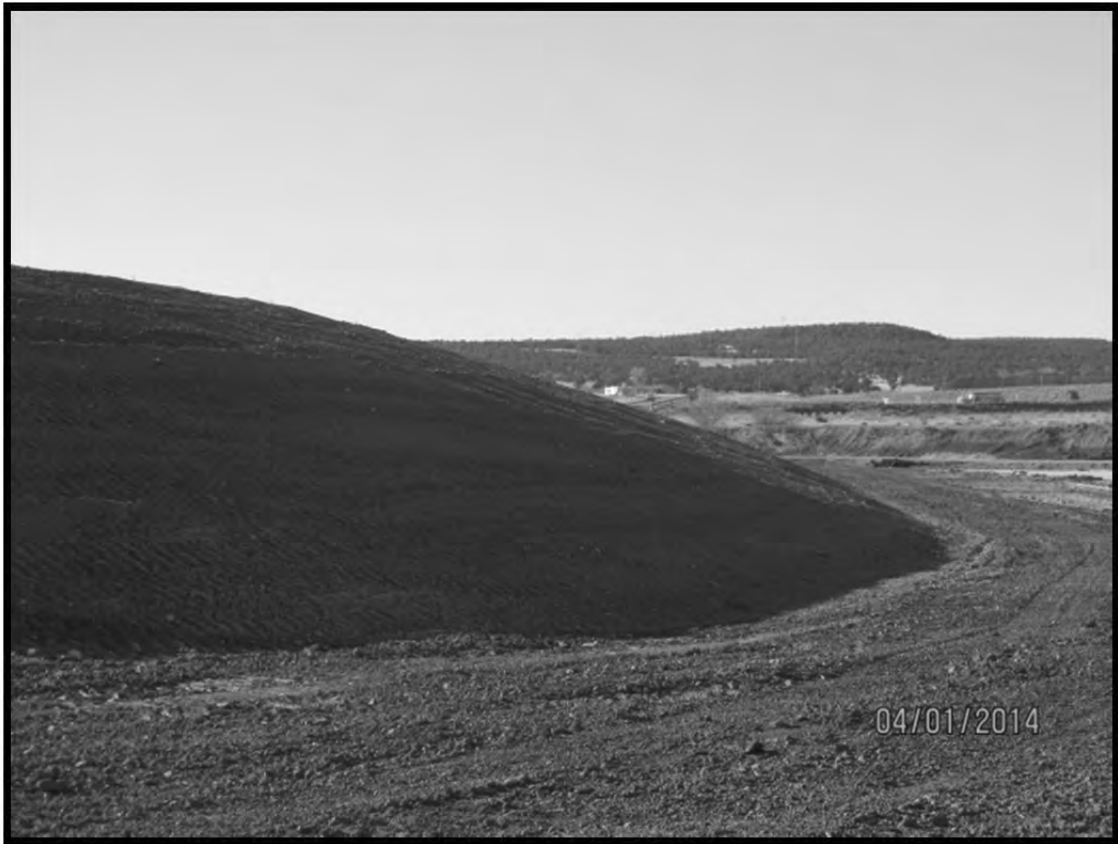
Photo #1: Pond 6 Northwest Corner After Fill Placement - Looking South

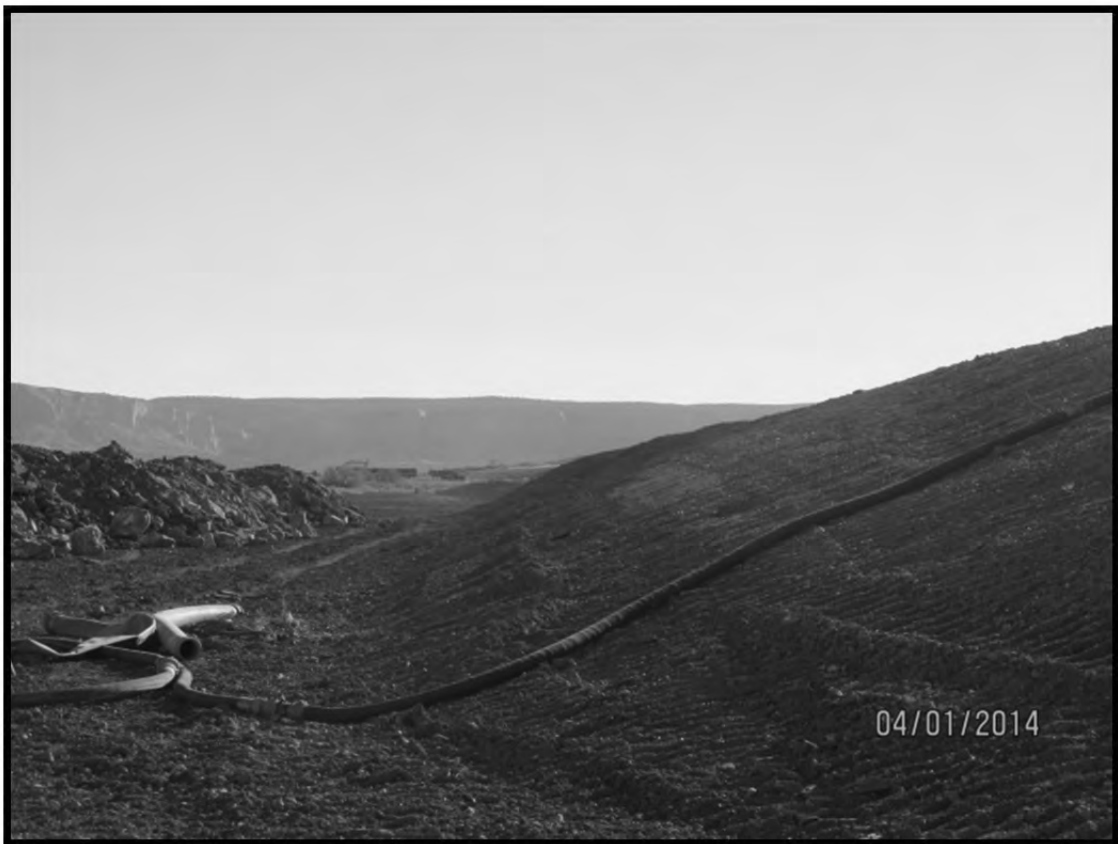
Photo #2: Pond 6 Northwest Corner After Fill Placement - Looking North

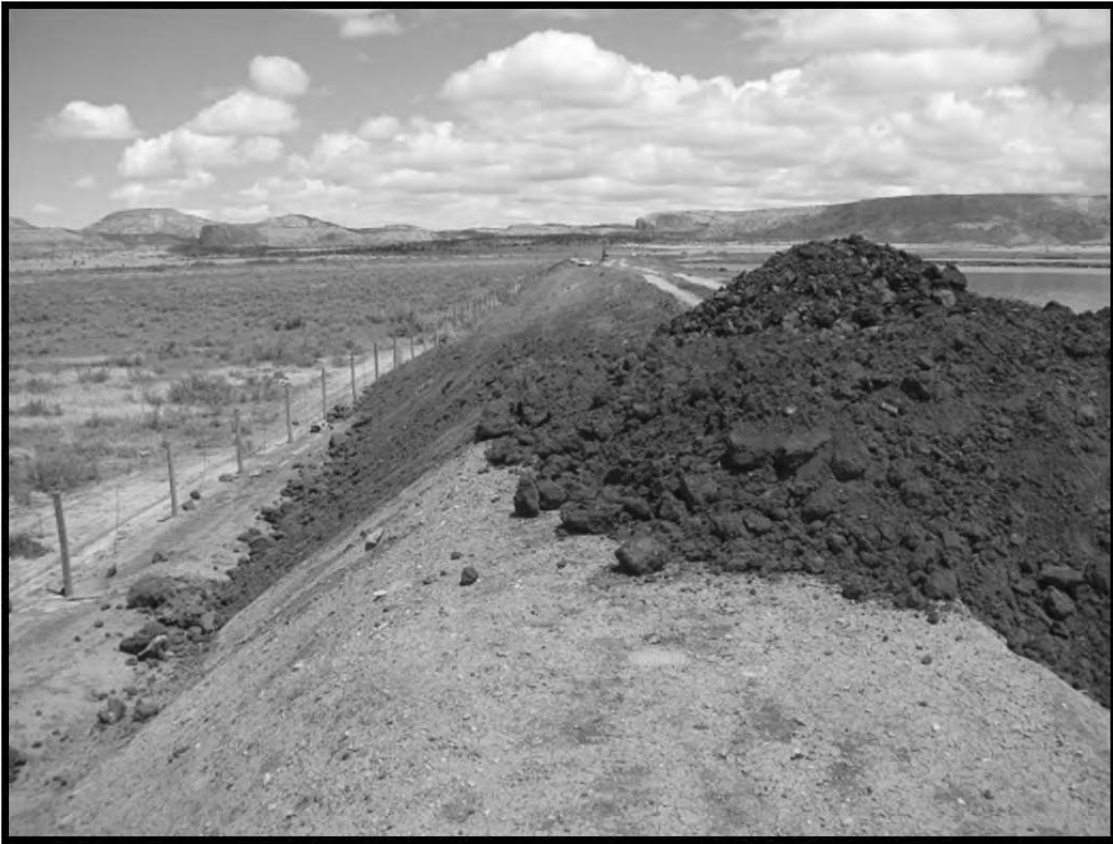
Photo #3: Pond 7/8 West Berm Under Construction - Looking North
(Note how the new crest alignment is shifted to the east)

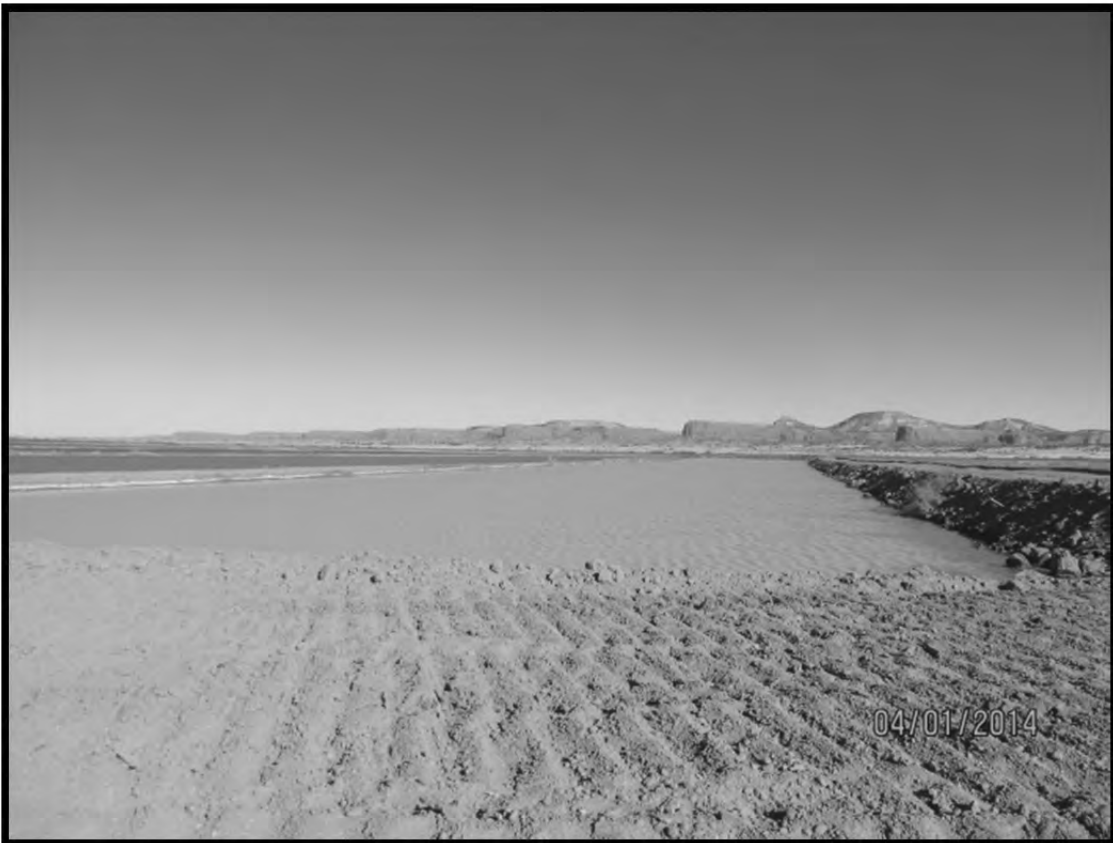
Photo #4: Pond 11 South Berm Construction Complete - Looking North

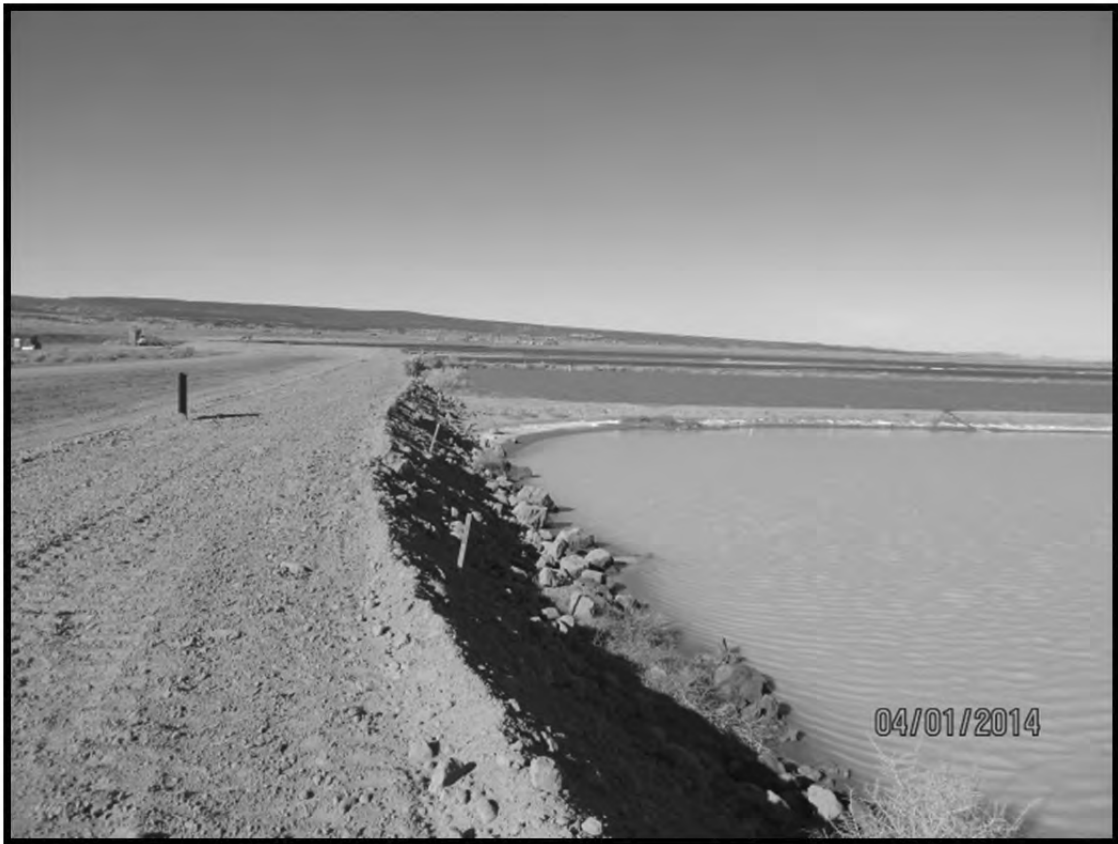
Photo #5: Pond 12A South Berm Construction Complete - Looking West

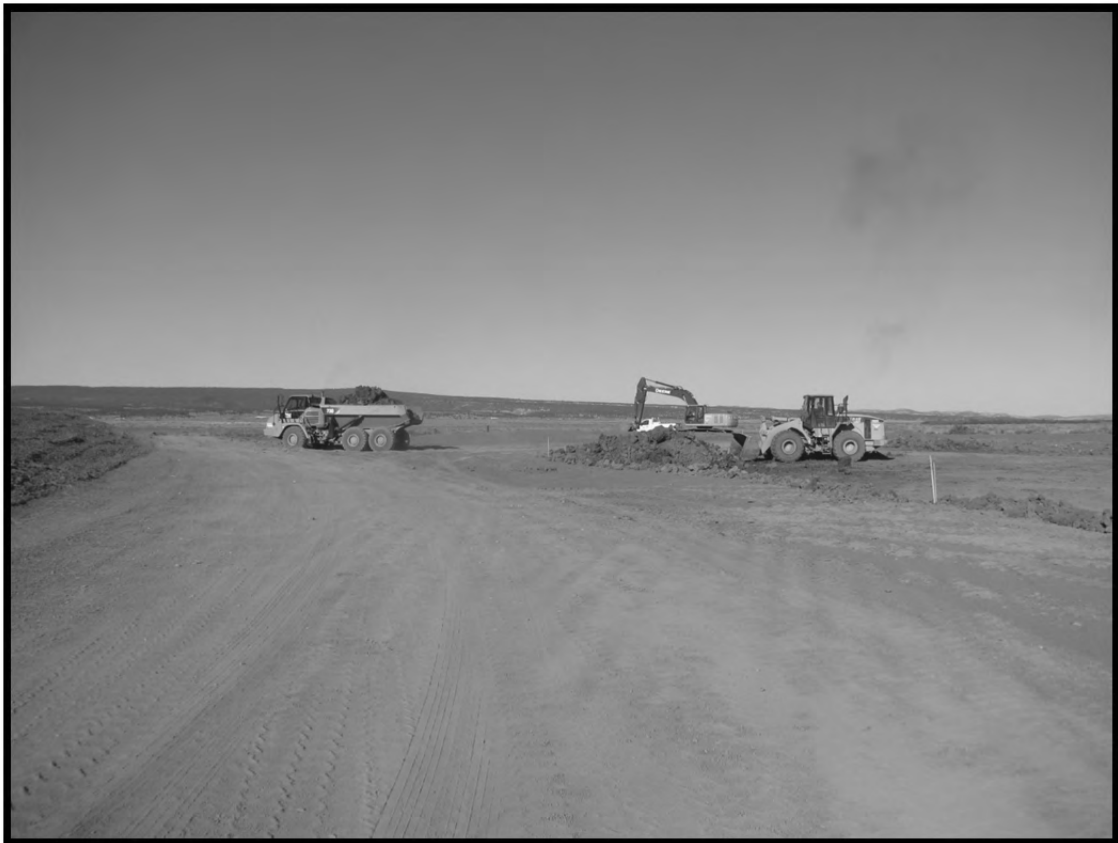
Photo #6: Borrow area north of Pond 11 – Looking West

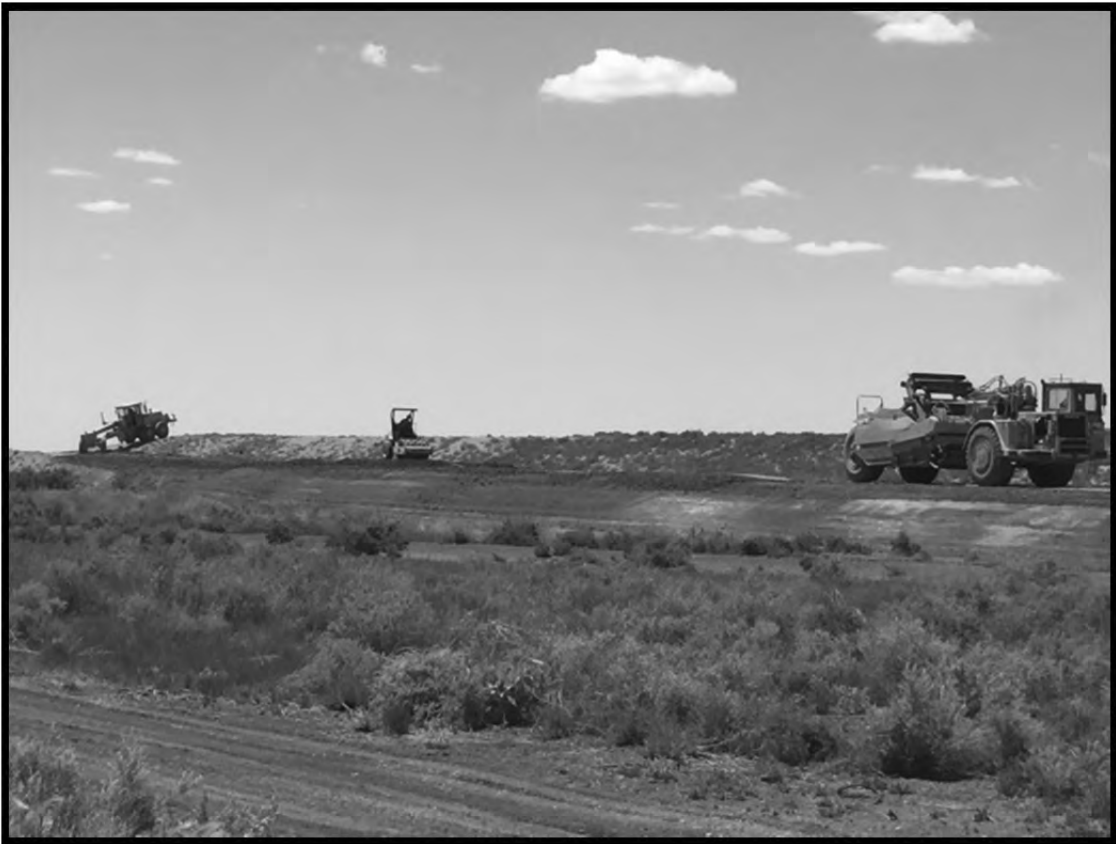
Photo #7: Pond 5 North Berm Under Construction, Nearly Complete - Looking East

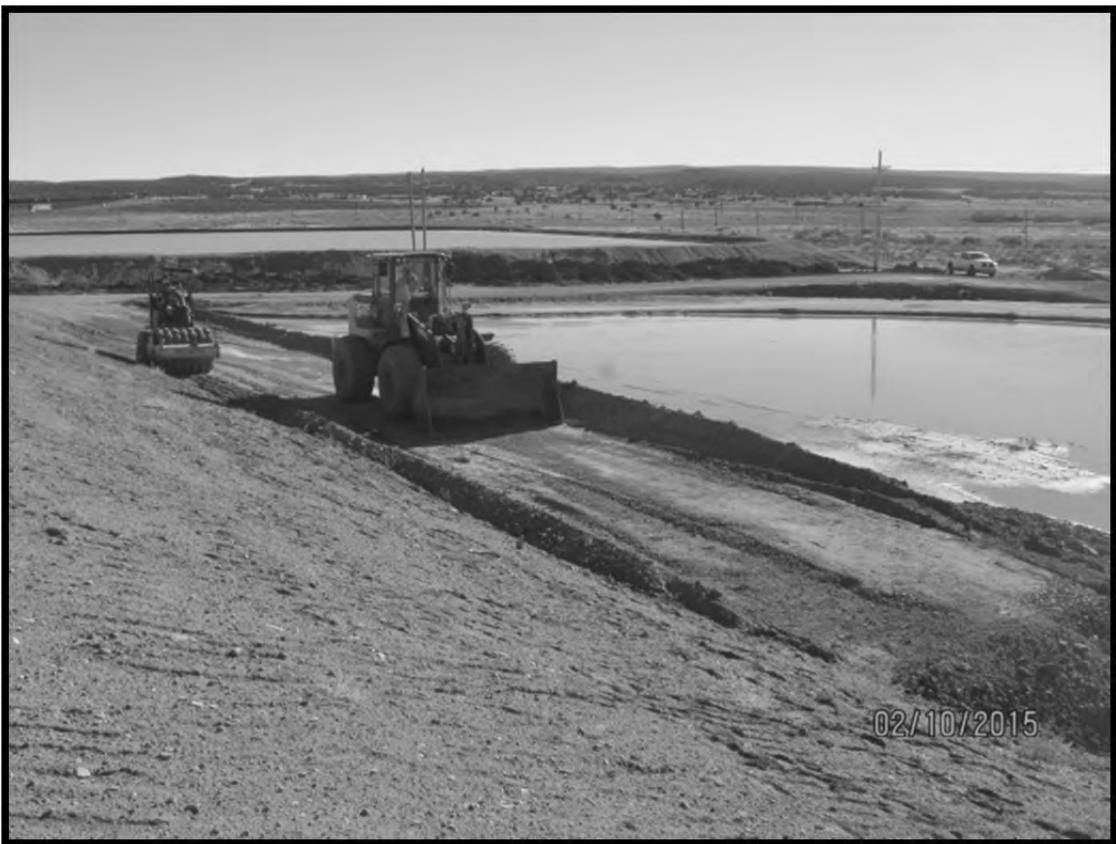
Photo #8: Pond 6 West Berm Under Construction - Looking South

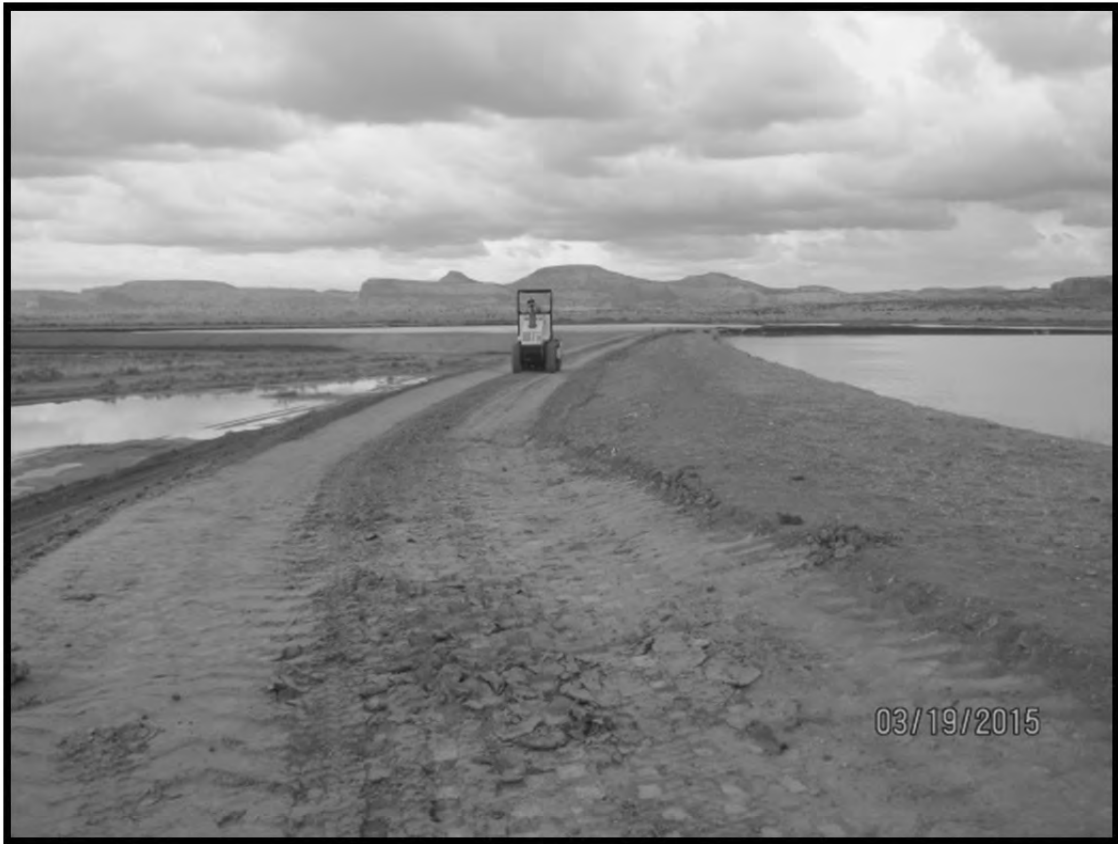
Photo #9: Pond 6 West Berm Under Construction, Nearly Complete - Looking North

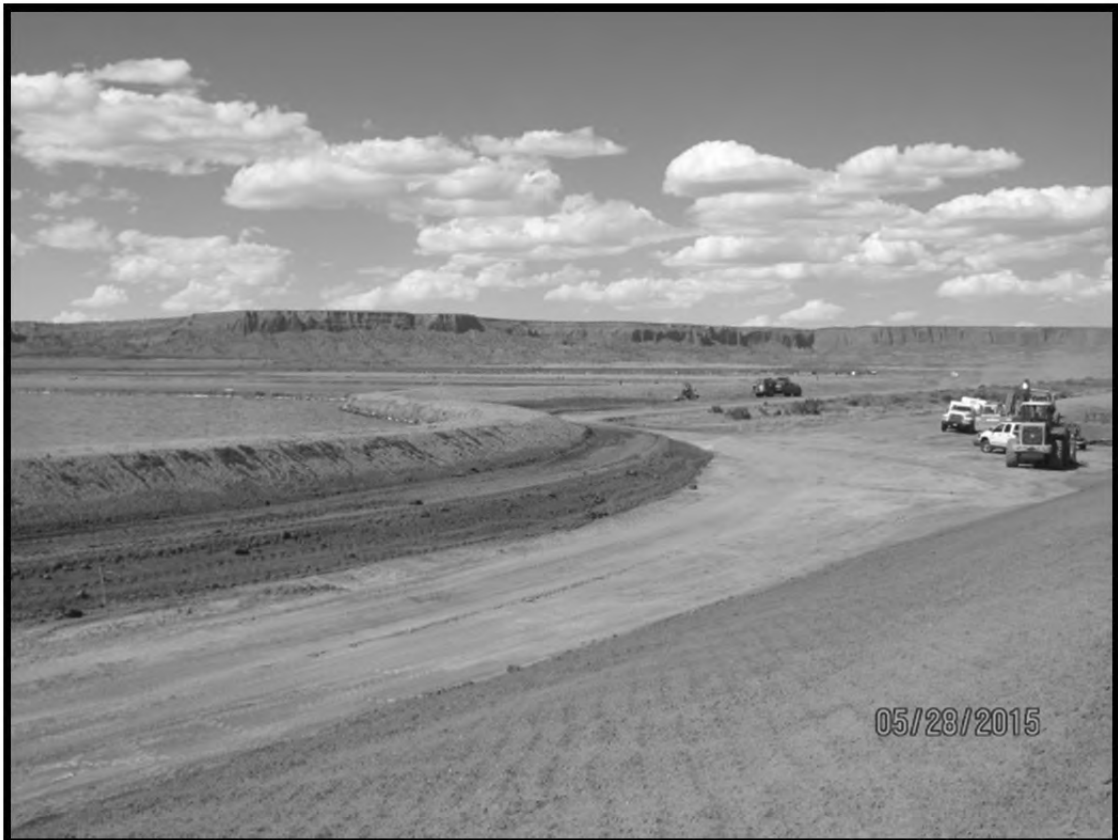
Photo #10: Pond 7/8 and Pond 11 South Berms Under Construction - Looking Northeast

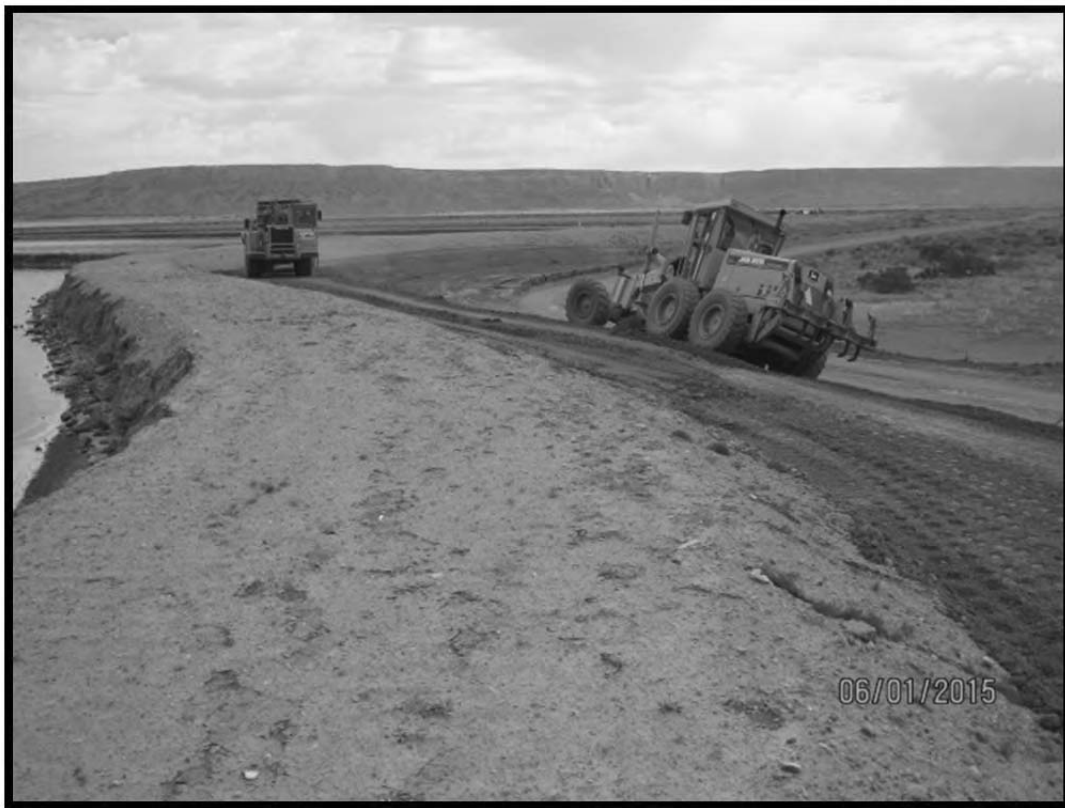
Photo #11: Pond 7/8 and Pond 11 South Berms Under Construction, Nearly Complete - Looking Northeast

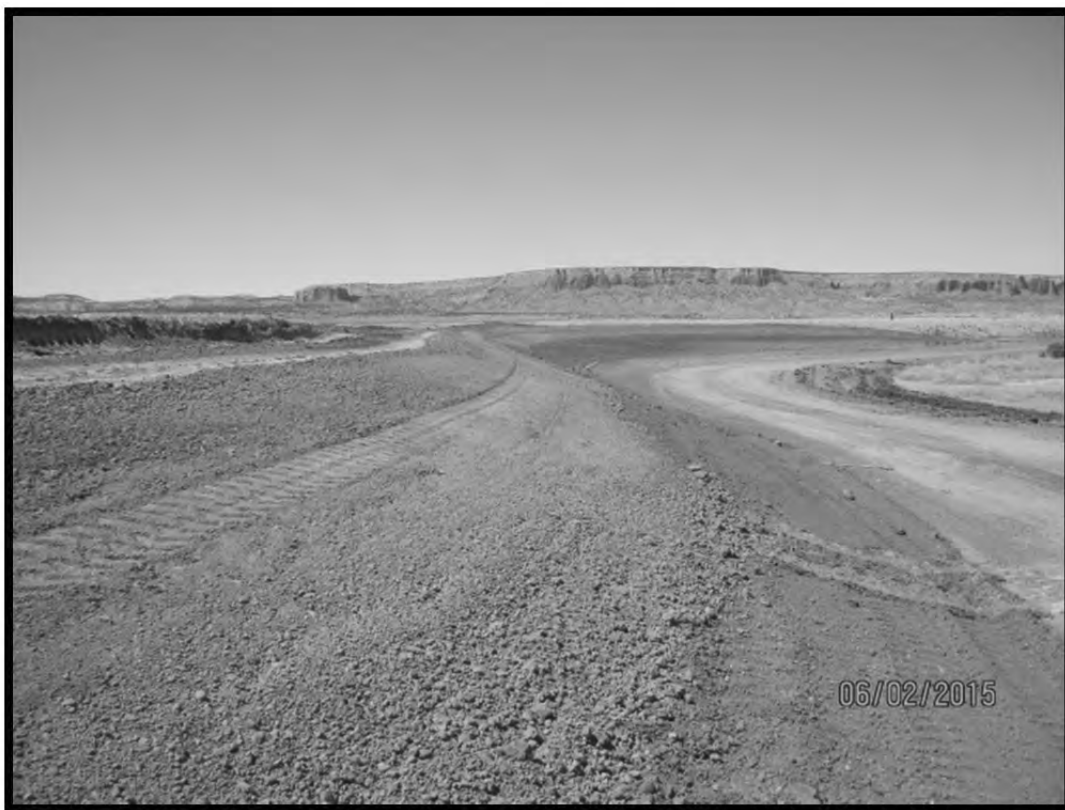
Photo #12: Pond 7/8 and Pond 11 South Berms Under Construction, Nearly Complete - Looking Northeast

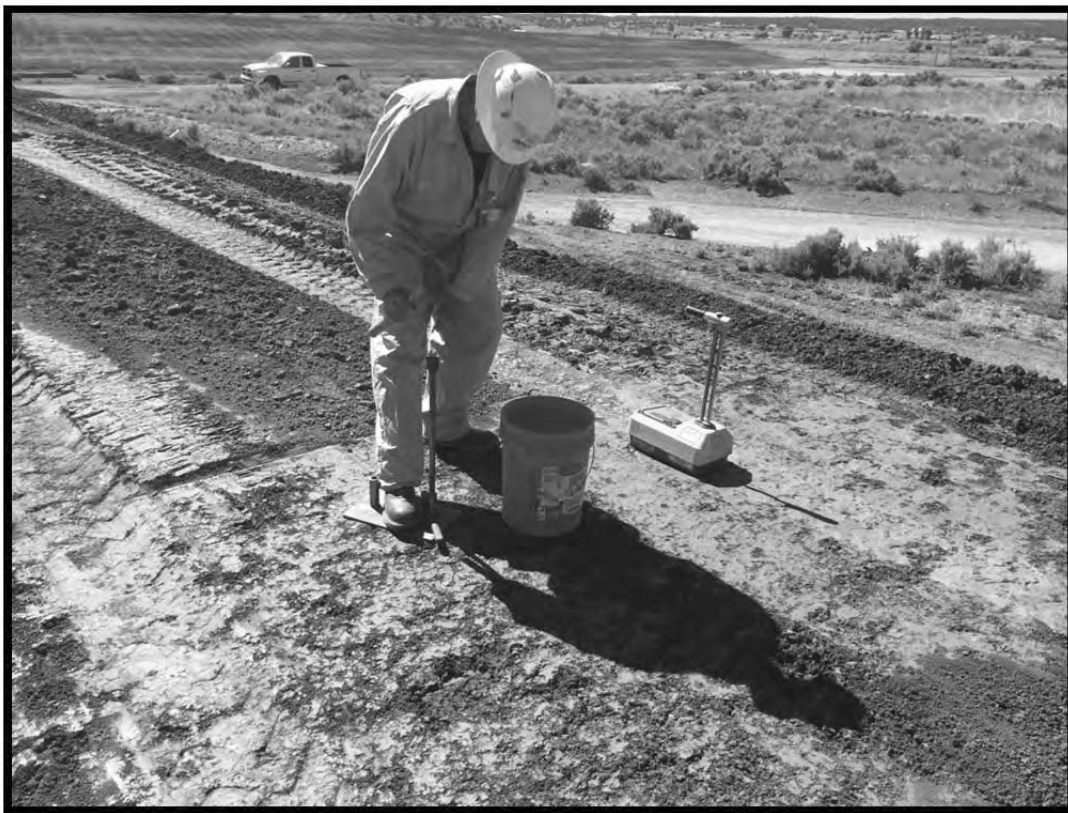
Photo #13: Density Testing Pond 7/8 with repaired Pond 6 in the background

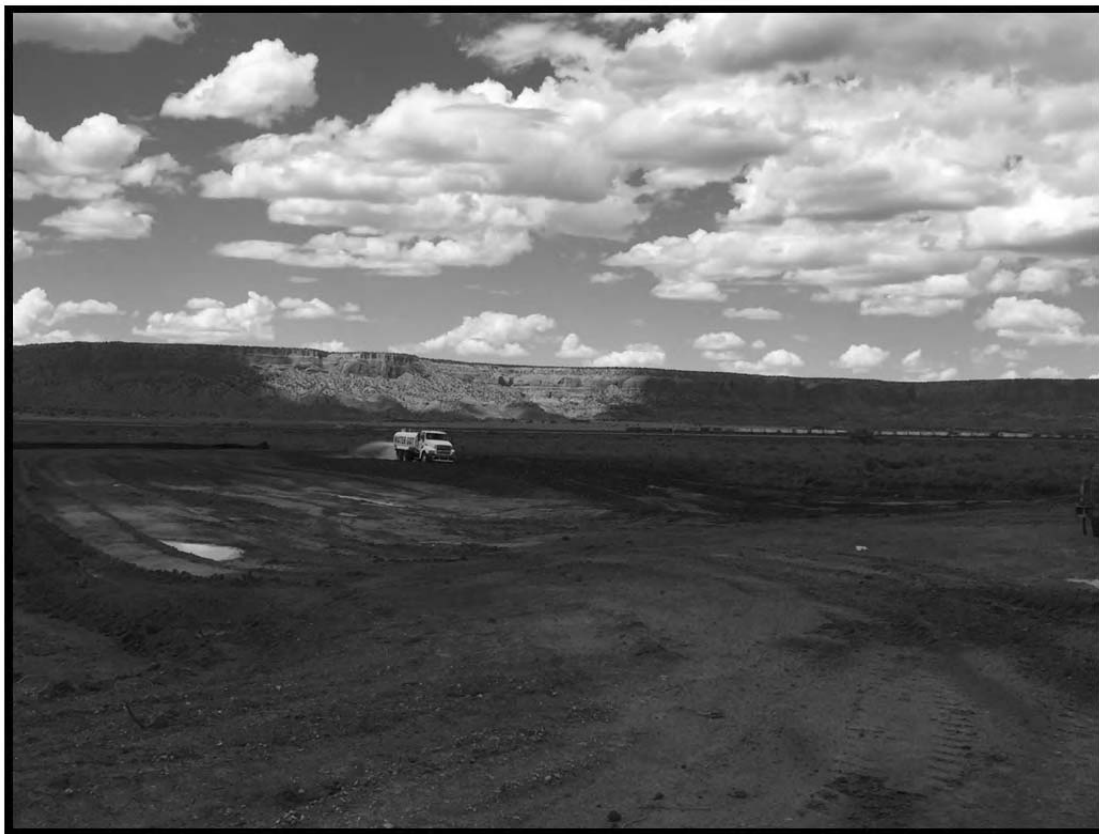
Photo #14: Moisture conditioning soil in the borrow area.

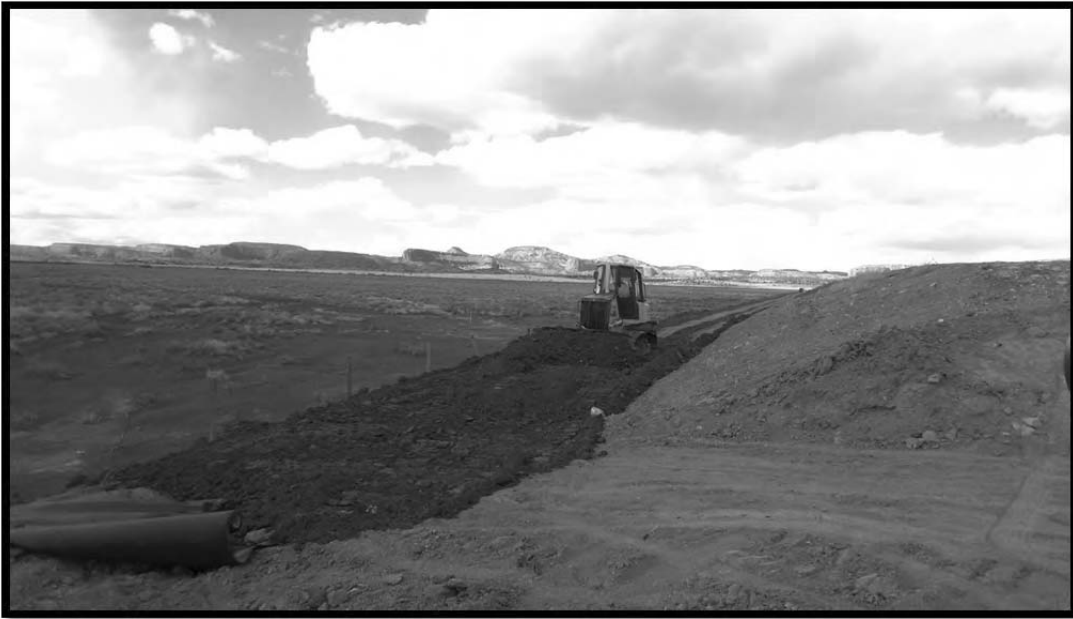
Photo #15: Pond 7/8 West Berm Fill Over Geotextile

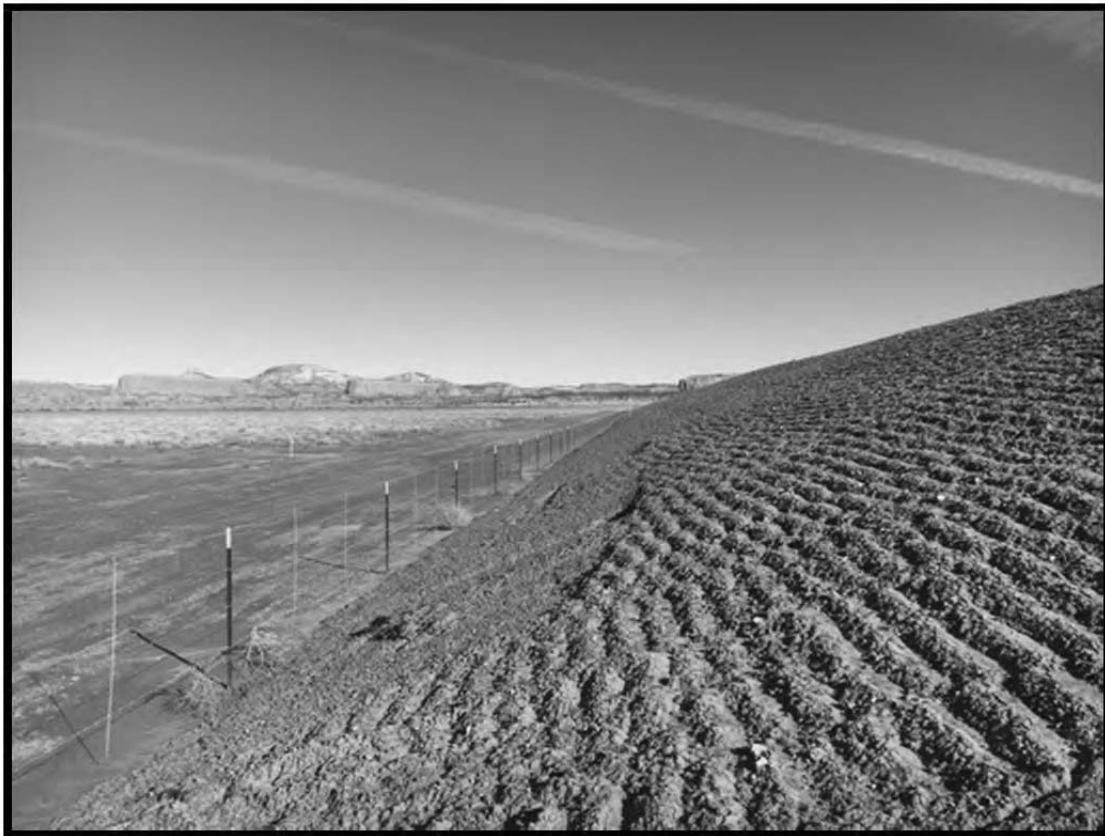
Photo #14: Pond 7/8 West Berm Completed Fill.

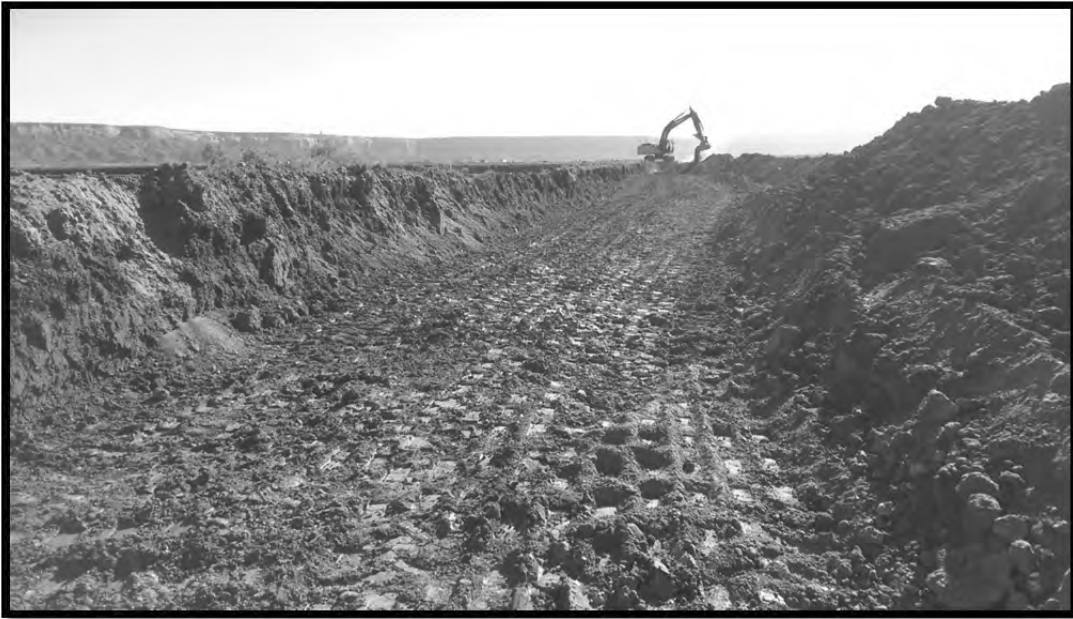
Photo #17: Pond 11-12 Berm Being Removed and Reworked

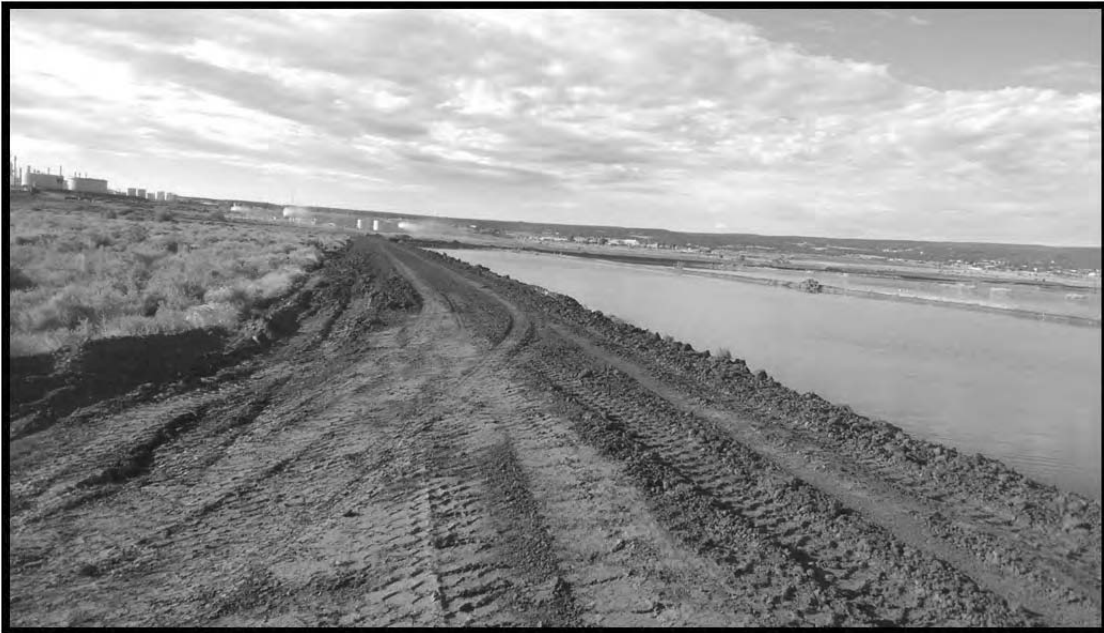
Photo #18: Pond 11-12 Berm Fill Repair Completed.

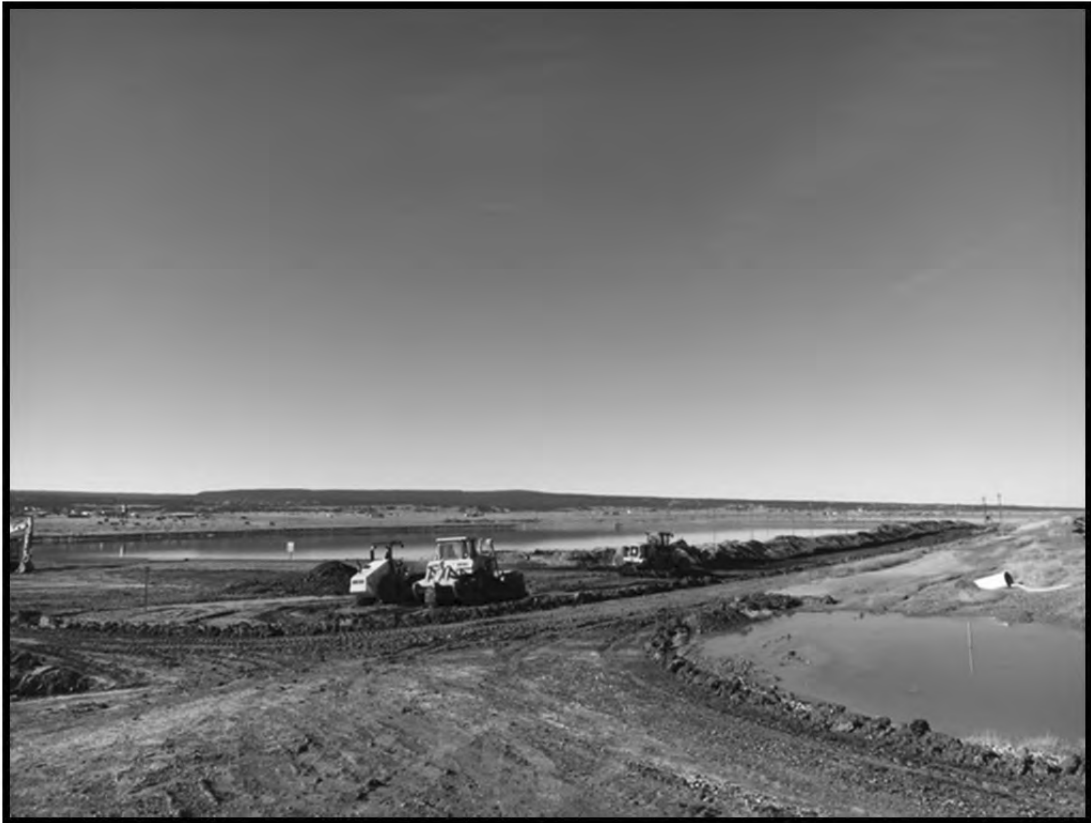
Photo #19: Pond 9 Start of Fill Placement on North Berm

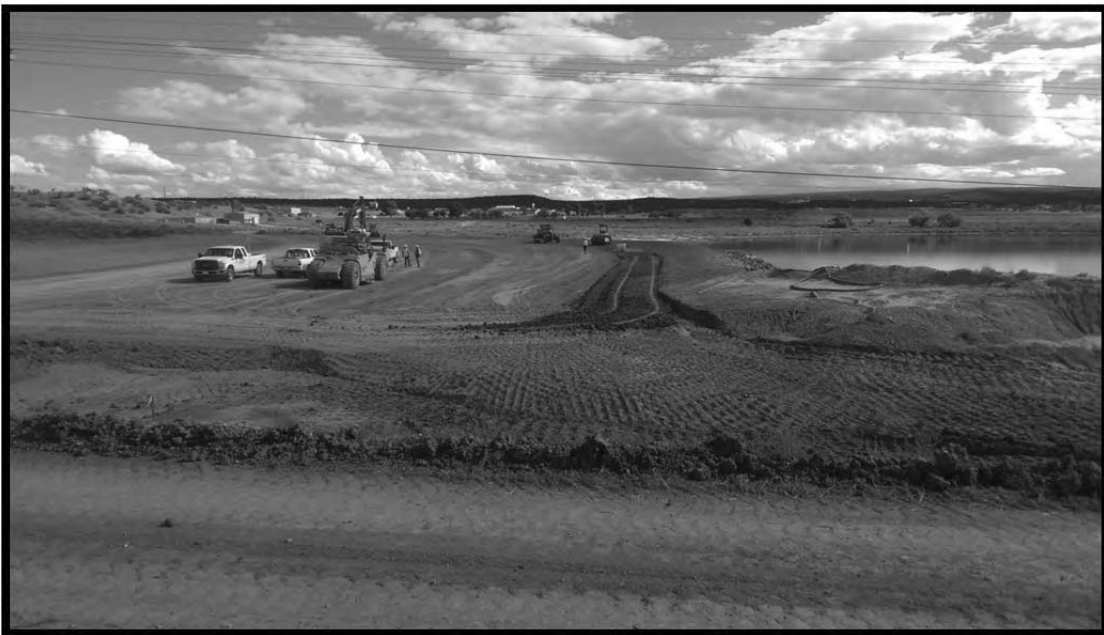
Photo #20: Pond 9 East End Completed.

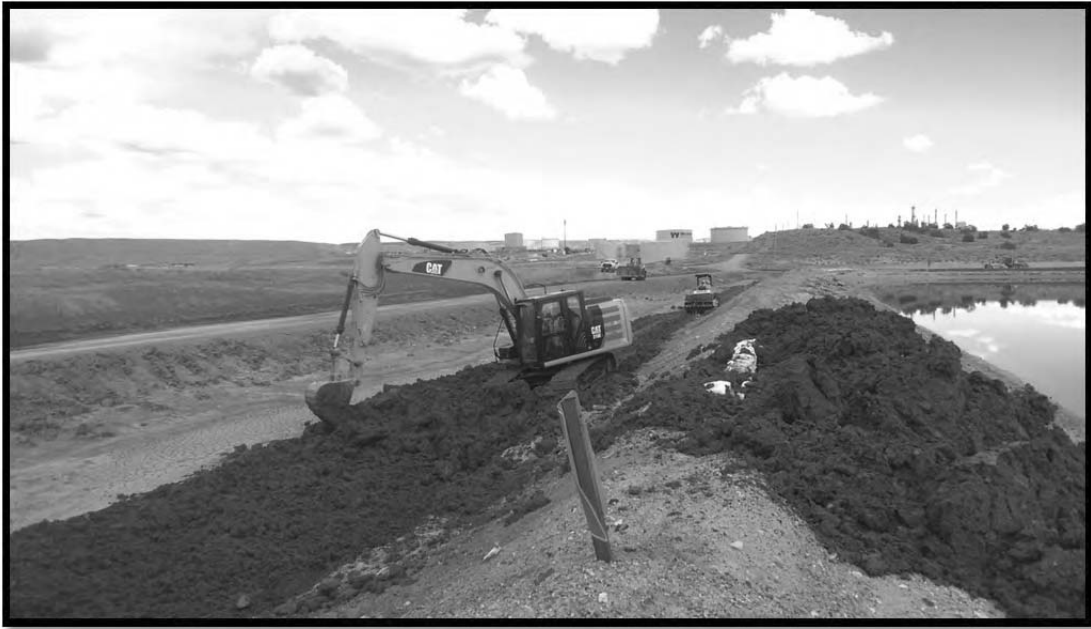
Photo #21: Pond 9 Start of Fill Placement on North Berm
Removing Base Material and Placing it on the Interior

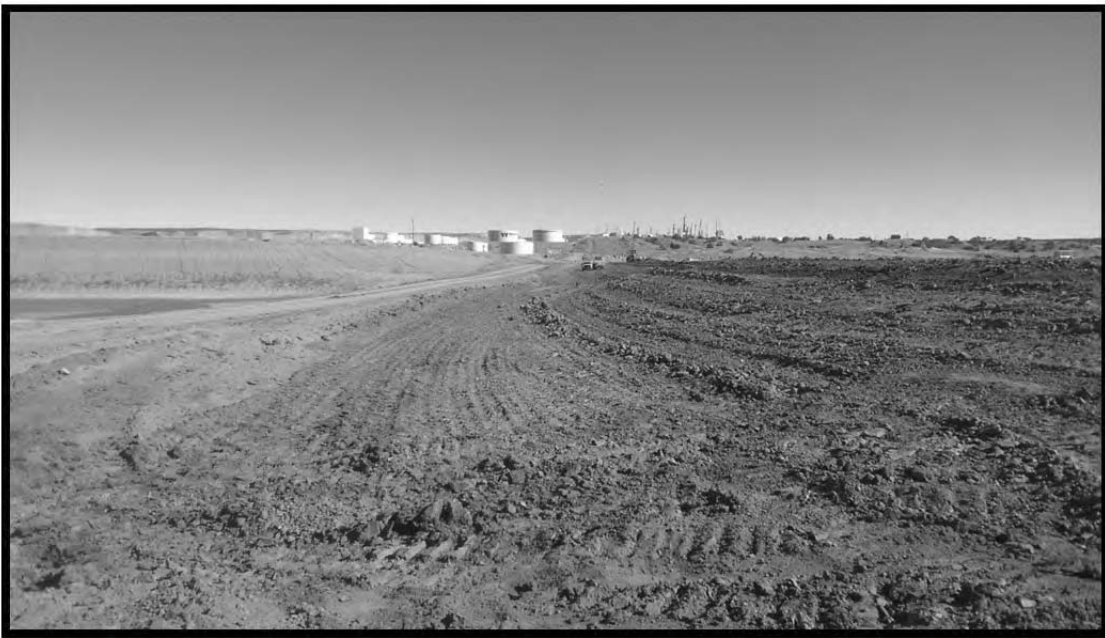
Photo #22: Pond 9 North Berm Completed.

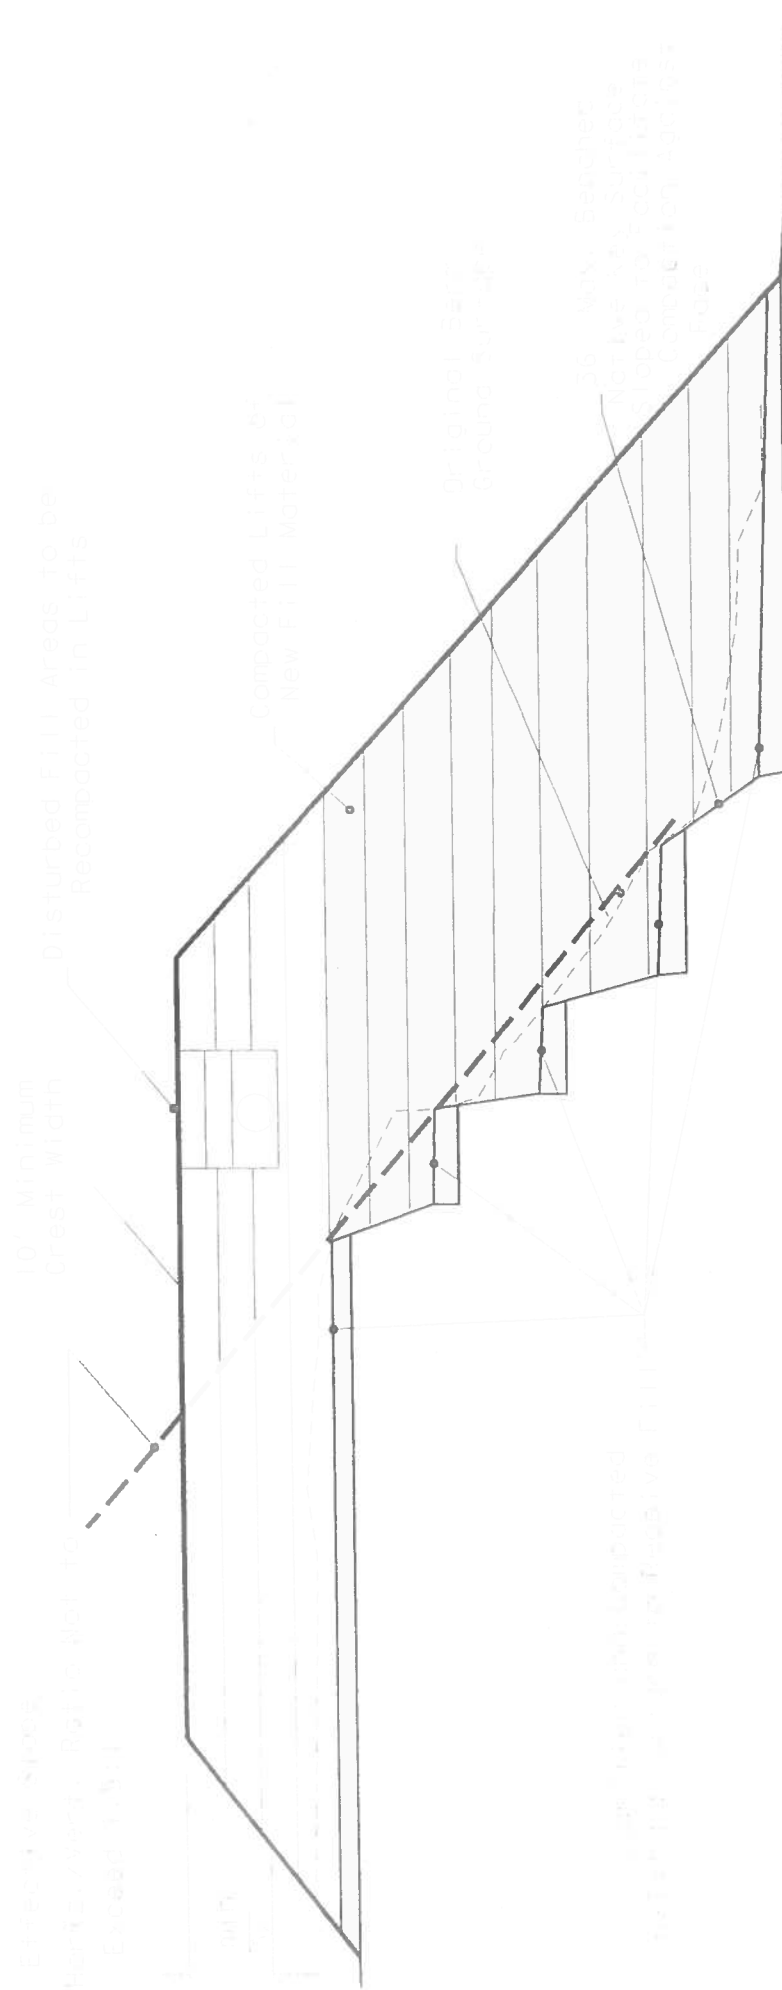
Figure 1

General Fill Placement on Existing Slopes

Soil placed on the berms should be keyed into the berms to provide the maximum strength. The side slopes of the existing embankments should be benched to create a horizontal surface for fill construction. This will provide structural interlock with the existing material. All new fill should be placed and compacted in lifts on the benched surfaces. Keys should be cut in the excavated slope to form horizontal benches as nearly level as is reasonable. Each bench should not exceed thirty-six (36) inches in elevation change to avoid stress concentrations within the fill. Bench cut faces may be sloped steeply to facilitate compaction adjacent to the cut face.

Fill should be placed and compacted beginning at the slope toe and progress to the top of the berm to allow for a more homogeneous new fill section. The berm will be more stable if the new slope section is constructed prior to adding height to the berms. The intent of this recommendation is illustrated in Figure 1.

New fill should be placed on existing material that has been properly prepared to receive material. The existing surface should be cleared and grubbed to remove any organic debris and oversized material. Oversized material consists of rocks or soil lumps that exceed six (6) inches in maximum dimension. The standard proctor test (ASTM D-698) should be used as the reference unit weight because the test results provide a more flexible structure that resists cracking during any potential deformation. The prepared surface should be scarified eight (8) inches and compacted to a minimum of 95% of Standard Proctor unit weight.
