AP - 111

**EVAPORATION
POND REPAIRS
REV. 1 (4 of 4)**

REVISED SUMMARY REPORT EVAPORATION POND REPAIRS

Summary Report, Evaporation Pond Repairs
Western Gallup Refinery

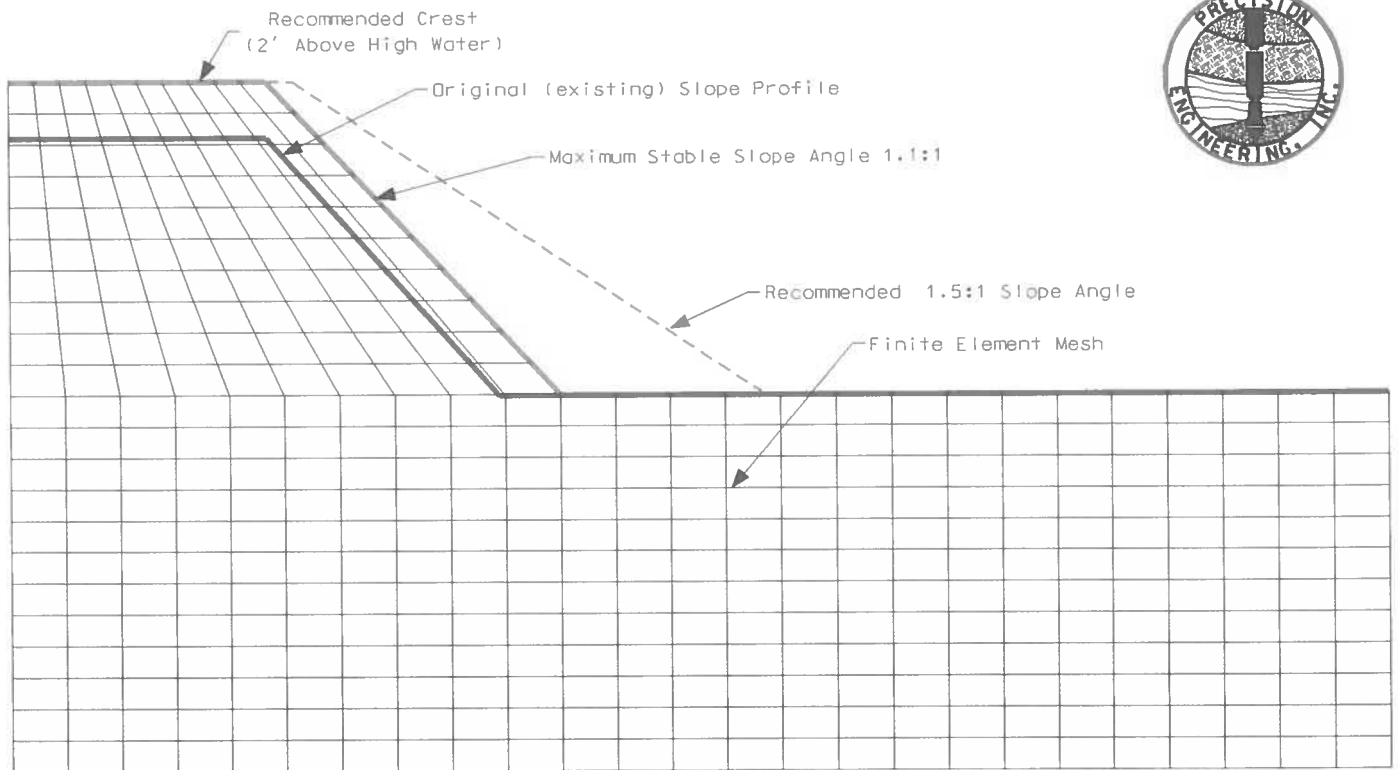
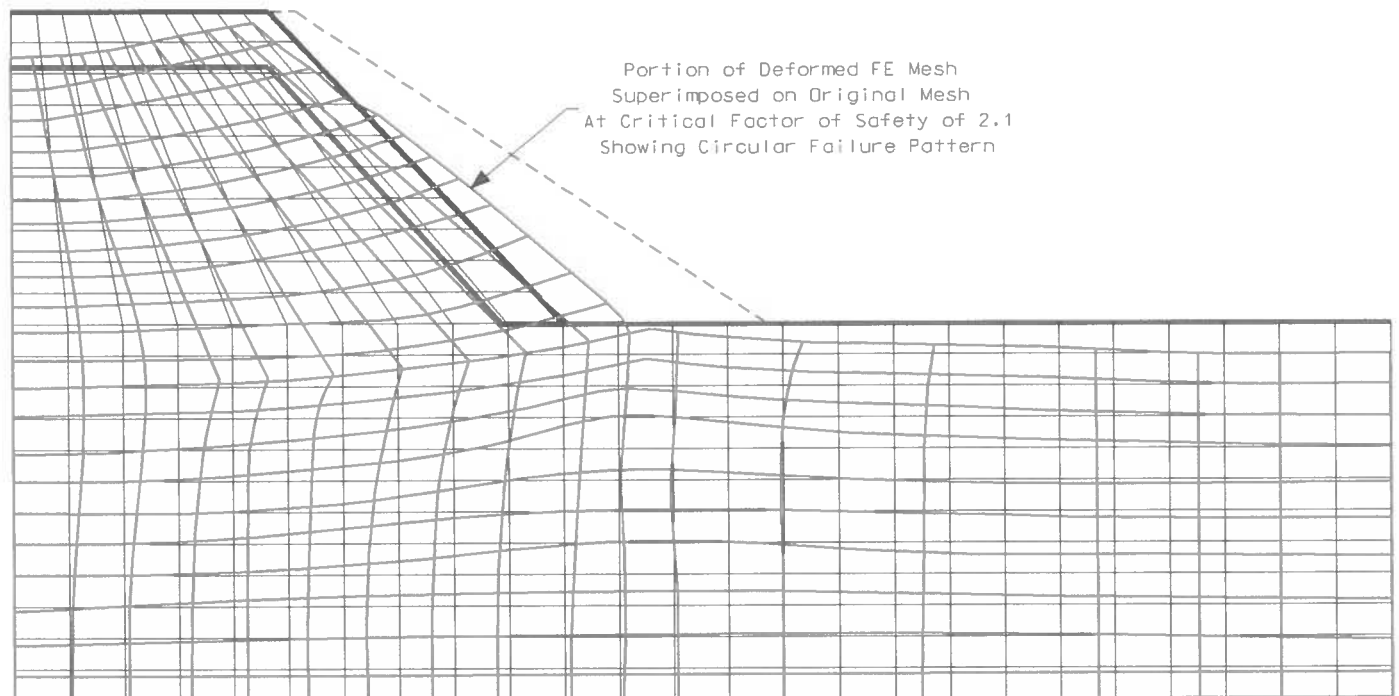
Figure 2 - Section 12

Analysis indicates that when the elevation of the top of the outside containment berms are elevated approximately two (2) feet the minimum factor of safety against failure is 2.1. This minimum critical section is represented by Section 12 on the west side of the ponds (see boring plan). The failure mechanism and associated factor of safety is illustrated in Figure 2.

Critical Section and Failure Mechanism After Elevating and Reshaping Containment Berms

It is recommended that the berm elevations be adjusted to be two (2) feet above the maximum anticipated water level elevation. It is recommended that the minimum width of the top of the containment berms be ten (10) feet. For structural stability, the side slopes of the berms should not exceed their present slope angle after the addition of material to raise the crest elevation. It is recommended, however, that the slope angles not exceed an angle having a horizontal to vertical ratio of 1.5:1. This typically flatter slope angle will resist the development of erosion channels on the exterior face of the berms.

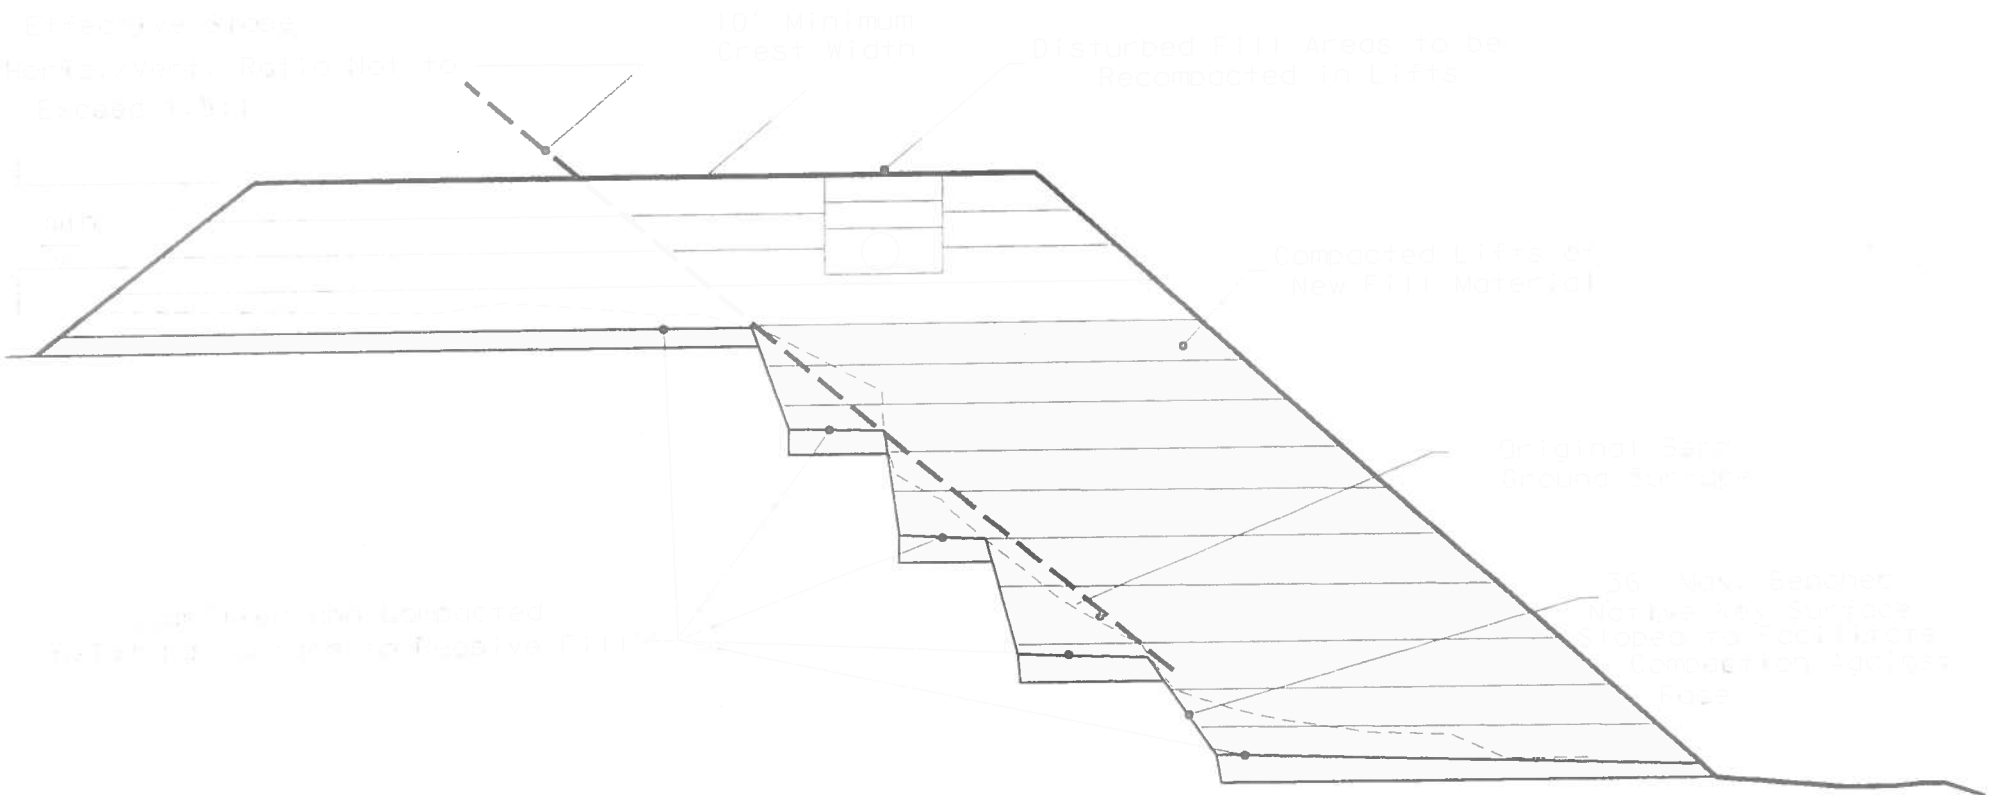
Figure 1

General Fill Placement on Existing Slopes

Soil placed on the berms should be keyed into the berms to provide the maximum strength. The side slopes of the existing embankments should be benched to create a horizontal surface for fill construction. This will provide structural interlock with the existing material. All new fill should be placed and compacted in lifts on the benched surfaces. Keys should be cut in the excavated slope to form horizontal benches as nearly level as is reasonable. Each bench should not exceed thirty-six (36) inches in elevation change to avoid stress concentrations within the fill. Bench cut faces may be sloped steeply to facilitate compaction adjacent to the cut face.

Fill should be placed and compacted beginning at the slope toe and progress to the top of the berm to allow for a more homogeneous new fill section. The berm will be more stable if the new slope section is constructed prior to adding height to the berms. The intent of this recommendation is illustrated in Figure 1.

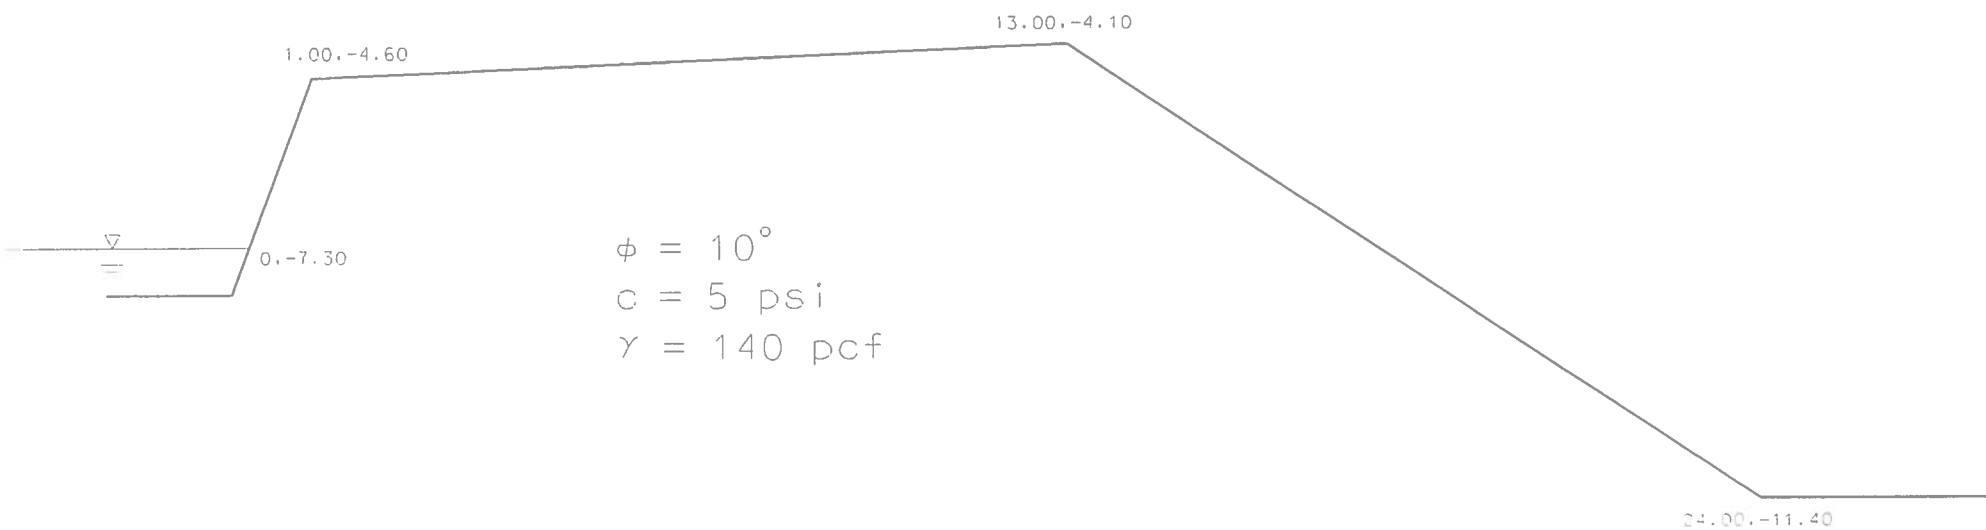
Section 8

Factor Of Safety = 4.9

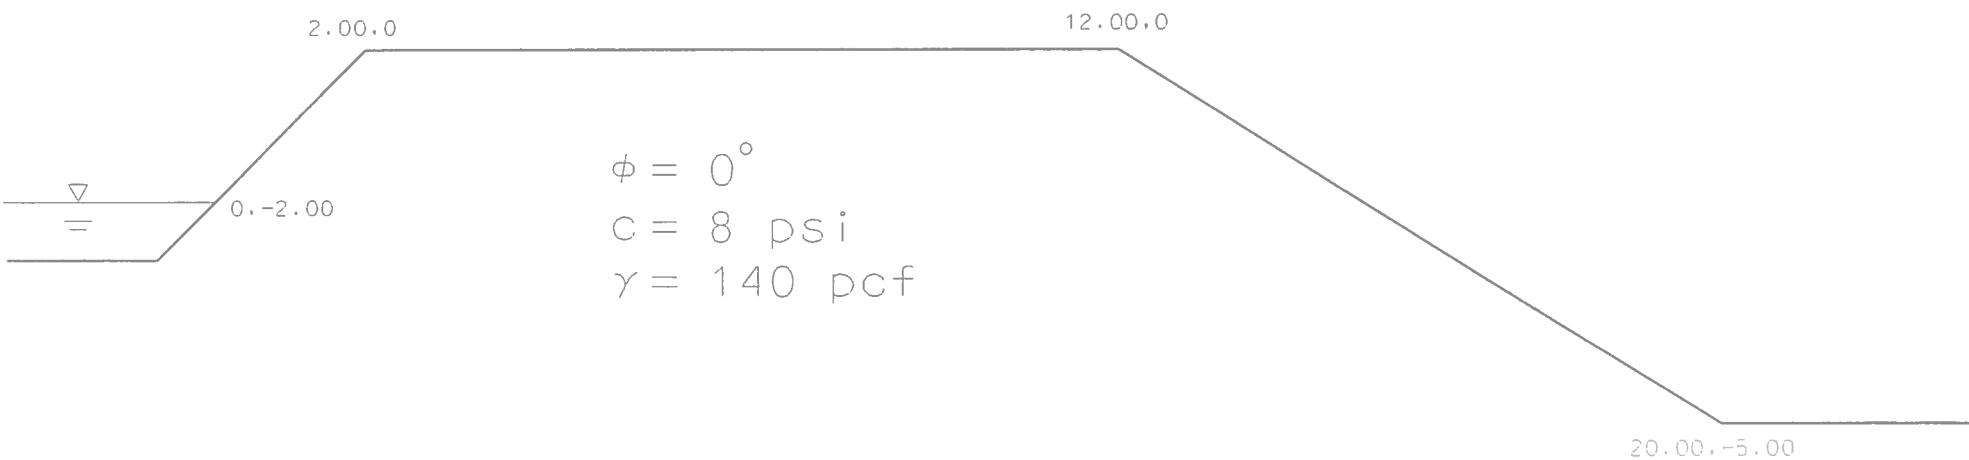
Section 11

Factor Of Safety = 9.4

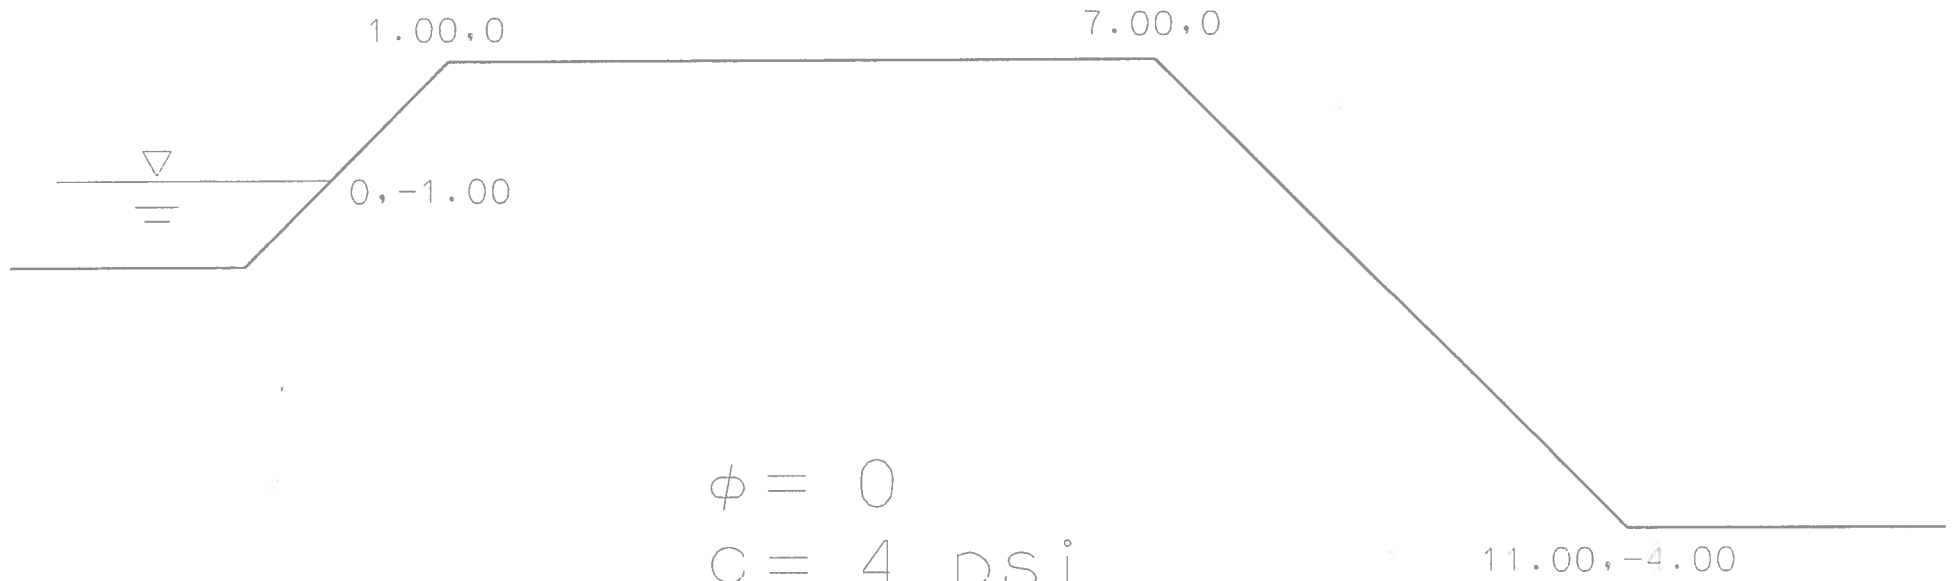
Section 13

Factor Of Safety = 5.4
