Evaporation Pond
Repairs
(1 of 2)

RE: RESPONSE TO DISAPPROVAL LETTER REPORT
EVAPORATION POND 7 DIKE BREACH AND SUMMARY REPORT EVAPORATION POND
REPAIRS
WESTERN REFINING SOUTHWEST, INC. GALLUP REFINERY
EPA ID # NMD000333211
HWB-WRG-15-006

**GEOTECHNICAL EVALUATION OF
EVAPORATION PONDING
CONTAINMENT BERMS**

**GIANT REFINING COMPANY
CINIZA REFINERY**

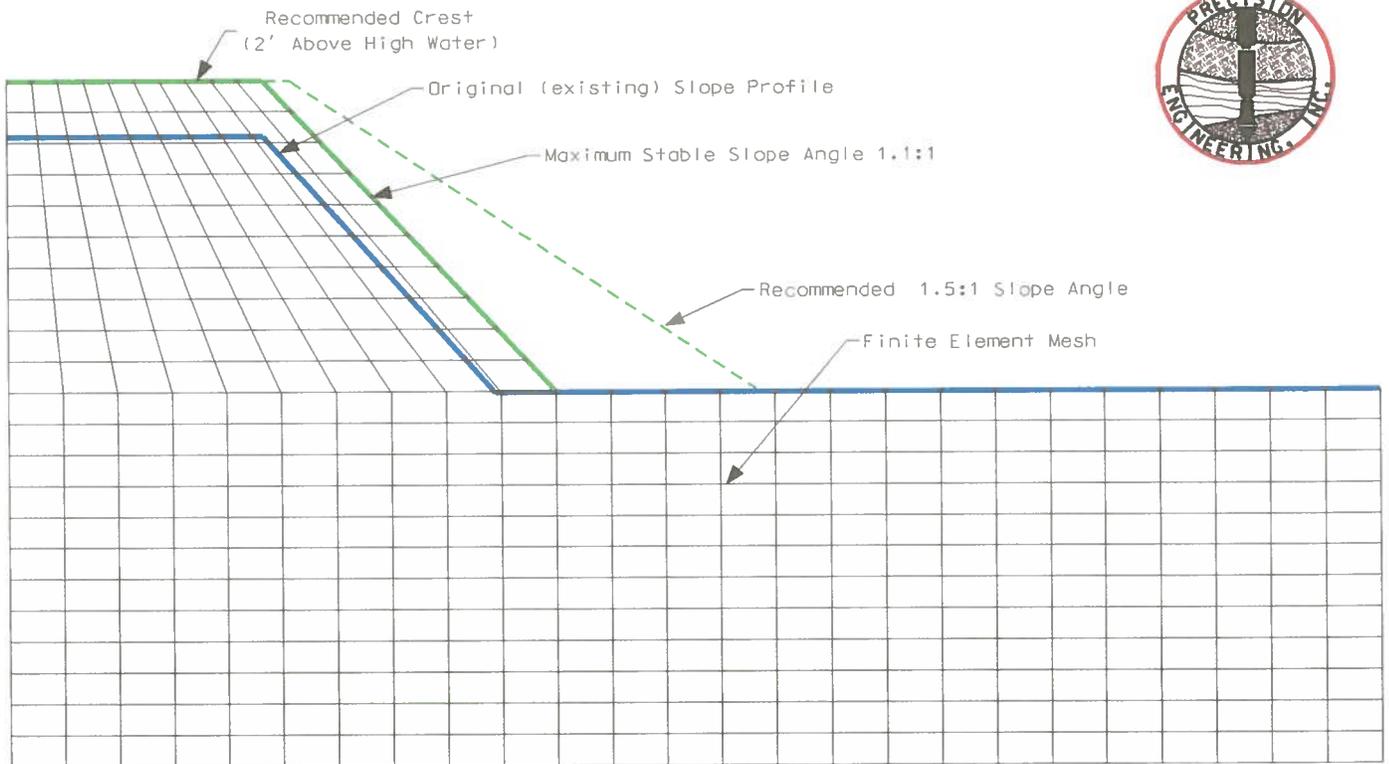
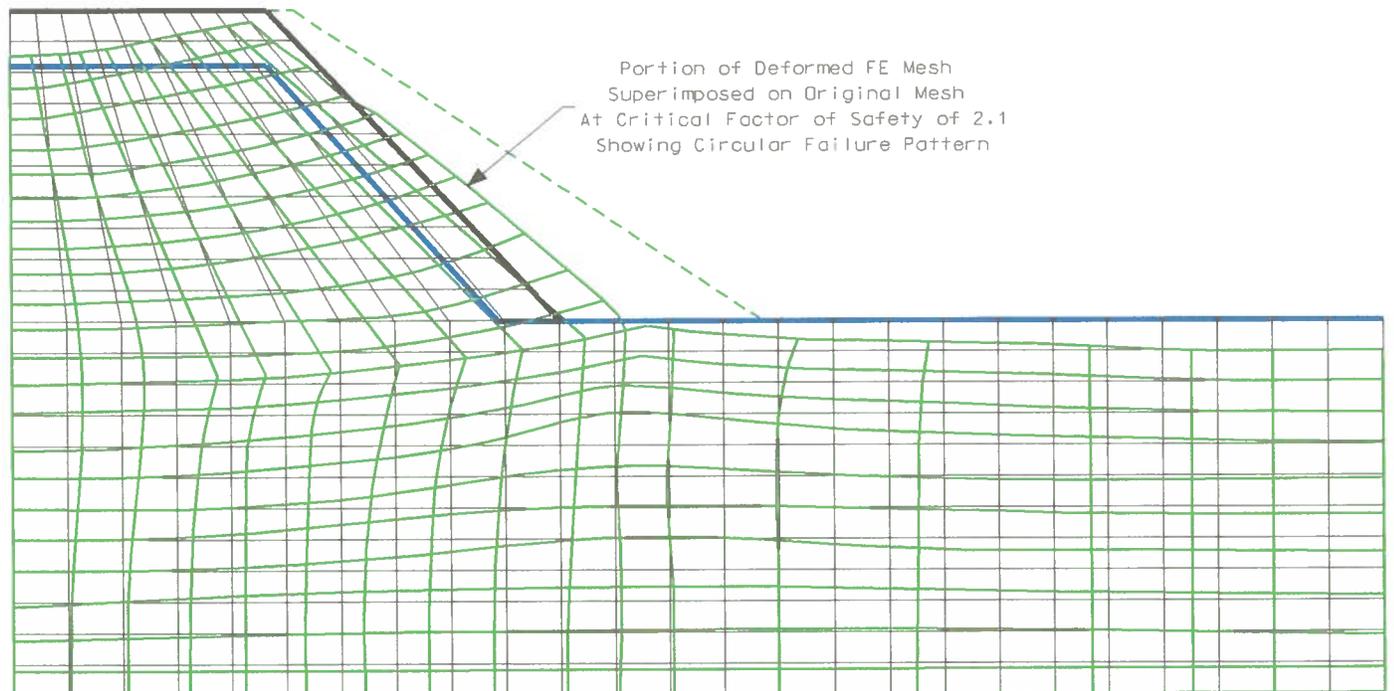
Figure 2 - Section 12

Analysis indicates that when the elevation of the top of the outside containment berms are elevated approximately two (2) feet the minimum factor of safety against failure is 2.1. This minimum critical section is represented by Section 12 on the west side of the ponds (see boring plan). The failure mechanism and associated factor of safety is illustrated in Figure 2.

Critical Section and Failure Mechanism After Elevating and Reshaping Containment Berms

It is recommended that the berm elevations be adjusted to be two (2) feet above the maximum anticipated water level elevation. It is recommended that the minimum width of the top of the containment berms be ten (10) feet. For structural stability, the side slopes of the berms should not exceed their present slope angle after the addition of material to raise the crest elevation. It is recommended, however, that the slope angles not exceed an angle having a horizontal to vertical ratio of 1.5:1. This typically flatter slope angle will resist the development of erosion channels on the exterior face of the berms.

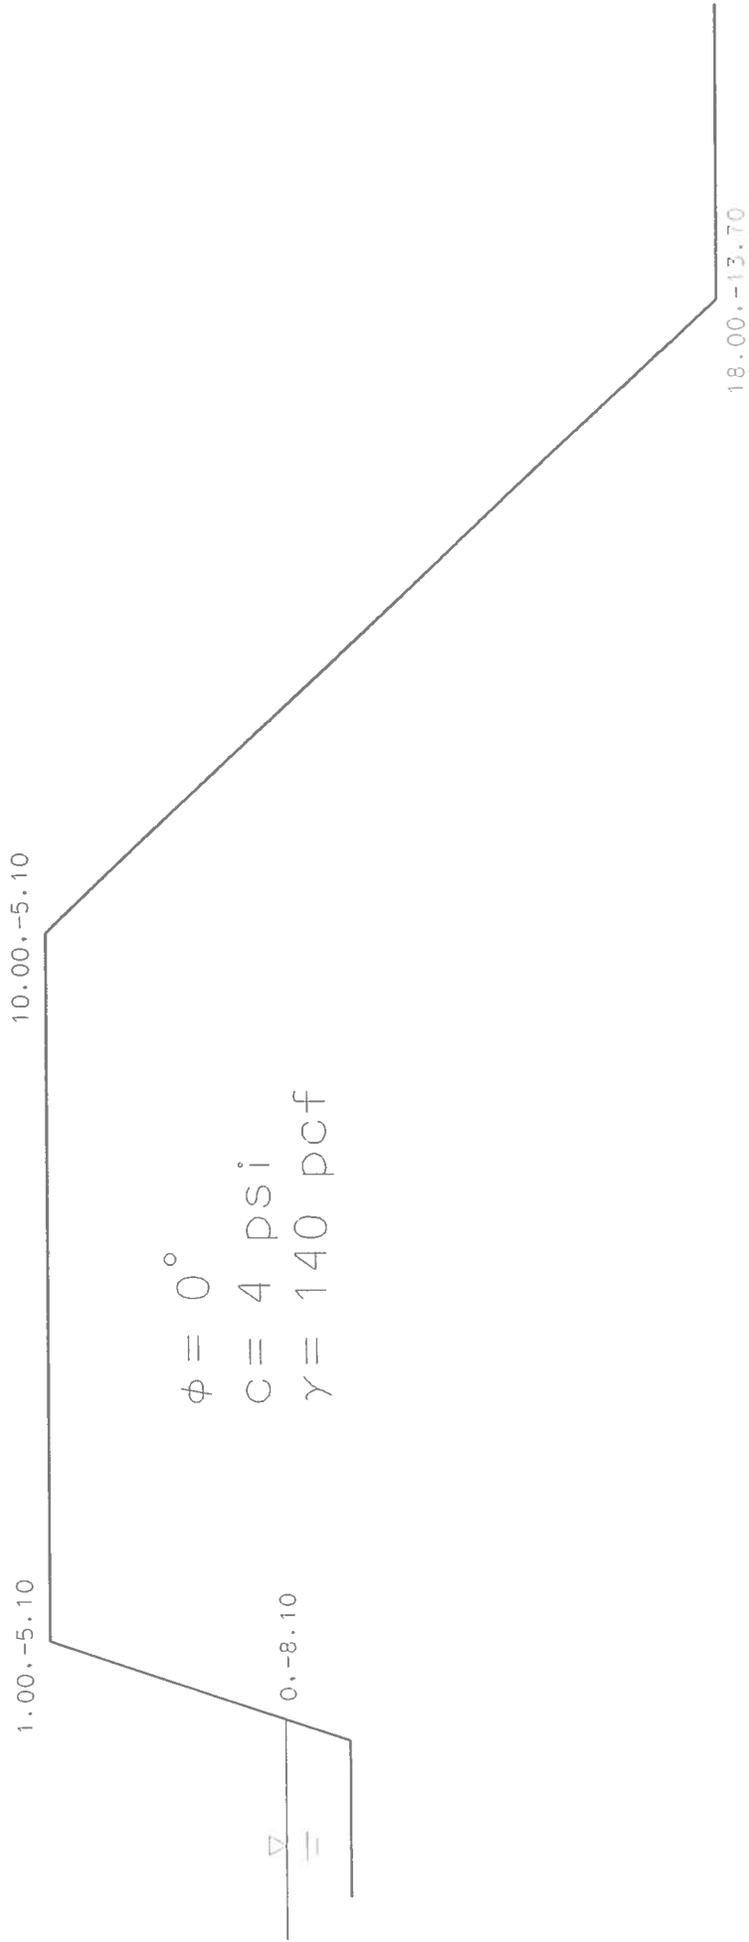
Section 12

The analyses demonstrate that the berms are structurally stable. Factors of safety against failure for the sections analyzed range from a high of 10.0 to a low of 2.5. Typical minimum desirable factors of safety for this type of structure are in the range of 1.3 to 1.5. As mentioned previously the

Factor Of Safety = 2.5
