July 22, 2019

SMA #5E28395, BG3

**RE: LINER INSPECTION REPORT
MESA 8105 JV-P #11H CENTRAL TANK BATTERY (1RP-5310)**

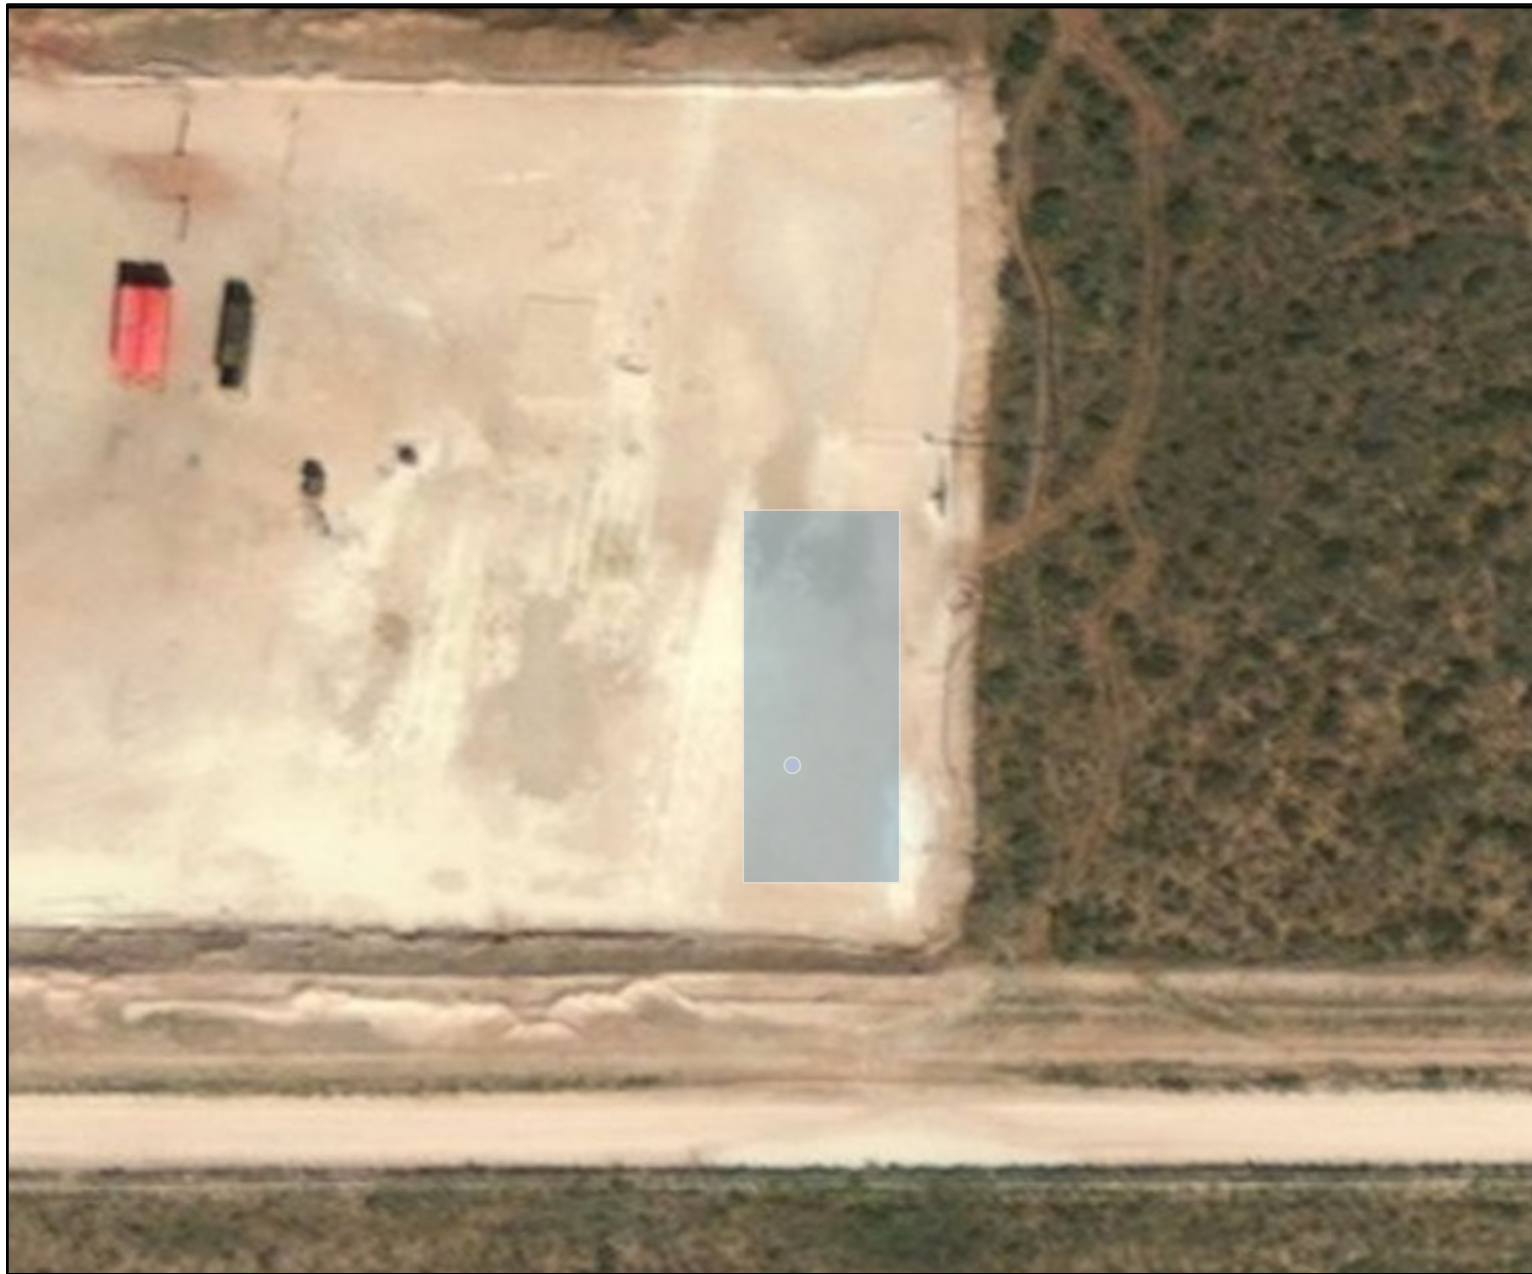
Figure 2

- Point of Release
- Lined Containment

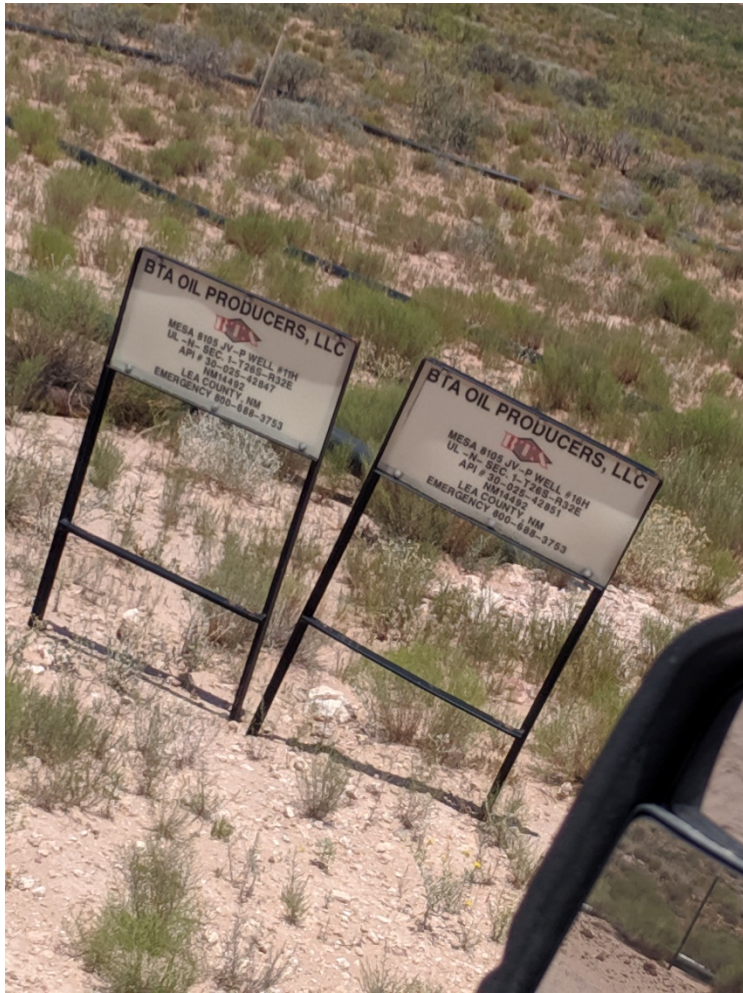
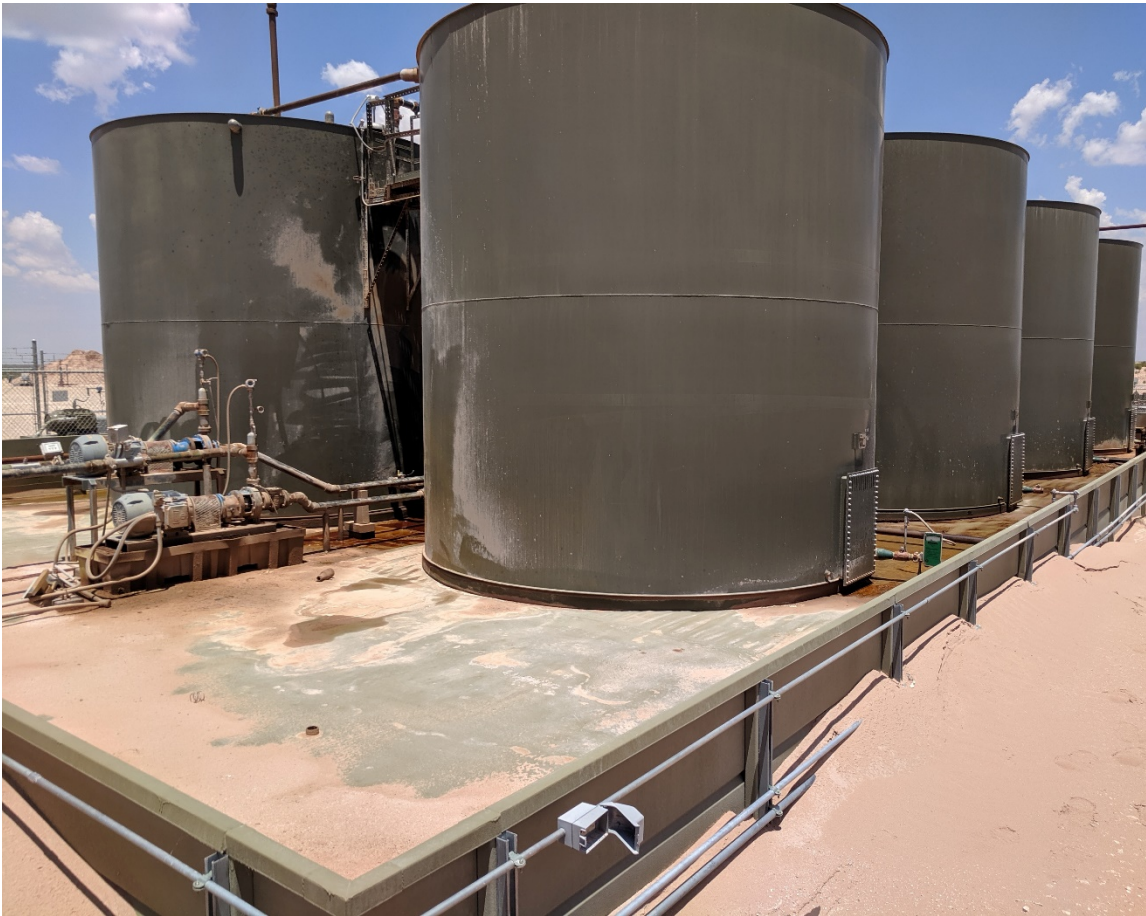
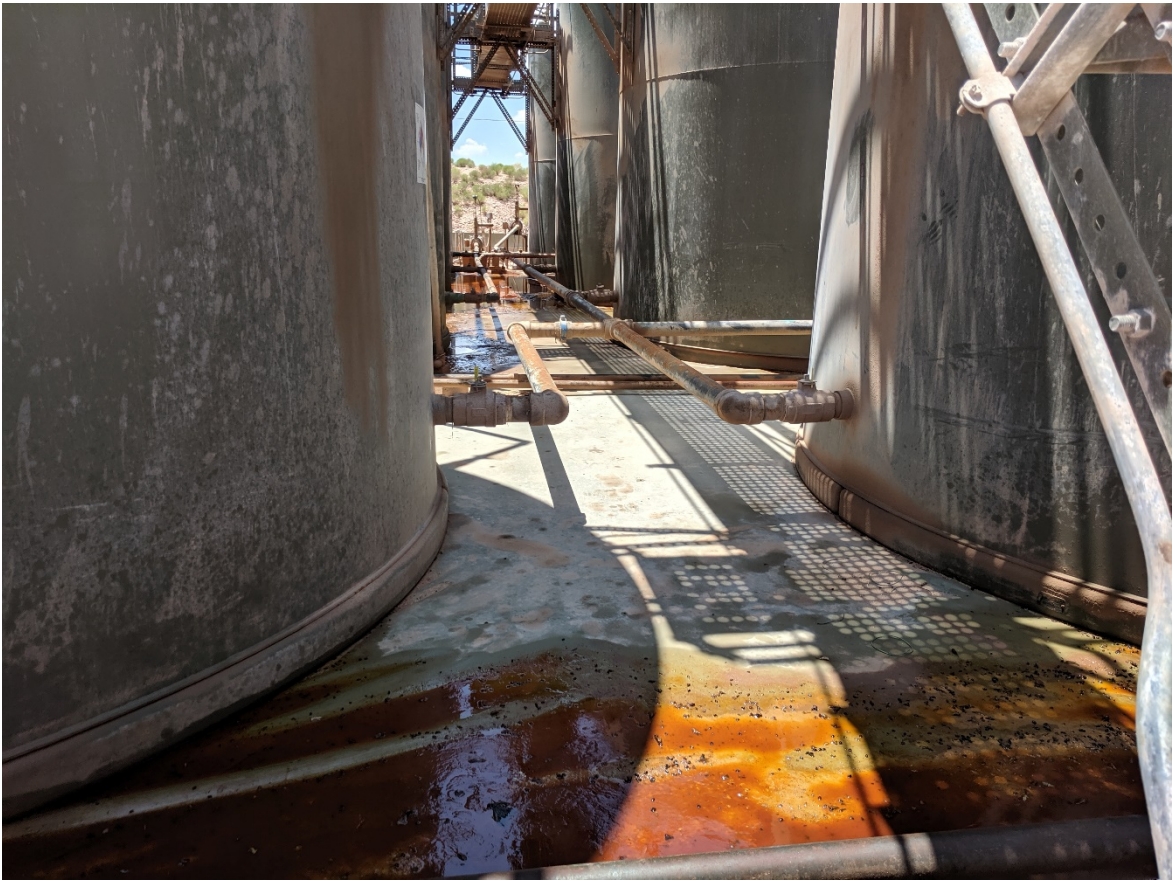
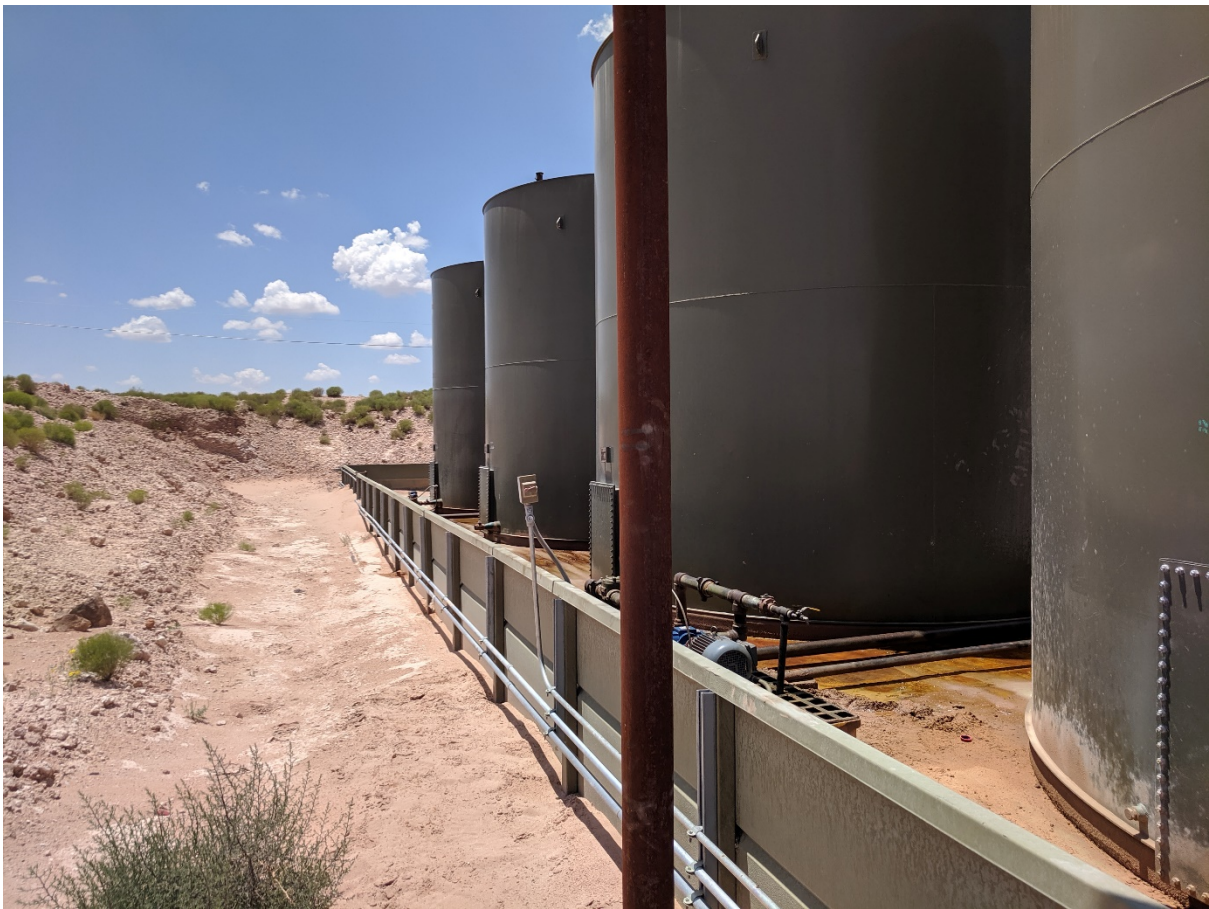
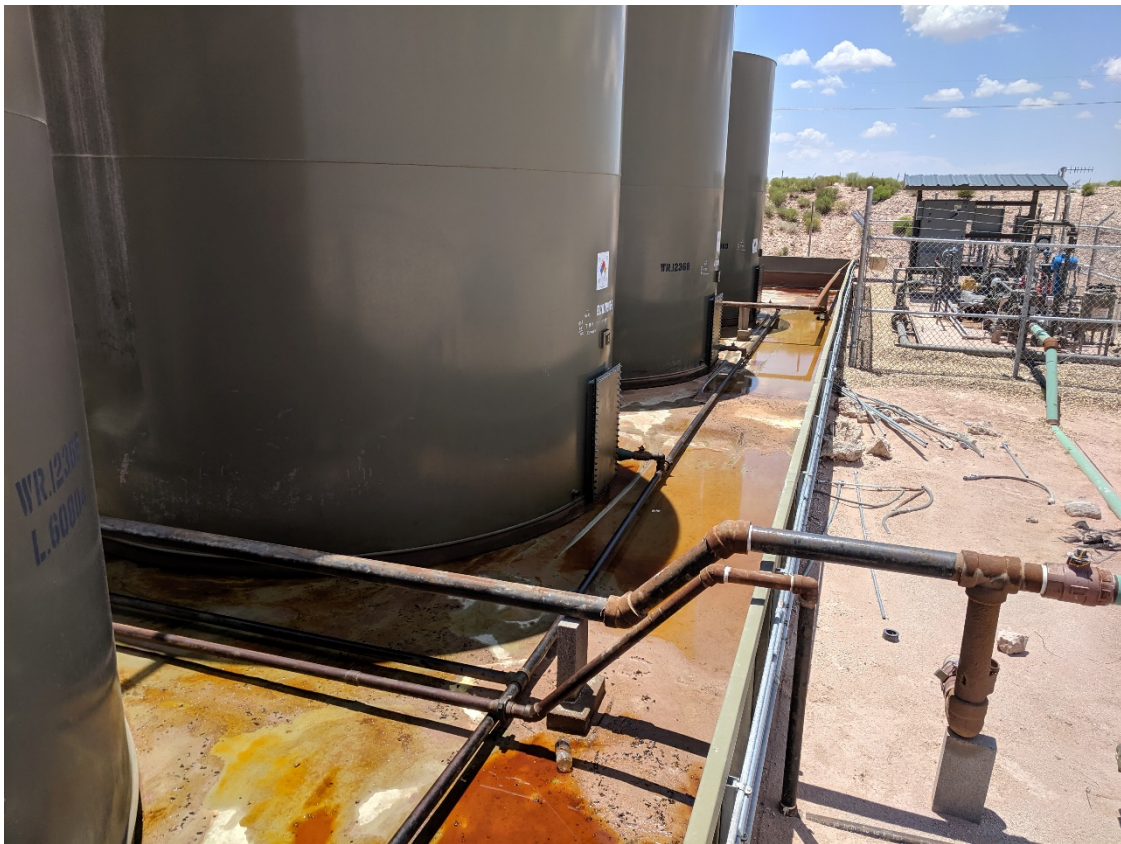
At the request of BTA, SMA conducted a liner integrity inspection per the requirements of 19.15.29.11.A(5)(a) NMAC. NMOCD was notified on July 8, 2019 that the liner inspection was to occur, and SMA conducted the inspection on July 11, 2019. After a thorough visual inspection of the liner within the tank battery containment, the liner appeared to be intact and had the ability to contain the leak in question. The tank from which the release occurred was identified, and SMA verified that the release did not occur outside of the lined containment. A photo log and field notes of the inspection is included in Appendix A.

Liner Integrity Was Maintained (per SMA Inspection)

Release Was Contained to Lined Containment Area

Liner Was Able to Contain the Leak

SMA recommends no further action for this release.
