Subject: **Remedial Activities and Closure Report**
 Lime Rock Resources
 West Red Lake Water Station No.1

2RP-1675

Lime Rock Resources (Lime Rock) has contracted Talon/LPE (Talon) to perform soil and surface water remediation services at the above referenced location. The incident description, soil and water sampling results, remediation activities and closure request are submitted herein.

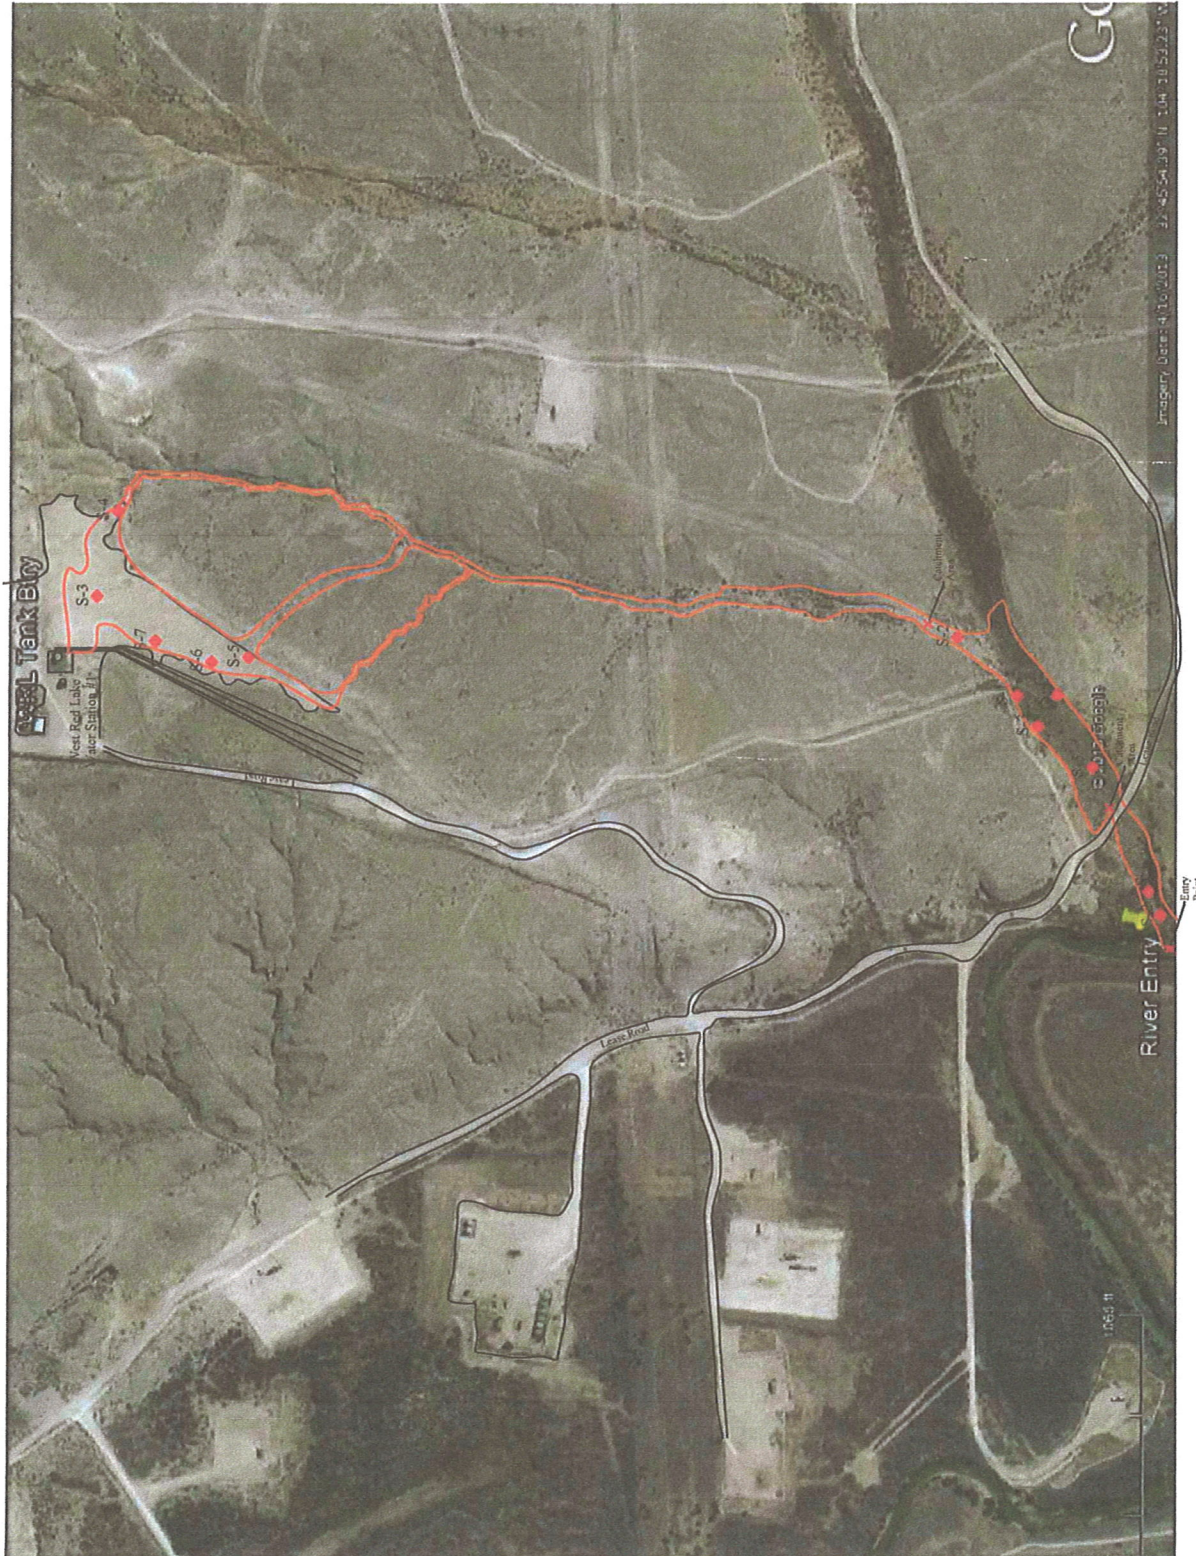
West Red Lake Water Station #1
Lime Rock Resources
Eddy County, New Mexico
Figure 1 - Site Plan

- The impacted soil in the vicinity of the tank battery (source) was initially excavated to a depth of 0.5-feet below ground surface (bgs). Grab soil samples were collected at sample locations S-3, S-4, and S-5. The lab data reported for sample location S-5 was above NMOCD Recommended Remedial Action Levels (RRAL). The impacted area was then excavated further to a depth of 1.5-feet bgs. Additional grab soil samples were taken at sample locations S-5 (1.5'), S-6 (1.5'), and S-7 (1.5') ([See site maps of sample locations](#)).
