# MONITORING REPORTS

**Daughtery – Crosby Salt Lake  
Treating Plant and Disposal Facility  
Closure Report  
Section 19, Township 8S, Range 30E  
Section 24, Township 8S, Range 30E  
Section 19, Township 8S, Range 29E  
Chaves County, New Mexico**

**June 1, 2003**

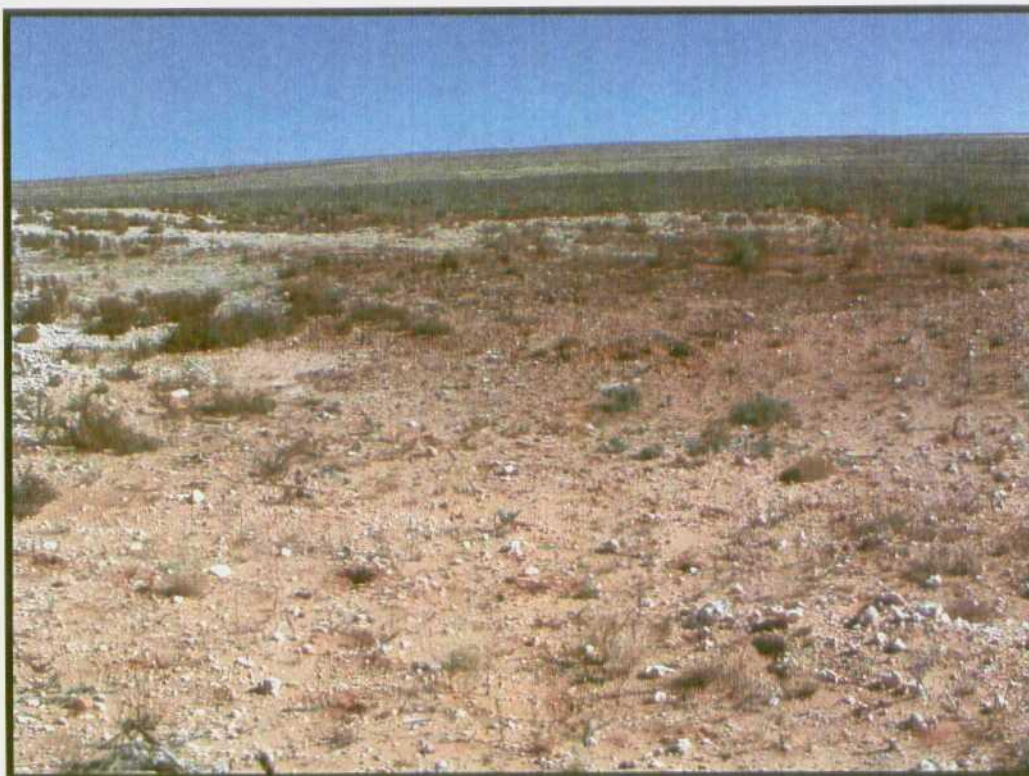
Surface contamination in the form of "hardpan" or well-degraded hydrocarbons was present in the process area. There was no evidence of contamination that would migrate either vertically or horizontally from that area. The hardpan was disced in place and broken into small pieces, which will hasten natural attenuation in the area.

Process Area Before 11/20/02

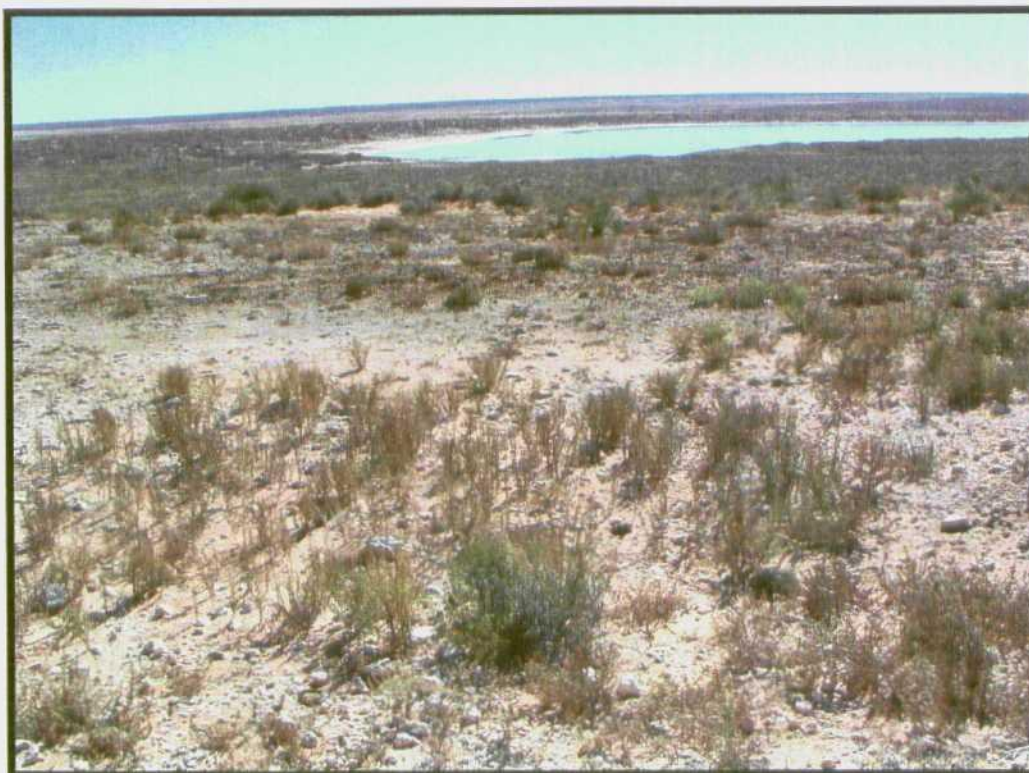
Process Area Before 11/20/02

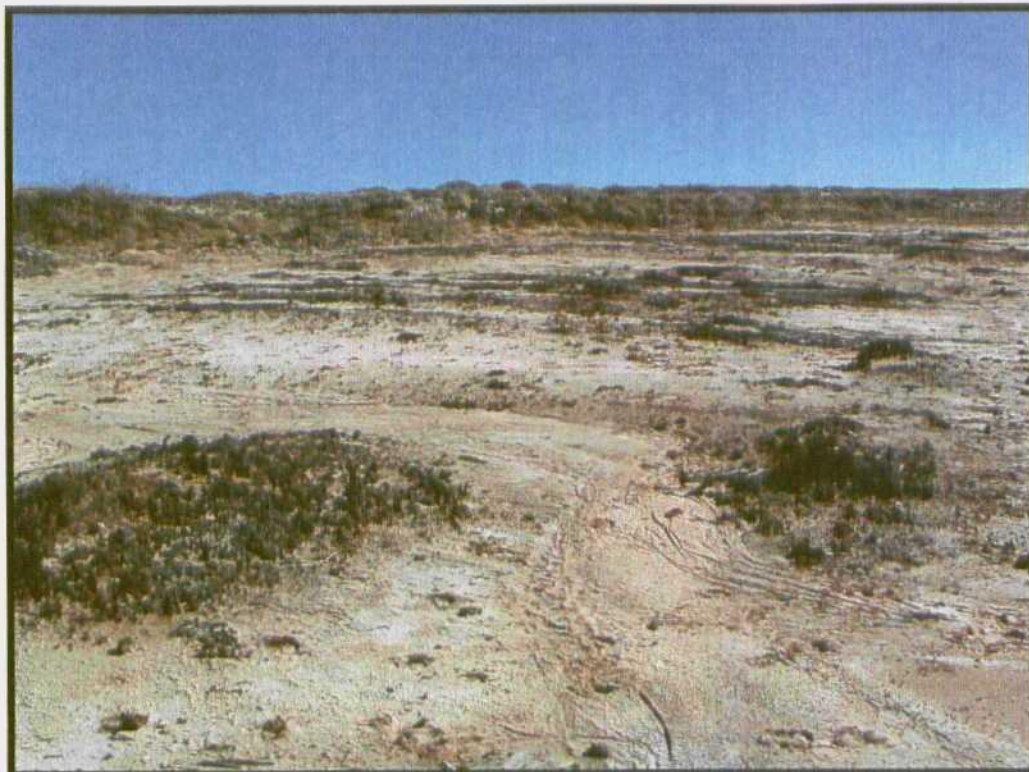
Lake Shore Before 11/20/02

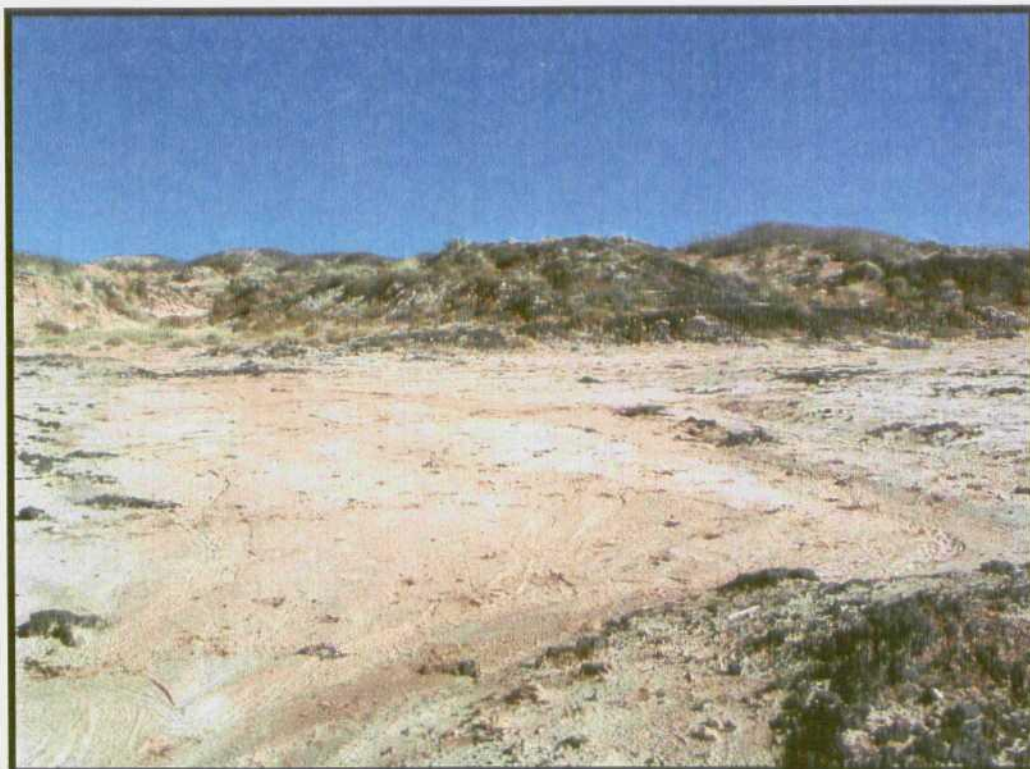
Lake Shore Before 11/20/02

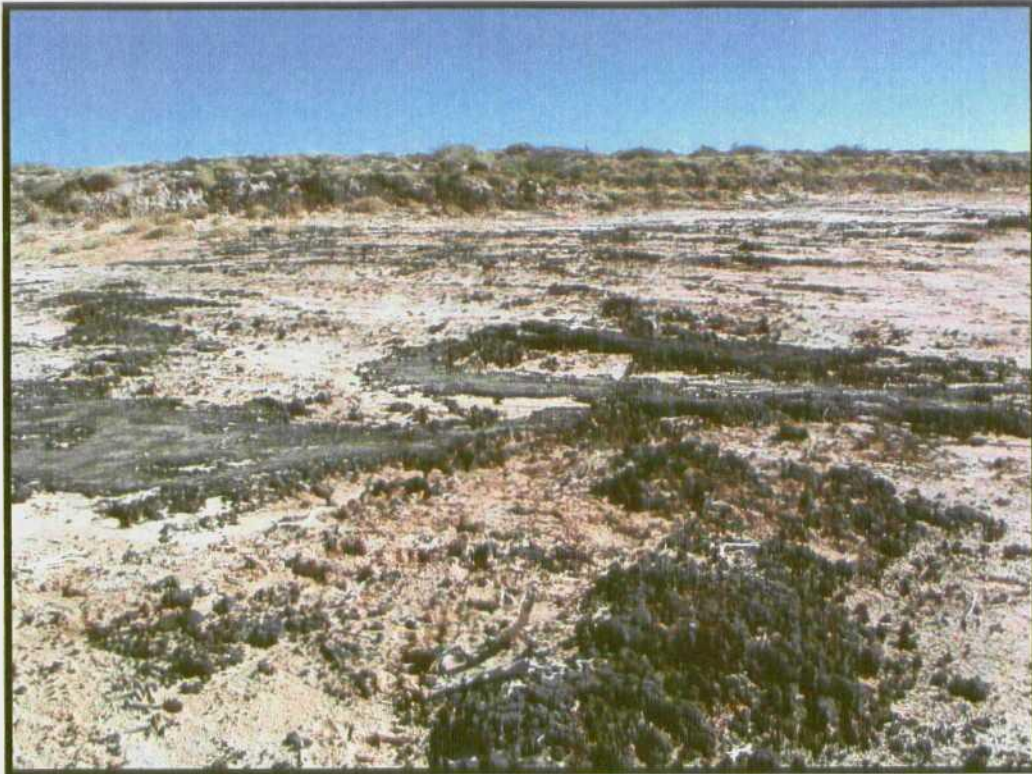
Lake Shore Before 11/20/02

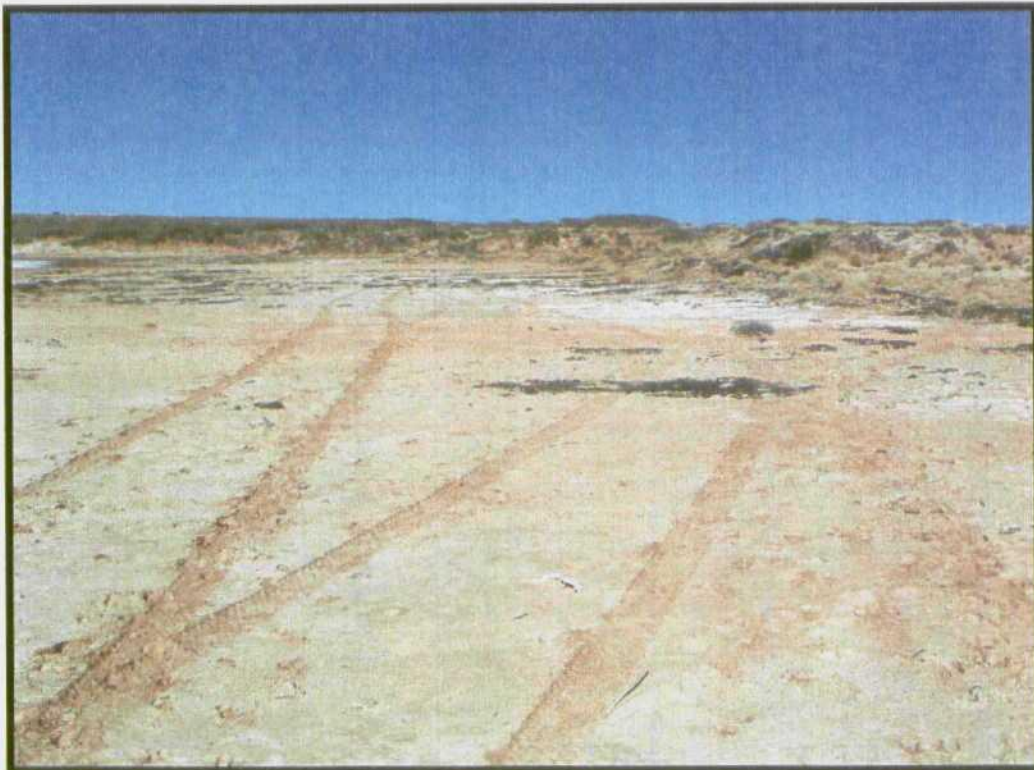
Lake Shore Before 11/20/02

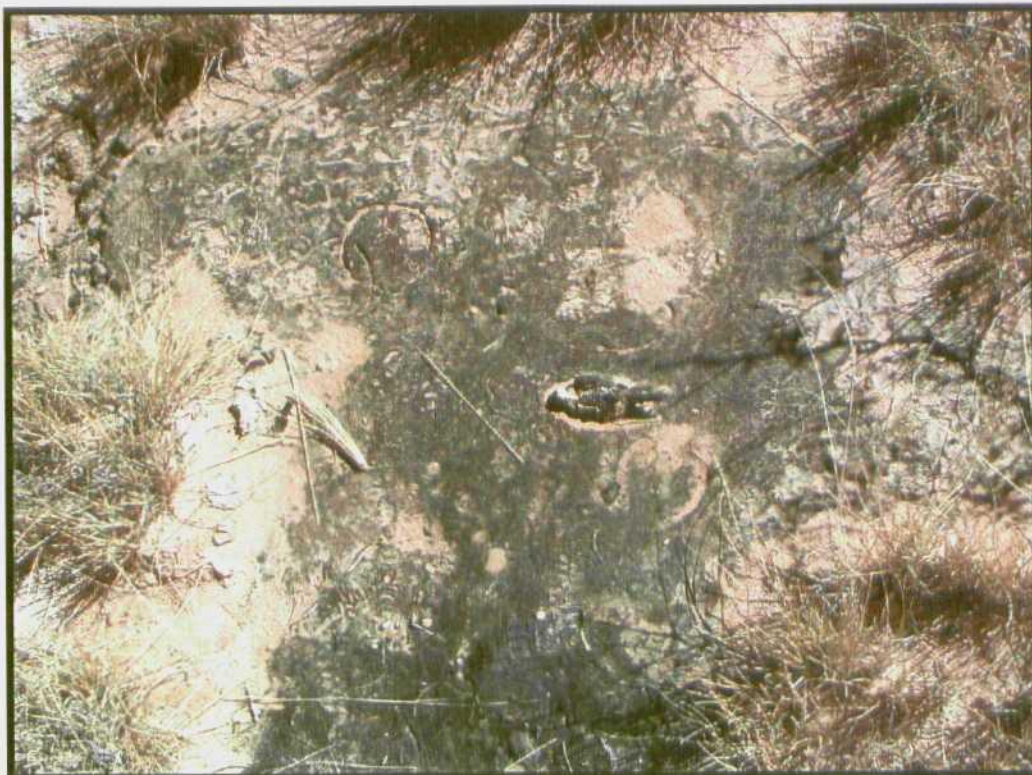
Typical "Run" at Lake Shore 11/20/02

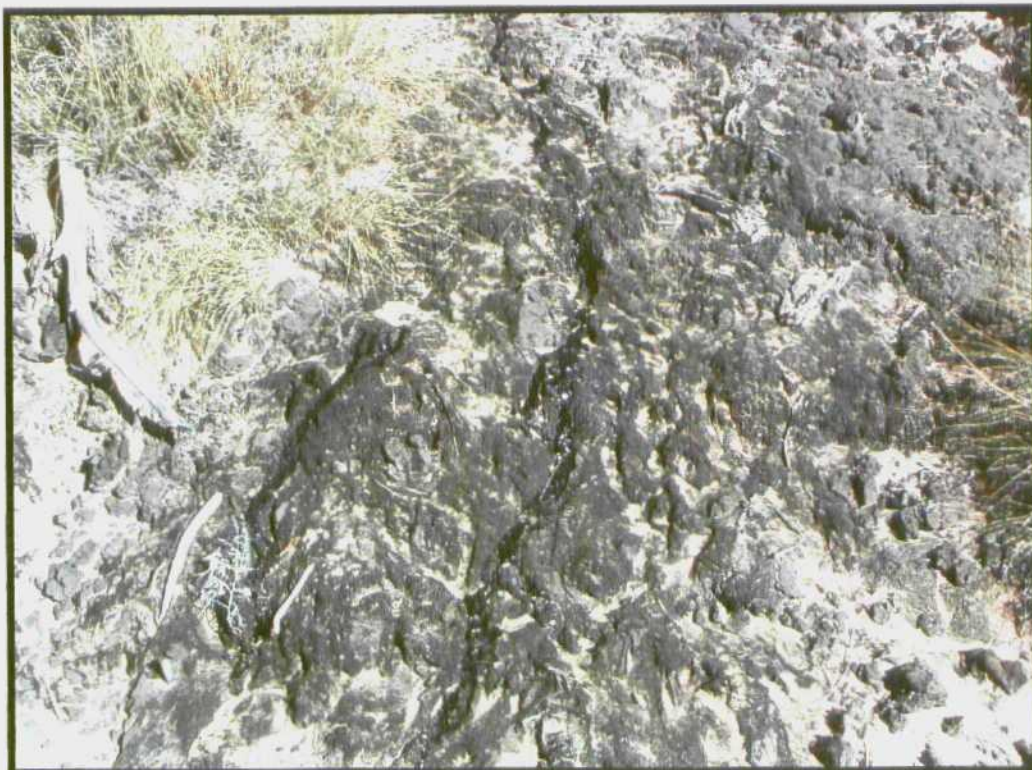
More "Run" at Lake Shore 11/20/02

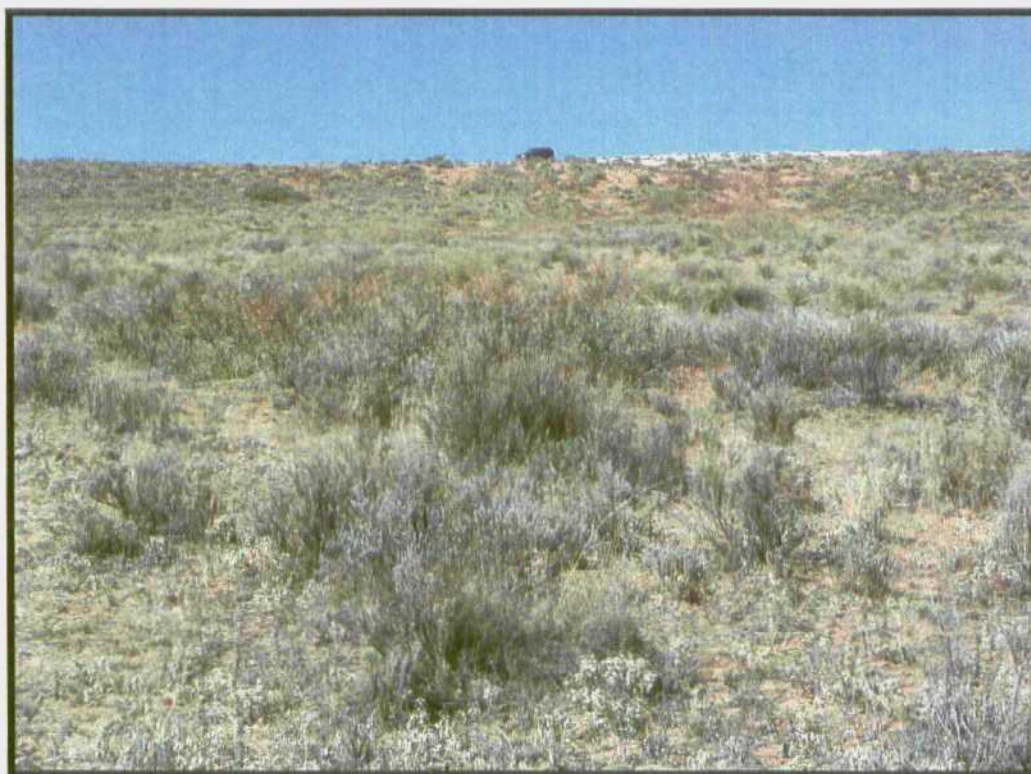
This area contained degraded hydrocarbon contamination along two "run" areas. This area was approximately 600' X 600' and was "disced" in place and broken into small pieces, which will hasten natural attenuation in the area.

"Run" Area Between Process Area & Lake Bed 11/20/02

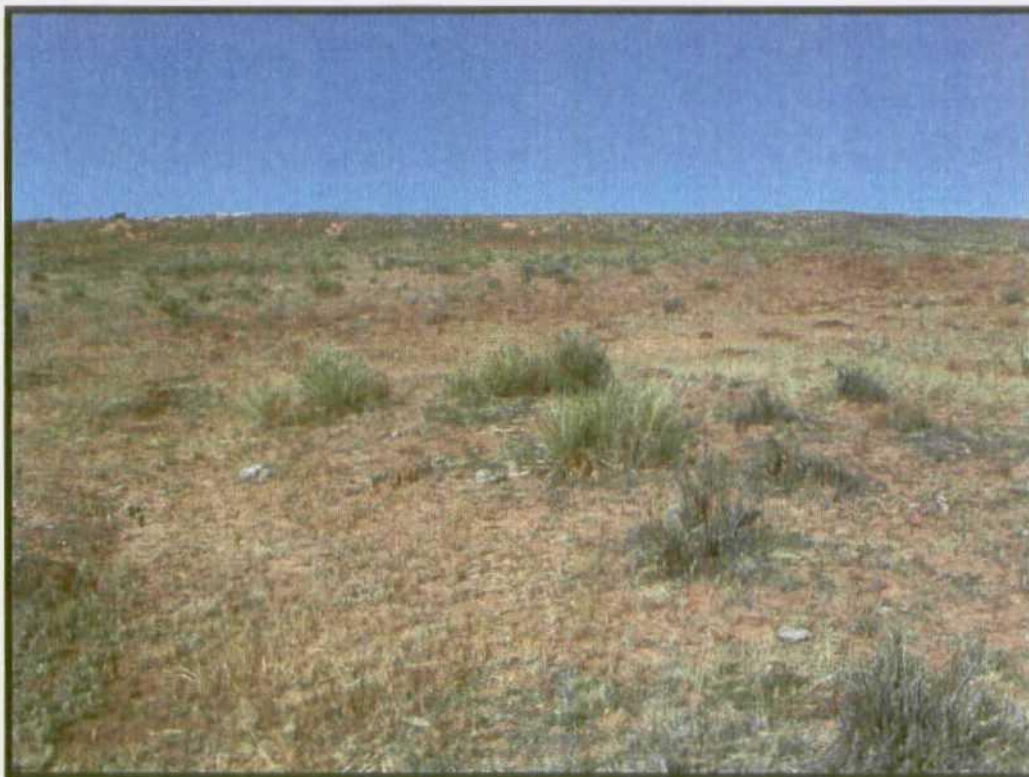
"Run" Area Between Process Area & Lake Bed 11/20/02

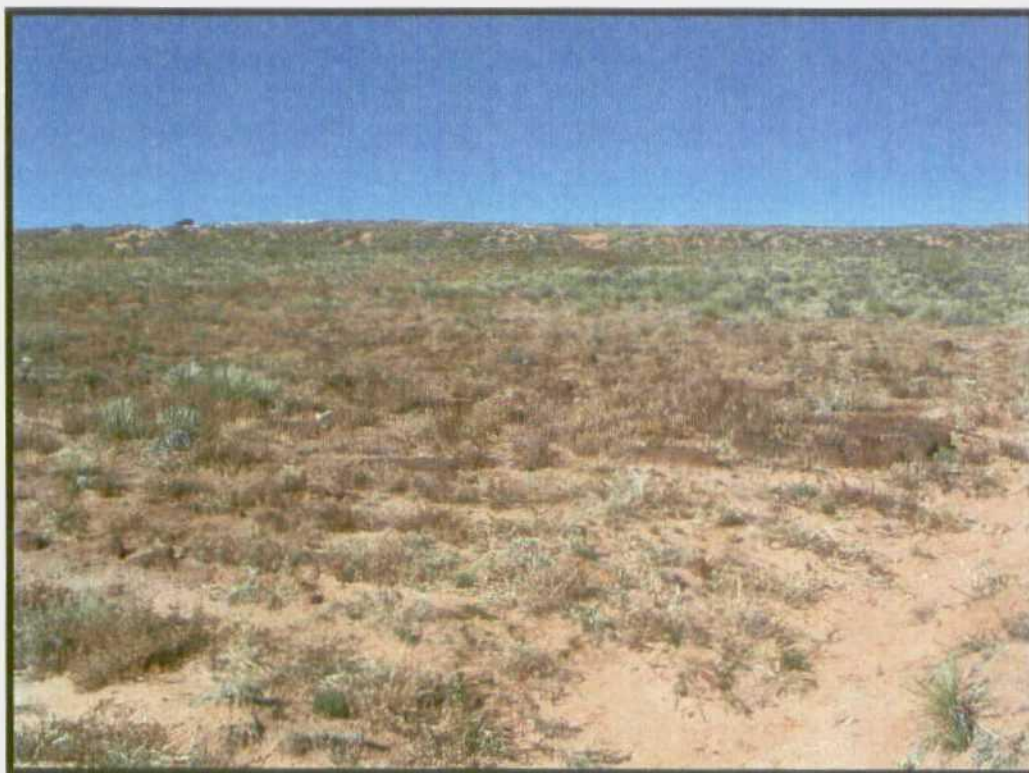
"Run" Area 11/20/02

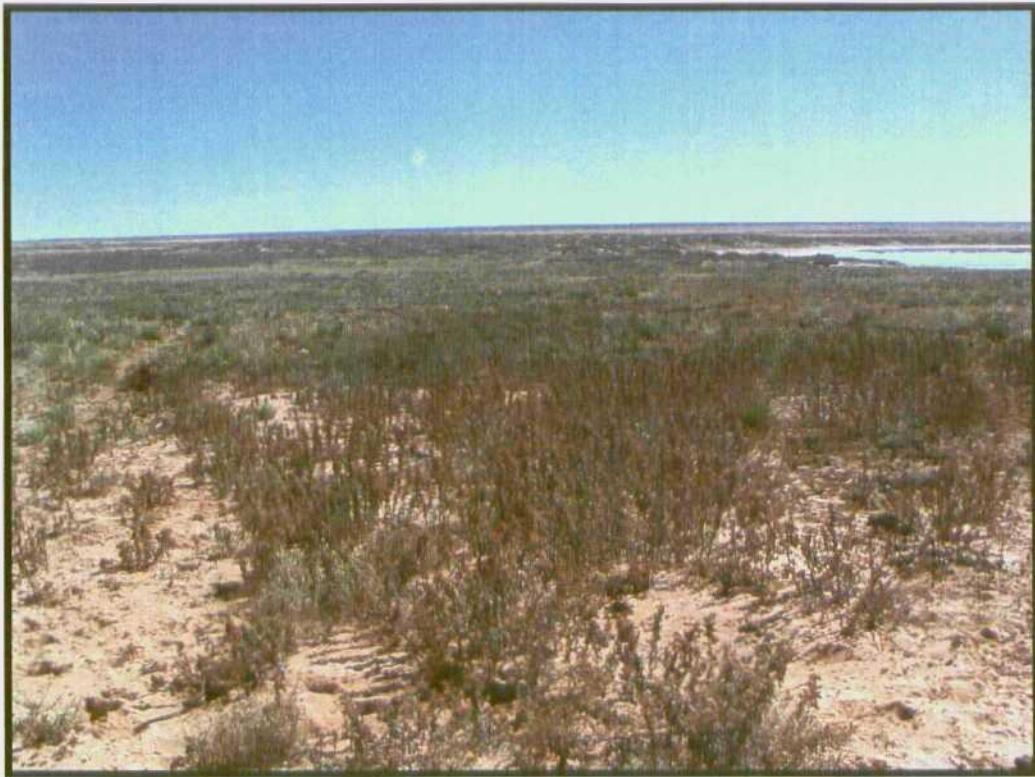
"Run" Area 11/20/02

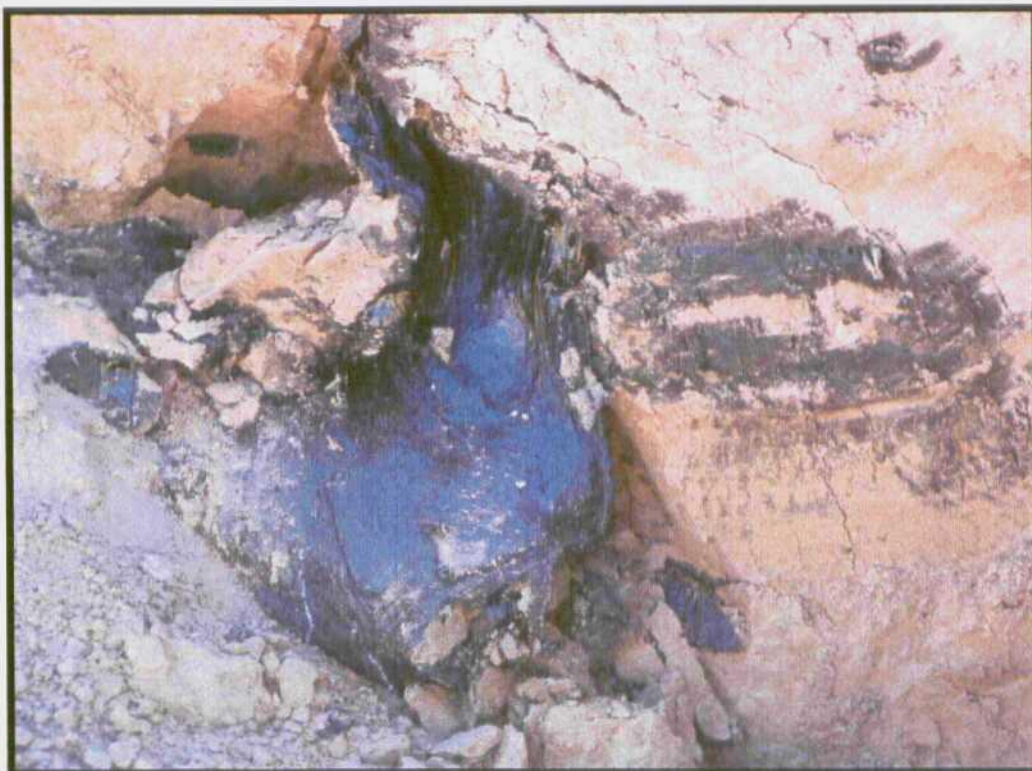
"Typical" Material Found at Lake Shore 3/5/03

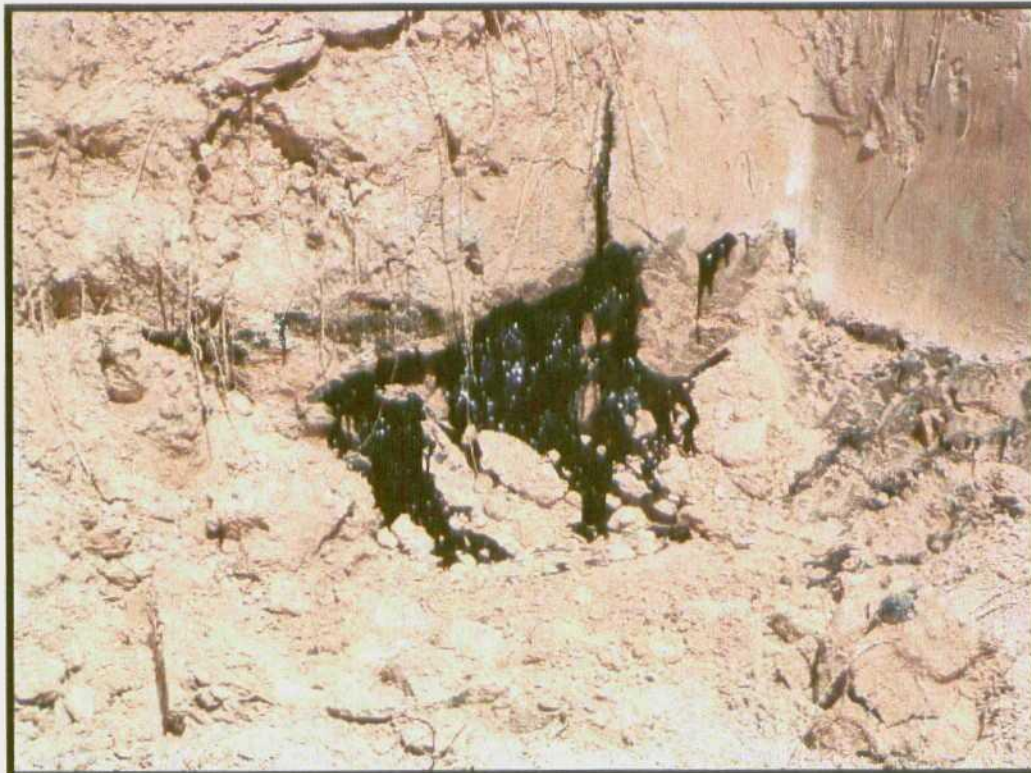
"Typical" Material Found at Lake Shore 3/5/03

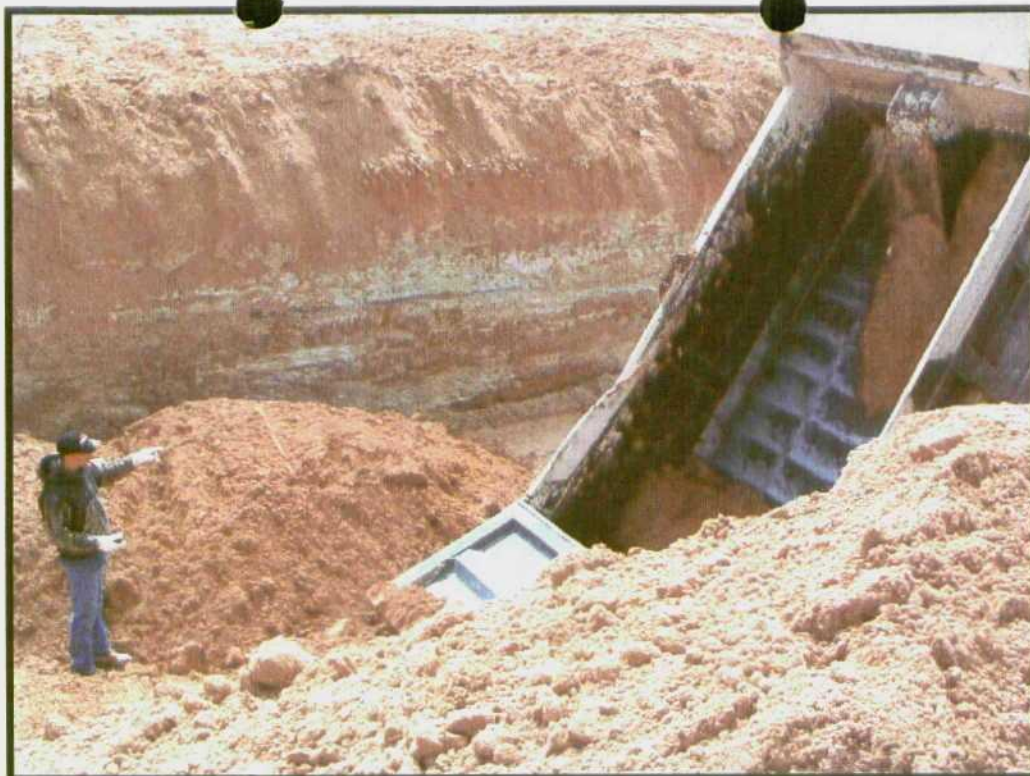
Contaminated Material Being Placed in Trench 3/25/03

The hydrocarbon material at the lake was excavated and disposed of onsite at the location near the lake agreed upon by the NMOCD at the last inspection in December 2002. Two disposal trenches were excavated at that location. One trench was 180' long, 25' wide and 18' deep resulting in the removal of 3,900 cubic yards of soil. Approximately 2,167 cubic yards of contaminated material was placed into this pit and the pit was capped with approximately 2,500 cubic yards of clay and sand. The second trench was 180' long, 30' wide and 16' deep resulting in the removal of approximately 4,160 cubic yards of soil. Approximately 2,600 cubic yards of contaminated material was placed into this pit and the pit was capped with approximately 2,500 cubic yards of clay and sand. The remaining soil that was excavated from the pits was used to build a roadway from the lakebed to the disposal site. This road was ripped and left in place after completion of the project.

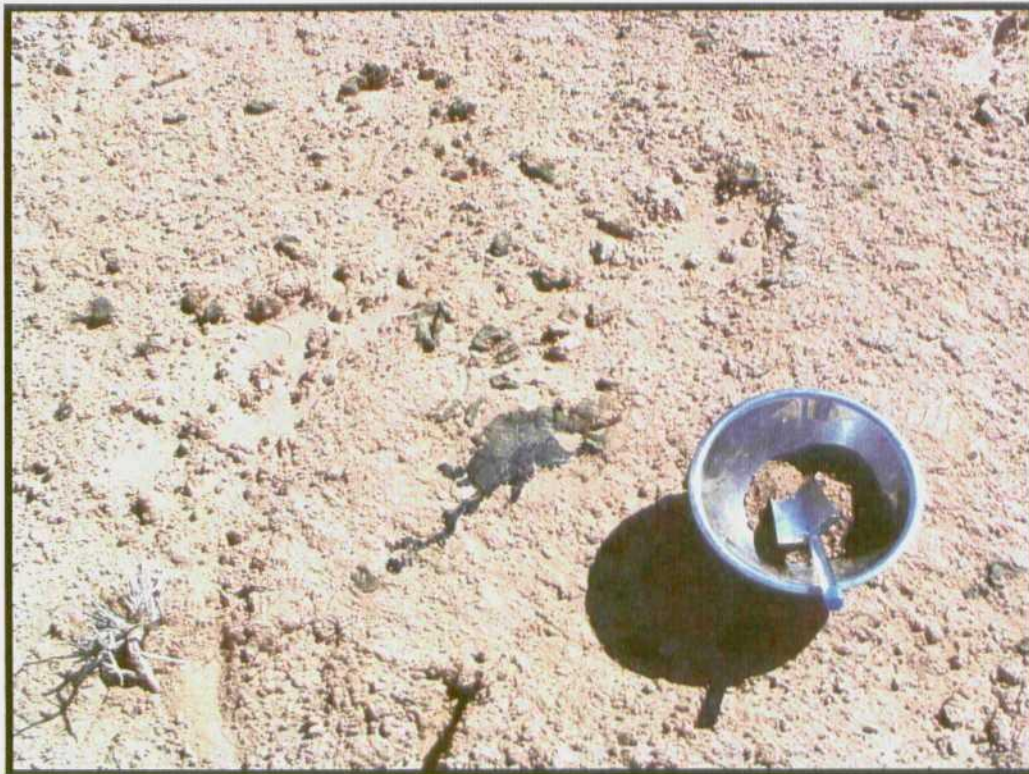
Example of Isolated Small Run  
Soil Sampled Underneath This Run 5/16/03

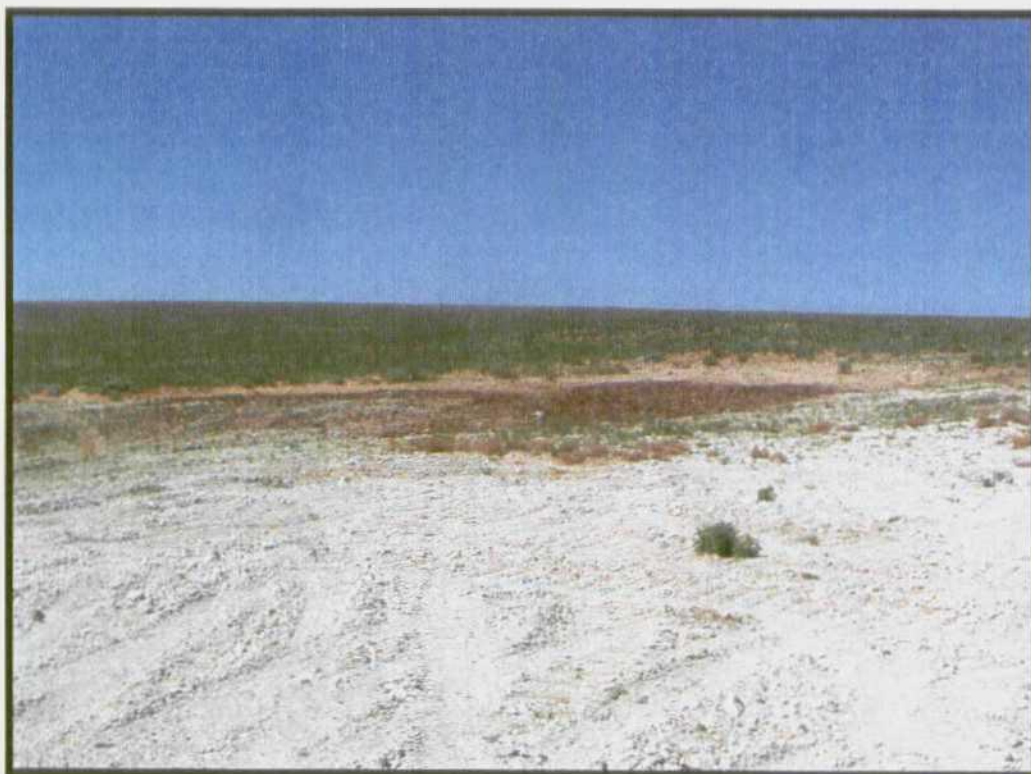
Process Area Final 5/16/03

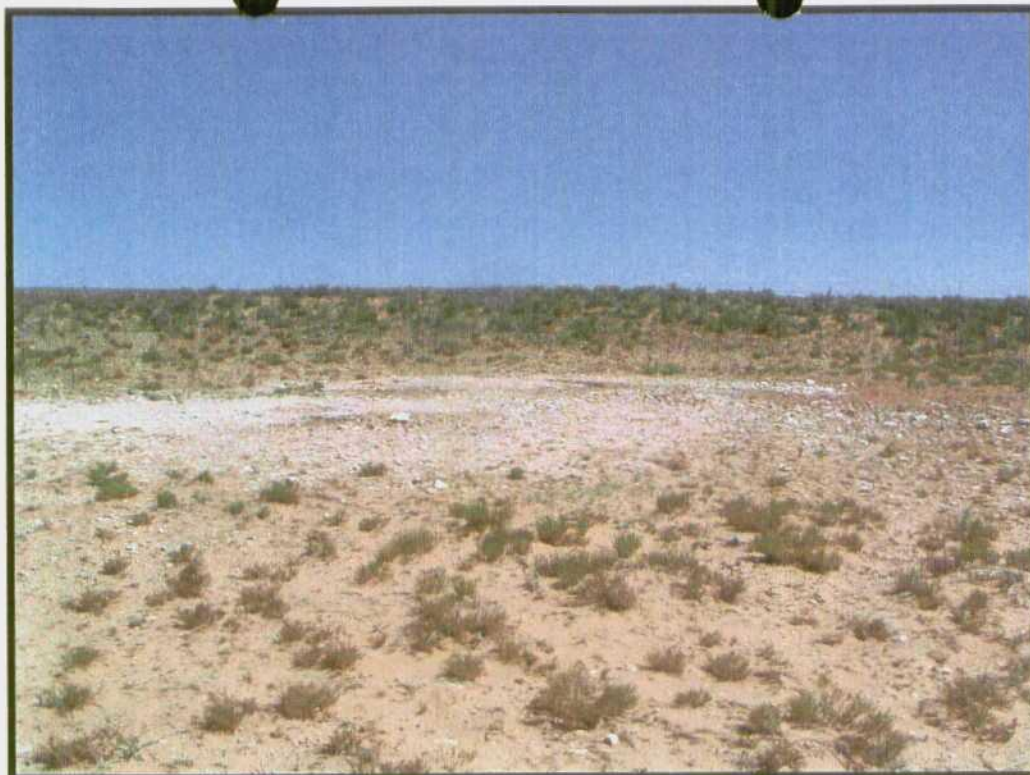
Above Ground Tank Area Final 5/16/03

The two above ground tanks at the site were removed by Wilbanks Trucking Company of Artesia, New Mexico, who accepted the tanks for disposal. The area where the tanks were located was returned to natural grade.
