# **INSPECTIONS & DATA**

**Oil Conservation Division**

RE: Doom Landfarm #01-0033

**RE: Doom Landfarm, LLC, Permit NM-01-0033**  
**S/2 NE/4 and N/2 SE/4 of Section 5, Township 25 South, Range 37 East, NMPM,**  
**Lea County, New Mexico**

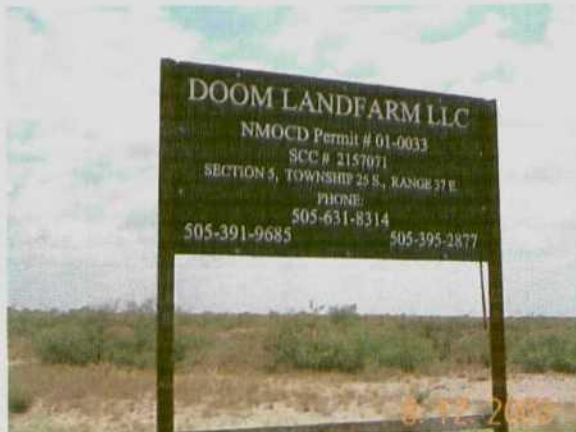
Photo 1: Facility sign at the Highway. Contains Facility name, Permit Number, Legal location and Emergency phone numbers. Looking East

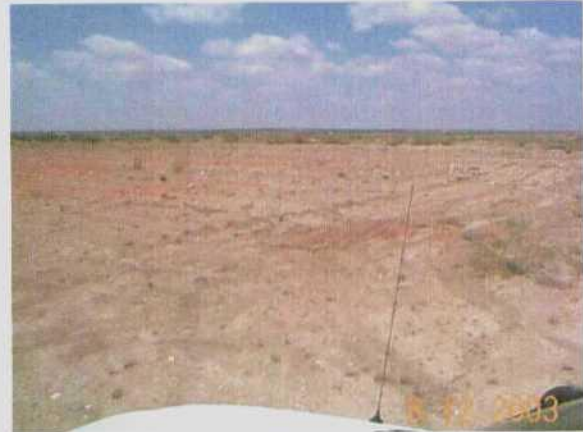
Photo 4: Landfarm Cell 1 half full. Looking Southwest.

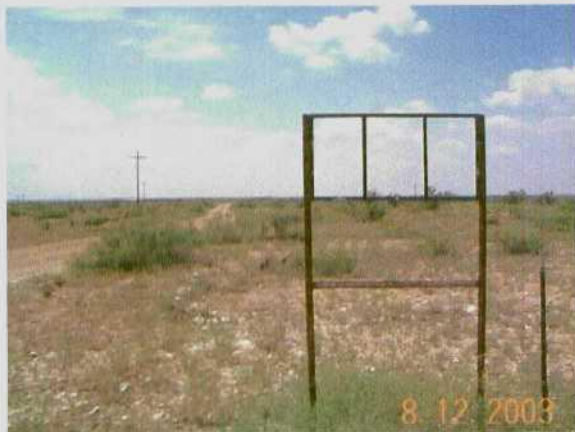
The New Mexico Oil Conservation Division (OCD) inspected Doom Landfarm, LLC (Doom) on August 12, 2003. The OCD found the facility to be well maintained and have good security (Photos 3, 4 and 5). However, the sign for the facility was missing at the entrance gate (Photo 2). Doom must replace the entrance sign. Tilling and inspection records were reviewed. All tilling and inspections have been performed according to permit requirements (Photo 4). A review of the financial assurance portion of Permit NM-01-0033 finds that a cash bond and assignment in the amount of \$27,833 is on file. This is the full financial assurance amount required by the permit.

Photo 2: Facility Sign at Landfarm gate entrance is missing. Looking south into the landfarm.

Doom shall provide OCD with a description of how the correction will be made and a time-table of when the correction will be completed. Doom must respond to the permit deficiency by September 29, 2003

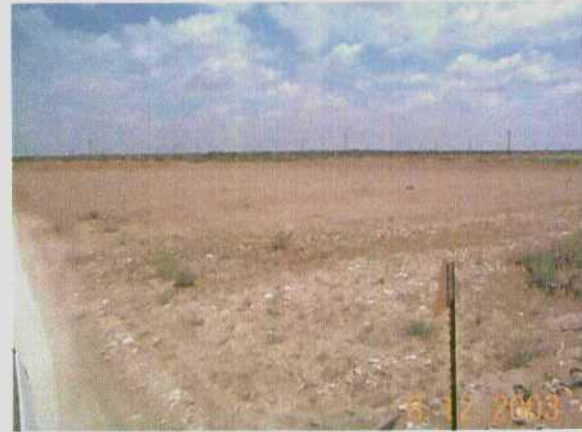
Photo 5: Landfarm Cell 2 prepared. Looking Northeast.

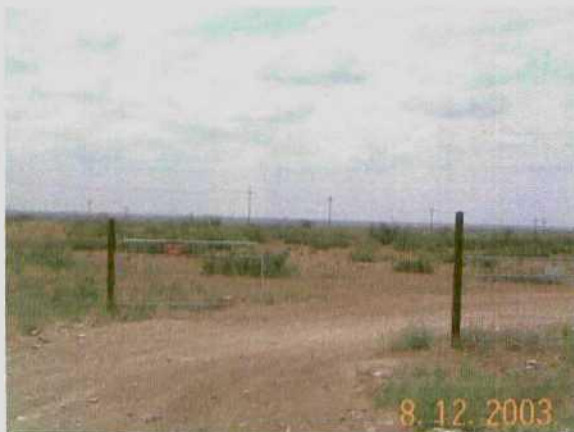
Photo 3: Facility gate entrance Looking Southeast.
