GW - 37

INSPECTIONS & DATA

UNITED STATES ENVIRONMENTAL PROTECTION AGENCY
Official Photograph Log

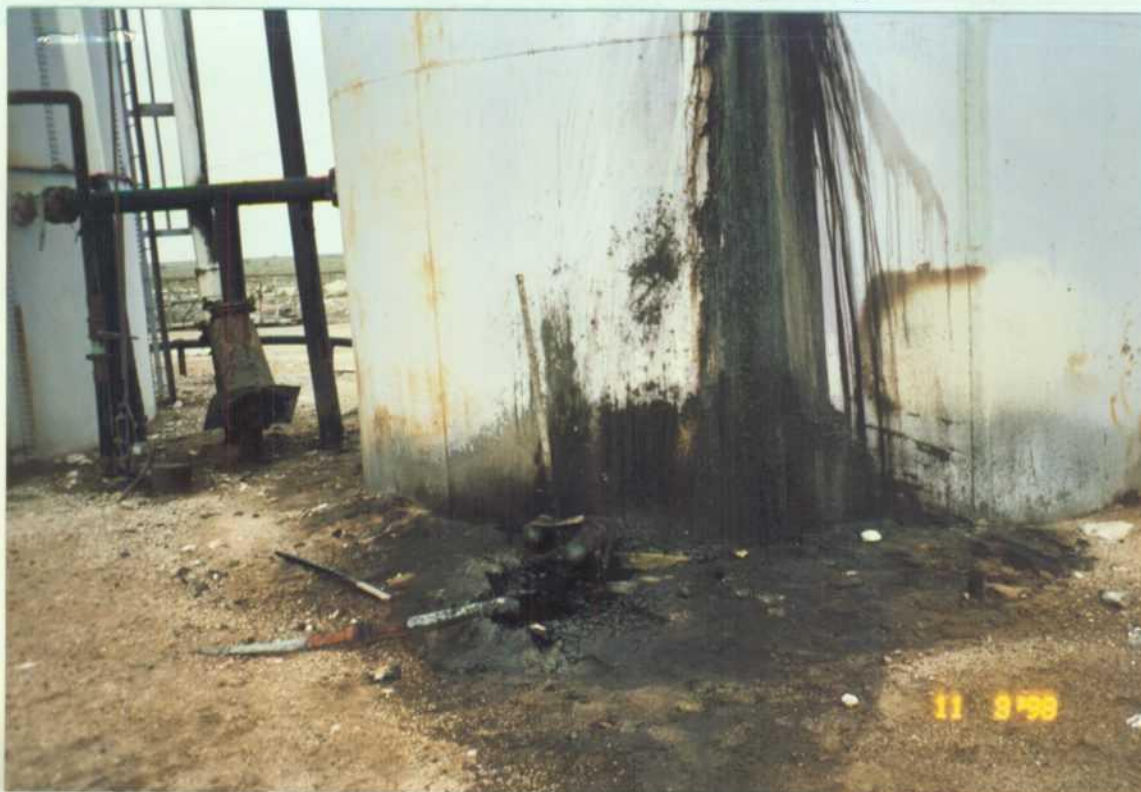
Photo Number: 3 Photographer: T. Reeves, SAIC

Subject: Tank which appears to be leaking oil

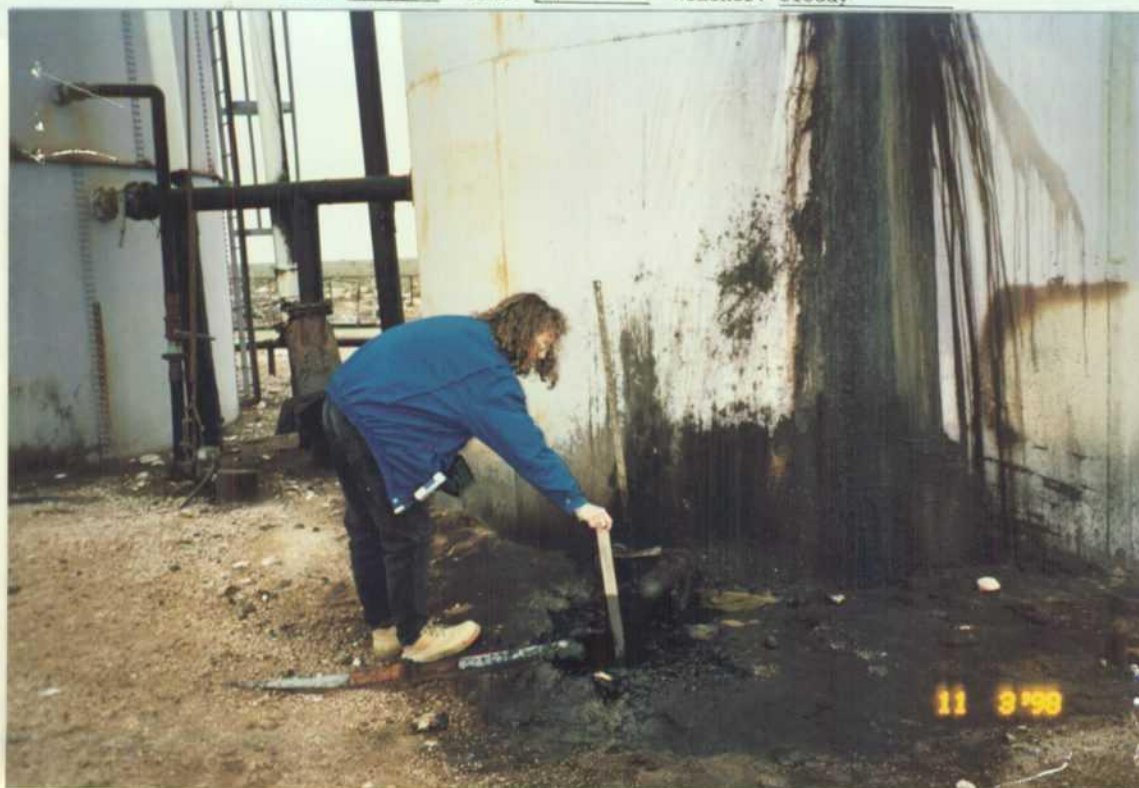
Photo Number: 4 Photographer: T. Reeves, SAIC

Subject: Sump full of oil beneath tank valve (measured with stick)

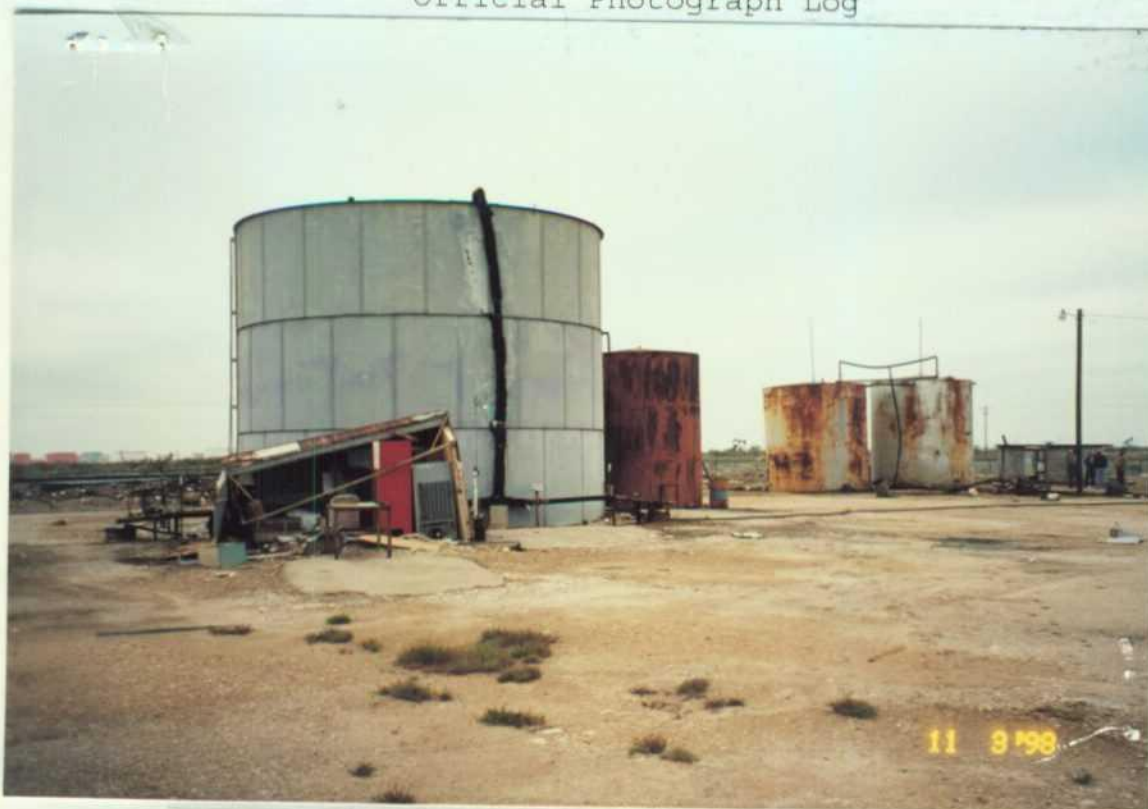
Photo Number: 1 Photographer: T. Reeves, SAIC

Subject: General facility layout, looking NE

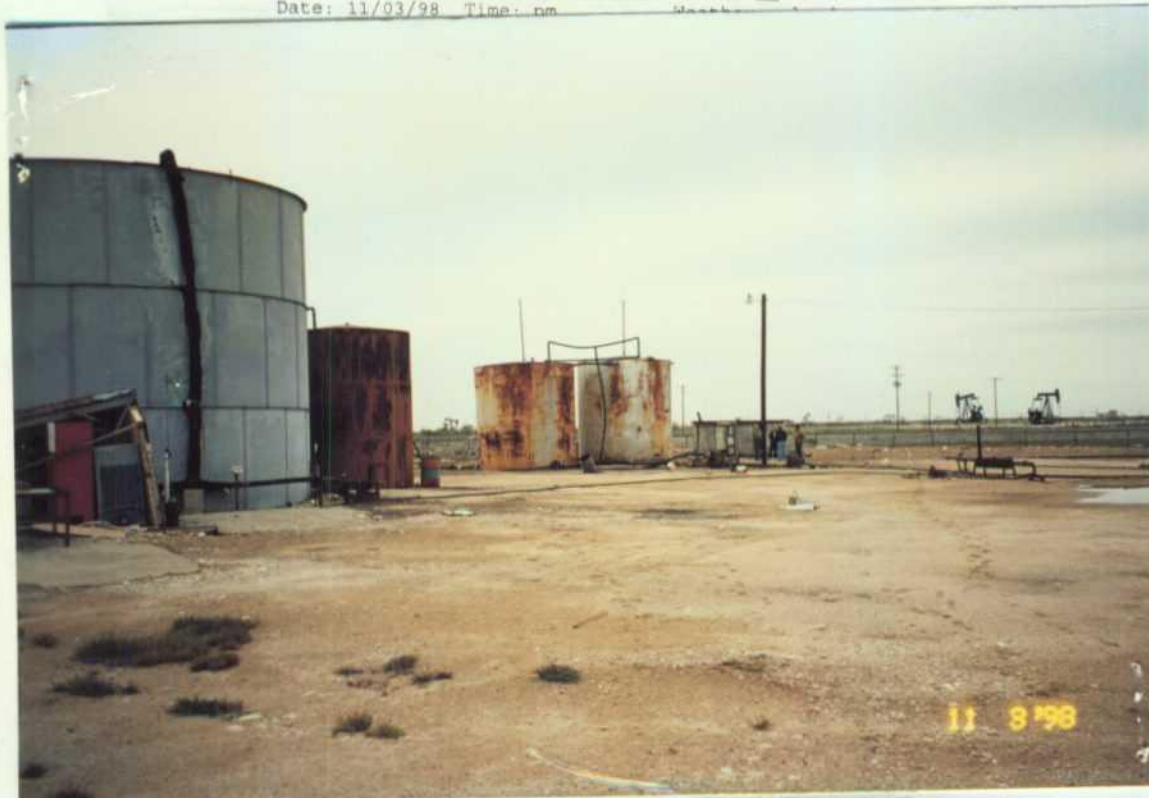
Photo Number: 2 Photographer: T. Reeves, SAIC

Subject: General facility layout, looking NE

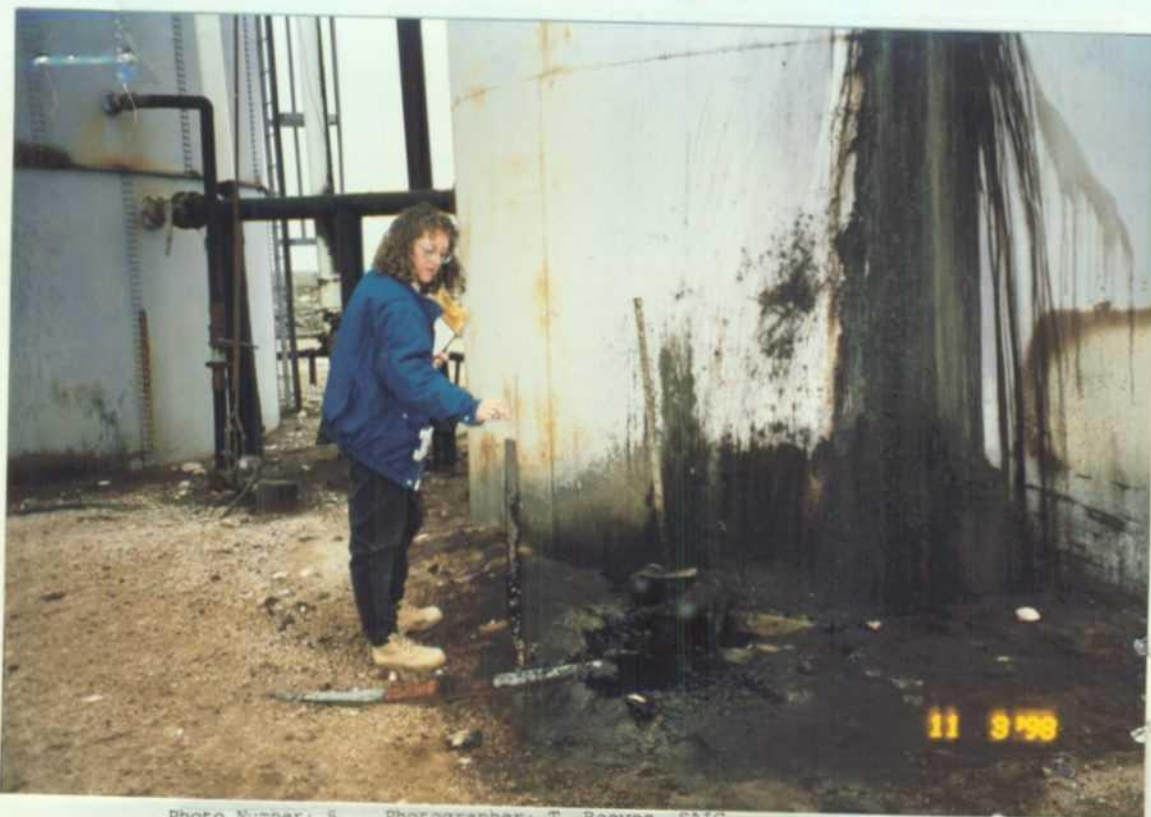
Photo Number: 5 Photographer: T. Reeves, SAIC
Location: Araho, Inc.
Subject: Sump full of oil beneath tank valve (measured with stick)
City/County: Lea County State: NM
Date: 11/03/98 Time: pm Weather: cloudy

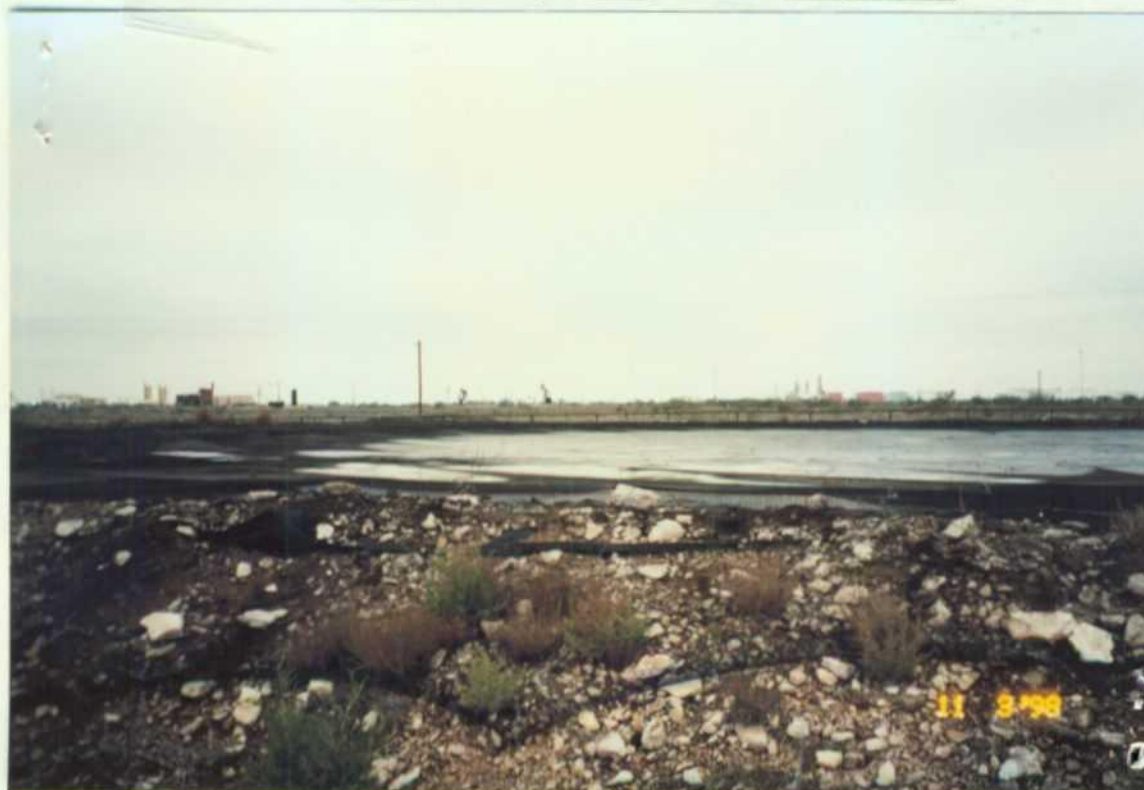
Photo Number: 6 Photographer: T. Reeves, SAIC
Location: Araho, Inc.
Subject: Pit covered with oil, little freeboard, submerged netting
City/County: Lea County State: NM
Date: 11/03/98 Time: pm Weather: cloudy

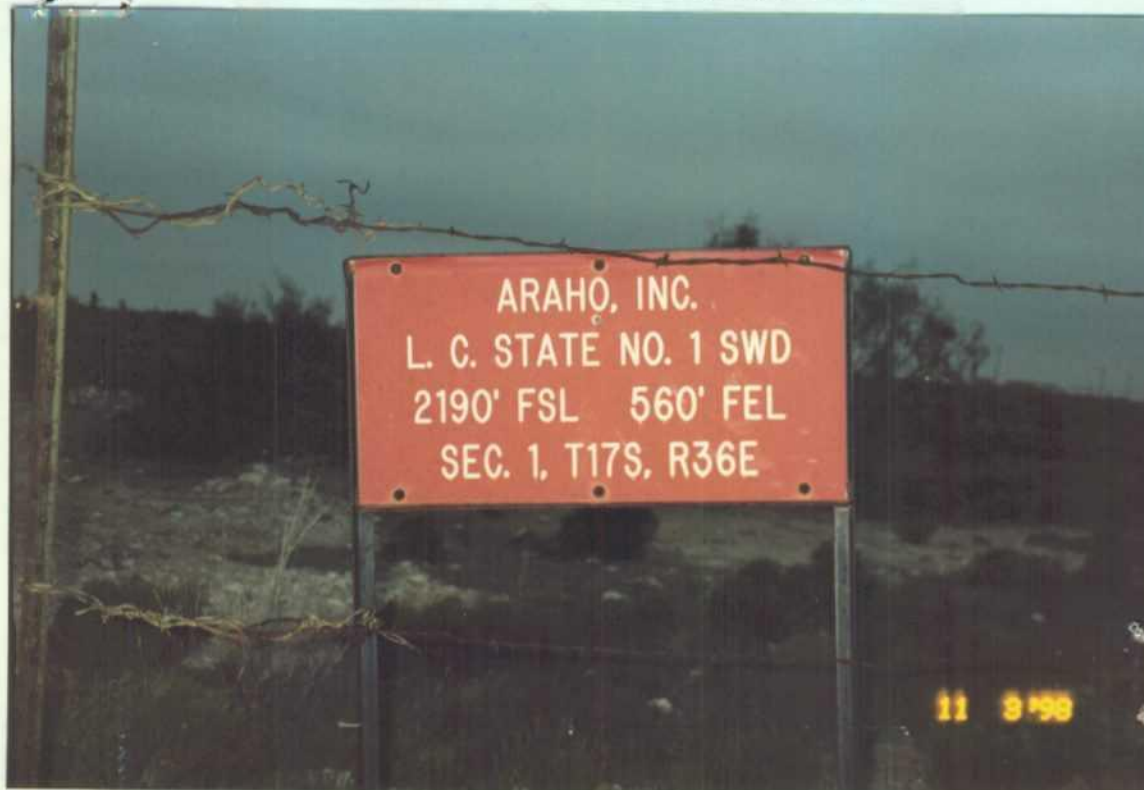
Photo Number: 7 Photographer: T. Reeves, SAIC

Subject: Placard sign at entrance to facility
