DYE TRACE STUDY 2006

GIANT REFINING

CINIZA REFINERY

June 19, 2006

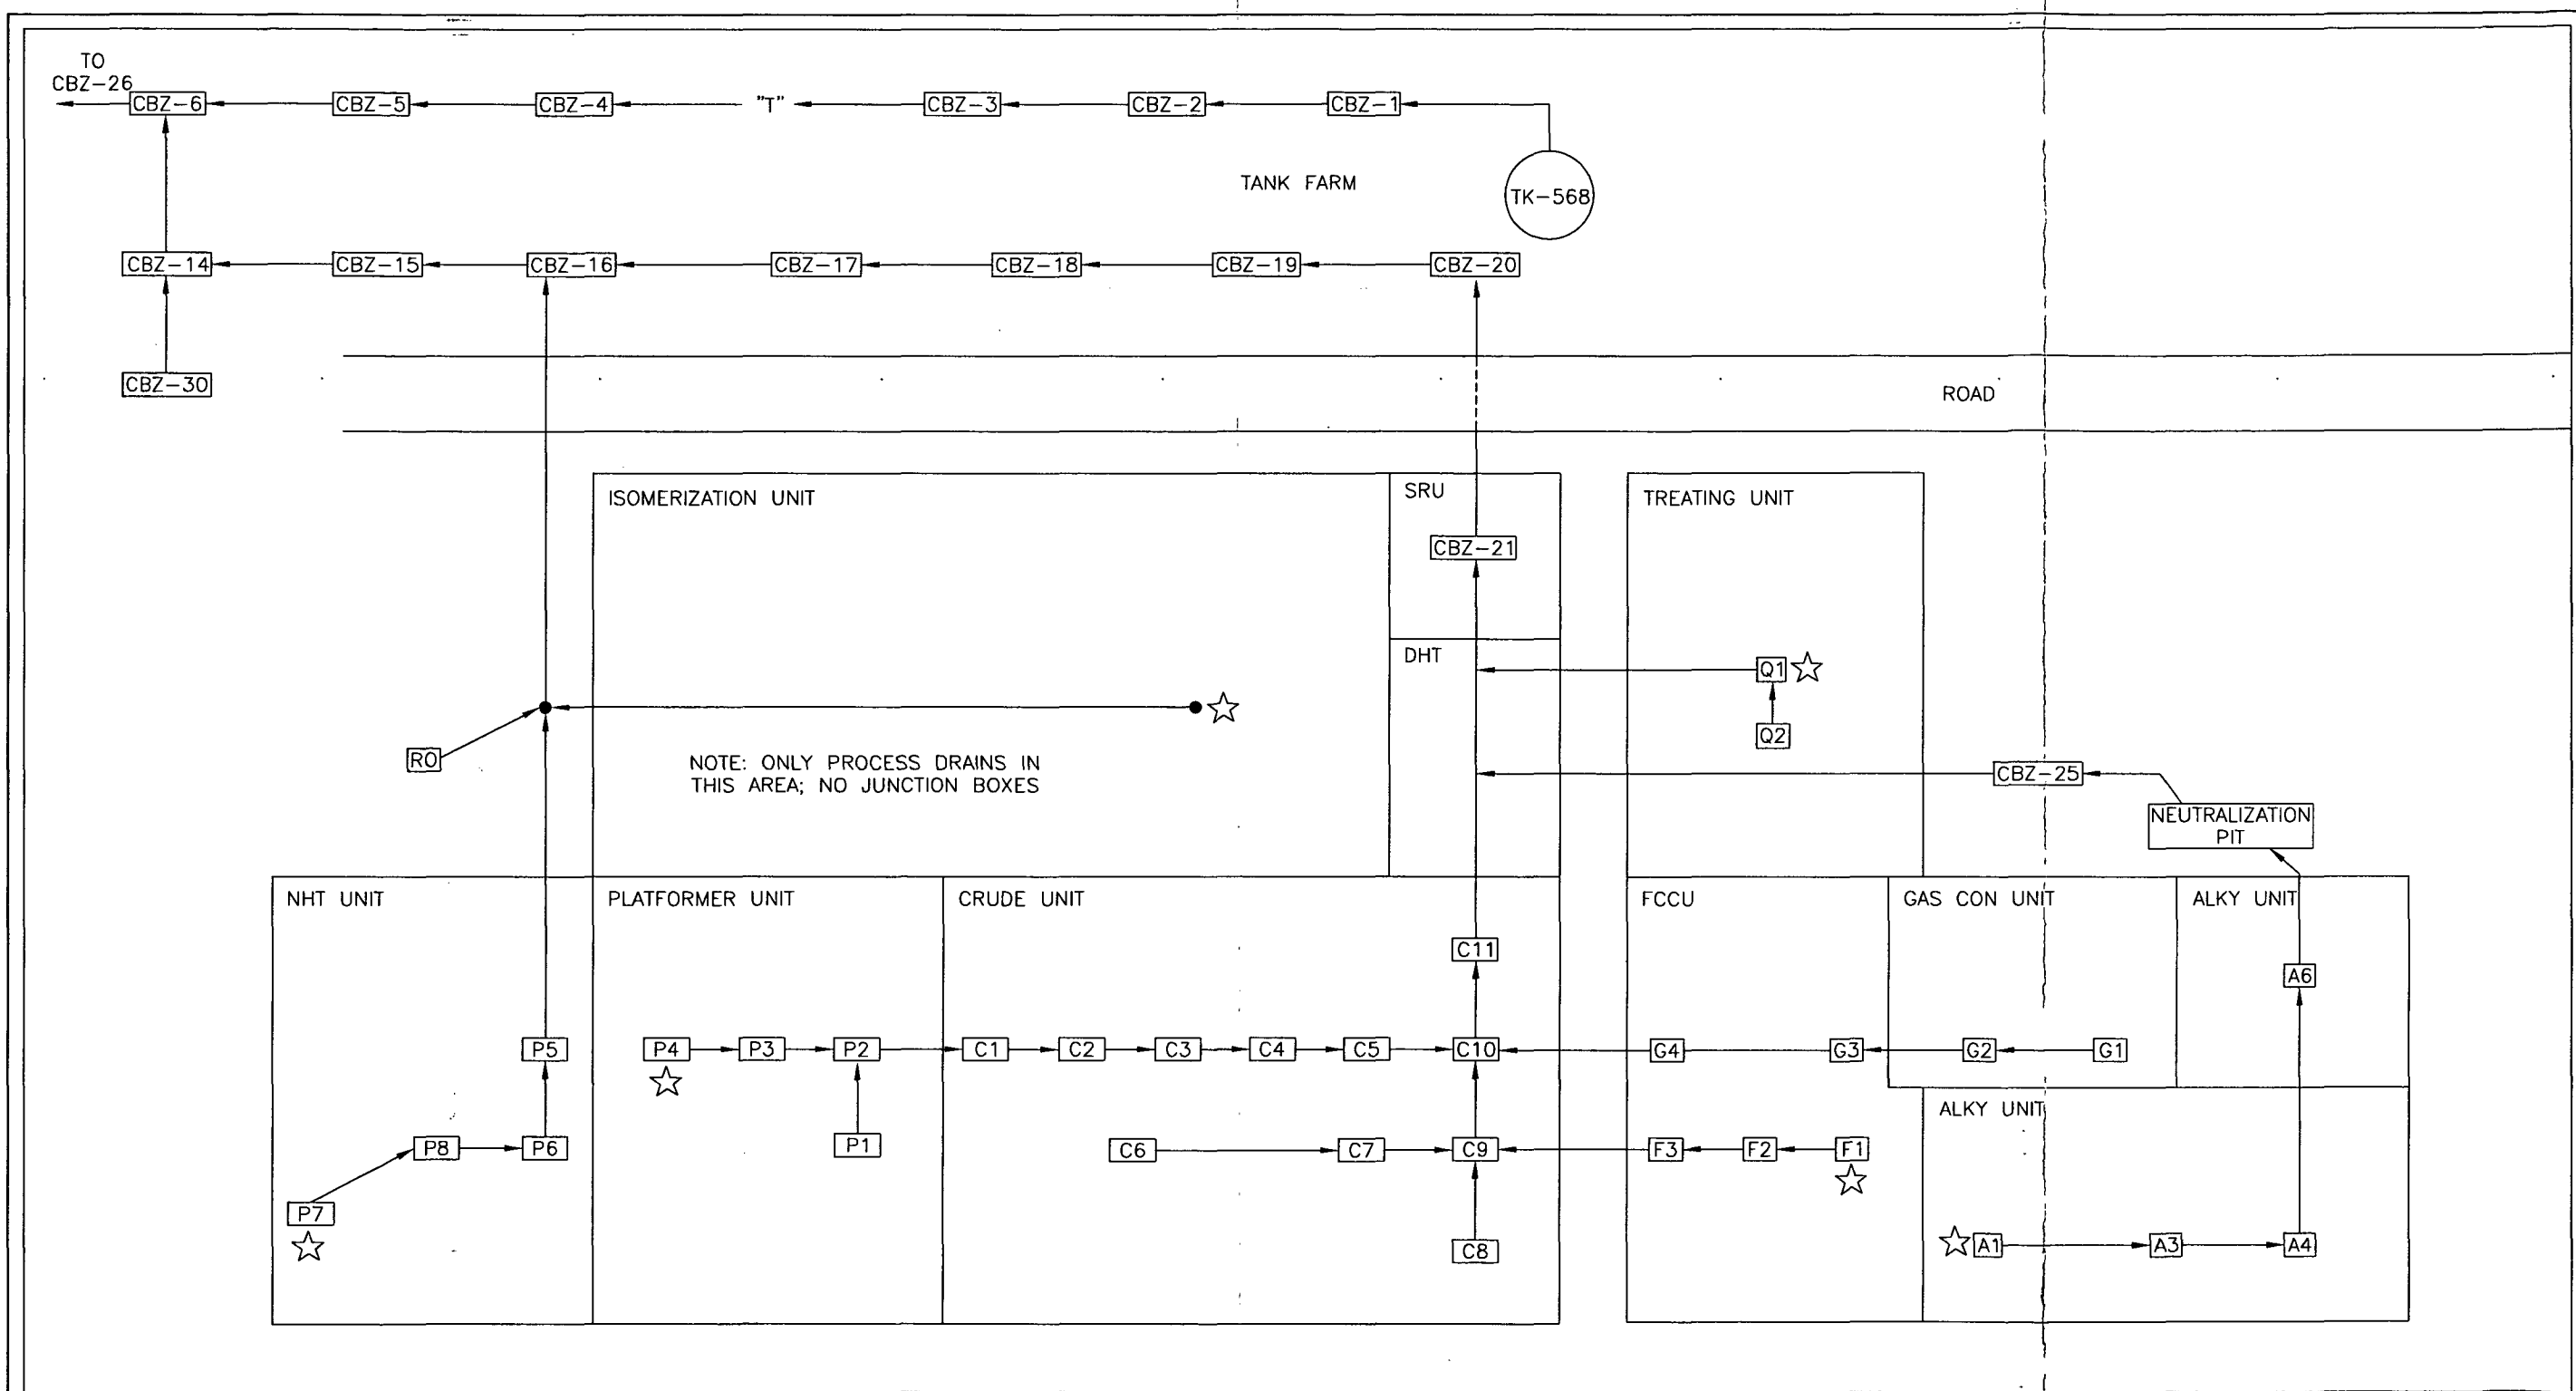
PROCESS WASTEWATER SEWER 2006

identified in Refinery records as A2 and A5, were removed from service (see Figure 1). Remaining junction boxes were also repaired to ensure that there were no leaks or cracks. In addition, new process sewer lines were installed between equipment drain hubs and the main process sewer line.

Based on observations made during the initial site walk, history of the sewer systems (e.g., the Alky sewer repairs), and the process sewer inspection requirements and procedures, it was decided to conduct an initial test for cross-connects by introducing dye into the process sewer system. To accomplish this, dye was introduced at locations that were the farthest points upstream in each branch of the process sewer. Subsequently, the stormwater sewer system manhole #17 (MH17) was then monitored for evidence of the dye. Stormwater sewer MH17 is the storm sewer end-of-line (EOL) test location for the purpose of this dye trace study. This location was chosen because it was the furthest location downstream in the storm sewer system and that stormwater could be tested before reaching the OAPIS. Figure 1 shows the locations where dye was introduced into the process sewer system.

Fluorescent dyes were used to determine if there were cross-connects between the process and stormwater sewers at the Refinery. Dye was placed in process sewer locations as far upstream as possible in each unit (see Figure 1). The storm sewer was then observed for dye at certain downstream locations. The storm sewer was observed at the EOL location stormwater sewer MH17 and other manholes located outside of individual process units. Water in the storm sewer was also examined at other manhole locations in order to detect dye before it became too diluted. If no feasible location was available, stormwater sewer MH17 was observed and sampled.

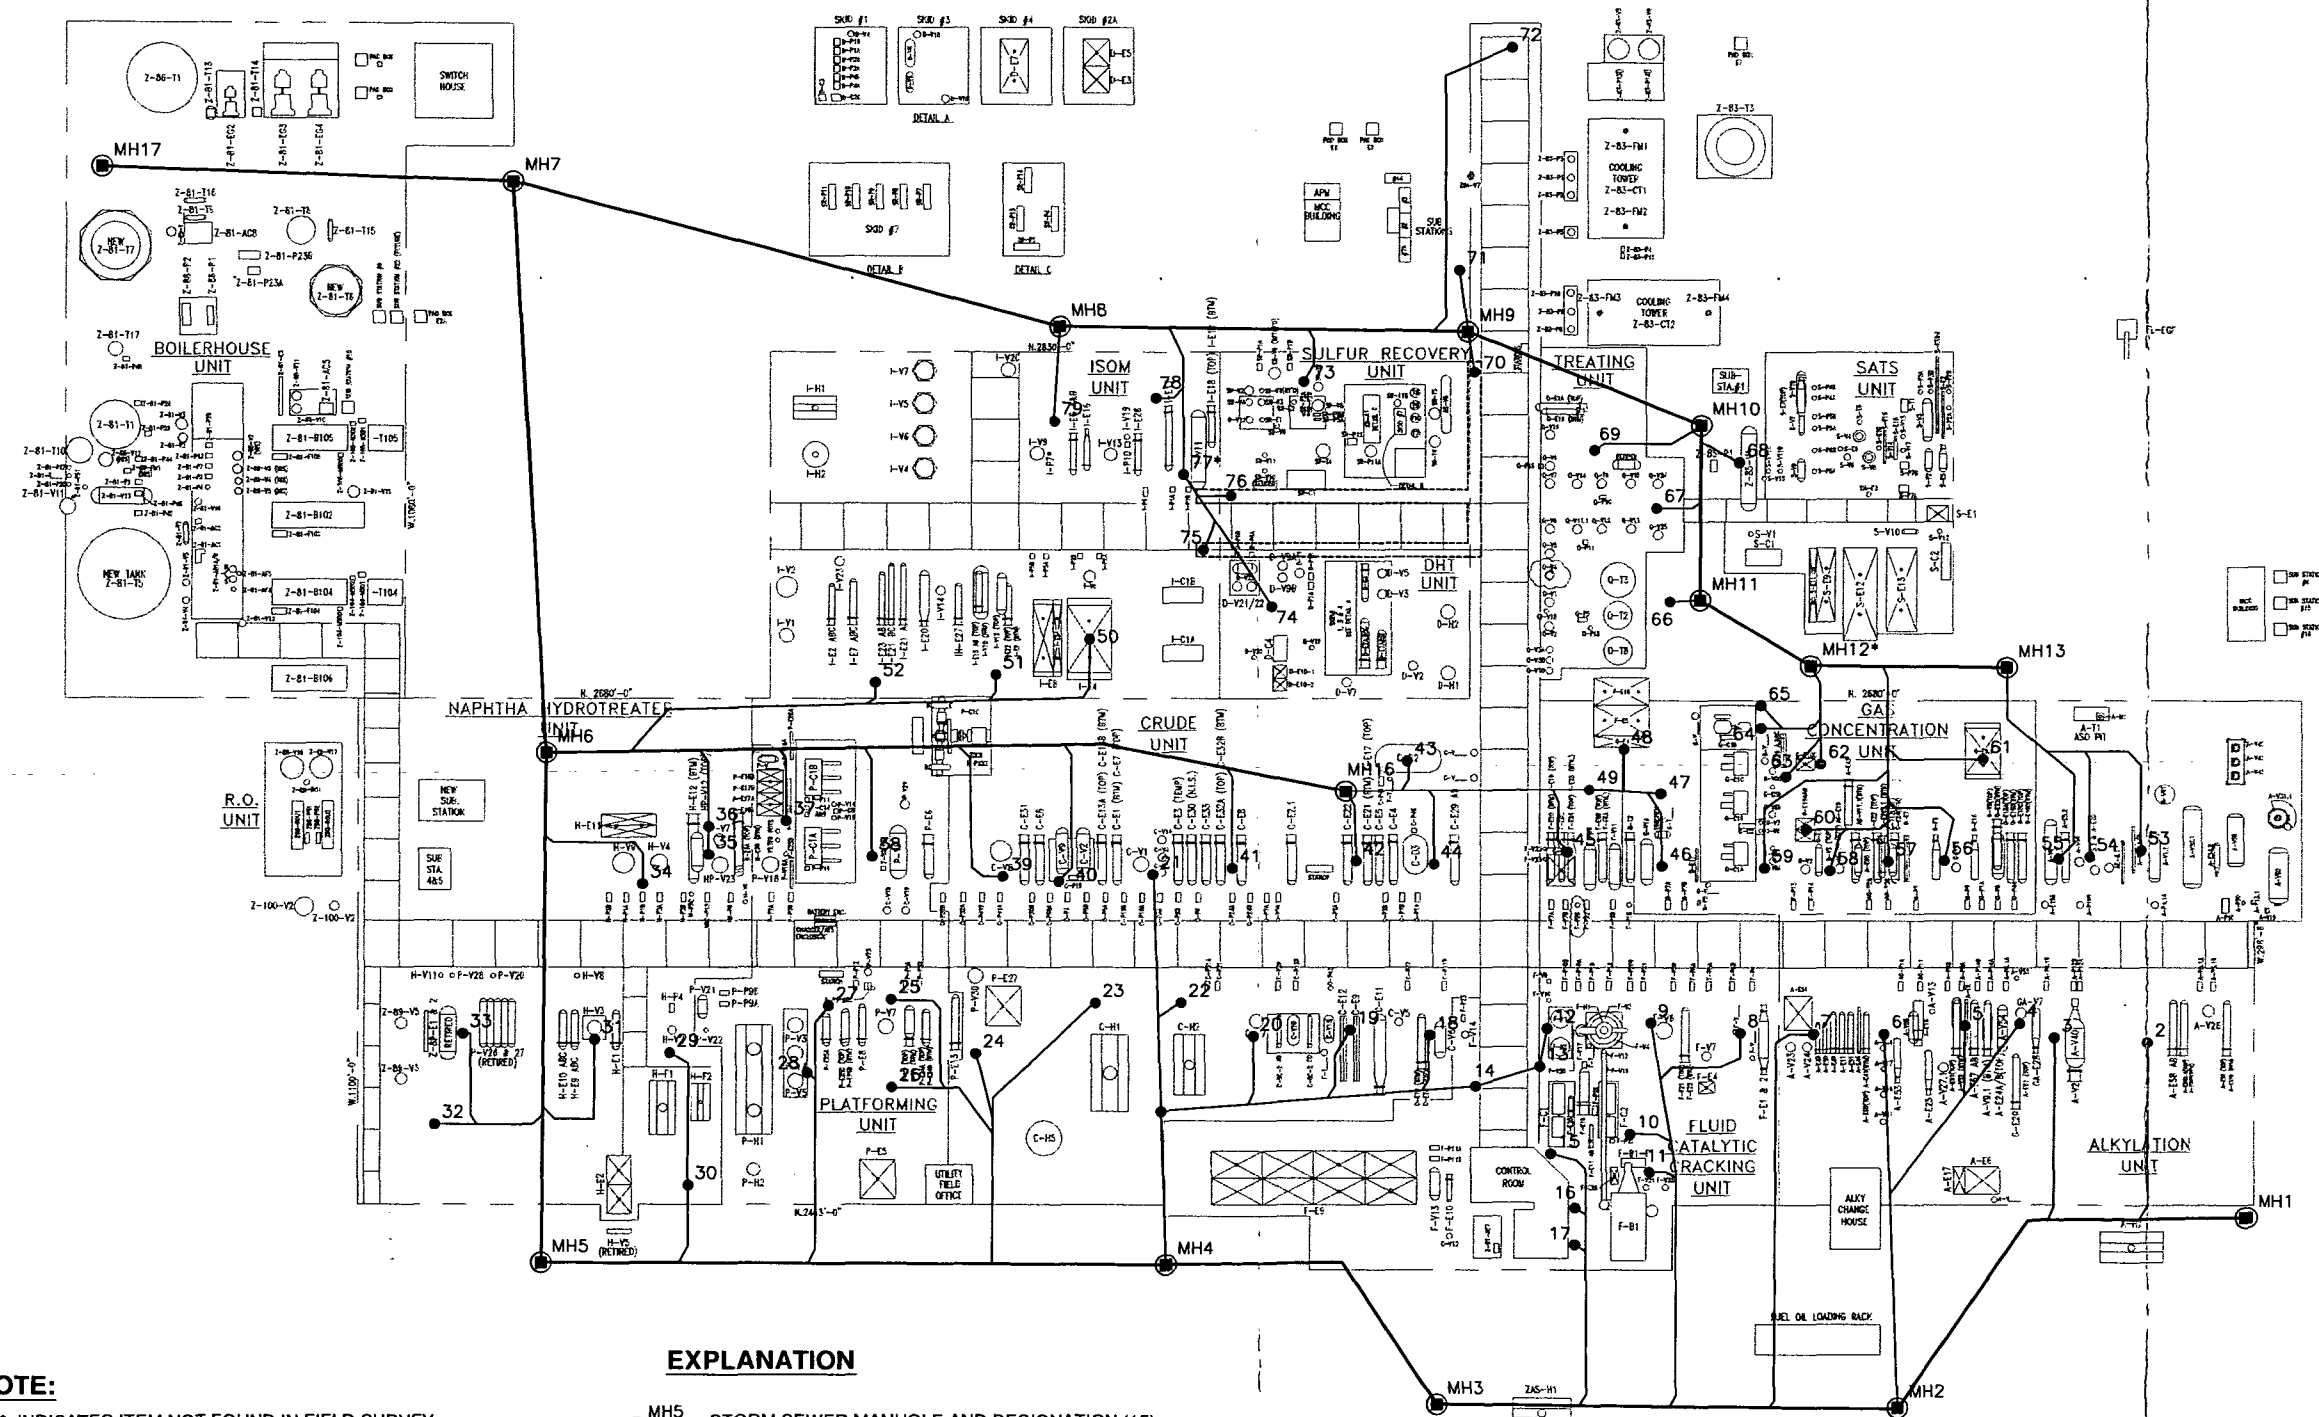
There are two branches of storm sewer system in the Platformer Unit (See Figure 2) that both flow to stormwater sewer MH6. Stormwater MH6 was observed for red dye. Water hoses were used to aid the storm sewer flow in each branch. The flow in the storm sewer system was verified to be adequate and three samples were collected from stormwater sewer MH6. Dye was not detected visually or when the samples were examined with UV light. Therefore, it is believed that there are no cross-connects in the Platformer Unit.

Some stormwater/non-process wastewater sewer drains, identified during the on-site visit, need to be eliminated or further segregated from non-stormwater water flow potential. This segregation will help to assure that non-stormwater flow does not enter the storm sewer system (which is intended to receive only stormwater and non-process wastewater). Some drains had fresh oil stains while others were clean.

Based on observations, it is recommended that a cup or lip be installed on some storm sewer drains. Recommendations for storm sewer drains are listed in Table 2. A cup or lip will help prevent non-stormwater flow from entering an adjacent storm sewer drain. This will also aid in keeping spills from flowing into storm sewer drains that are located below grade of the process sewer drain. In all cases, proper draining procedures will need to be followed. Failure to implement proper procedures to prevent non-stormwater flow from entering the storm sewer can result in hydrocarbon and other non-storm water entering any downstream stormwater collection system.

Recommendations include permanently plugging some storm drains, periodic cleaning of storm drains, and rerouting non-stormwater flow. Some storm sewer drains listed in Table 2 are in unsuitable locations. In these cases, it is our recommendation that these storm sewer locations be permanently plugged.
