**SITE REMEDIATION REPORT
HOMCO Location 151 Facility
HOMCO International, Inc.
Farmington, New Mexico**

July 19, 1991

BUYS AND ASSOCIATES, INC.

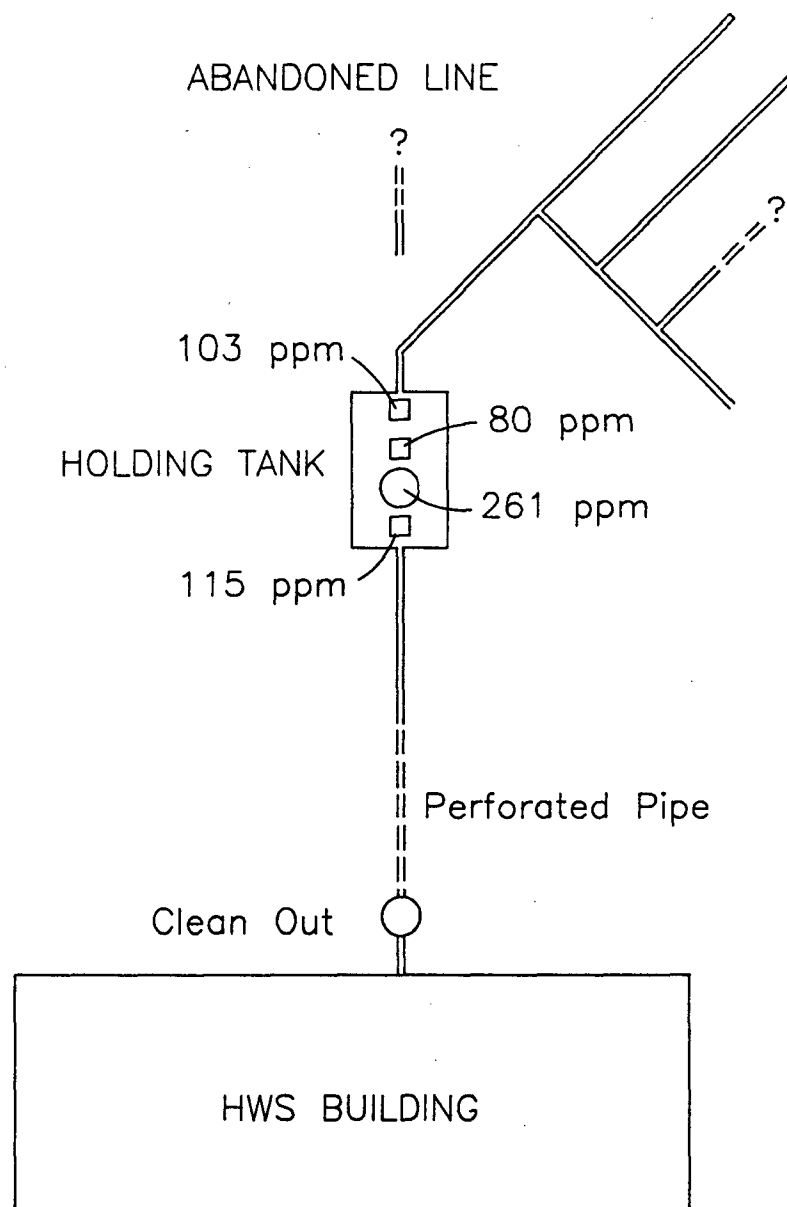
BUYS & ASSOCIATES		
FIGURE 4-2		
HWS LEACH FIELD CONFIGURATION AND DISTRIBUTION OF OVM RESPONSES		
HOMCO Location 151 Remediation Farmington, New Mexico		
Date: 3-25-91	Scale: 1"=10'	Drawn by: NM

might explain why the leach field itself was dry and apparently uncontaminated. However, it is more likely that the leach field system never operated correctly and the waste water discharged prior to making it to the holding tank. Evidence of this was encountered during the installation of the separator in September, 1990, when a 10-ft section of perforated pipe was found next to the building, leading from a clean-out north of the building to the holding tank (Figure 4-2).

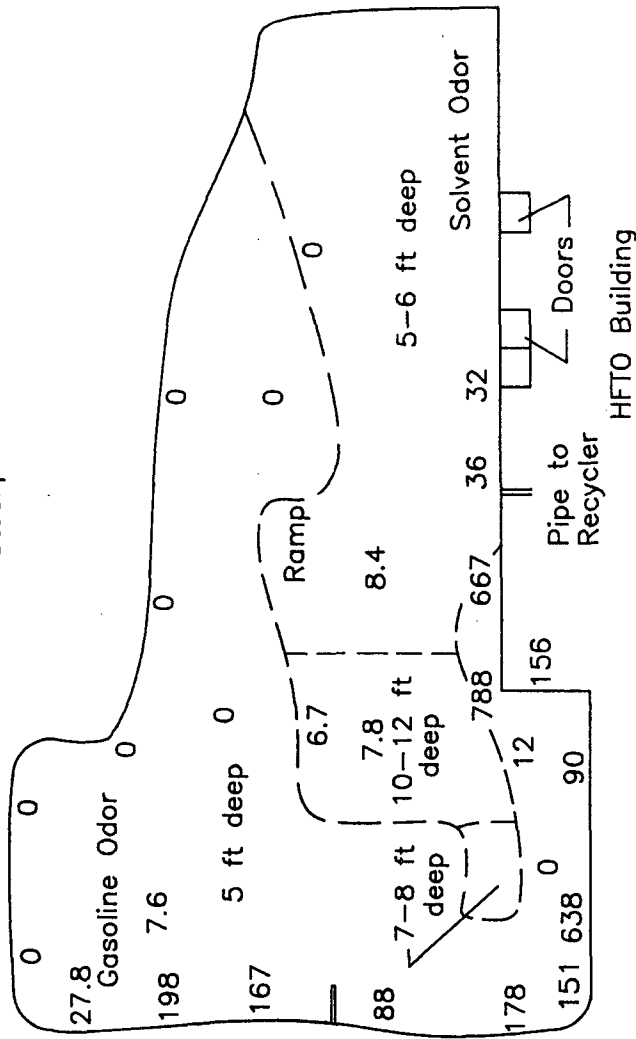
FIGURE 4-3

Subsurface contamination was encountered throughout the excavation of Area A. Figure 4-3 illustrates the extent of the Area A excavation and the distribution of OVM responses recorded in the base and sidewalls after the remediation was completed. Significant concentrations of organic vapors ranging from 113 to over 2,000 ppm were observed in three general areas: below the HFTO holding tank; below the northwest corner of the concrete pads where two, 2,000-gal

Strong gasoline odors were observed during the excavation of the northwest corner of Area A (Figure 4-3), close to where two underground storage tanks had been removed in 1989. OVM responses ranged from 1424 ppm to 1922 ppm in the soils excavated from approximately 5-ft below grade. Crew members upgraded to level C respiratory protection due to high OVM readings and extremely strong gasoline odors in the breathing zone. Excavation of the west end of the north sidewall ended approximately 60-ft north of the west end of the south sidewall (Figure 4-4), where maximum OVM readings recorded in the base and sidewall soils were below 50 ppm.

A seam of loose rock resembling a leach field bed was exposed approximately 3-ft below grade in the north wall, approximately 15-ft east of the northwest corner of the excavation (Figure 4-3). The gravel most likely represents the tail end of an abandoned leach field which was probably excavated by Sweetwater Corporation during the removal of the two underground storage tanks in 1989. The rest of the leach field bed would have been laid closer to the building and removed with the tanks. According to HOMCO personnel, a perforated PVC pipe used to extend towards the north from the northwest corner of the HFTO building. The fact that no piping or gravel was encountered during the excavation of Area A supports the theory that the majority of the leach field was removed by Sweetwater and the gravel exposed in the north wall is all that was left behind. Because OVM responses in the gravel unit were insignificant, the extent of the gravel was not investigated.

Approximately 100 yds³ of very loose, well sorted, medium- to coarse-grained sand which smelled like solvent was removed from the southeast corner of the excavation (Figure 4-3). The sand was stockpiled separately on plastic sheeting in the northeast corner of the yard until the nature of the contamination could be determined through laboratory analysis. Organic vapors were recorded with the OVM over the stockpile at a concentration of 739 ppm. One composite sample was collected and sent to Core Laboratory for a solvent scan using EPA Method 8240. Ethylbenzene and xylenes

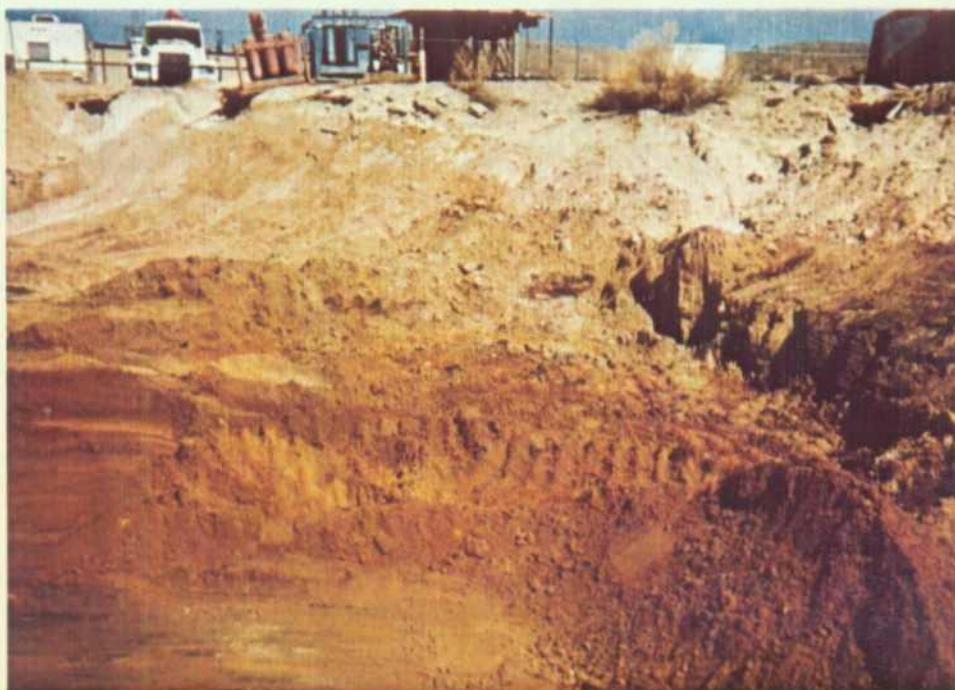
A-1. Area C Excavation

Area C was excavated with a backhoe on March 7, 1991. The excavation was oriented north-south and was approximately 10-ft wide by 20-ft long by 2-ft deep (Photograph A-1). Area C was excavated from north to south and contained loose, silty sand with minor amounts of clay from zero

to two feet below grade. A very loose, coarse-grained, iron-stained sand was encountered at approximately the 2-ft depth. In some areas, the sand was present as a moderately-well cemented sandstone. Black staining was observed throughout the excavation in moist, clayey zones. OVM responses ranged from 28 parts per million (ppm) at the surface to 72 and 99 ppm in the stained soils encountered in the zero to two foot interval. Per the recommendation of the NMOCD, the excavation was halted after all detectable signs of contamination (stained or odiferous soils) were removed. The OVM was used to screen the soils for organic vapors. Soils emitting vapors in concentrations greater than 50 parts per million (ppm) were removed from the pit and disposed of as hydrocarbon-contaminated waste at the Envirotech facility. Soils below the 50 ppm limit were considered clean and used to backfill the excavation.

Per the approval of the NMOCD, clearance samples were not collected from Area C due to the lack of visibly significant contamination and existing analytical data. The maximum OVM response observed over the base and sidewalls of the completed excavation was 43.3 ppm.

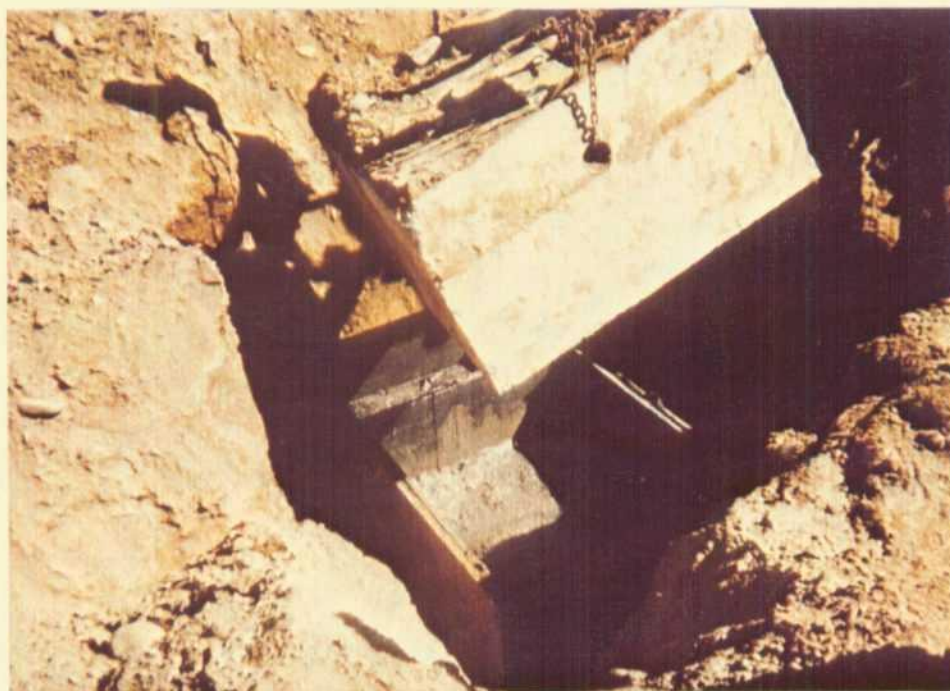
A-6. Removal of Top Half of HWS Building's Holding Tank

The HWS tank was removed in two halves (top and bottom). The bottom half was divided into two compartments by a concrete wall (Photograph A-6). Approximately one foot of a black, oily sludge was present at the bottom of both compartments. Both halves of the tank were removed

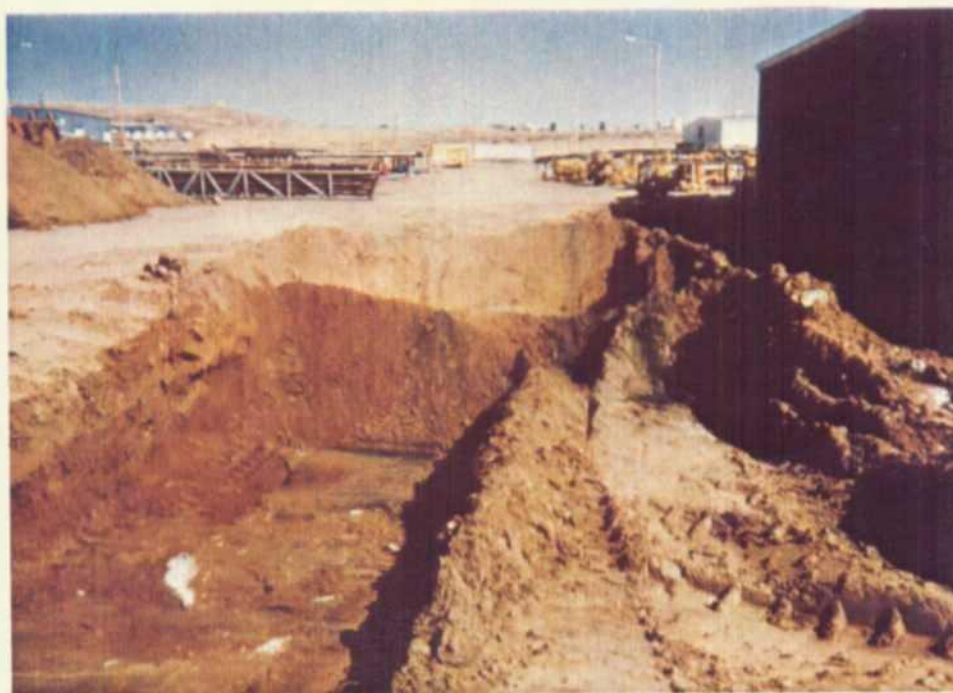
The top of the fill below the western half of the concrete pads was stained black (Photograph A-8) and had a strong hydrocarbon odor. The maximum OVM response observed in the shallow fill was 119 ppm. OVM responses increased with depth to 340 ppm approximately 5-ft below the northwest corner of the concrete pads. The holding tank for the HFTO leach field was exposed at the northwest corner of the HFTO building (Photograph A-9). The tank contained approximately 1000-gals of water and an undeterminable amount of sludge. Garcia's Septic Service transferred the water to a second, open-topped mud tank provided by HOMCO for temporary storage.

A-8. Stained Soils Exposed from Underneath HFTO Buildings's Concrete Pads

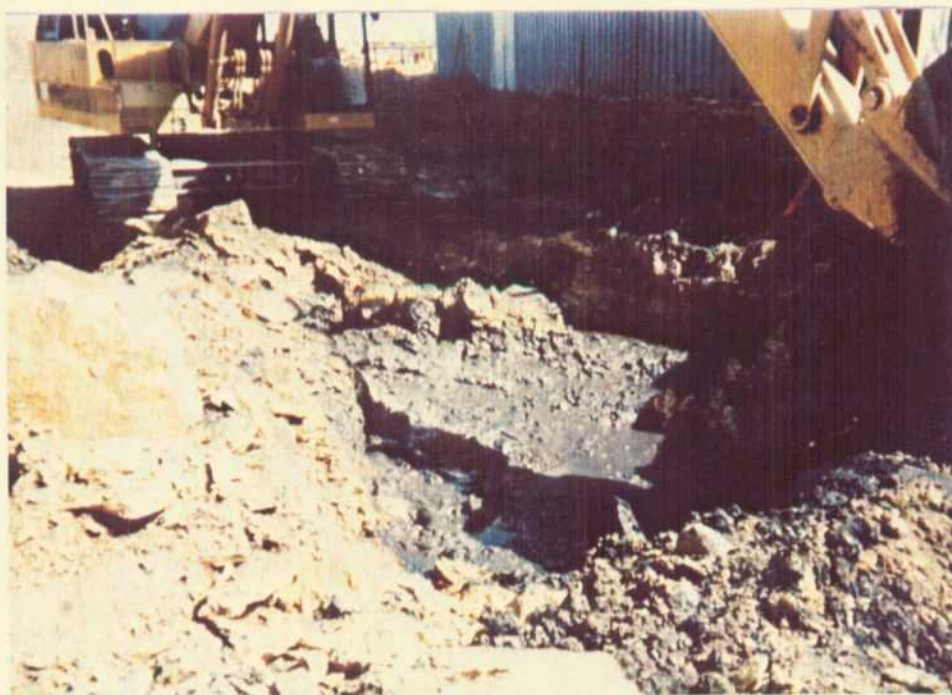
A-12. Sludge from HFTO Building's Holding Tank

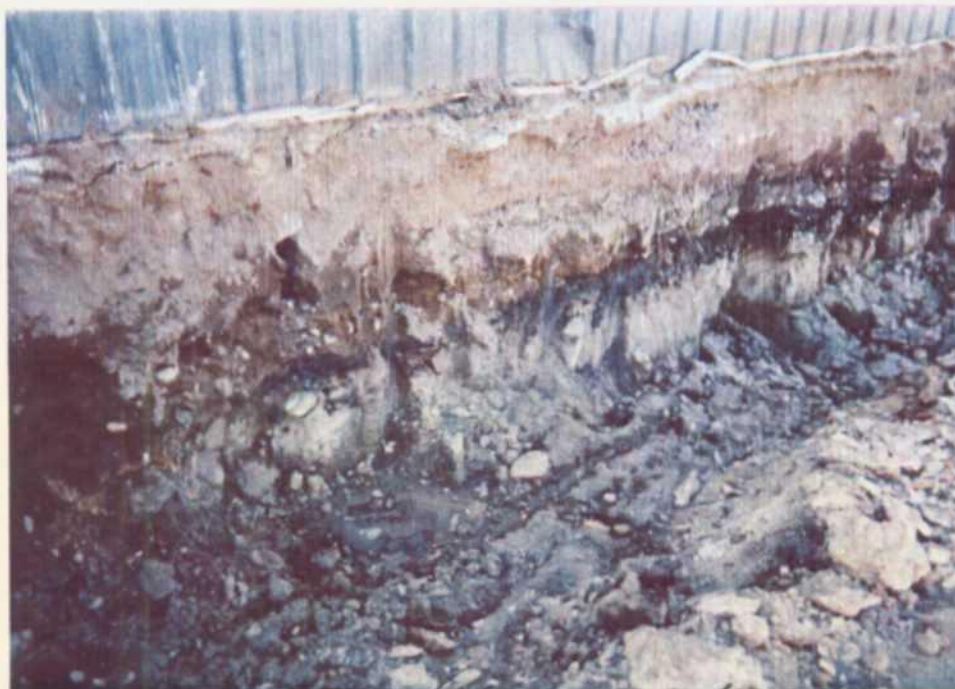
During the initial stage of the Area A excavation, the 2-inch (in) diameter PVC line connecting the HWS sump with the oil-water separator in the HFTO building was broken off flush with the north wall of the HFTO building (Photograph A-13). Liquid intermittently drained out of the pipe and collected in the deepest portions of the excavation until a plug was inserted in the pipe prior to backfilling. The pipe was hooked back up to the HWS building by Compton's Plumbing during the backfilling and compaction process (Photograph A-19).

A-13. Contamination along the South Wall of Area A and Inlet to HFTO Building's Separator

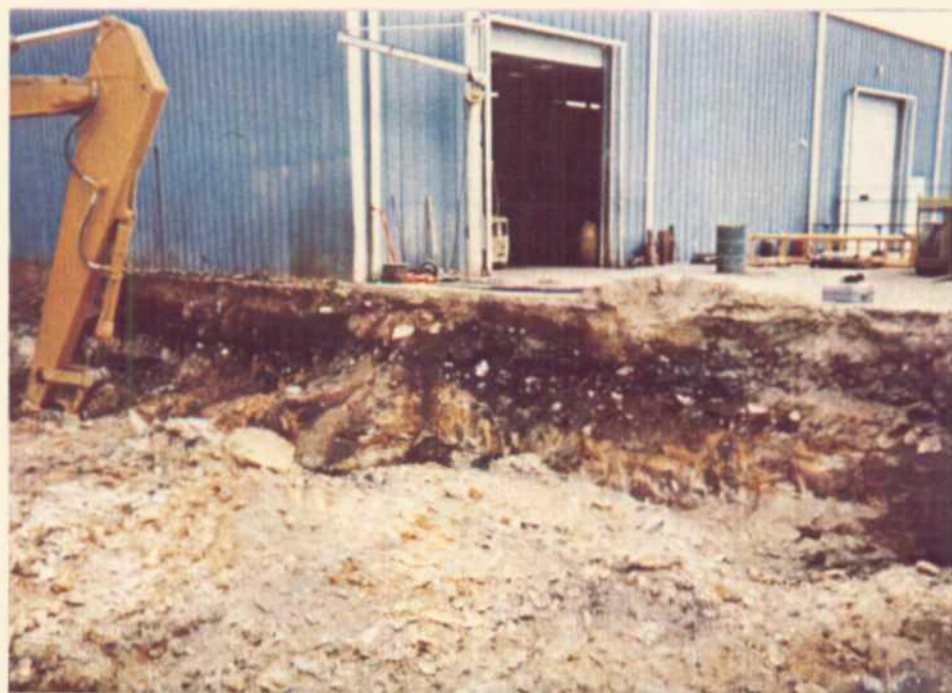
The extent of the excavation along the south wall is shown in Figure 4-3. Heavy hydrocarbon contamination was observed in a seam of cobbly gravel encountered approximately 3-ft below grade, starting about 43-ft west of the northeast corner of the HFTO building, and continuing past the southwest corner of the excavation (Photographs A-13 and A-14). The contamination appeared to persist southward under the building for an unknown distance. The extent of the contamination

was not investigated due to the likelihood of undermining the foundation and jeopardizing the structural integrity of the building. OVM responses recorded along the seam ranged from 32 ppm at the east end to 788 ppm under the northwest corner of the building. The sand and gravel in the seam were coated with an oily film and had a strong hydrocarbon odor.

A-14. Contamination Along South Wall of Area A Excavation

Based on field observations made during the excavation of Area A, it is evident that the contamination encountered under the concrete pads north of the HFTO building extends southward underneath the building. The concrete floor and apron of the building limits the infiltration of surface water and the resultant hydraulic head which helps to keep the contaminants stationary. The indoor sump at the north end of the building has been leaking for an unknown length of time. At present, the sump is scheduled to be removed during the construction of the HFTO building addition, at which time a new sump will be installed along with a leak detection system. The soils under the sump will be evaluated when the new sump is installed.

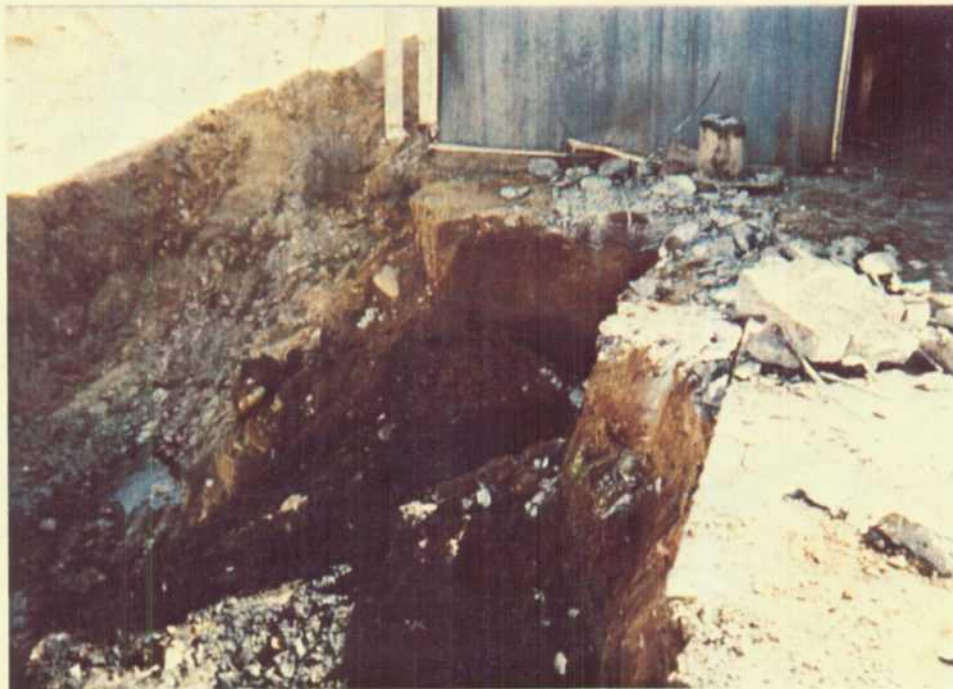
A-16. Damage to HFTO Building After Sump Removal

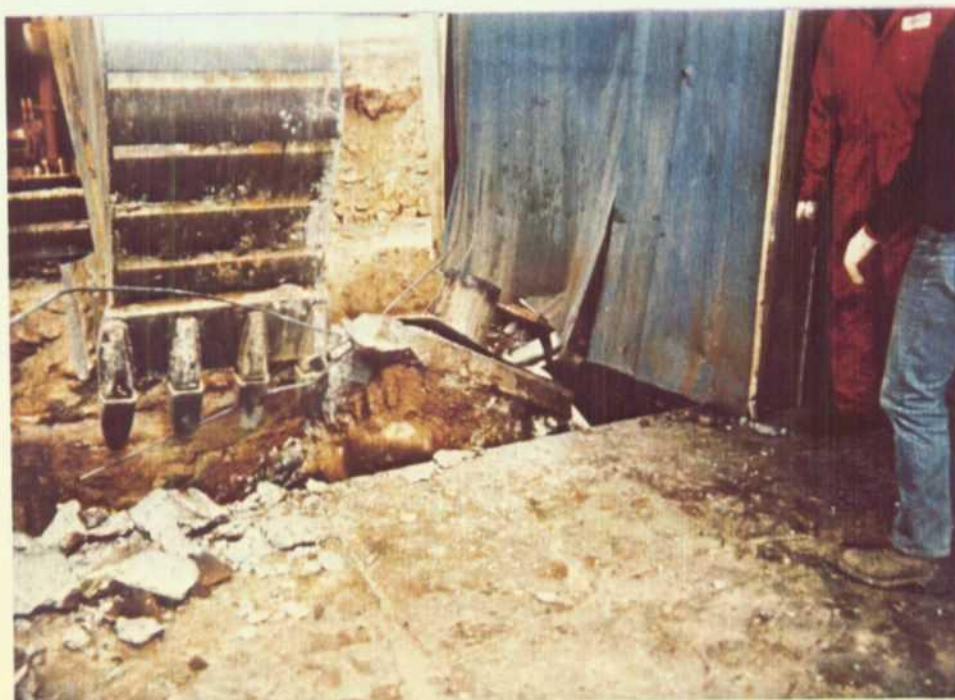
A-17. Damage to HFTO Building After Removal of the Base of the Crane

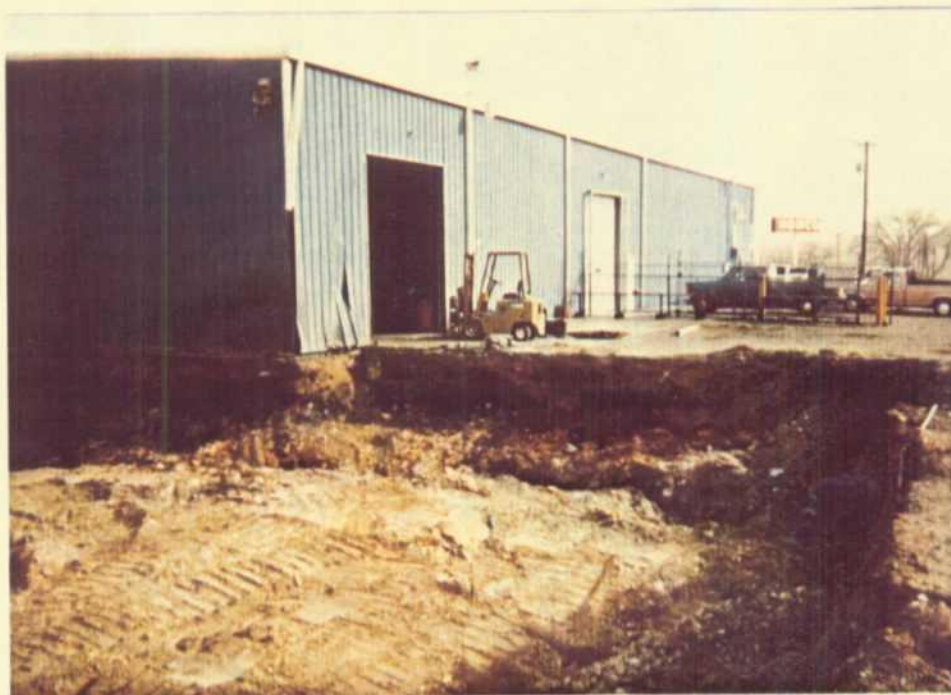
A-18. Contamination in Southwest Corner of Area A Excavation
