GW - 232

**Re: Closure Inspection Report, GW-232
Trunk "A" Compressor Station
Chavez County, New Mexico**

OCD Inspection: EPCO Trunk A, GW - 232

Date: 08.27.08

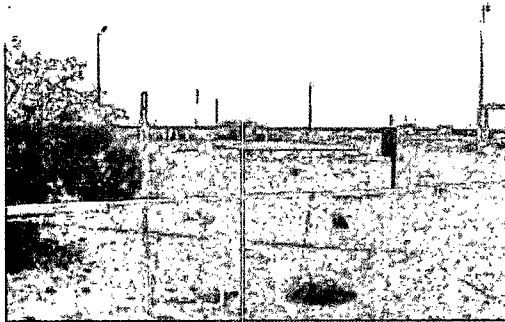
1. **Photos 1 & 2:** Compressor concrete slab is still on site with protruding underground conduits. Enterprise shall remove concrete slab and conduits.
2. **Photo 3 – 6:** Used and remaining debris, tanks and barrels need to be removed and properly disposed of, **photo 4**, show tank bottoms located directly on the ground. Waste shall never be placed directly on the ground. Enterprise shall properly remove unused items, waste and clean up any soil contamination on site.
3. **Photo 15:** An unused saddle tank is left in the yard. If tank is not longer needed for operation of this facility it shall be removed from site. Enterprise shall remove this tank if not in use.

Photo 1: Cement slab from compressor location remaining.

Photo 2: Close up of located compressor slab.

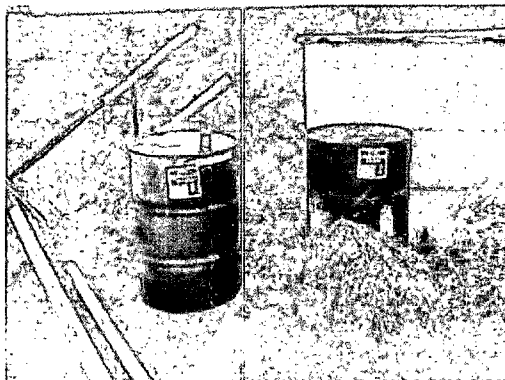
Photo 3: Located on the east side of yard, identified barrels located on ground. White colored bin has oil.

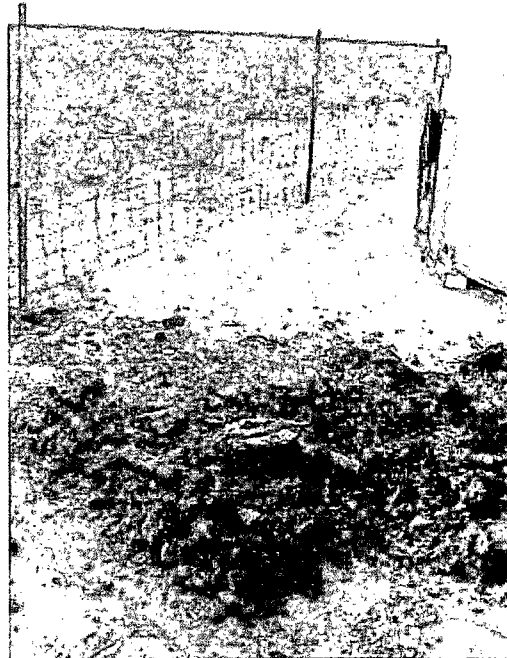
Photo 4: Assumed tank bottoms disposed on ground on east side.

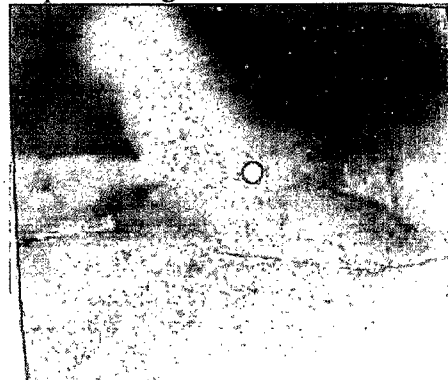
Photo 5: Residuals in empty tank.

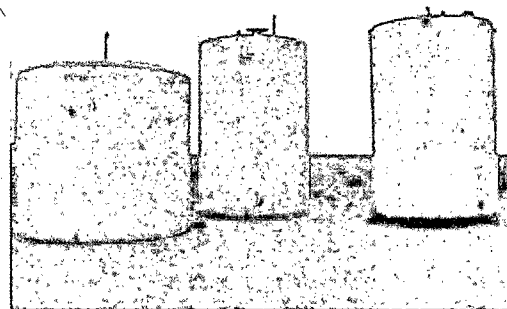
Photo 6: Used tanks not in use.

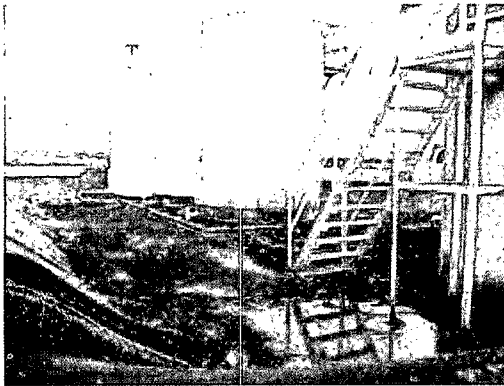
1. **Photo 7, 11, 12:** The integrity of liner underneath the three above ground storage tanks is a concern to the OCD. The liners are not properly seamed and welded throughout. Enterprise Field Services shall properly reline this containment area.
2. **Photo 8 – 10:** The integrity of the below grade tank needs to be verified. Liquids are present within its leak detection system. The leak detection appears to have a breach in its upper boundary, **photo 10**, where detection of false readings may result. Enterprise Field Services shall remove the liquids from the detection system and prevent any unnecessary fluids from entering. The OCD also requests the engineering design drawing of this tank.
3. **Photo 13:** this above ground storage tank has a visible pin-hole leak. This is unacceptable. Enterprise Field Services shall either repair the tank or replace it immediately.

Photo 7: Three AST's still in use, Trunk A. Residual fluids in secondary. BGT located near stairs.

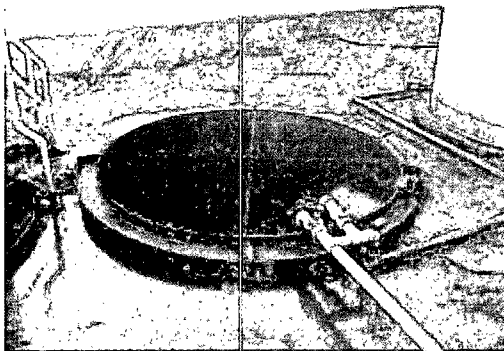
Photo 8: BGT surround by fluids.

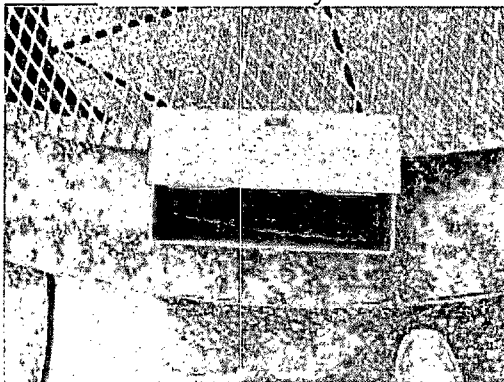
Photo 9: Leak detection of BGT, has fluids.

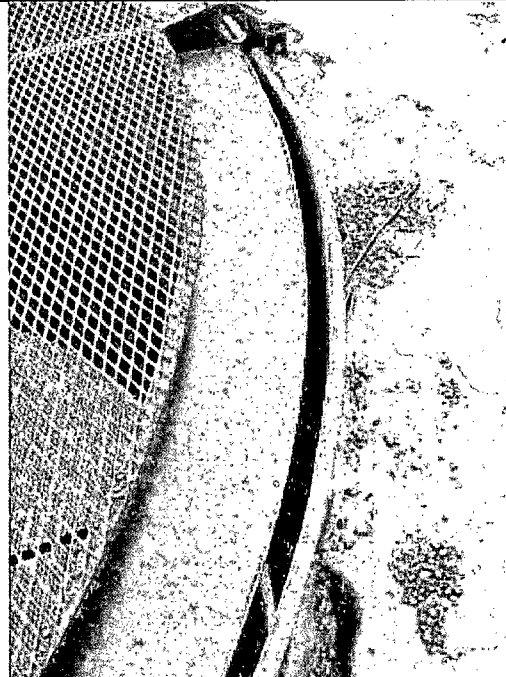
Photo 10: Unsealed cover of BGT. Opening is in secondary area.

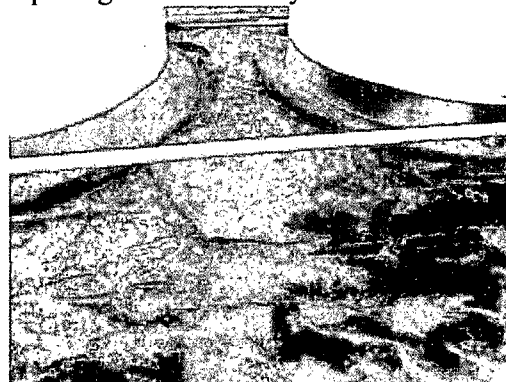
Photo 11: Liners are not sealed or appear to be one continuous barrier.

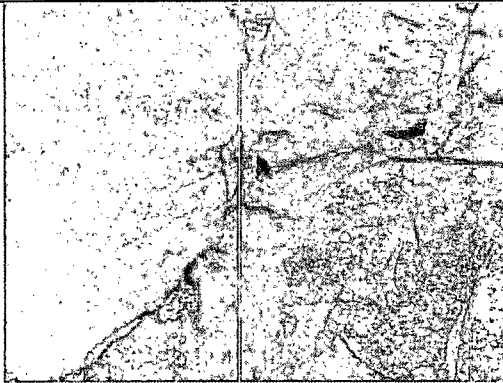
Photo 12: Liners around AST batteries not properly sealed.

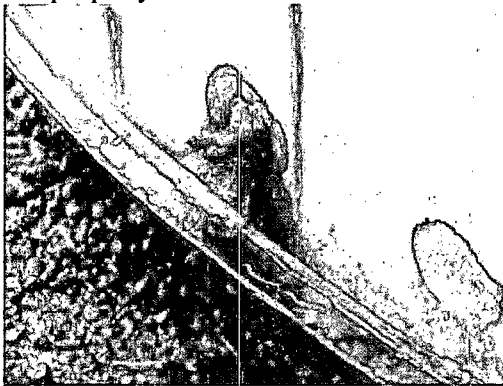
Photo 13: "Pipeline Liquids" tank located on far east side of battery has a pin hole leak. A temporary insufficient plug is in place blocking leak.

The OCD is requesting that Enterprise Field Services **submit a discharge plan application** for the remaining tanks and activity located at this station. The OCD has concluded that the conditions of all tanks on location do not adhere to best management practices. Enterprise Field Services has **30 days, by October 31, 2008** to submit a renewal application for this facility. The application shall provide resolution to the leaking tank, the liner and the below grade tank. Submit the application to Mr. Jim Griswold.

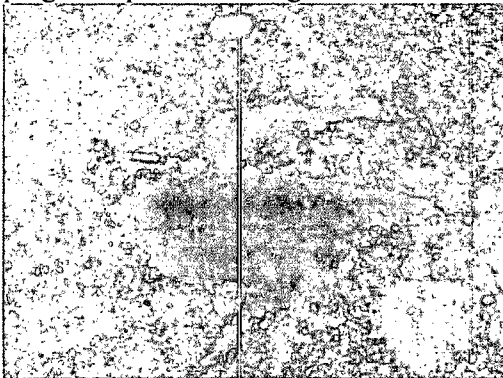
Photo 14: Unknown reddish dirt located on the southwest side of the yard.

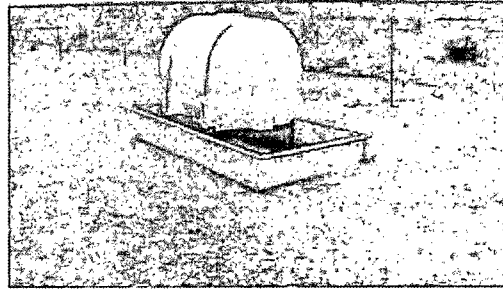
Photo 15: Saddle tank, unused, located on southwest side of yard.
