GW - 255

**INSPECTIONS &
DATA**

1996-2002

Re: Results of the annual sump integrity inspection program - Val Verde Facilities.

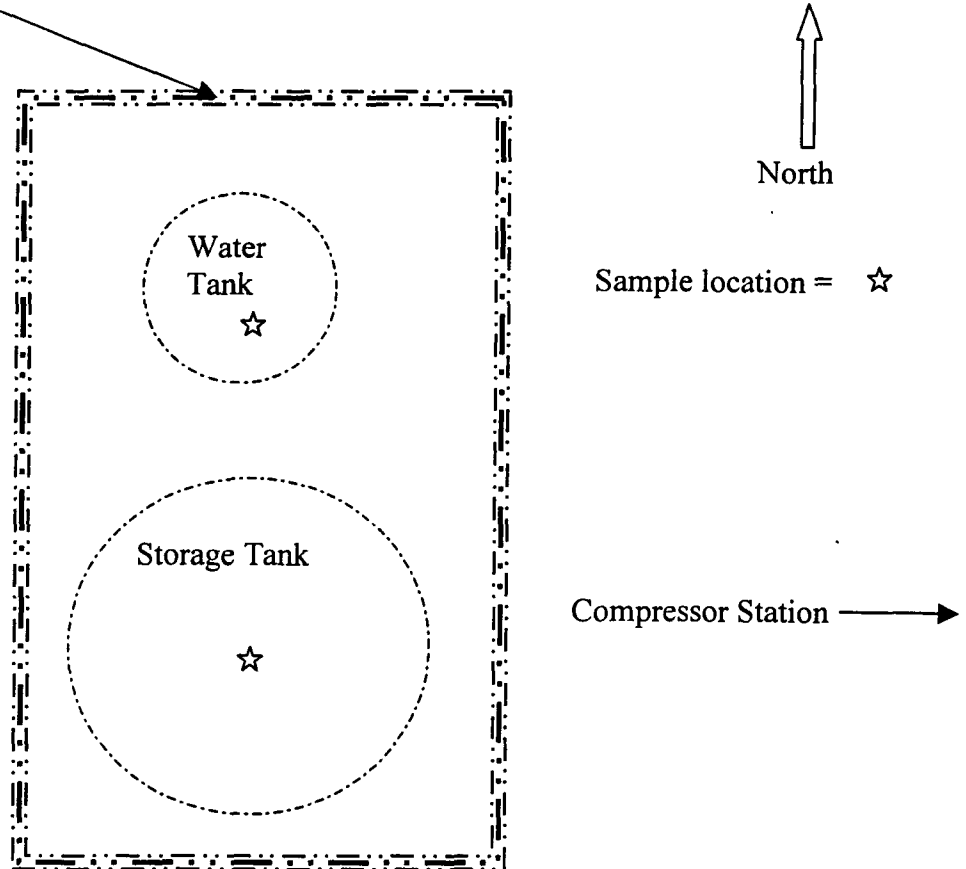
Excavation Boundary

Sample from Water Tank collected at 8 feet PID field reading 0.0 ppm

Sample from Storage Tank collected at 16 feet BTEX = < 50 ug/kg
DRO/GRO = <30 ug/kg
PID = 0.0 ppm

1. Area under both tanks excavated following the extent of soil contamination staining
2. Samples were collected at the deepest point of contamination under each tank.
3. The contamination was confined to area within berm perimeter (20 feet x 30 feet) and to a maximum depth under the storage tank of 16 feet.
4. Soil was replaced with clean fill and compacted and new water tank and the old storage tank were placed on liners and a berm reconstructed
5. Contaminated soil was land farmed at Quinn Compressor Station location

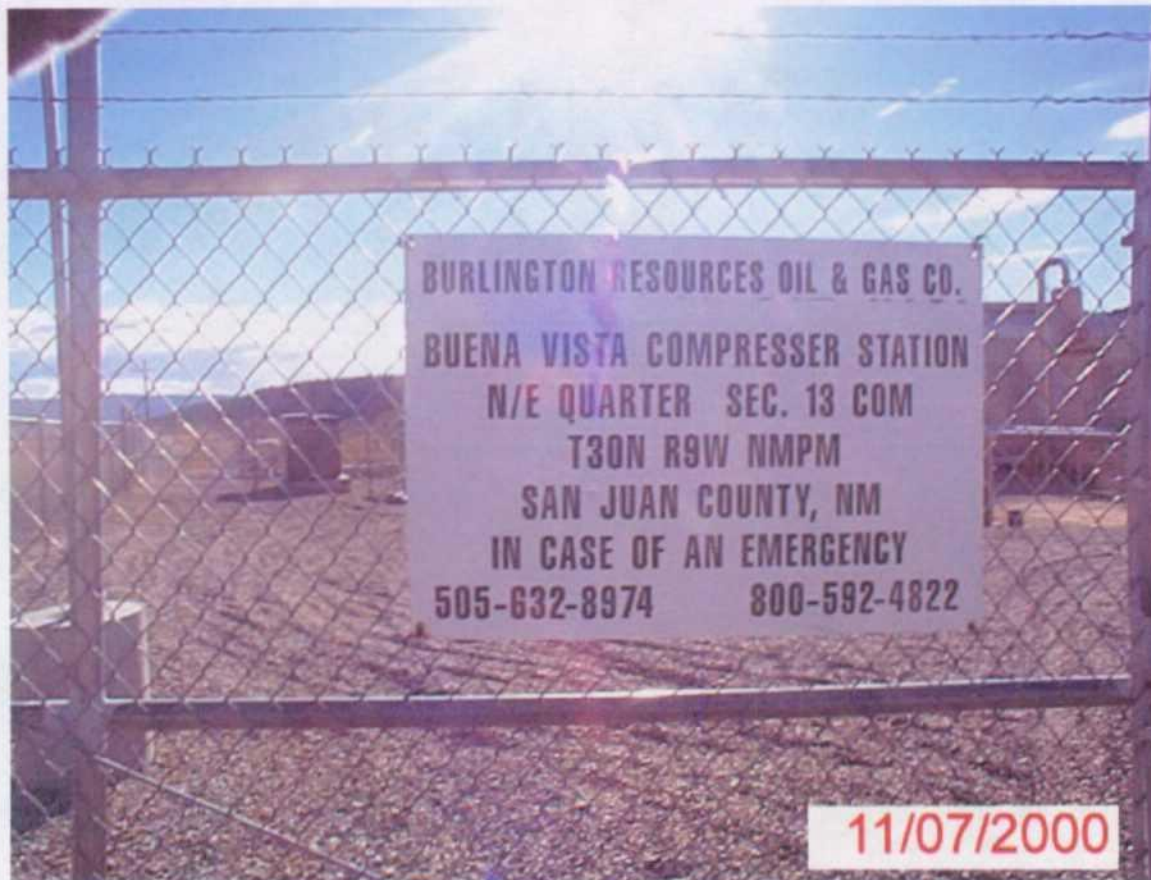
Picture #1-Sign

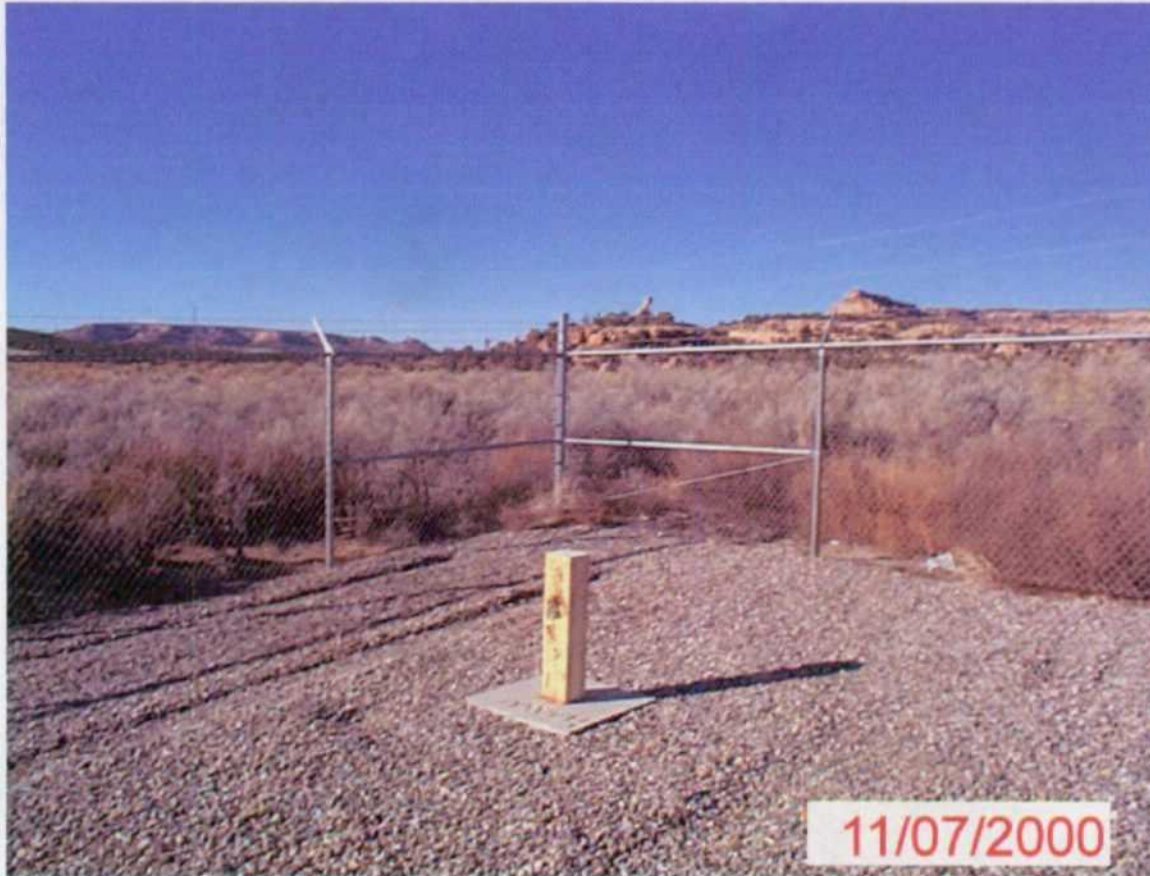
Picture#2- Monitor Well located in NE ^W part of yard.

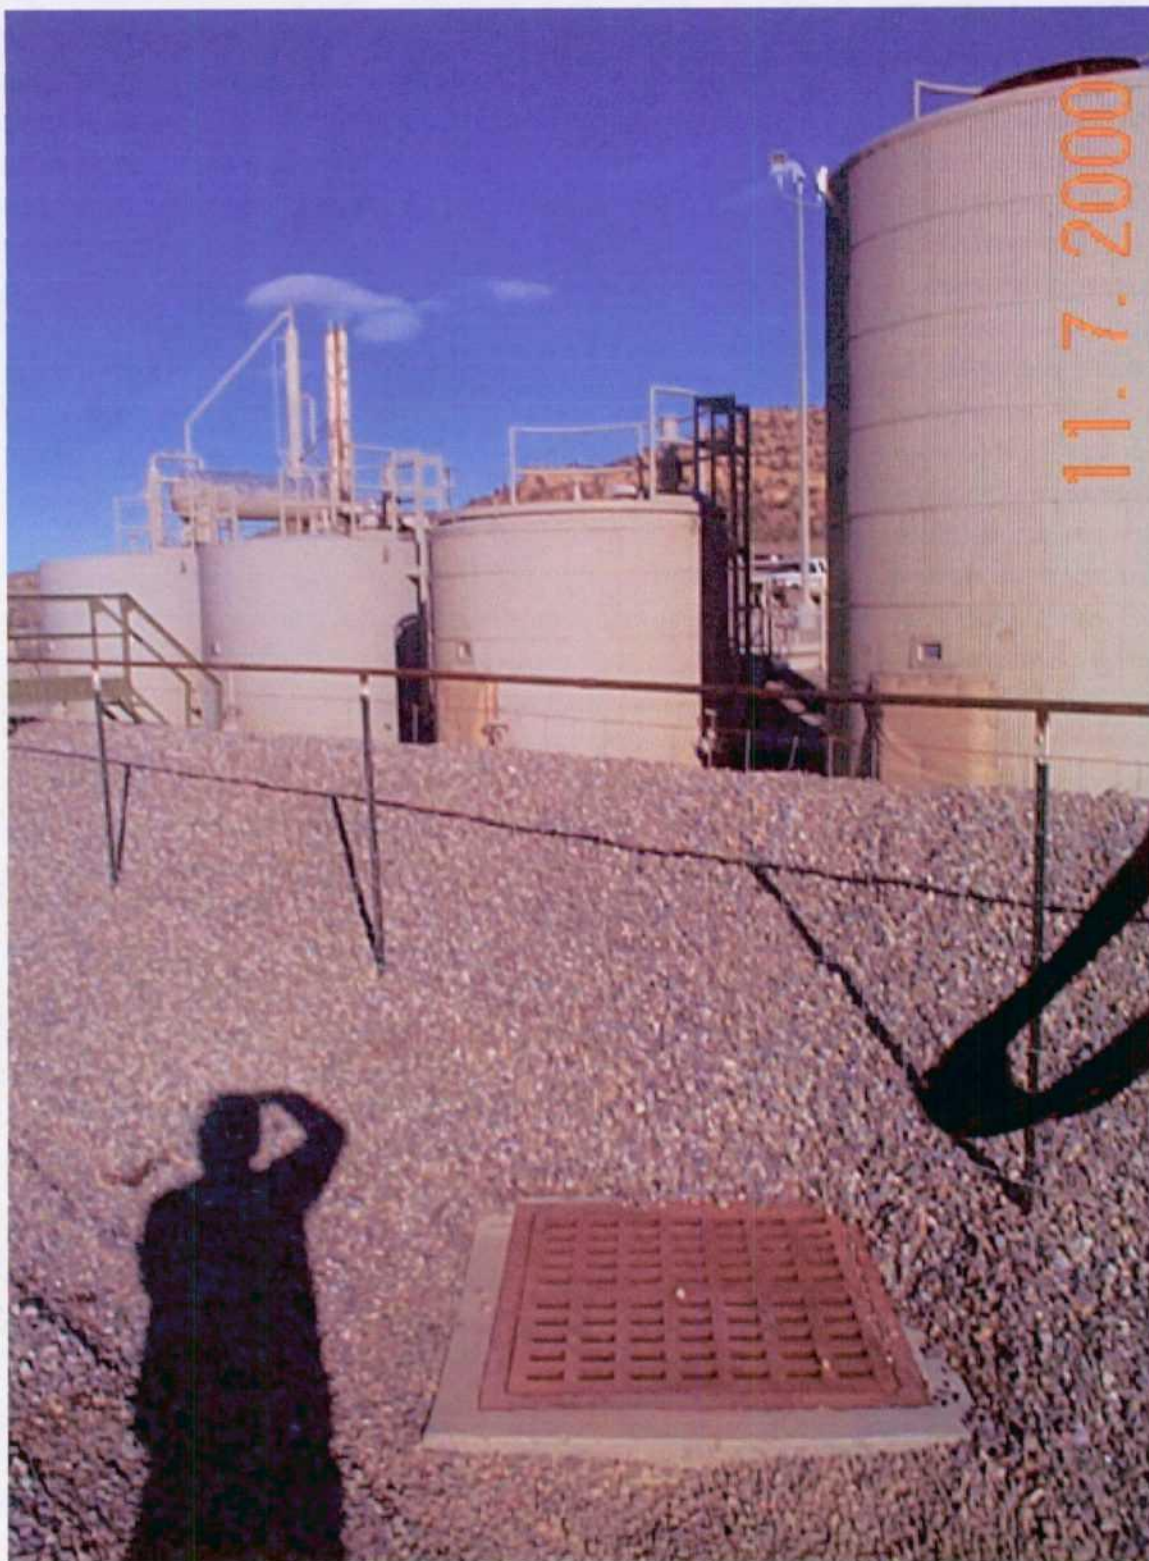
Picture #3- Stormwater Drain located west of tank battery

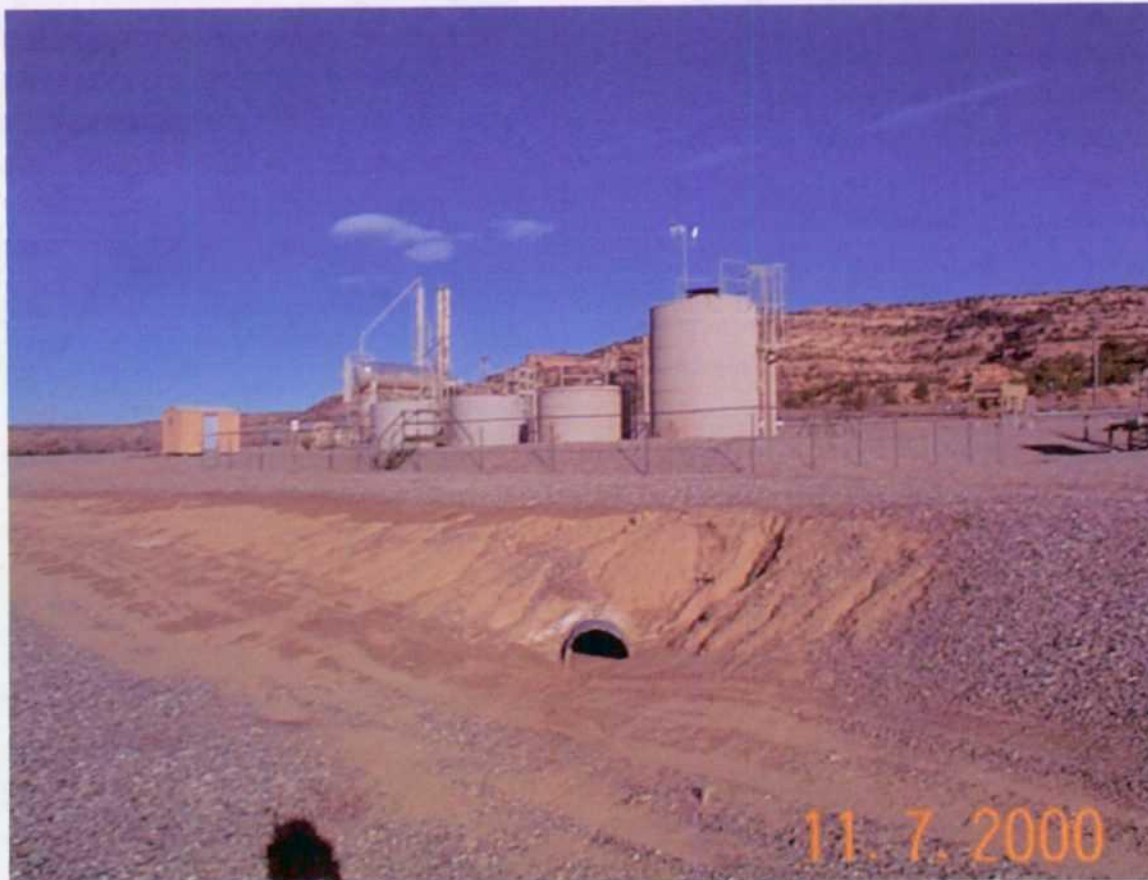
Picture #4- Looking NE- Stormwater drain pipe.

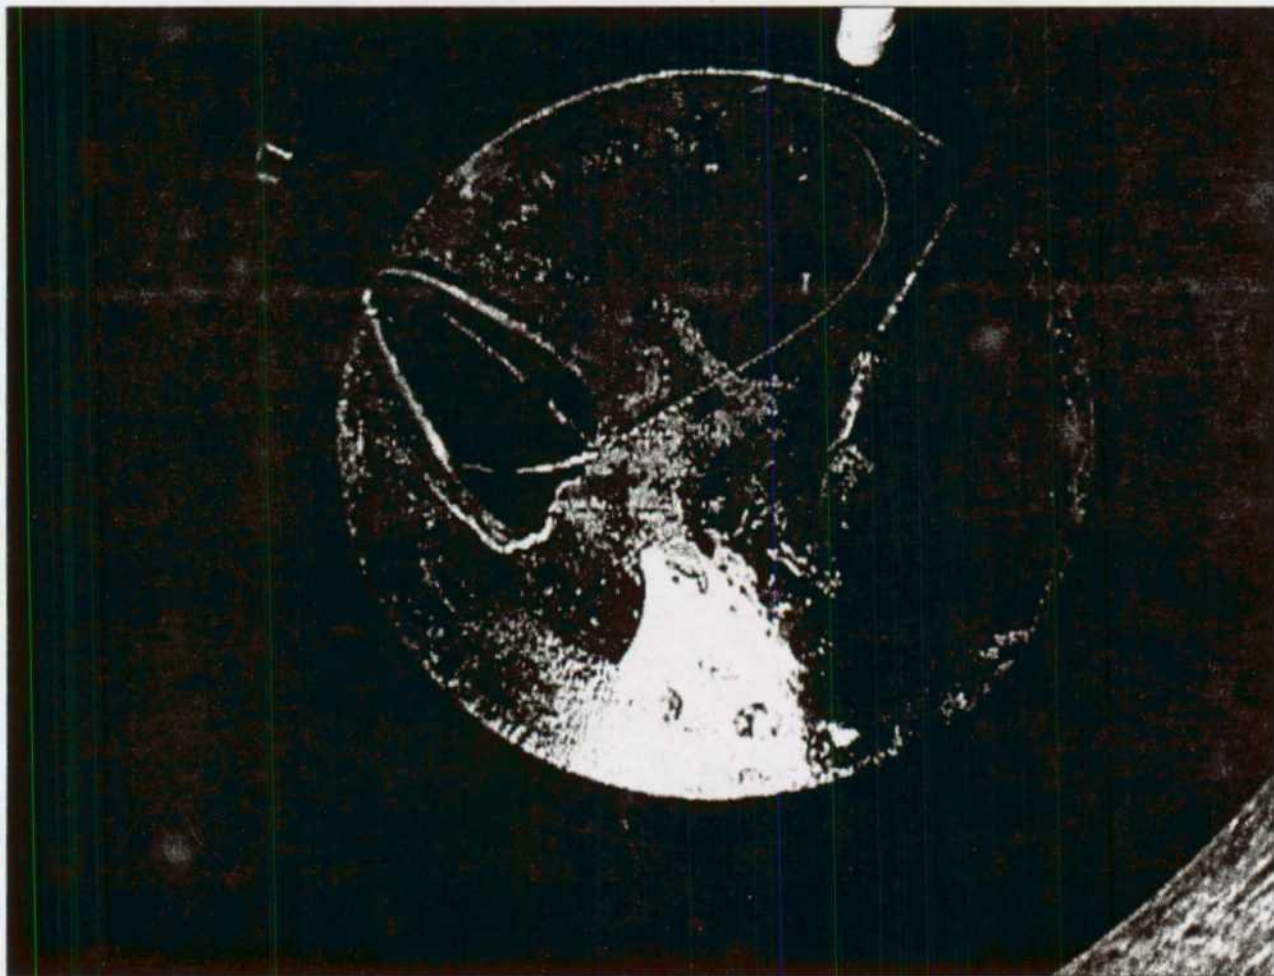
Comments: No problems were observed. Kevin Johnson was present for all sump inspections.

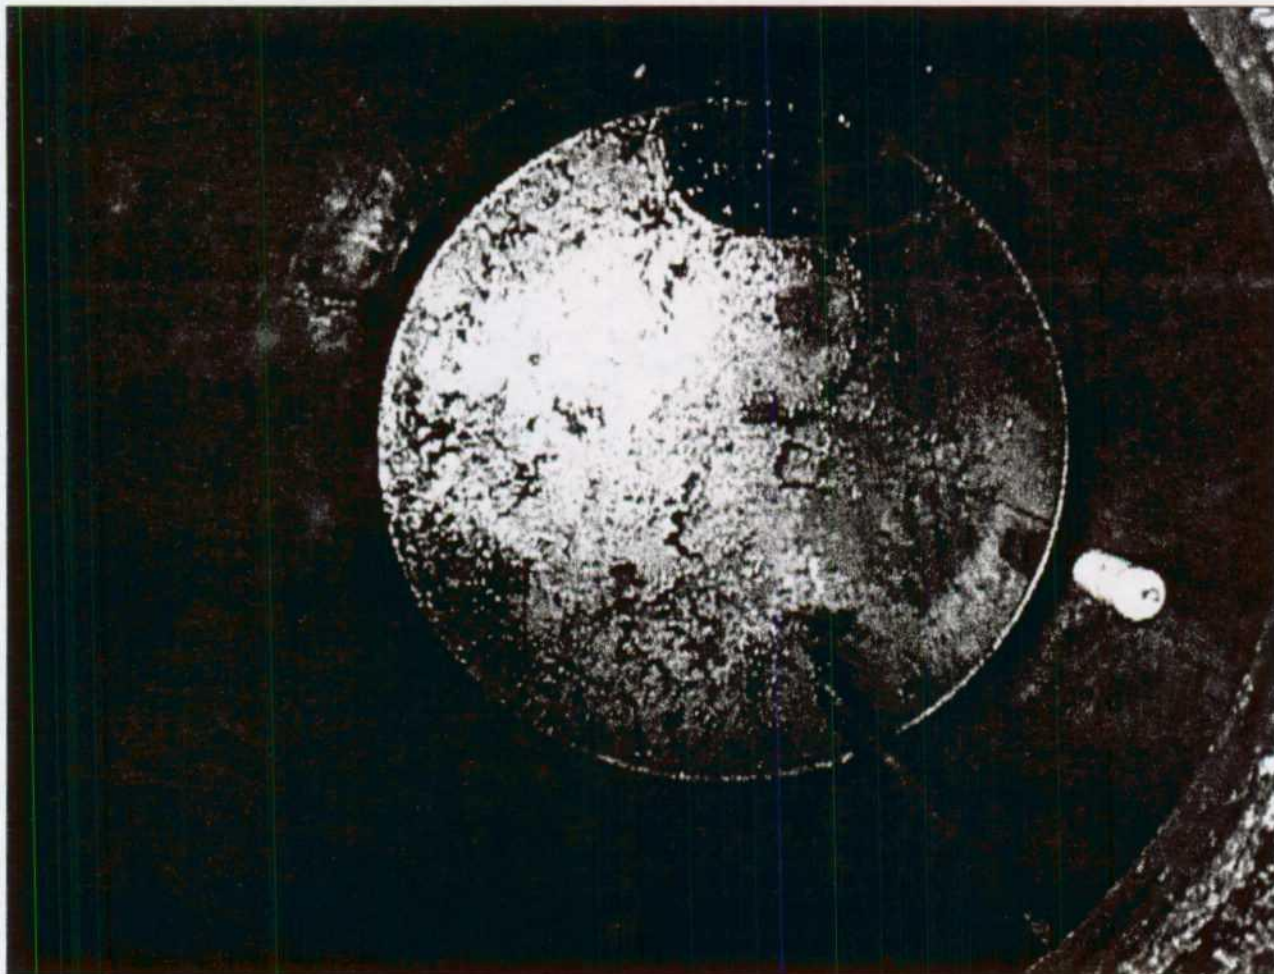
Comments: No problems were observed. Kevin Johnson was present for all sump inspections.

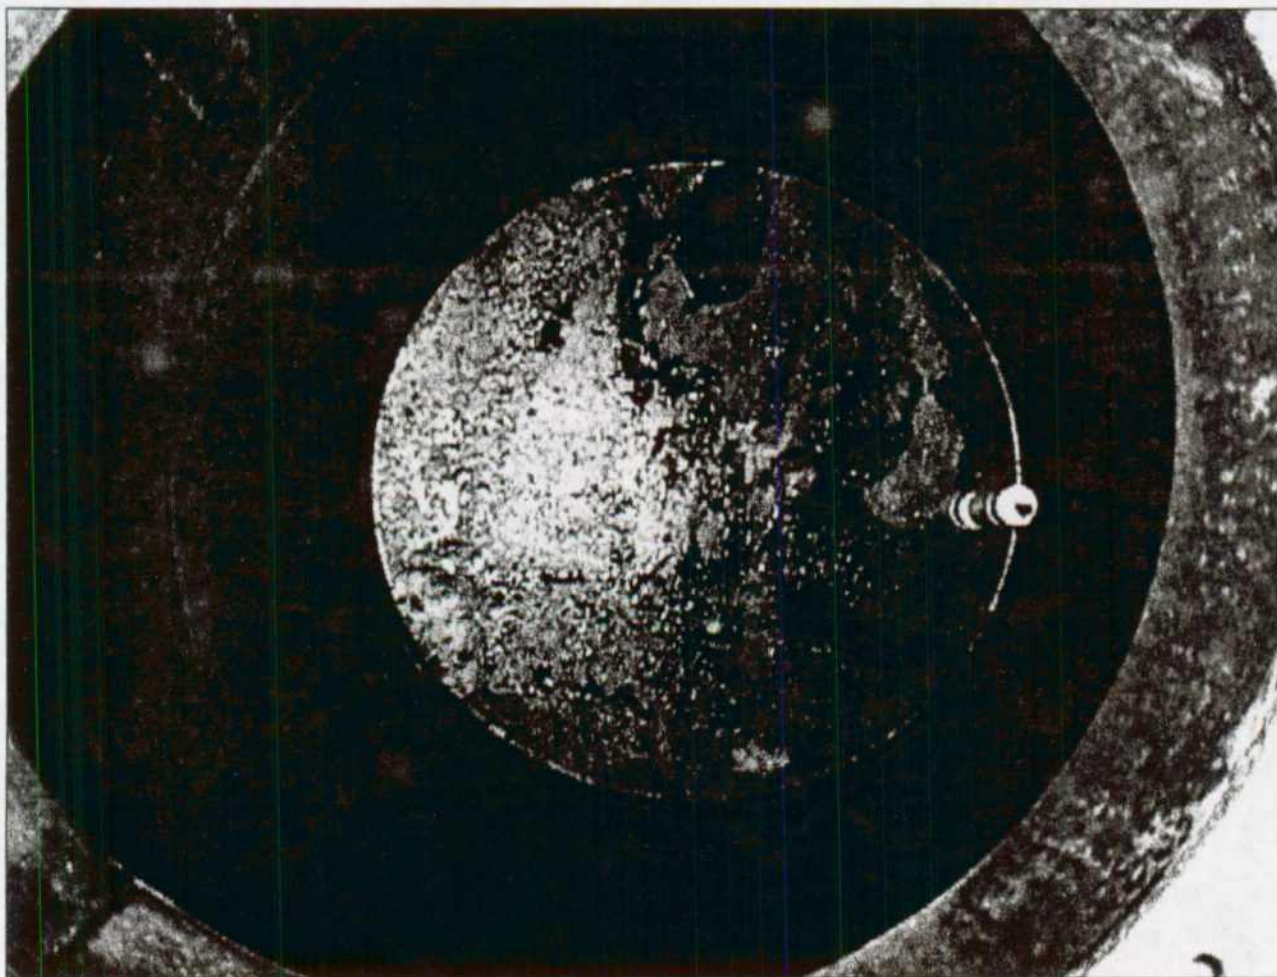
Comments: No problems were observed. Kevin Johnson was present for all sump inspections.

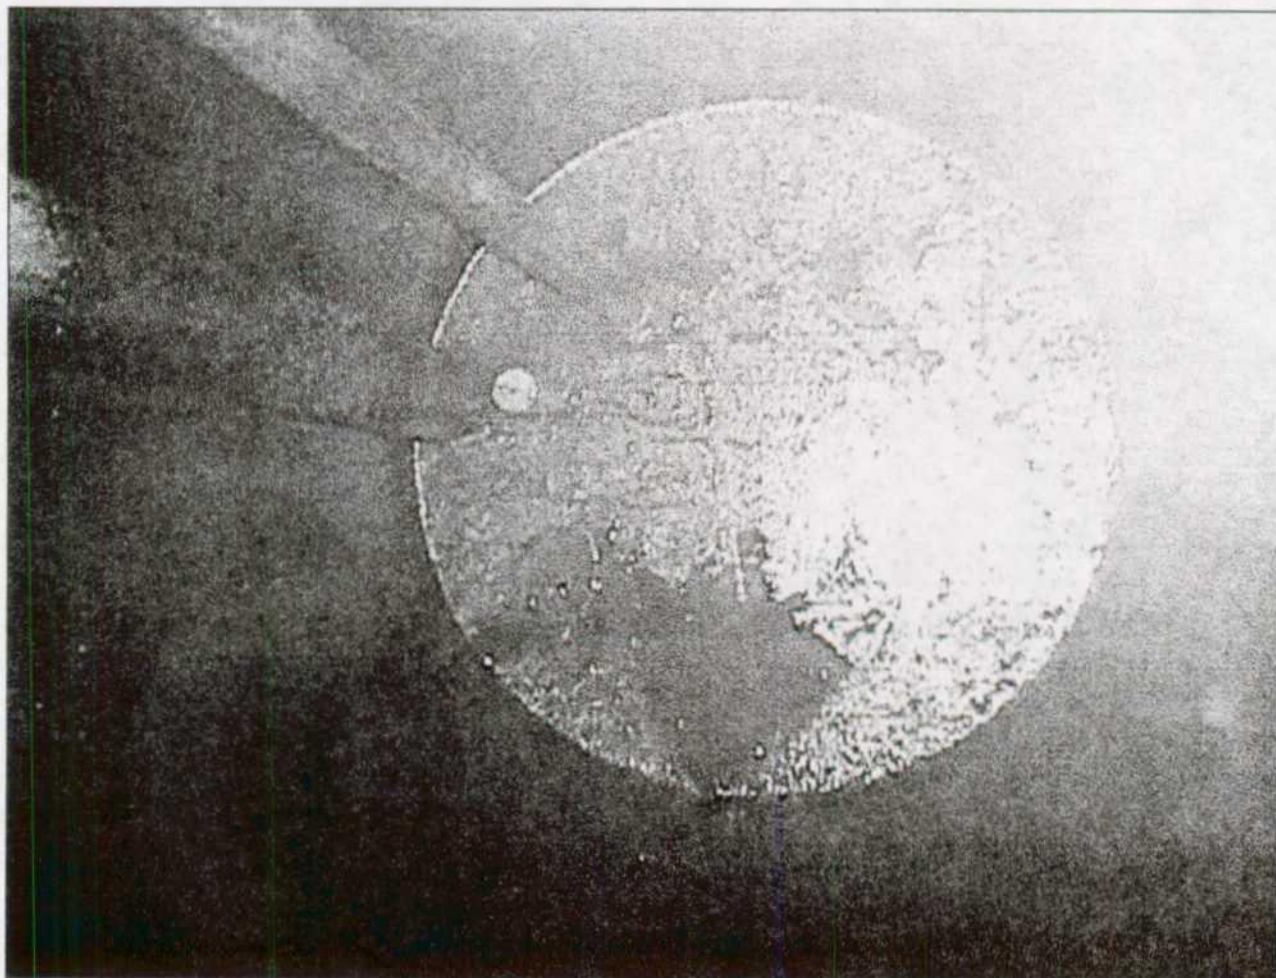
No problems were observed. Kevin Johnson was present for all sump inspections.

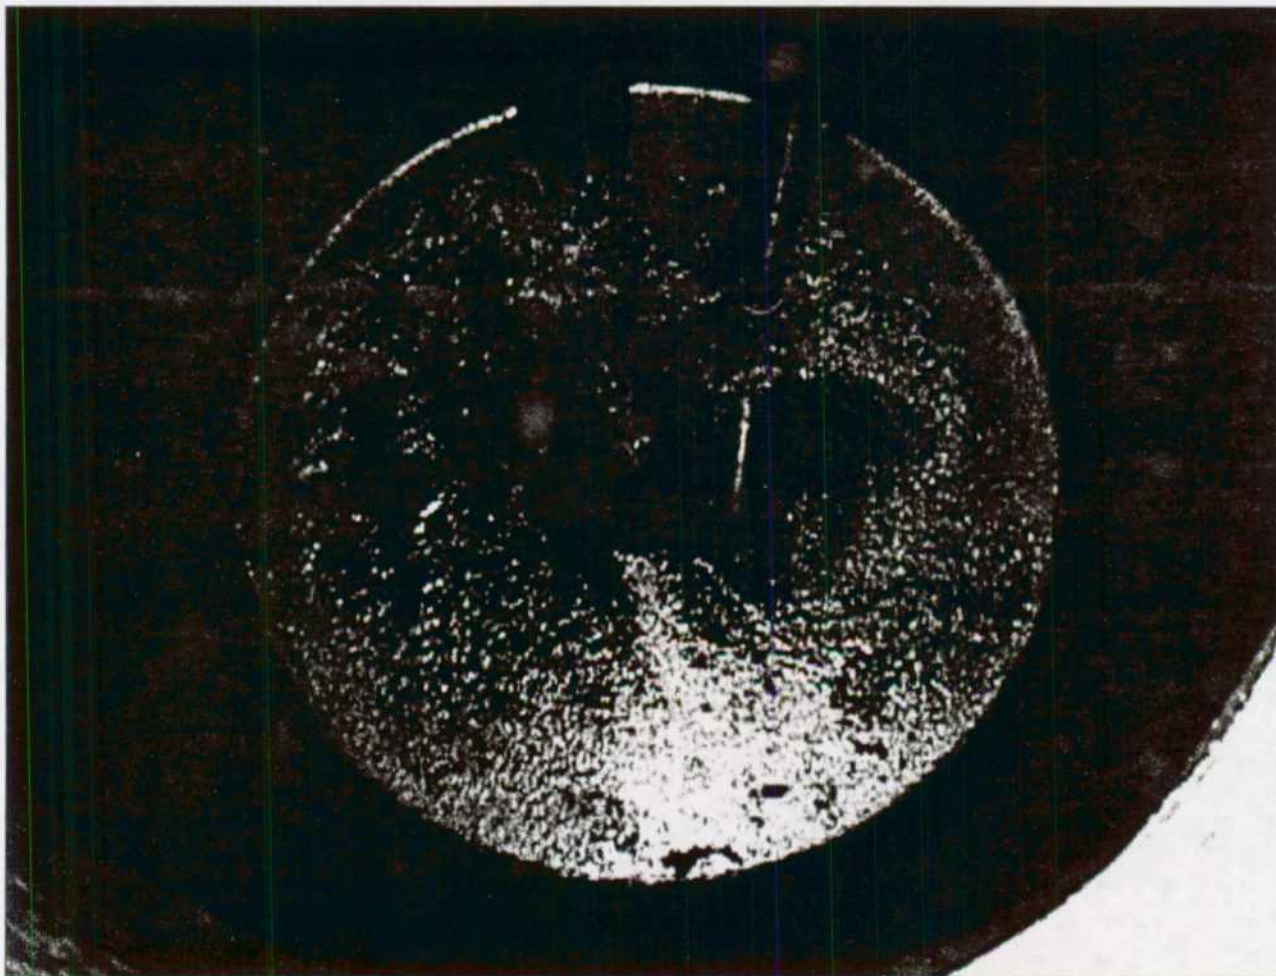
Comments: No problems were observed. Kevin Johnson was present for all sump inspections.

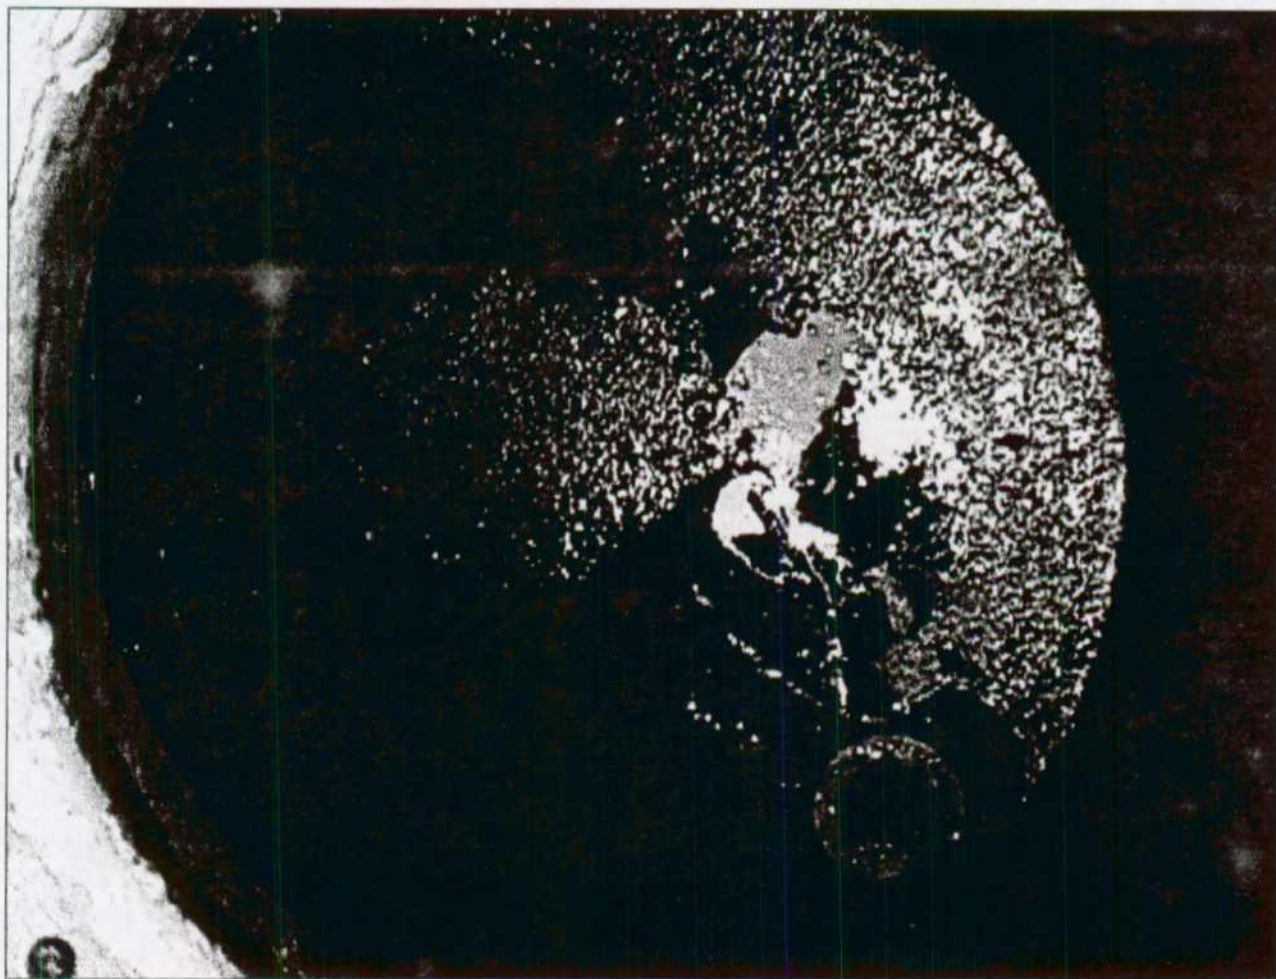
Comments: No problems were observed. Kevin Johnson was present for all sump inspections.

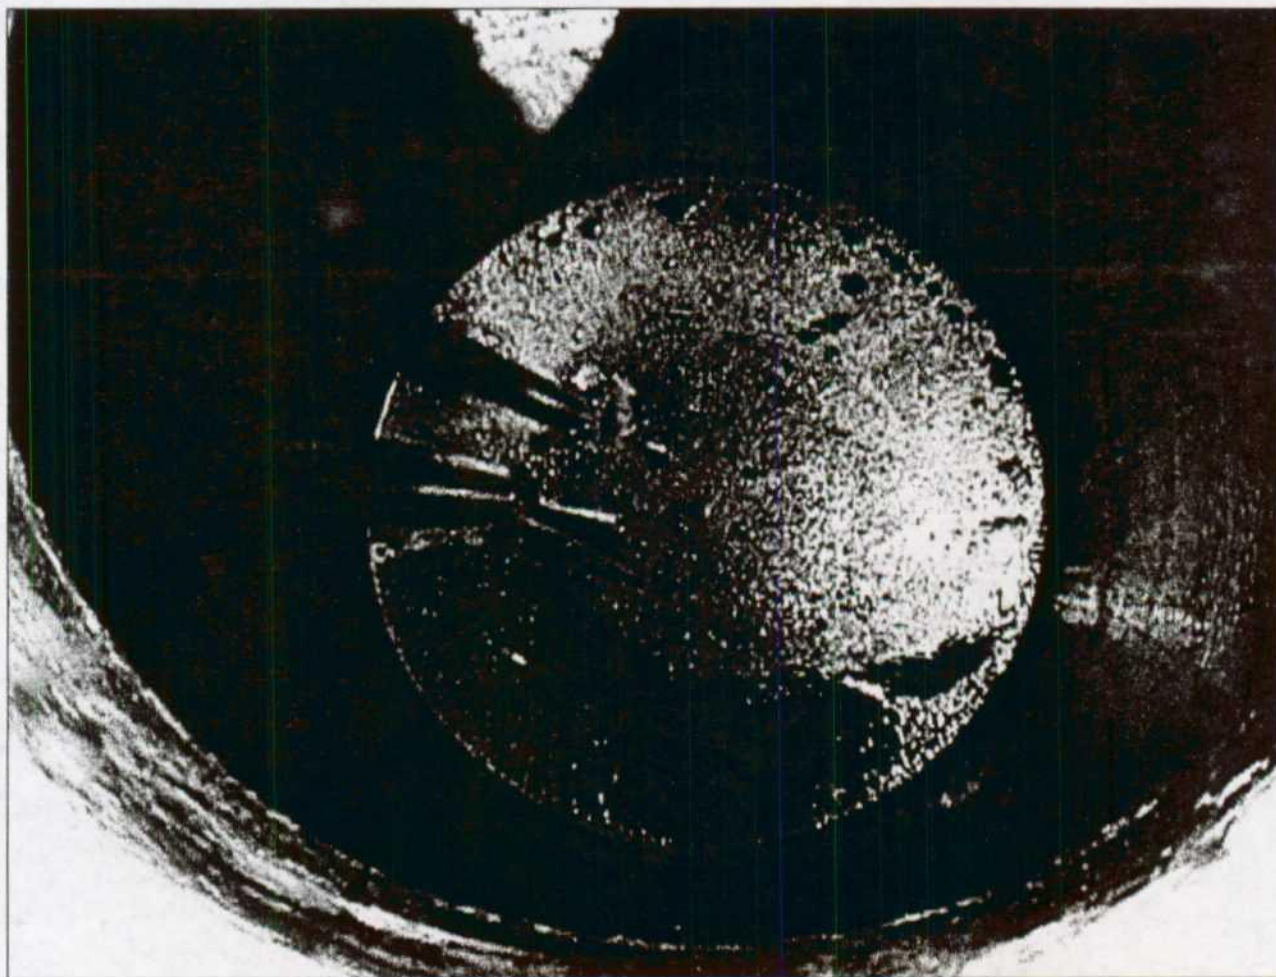
Comments: No problems were observed. Kevin Johnson was present for all sump inspections.

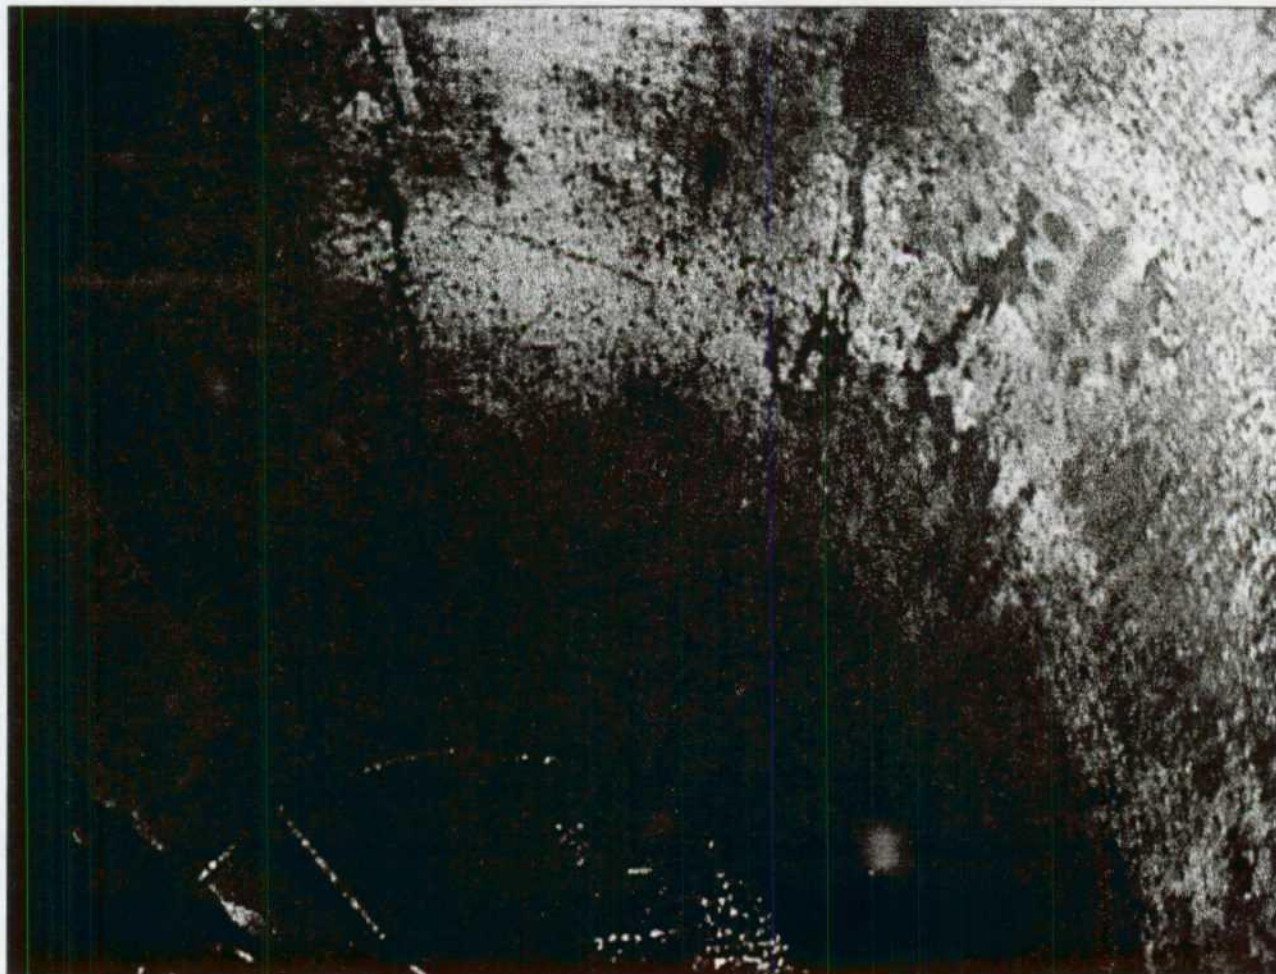
Comments: No problems were observed. Kevin Johnson was present for all sump inspections.

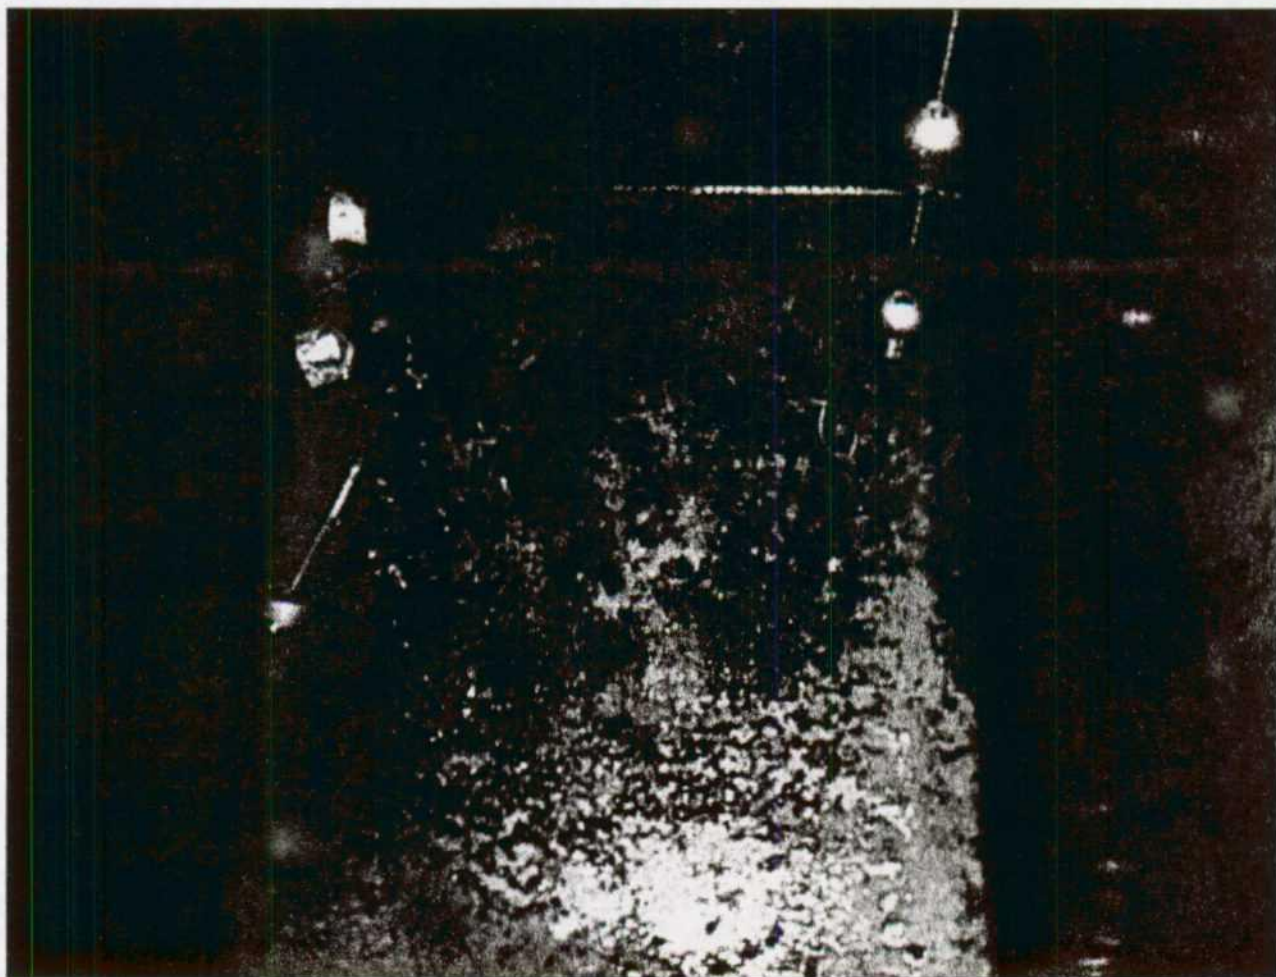
Comments: No problems were observed. Kevin Johnson was present for all sump inspections.

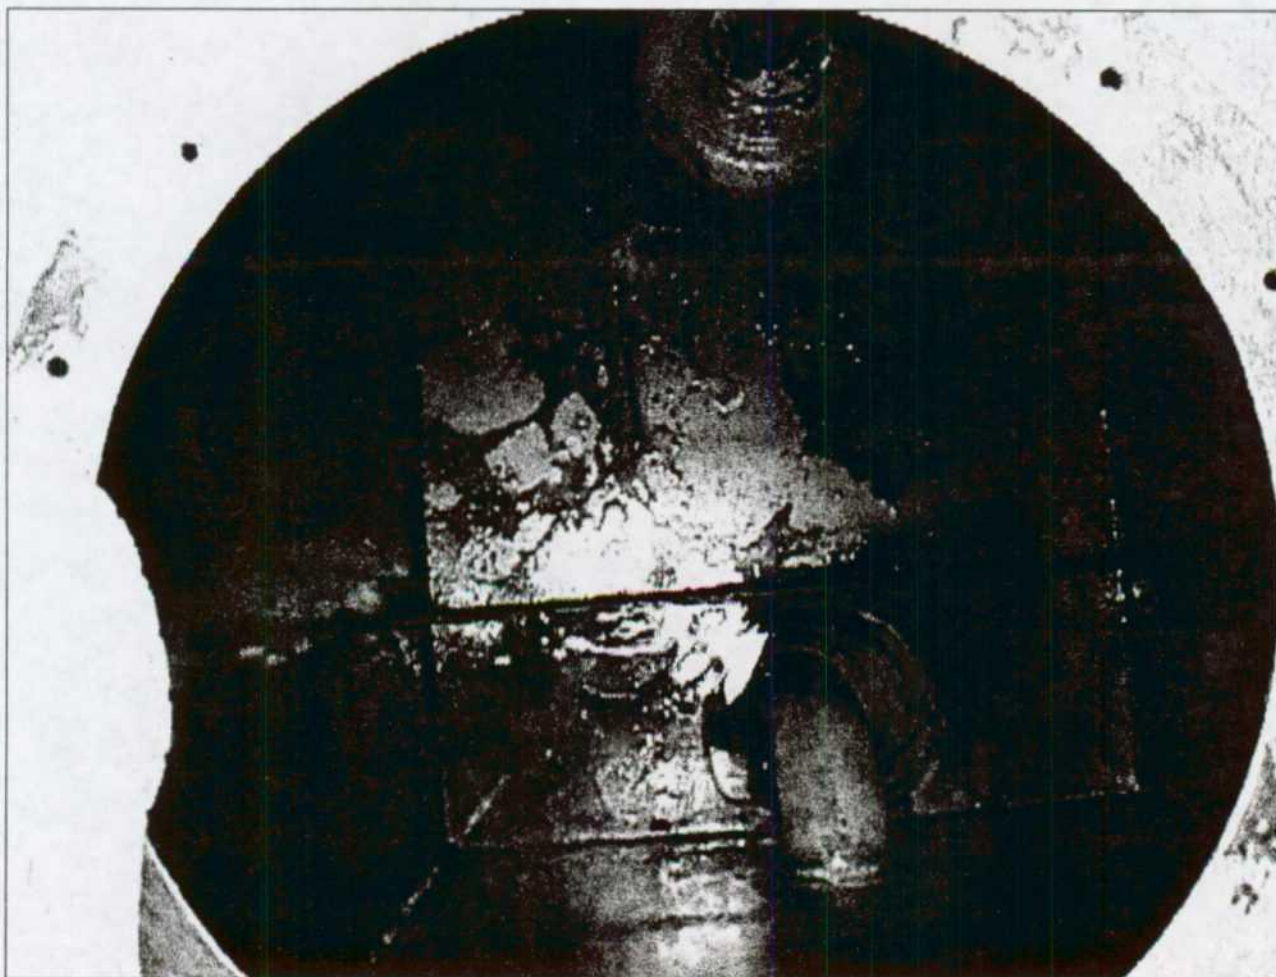
Comments: No problems were observed. Kevin Johnson was present for all sump inspections.
