1R - 143

Re: Final Well Plugging
Equilon Pipeline Company
Shell Pump Sites 1, 2, & 3- Jimmy Cooper Ranch
Monument, Lea County, New Mexico

**Re: Shell Tank Battery Sites 1, 2, and 3
Jimmie Cooper Ranch
Monument, Lea County, New Mexico**

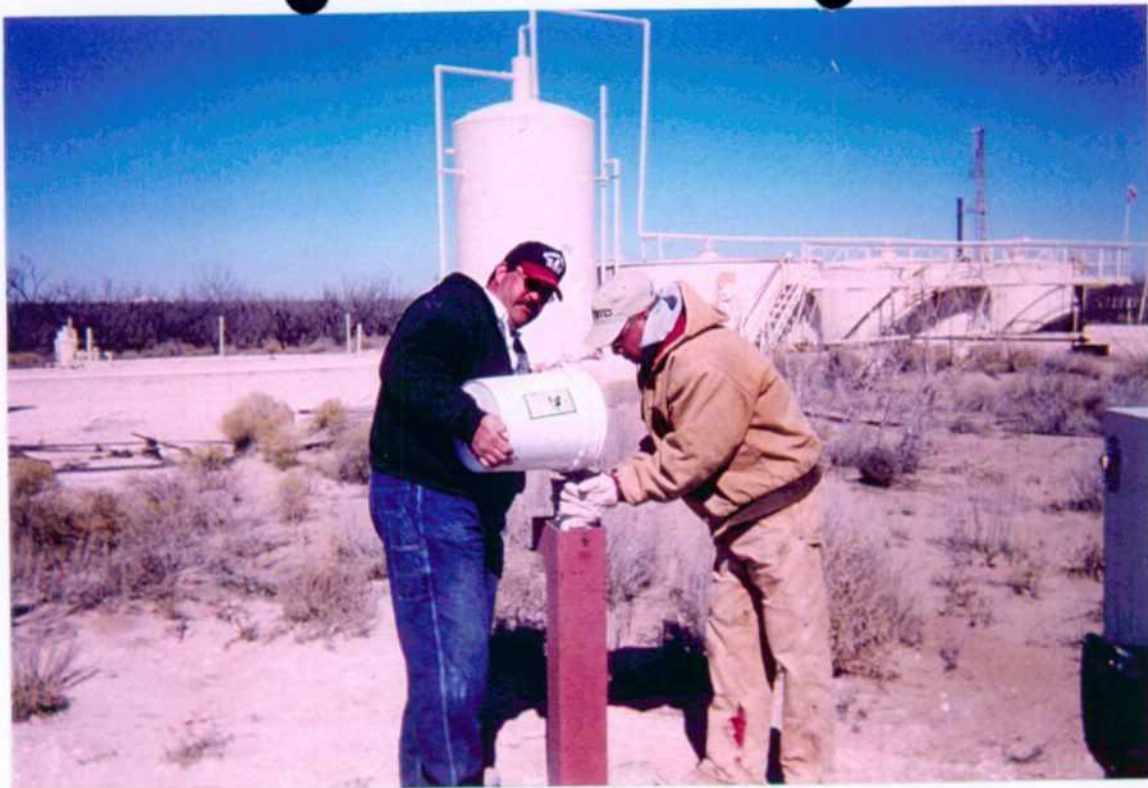
Photo 1: Grouting of monitor well MW-1.

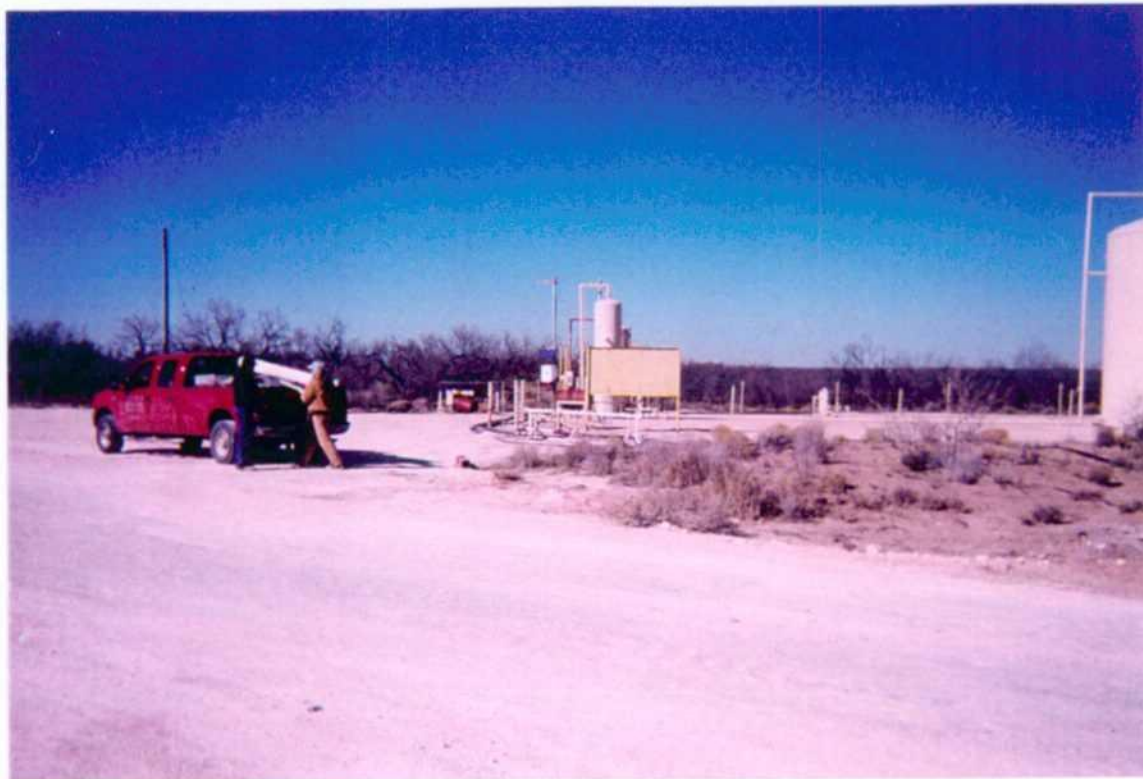
Photo 2 : Removal of monitor well MW-1.

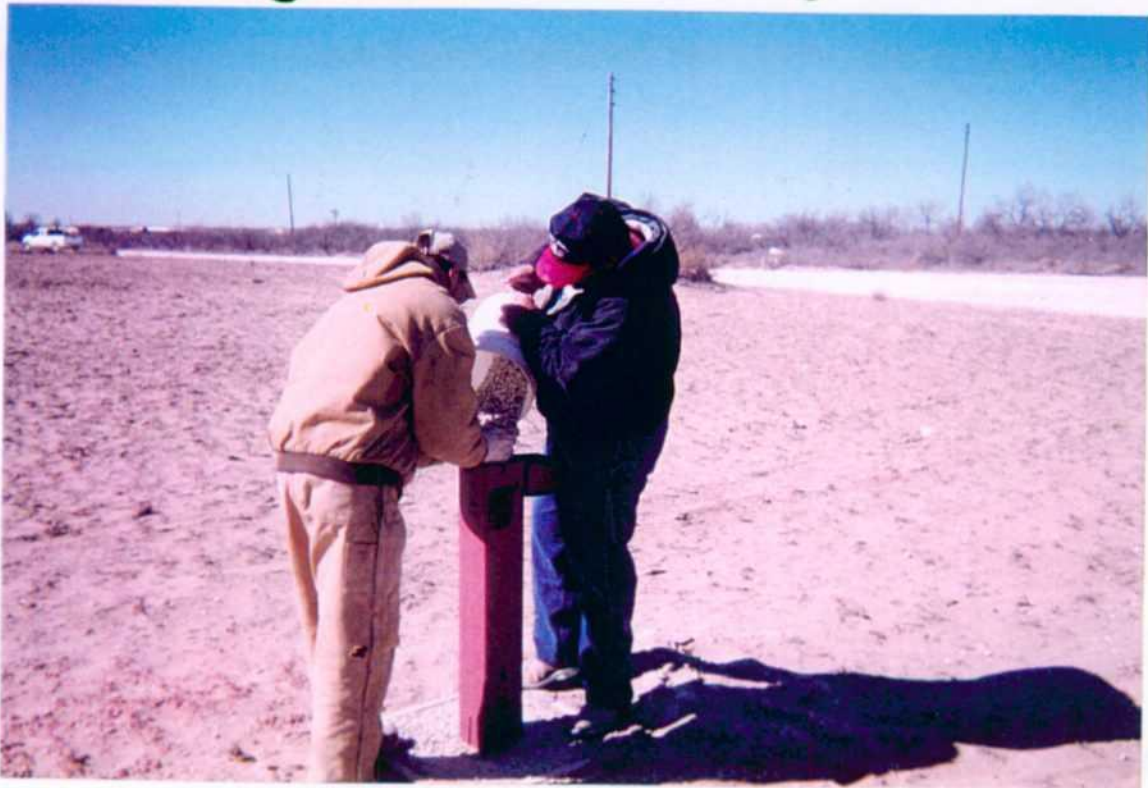
Photo 3: Grouting of monitor well MW-2.

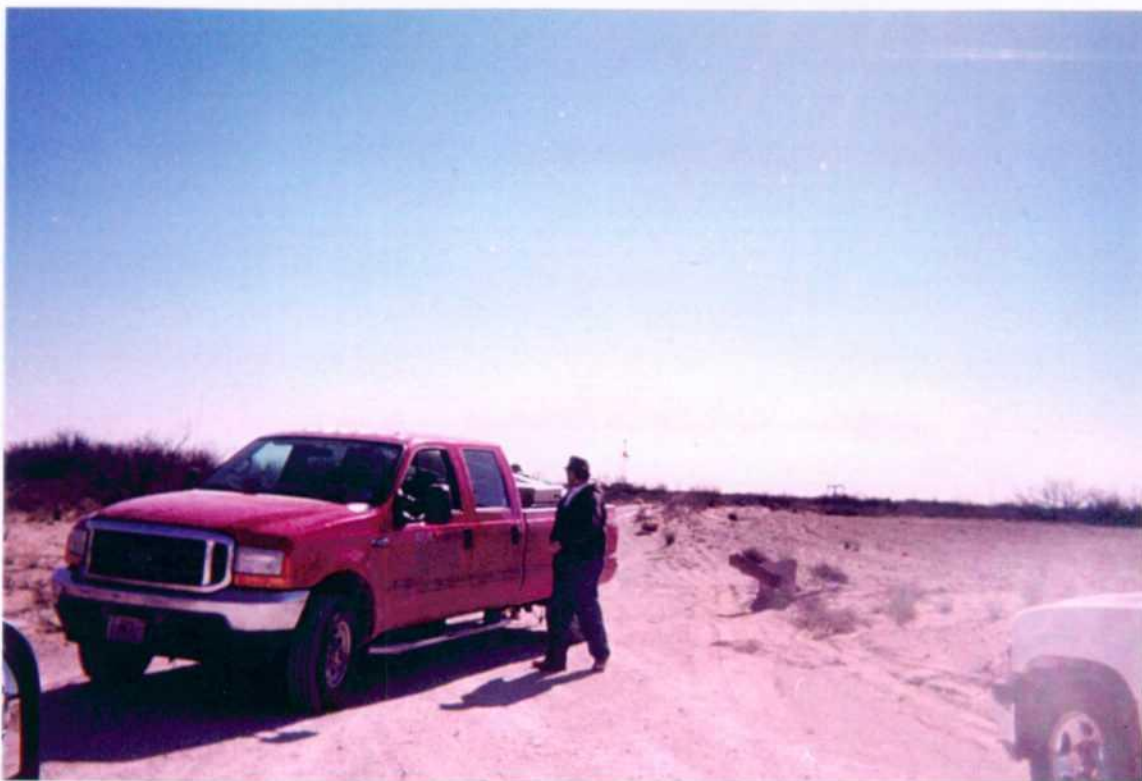
Photo 4: Removal of monitor well MW-2.

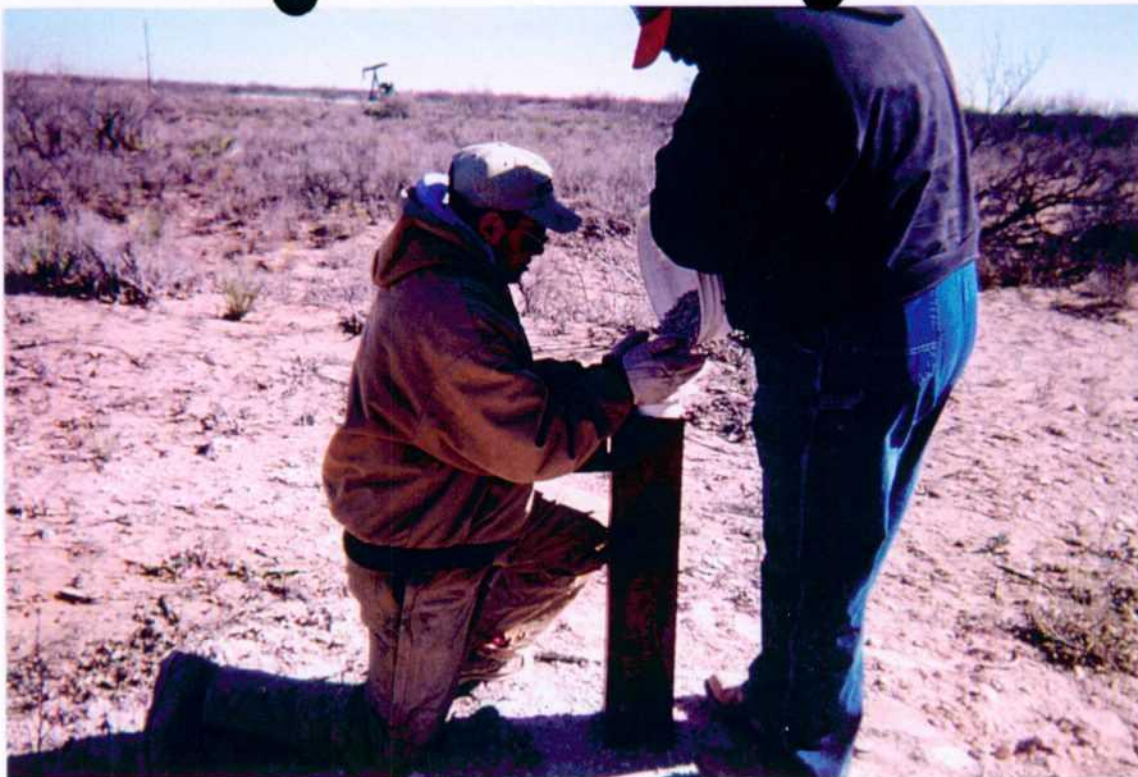
Photo 5: Grouting of monitor well MW-3.

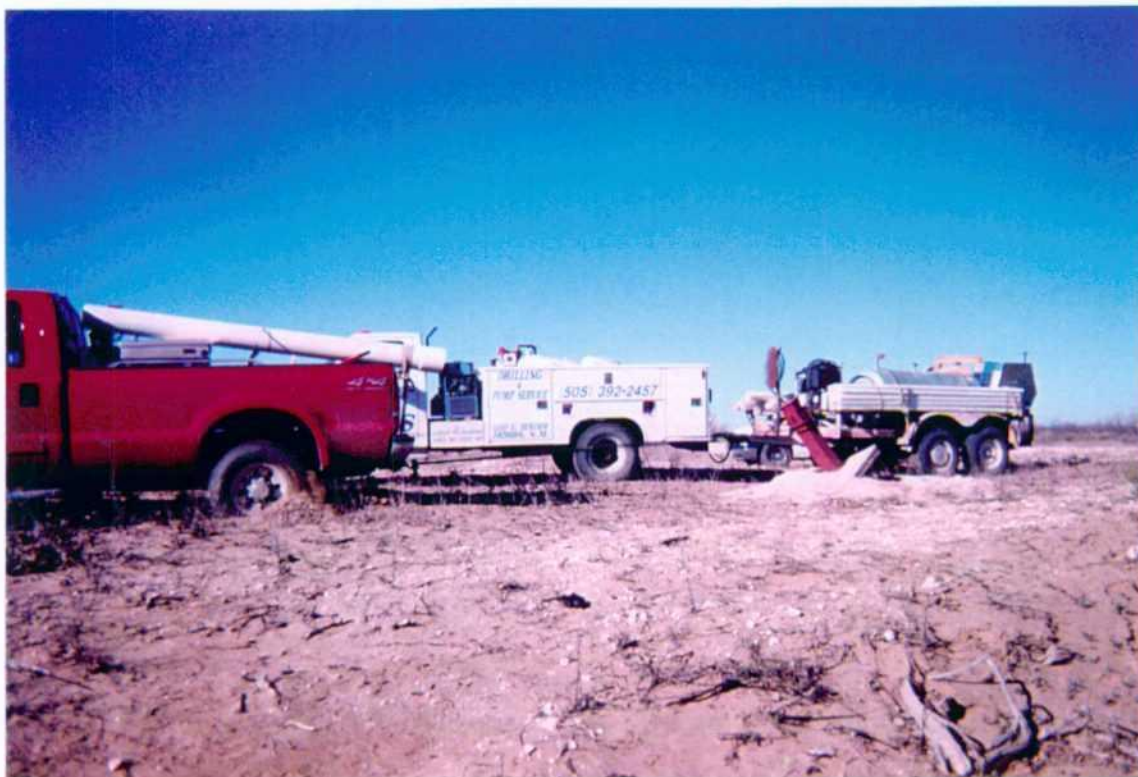
Photo 6: Removal of monitor well MW-3

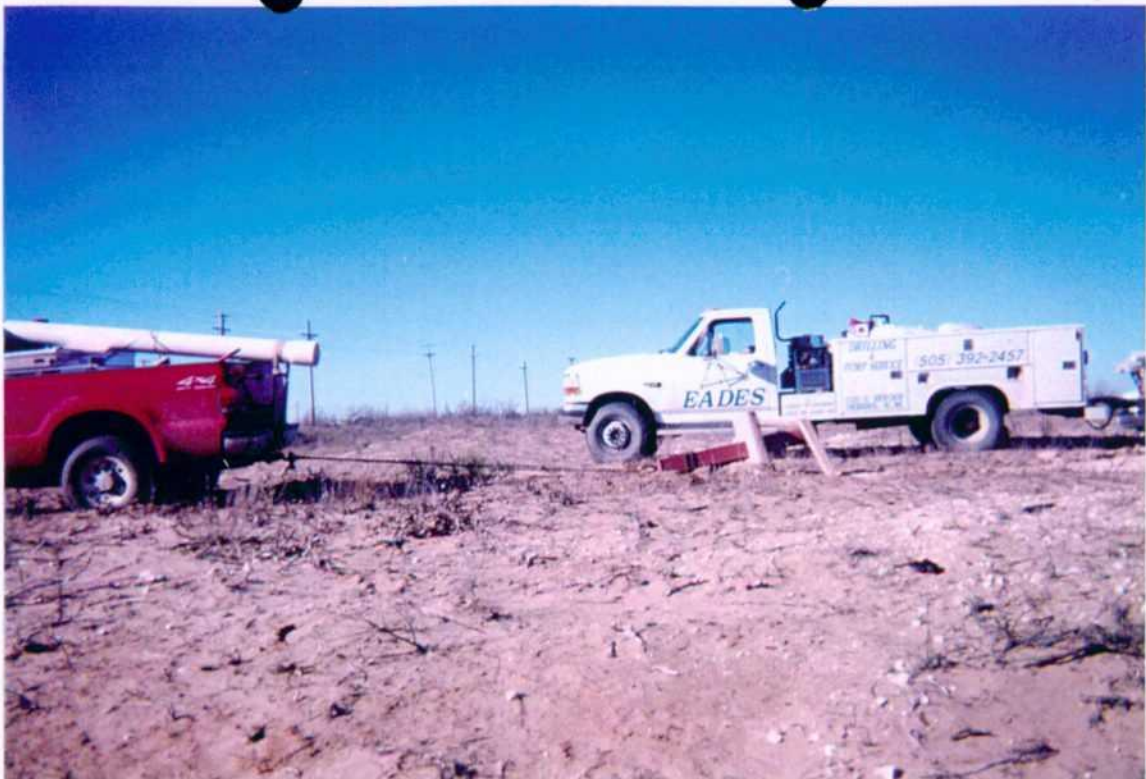
Photo 7: Removal of monitor well MW-3.

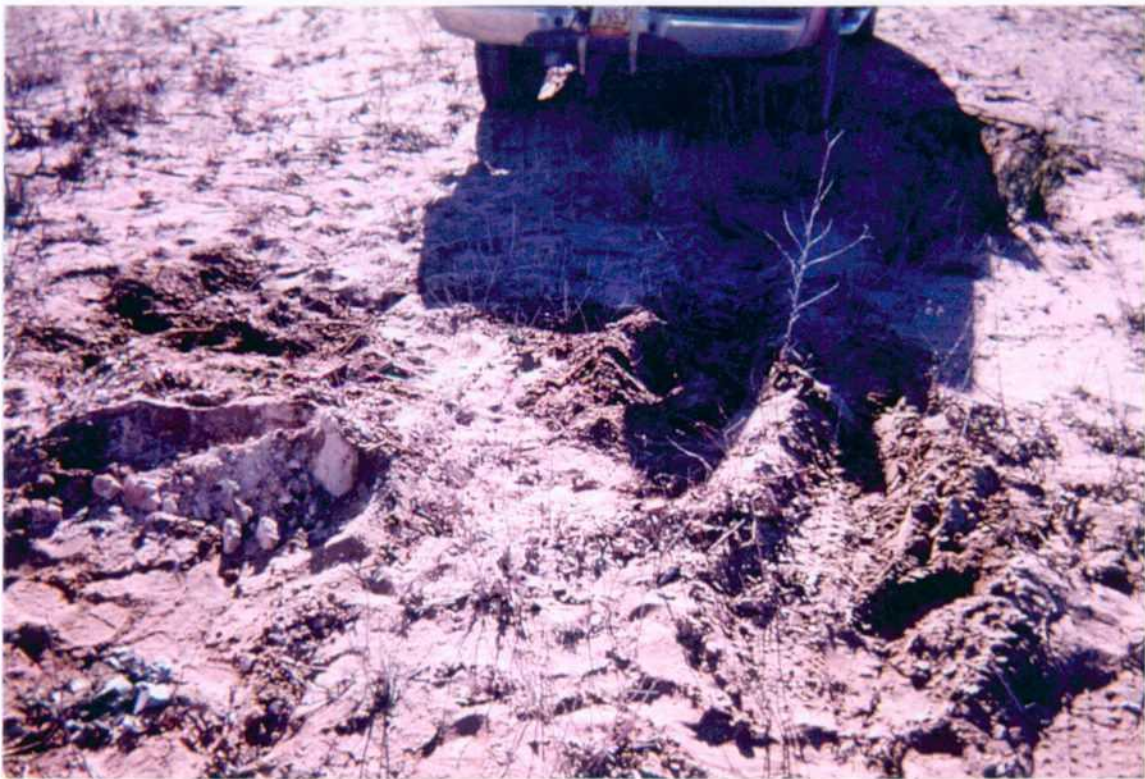
Photo 8: Completed removal of monitor well MW-3.
