Fasken Oil and Ranch

Felmont Collier Pit Closure Report

Lea County, New Mexico February 4, 2000

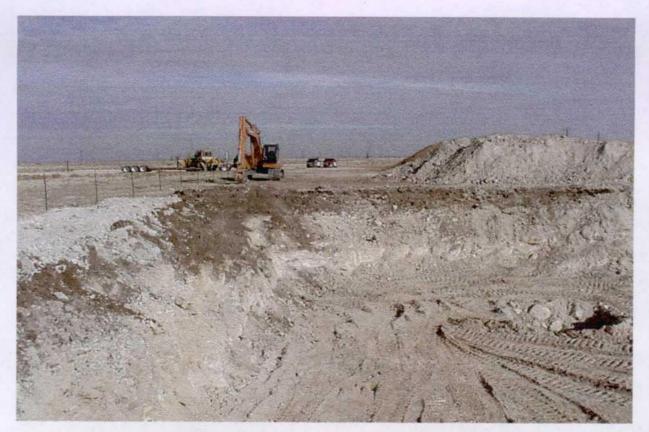
Felmont Collier - During Excavation of Pit Area

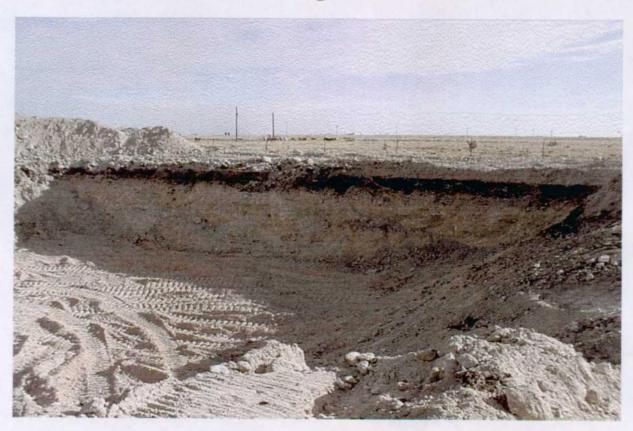
Felmont Collier - During Excavation of Pit Area

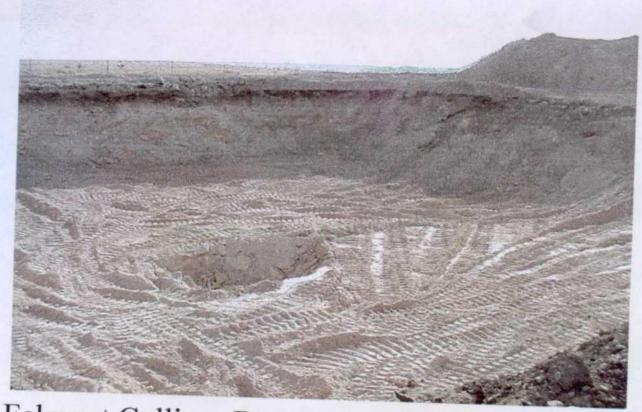
Excavation continued on the bottom of the pit area to a depth of approximately 25'. Field testing at this depth revealed TPH levels in the 700ppm range in a hardened, sandy limestone strata. Mr. Bill Olson of the NMOCD Santa Fe office was contacted concerning the contamination levels present at this depth, the area excavated to this point and the close proximity of three pipelines to the north, east and west-southwest. Mr. Olson consented to stop any further excavation of the bottom area based upon these criteria.

Felmont Collier - Bottom Area Facing Southwest

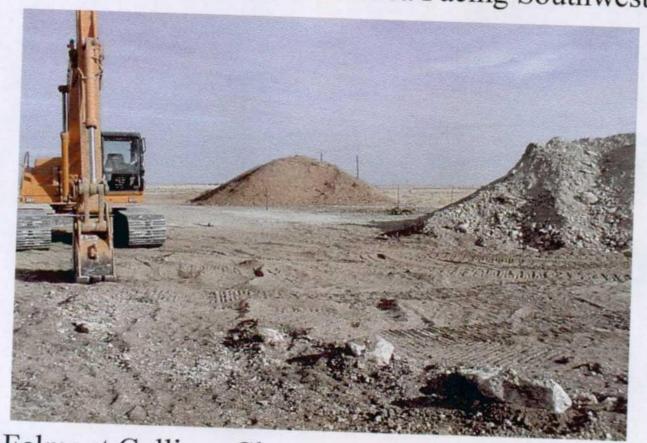
Felmont Collier - Clean Soils and East Spoils Pile

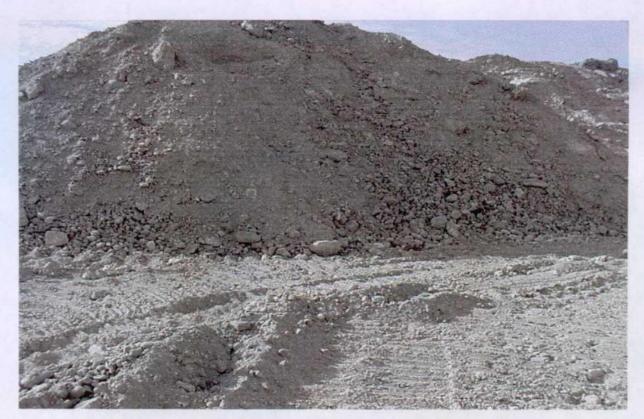
Felmont Collier - West Spoils Pile

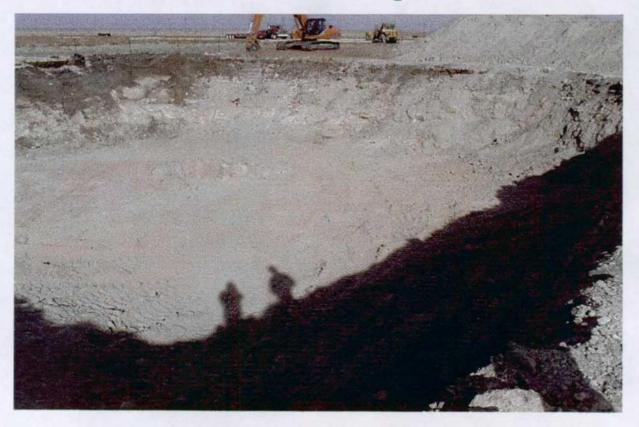
Felmont Collier - Bottom Facing Northeast

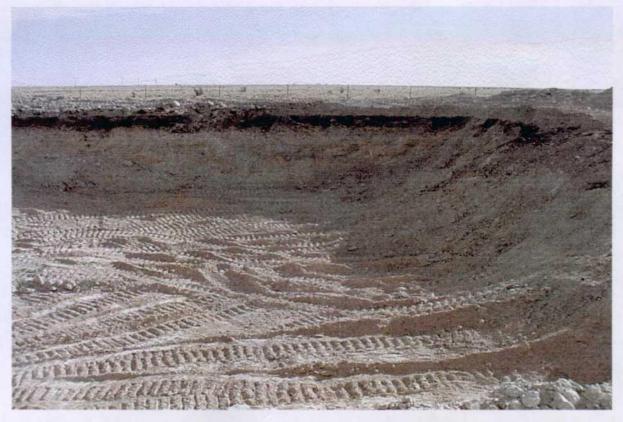
Felmont Collier - Bottom Facing South

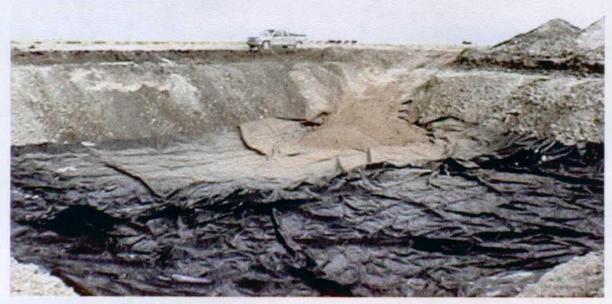
Felmont Collier - Bottom Liner Facing Northeast

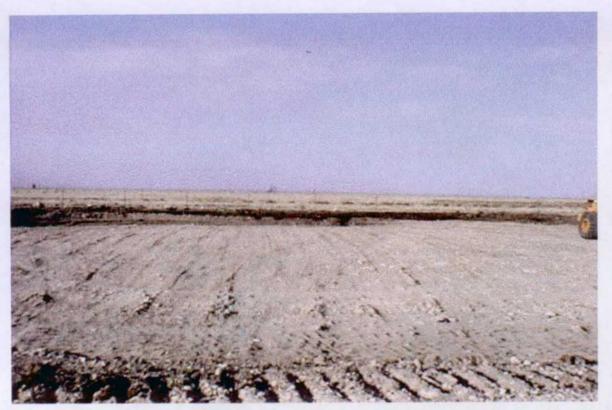
Felmont Collier - Mounded Area Facing North

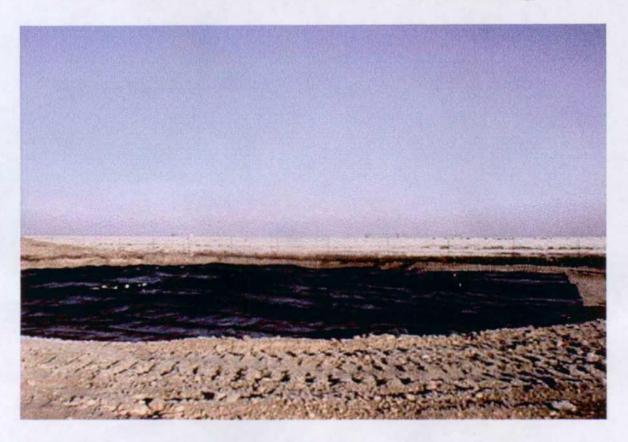
Felmont Collier - Top Liner Facing North

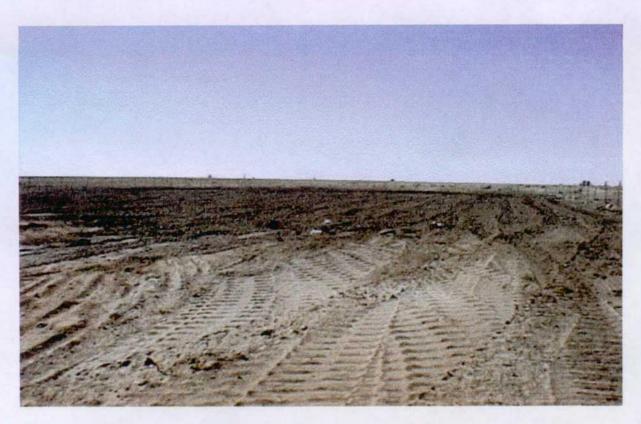
Felmont Collier - Site Final Facing West

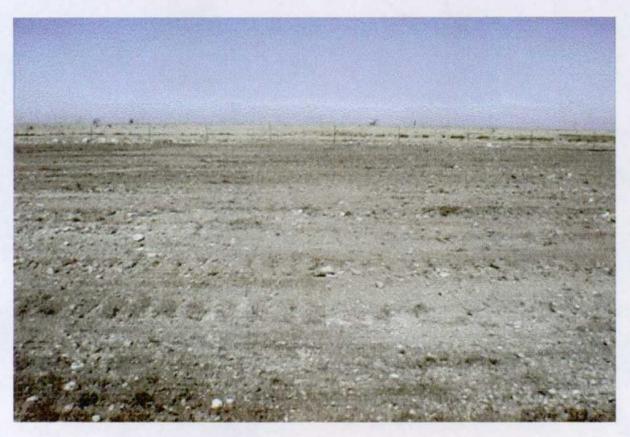
Felmont Collier -Site Final Facing West
