**Fasken Oil & Ranch, Ltd.
Site Assessment
Felmont Collier Site**

**Section 9 Township 11S Range 33E
Lea County, New Mexico**

October 25, 1999

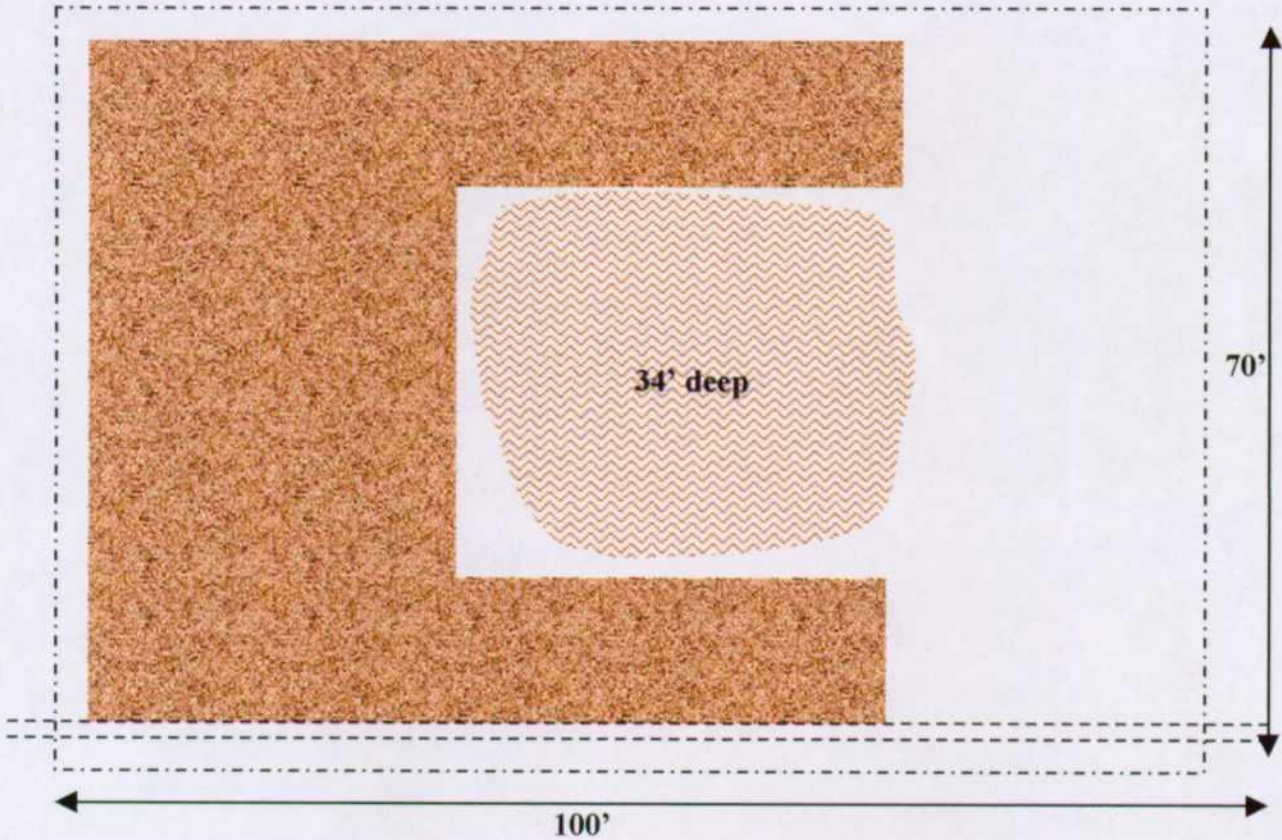
Figure 2
Site Plan

Safety & Environmental Solutions, Inc. (SESI) was engaged in September, 1999 to perform a site assessment at the Felmont Collier Site located in Section 9, Township 11S, Range 33E, Lea County, New Mexico (Figure 1). The site consists of an old "blow-down" pit adjacent to a well and lease road. (Figure 2). An old pit area was investigated.

The first test hole was completed on the north side of the pit to a depth of 9'.

This test hole was completed approximately 30' south of Test Hole #1 in the apparent center of the pit to a depth of 8'.

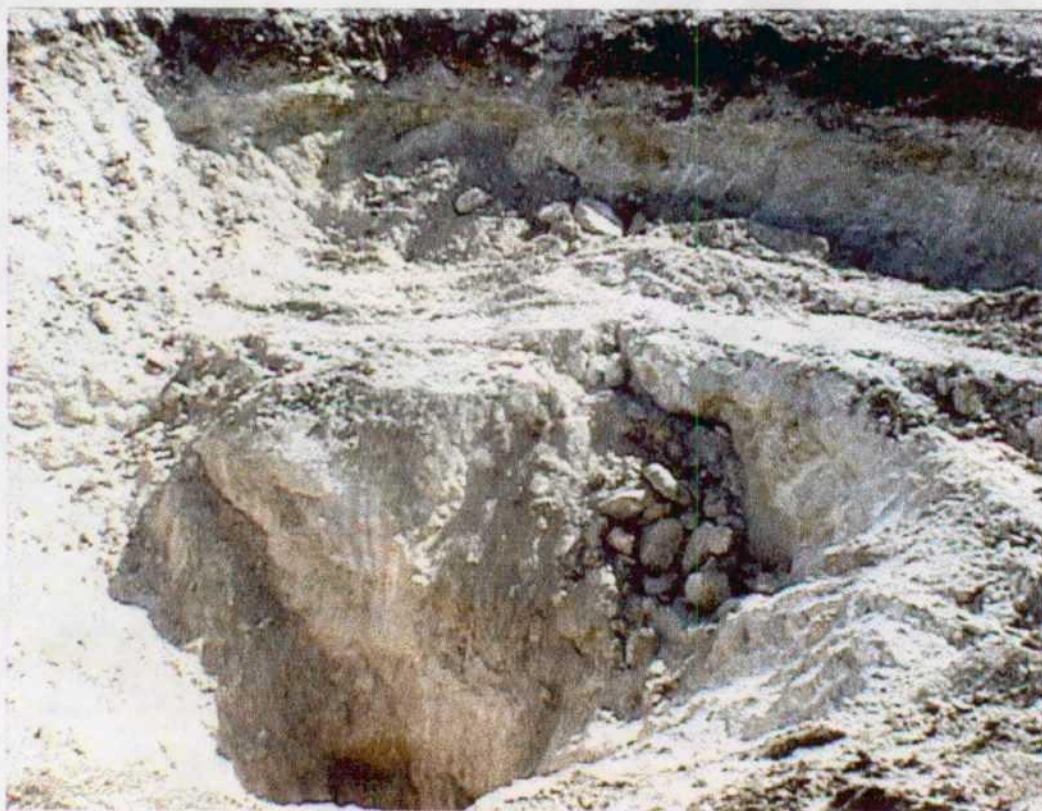
Felmont Collier - Excavated Pit Area at Bottom

This sample was collected from the final excavation depth of 34'.

This site assessment has revealed the vertical extent of contaminated soils is to a depth of 34' at the subject site. There was no indication that any contamination has migrated into the ground water in this area and no tests were conducted of the ground water.
