Re: Reported contamination incidents involving oil and produced water.

DATE: February 14, 1986

SUBJECT: BRINE CONTAMINATION IN LEA COUNTY

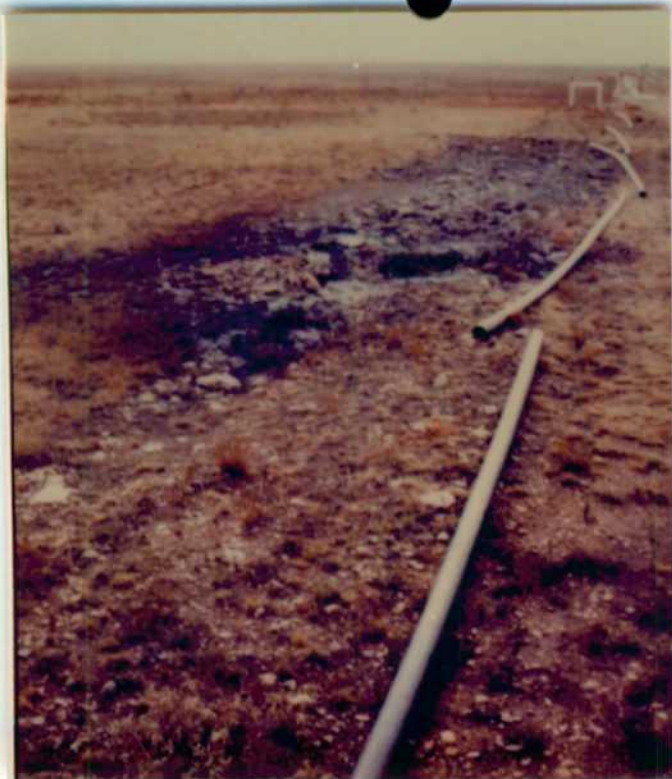
The pipeline is 4" plastic gas line pipe. Last spring and early summer, it developed many leaks. Figure 1 shows an area above a leaking pipe. Brine and oil have covered a large area, and the oil has stained the ground and vegetation. Figure 2 shows a roustabout patching a leak. The pipe is about a foot underground, so the brine saturates the soil at this level before it spreads out on the surface.

Figure 1 also shows some pipe laying on the surface. This was used in the last part of July 1985 to replace about 1.2 miles of the west end of the pipeline. To do this, they used a grader with the blade tilted at an angle and plowed out the old pipe. Wherever the pipe broke, the brine flowed out onto the pasture--1.2 miles of 4" pipe would contain a little over 4,000 gallons of brine.

Fig. 1 Brine and oil above a leak in the pipe line

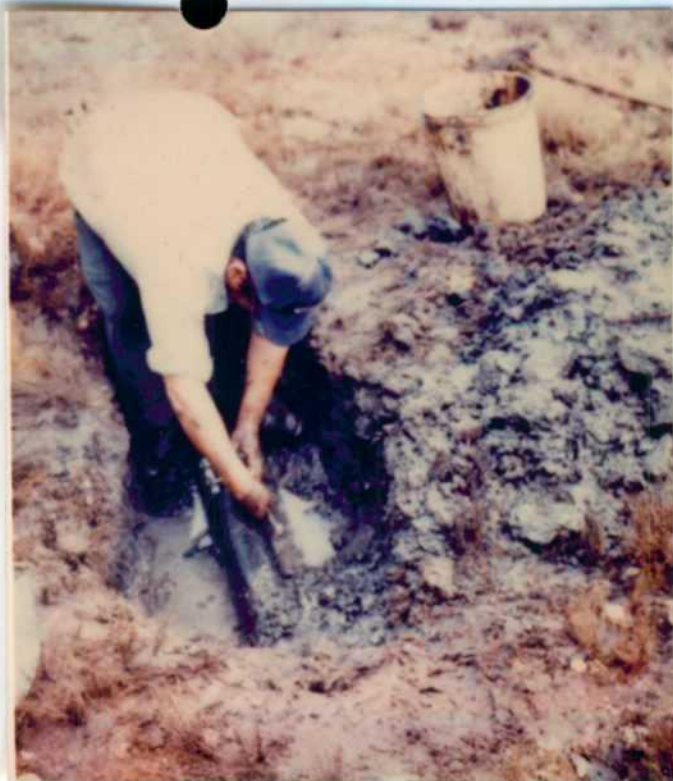
Fig. 2 Patching a leak. Dirt removed from around the pipe is saturated with brine and oil.

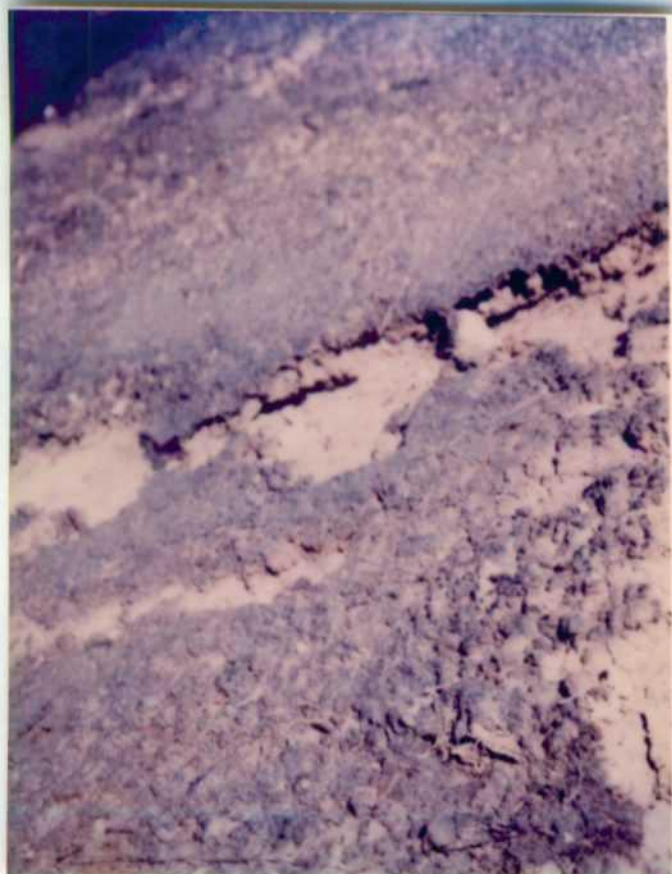
At the disposal well, there were two fiberglass storage tanks and an unlined pit in the ground for overflow. In June 1985, the tanks collapsed, spilling an unknown amount of brine. They were replaced with metal tanks. In the last of July or the first part of August 1985, the overflow pit was plowed out with a bulldozer, removing oil and salt crystals and enlarging the pit. The new pit is about 90 ft. by 60 ft. at the top and tapers down to about 45 ft. by 39 ft. at the bottom. TOMCO of Hobbs was called in to "line" the pit by spraying asphalt on the walls. After spraying with asphalt, it was defined as a "lined" pit and was supposed to achieve the letter of the law, if not the spirit of the law. The walls of this pit, of course, crumble and erode as easily as any other dirt pit. Figure 3 shows

a rainwater erosion channel on the south wall of the "lined" pit. The asphalt was sprayed only on the surface, and bare dirt could be seen between the high points. As the level of brine went up and down, the surface layer of oil dissolved or softened the asphalt. Figure 4 shows the tank overflowing into the pit. Jerry Sexton, at the Hobbs office of OCD, assured me that the tanks overflow only about once a month--I have reason to believe that it is more often than that. Actually it makes little difference how often, because there is always some standing brine in the pit; and it can be leaking into the ground continually.

Fig. 3 Rainwater erosion of the pit wall. Surface of standing brine and oil at upper left

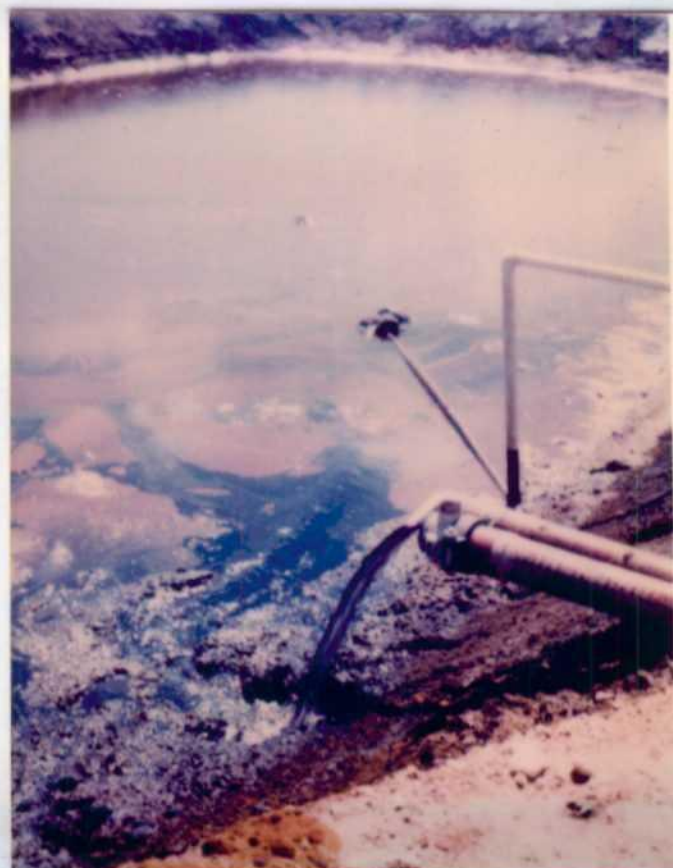
Fig. 4 Routine overflow into the pit.
