Subject: John H. Hendrix 1R0341

October 24, 2005

Re: Case #1R0341, John H. Hendrix Corporation, Danglade # 2 Emergency Pit Excavation Closure, Unit A (NE/4, NE/4), Section 24, Township 22 South, Range 37 East, Lea County, New Mexico

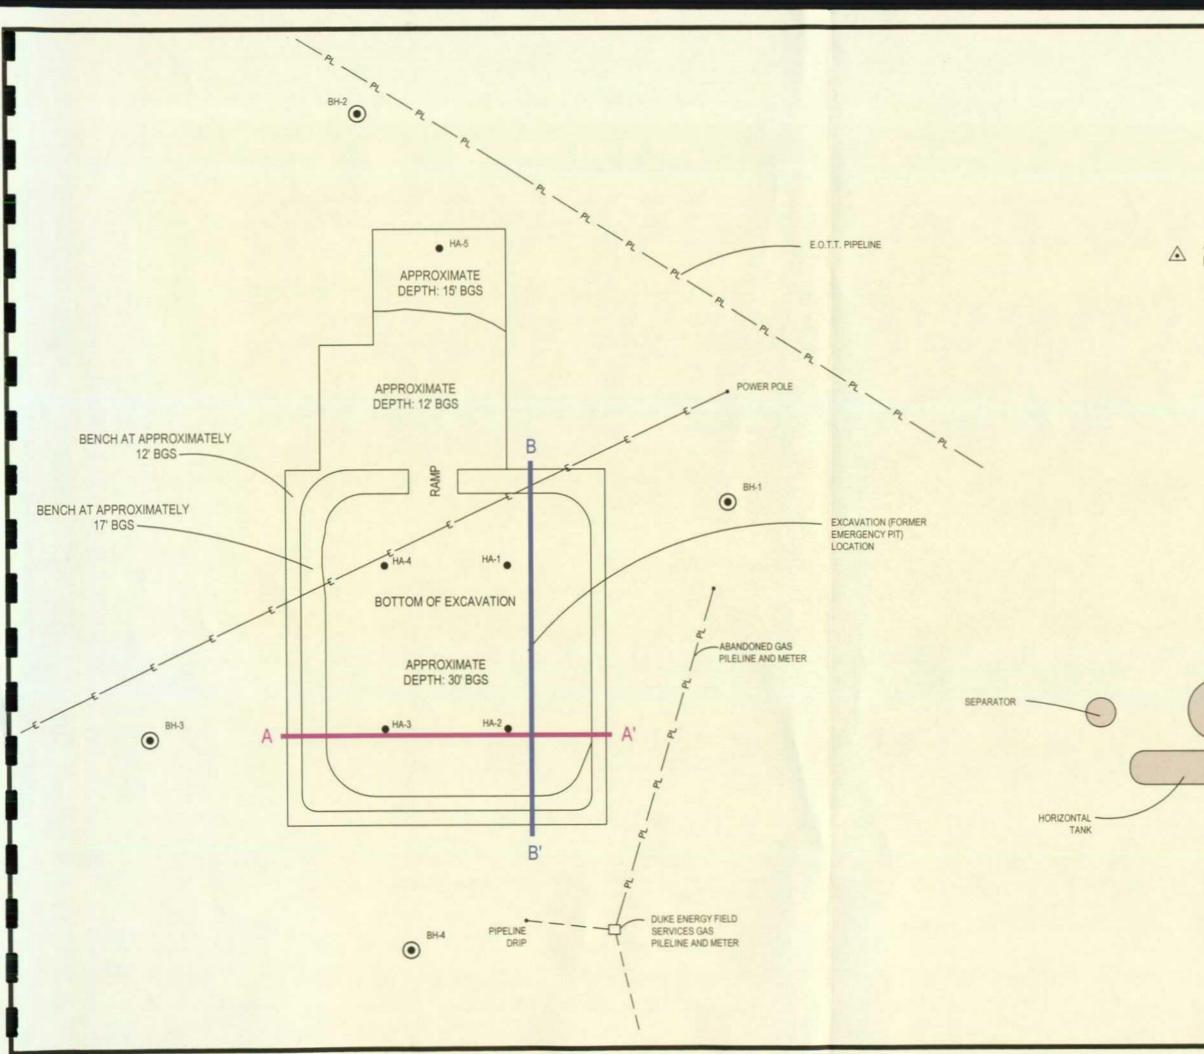
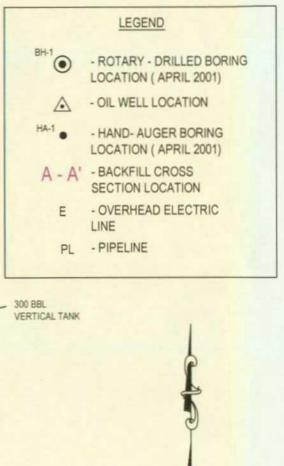
SITE DRAWING

20' Scole: 1" = 20' FIGURE #2 LEA COUNTY, NEW MEXICO JOHN H. HENDRIX CORPORATION DANGLADE # 2 NE/4, NE/4 SECTION 24, T-22-S, R-37-E

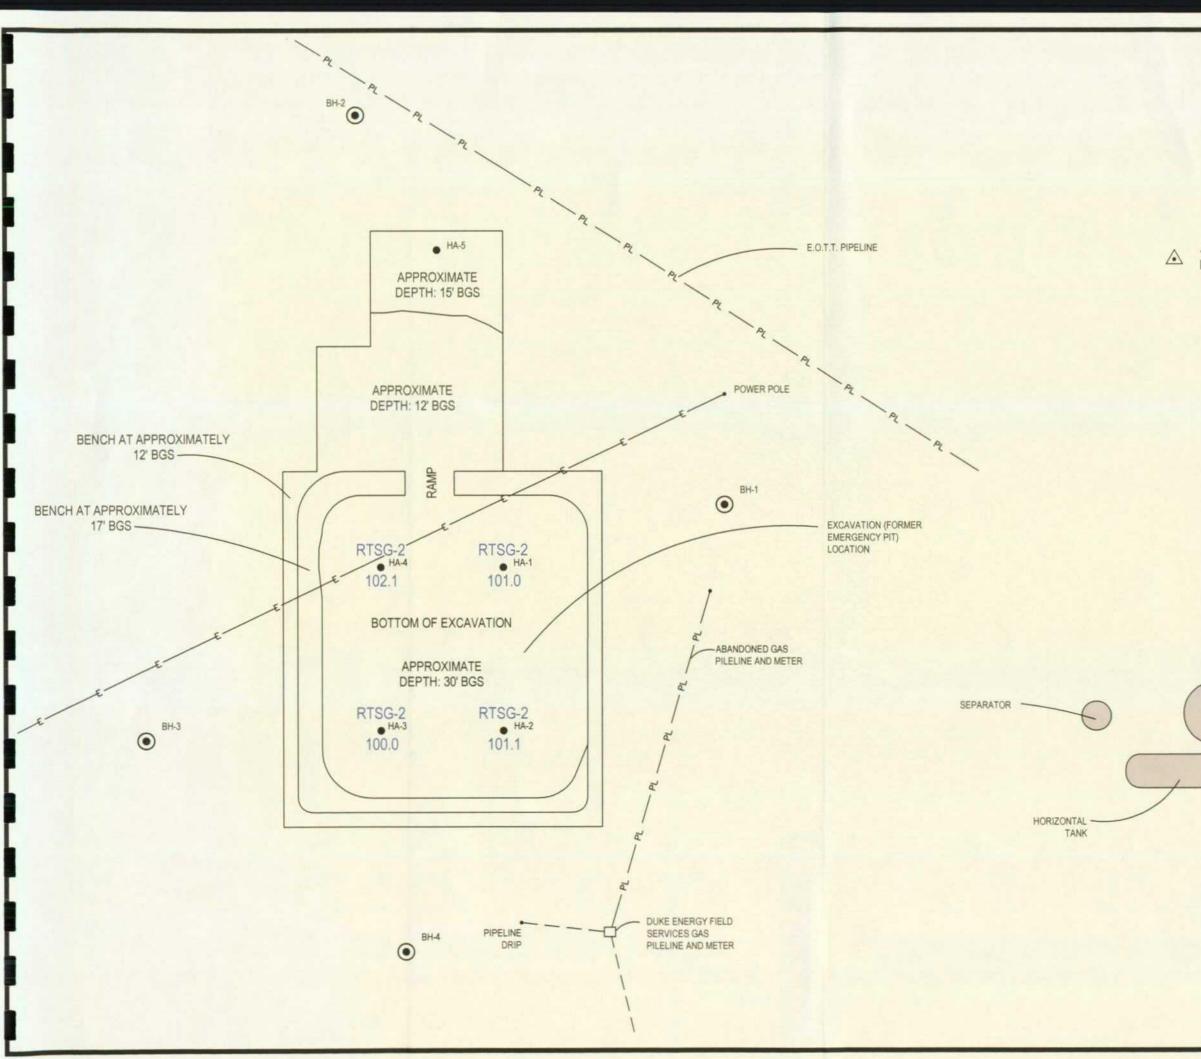
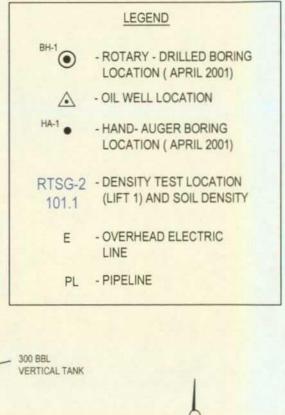
DENSITY READINGS, CLAY LIFT # 1

20' Scale: 1" = 20' FIGURE # 5

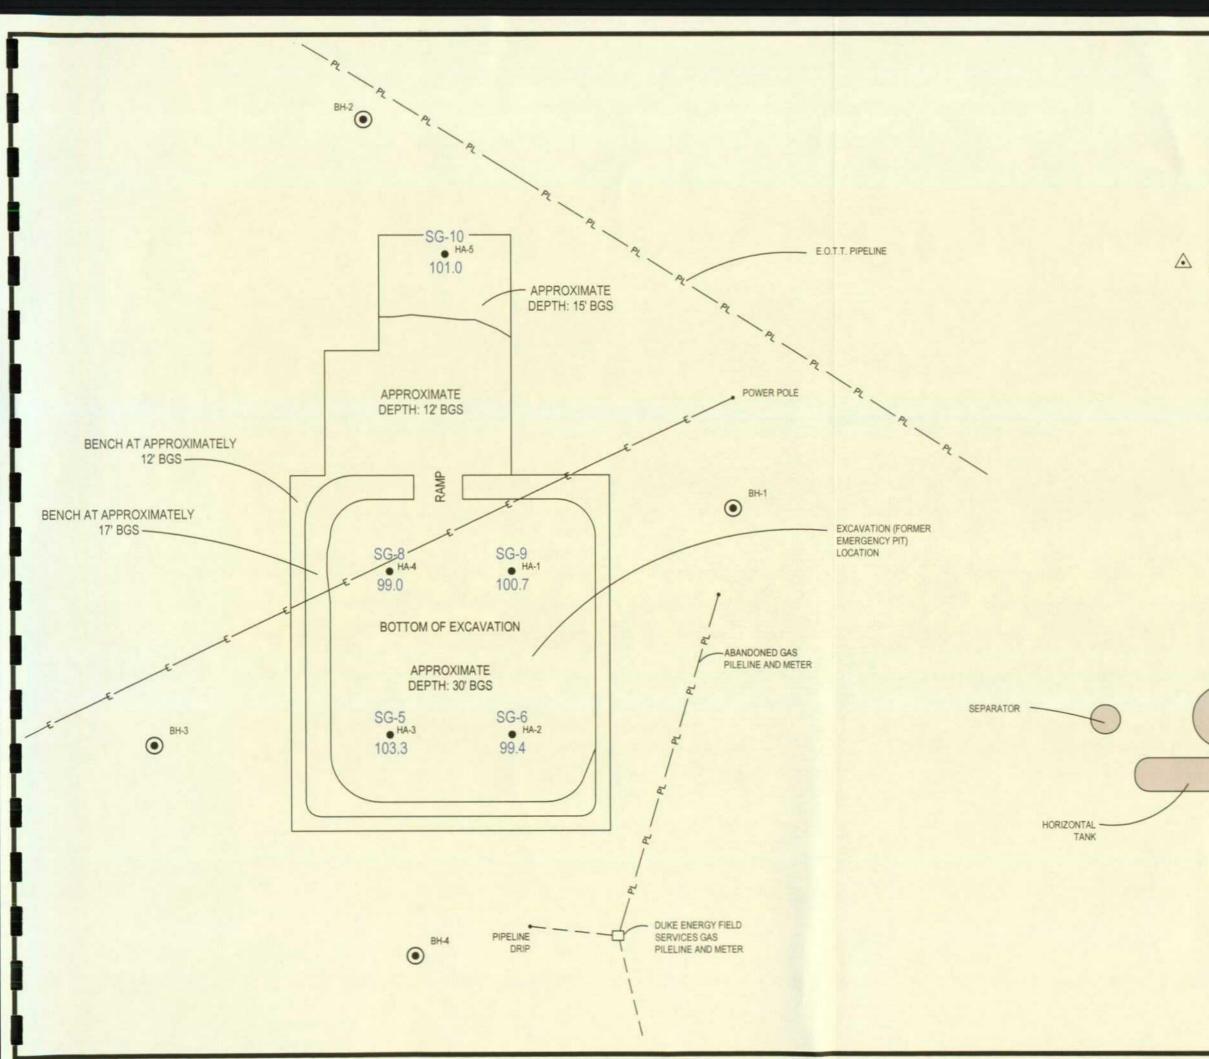
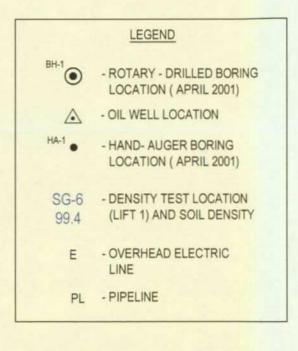
300 BBL VERTICAL TANK GRAPHIC SCALE IN FEET 20' Scale: 1" = 20' FIGURE #6 LEA COUNTY, NEW MEXICO JOHN H. HENDRIX CORPORATION DANGLADE # 2 NE/4, NE/4 SECTION 24, T-22-S, R-37-E DENSITY AND MOISTURE READINGS, CLAY LIFT # 2 DATE 10-14-05 MAY 10, 2005 Aarson NAME: SJA FILE: 01-0100

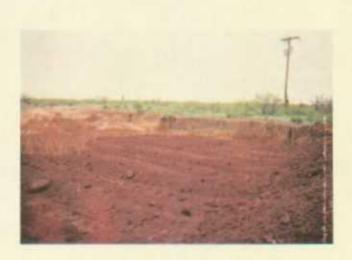
14. Spreading clay, looking northeast
