1R - 410

REPORTS

PHOTOS

H PENROC OIL CORP.
(505) 297-3996
HUTCHERSON A LEASE

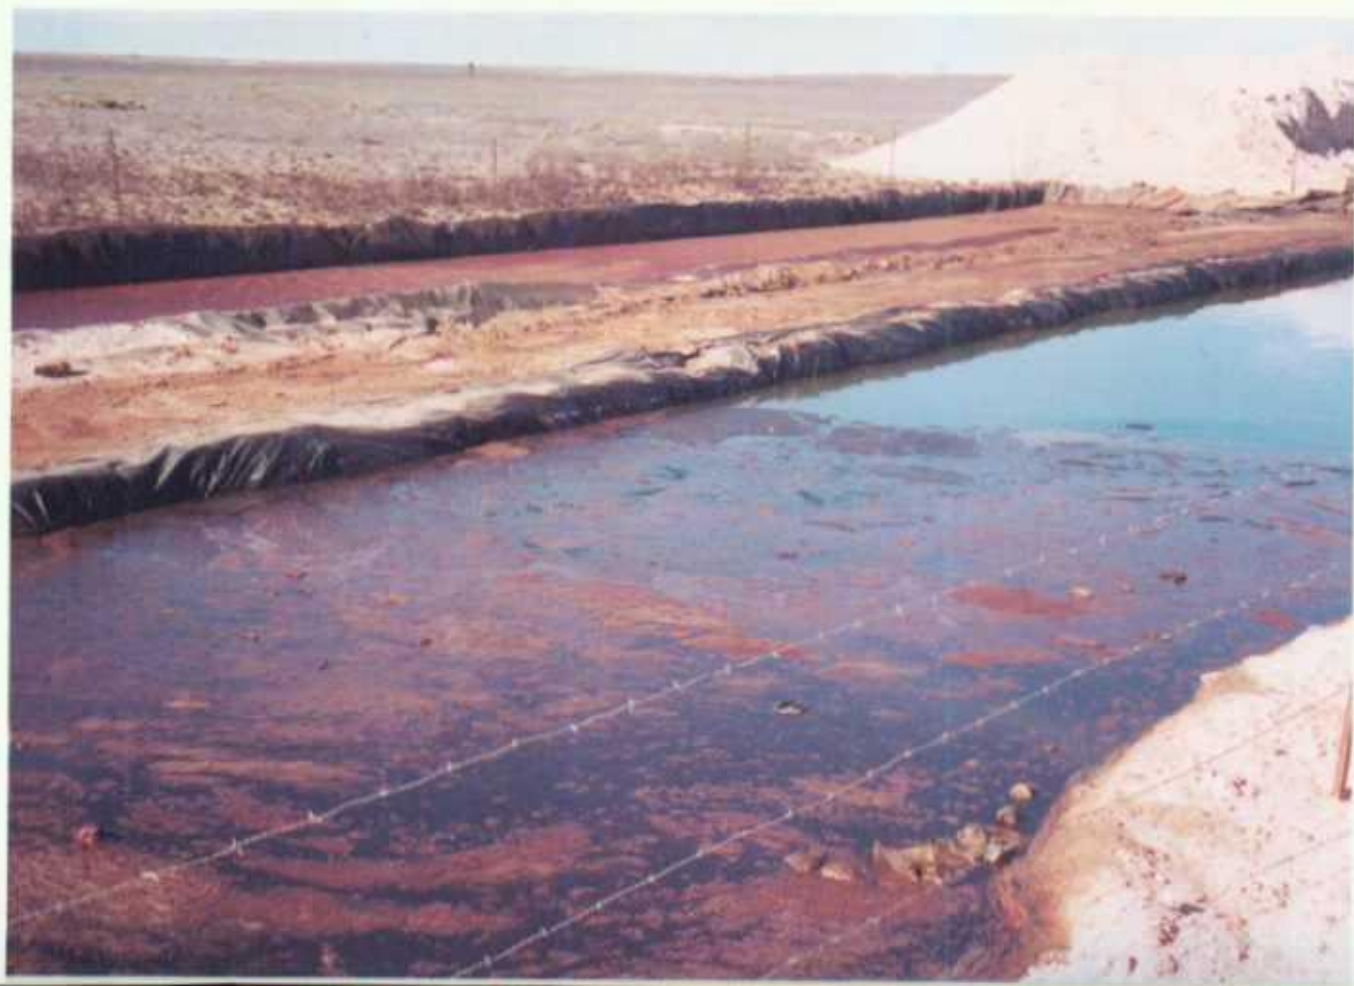
Oil

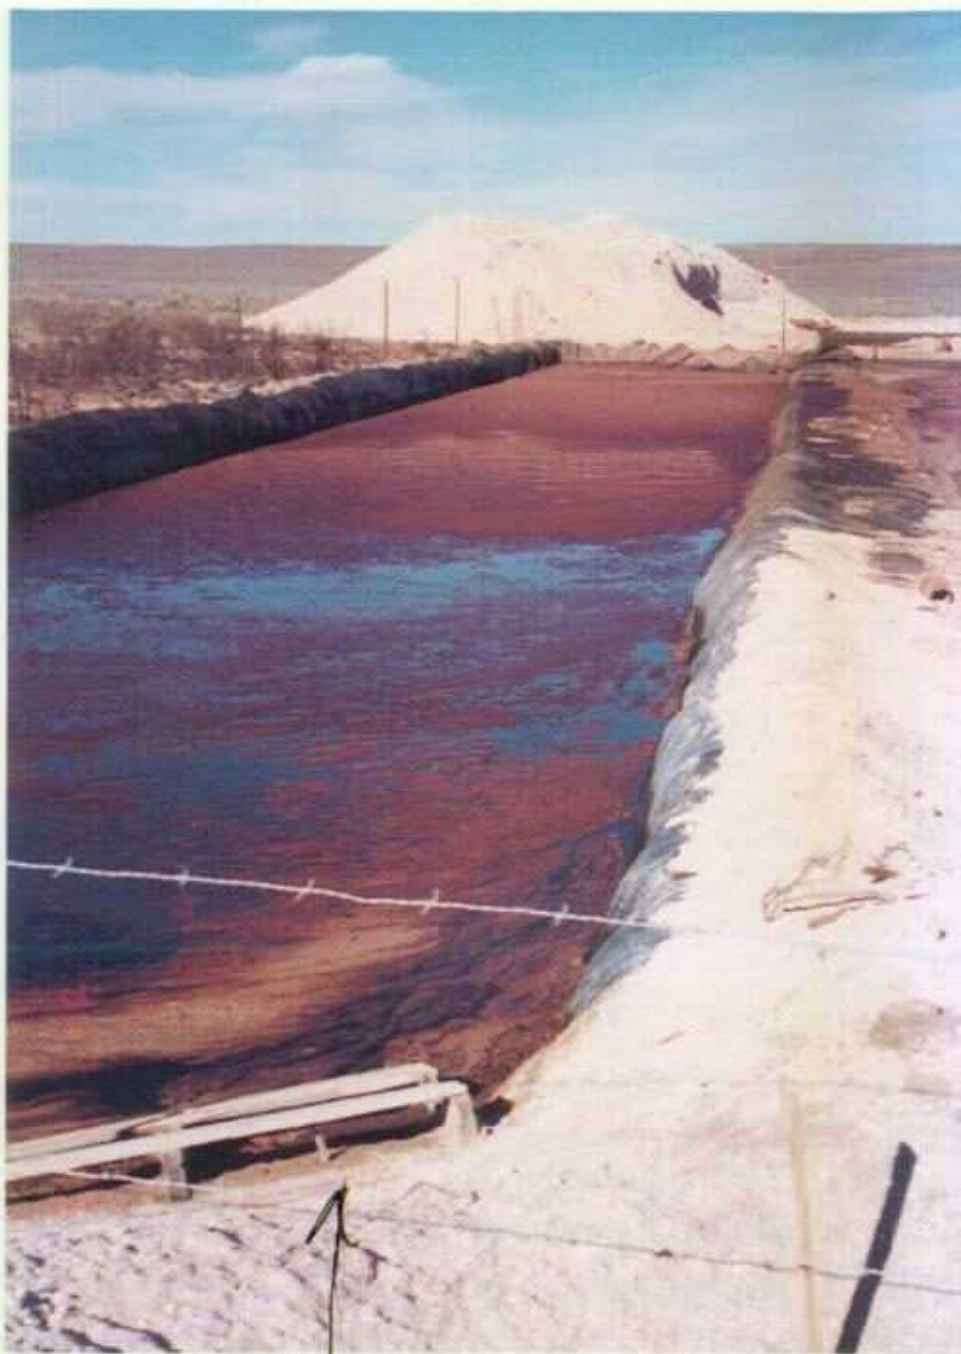
Debris

Pits over flowing behind liner

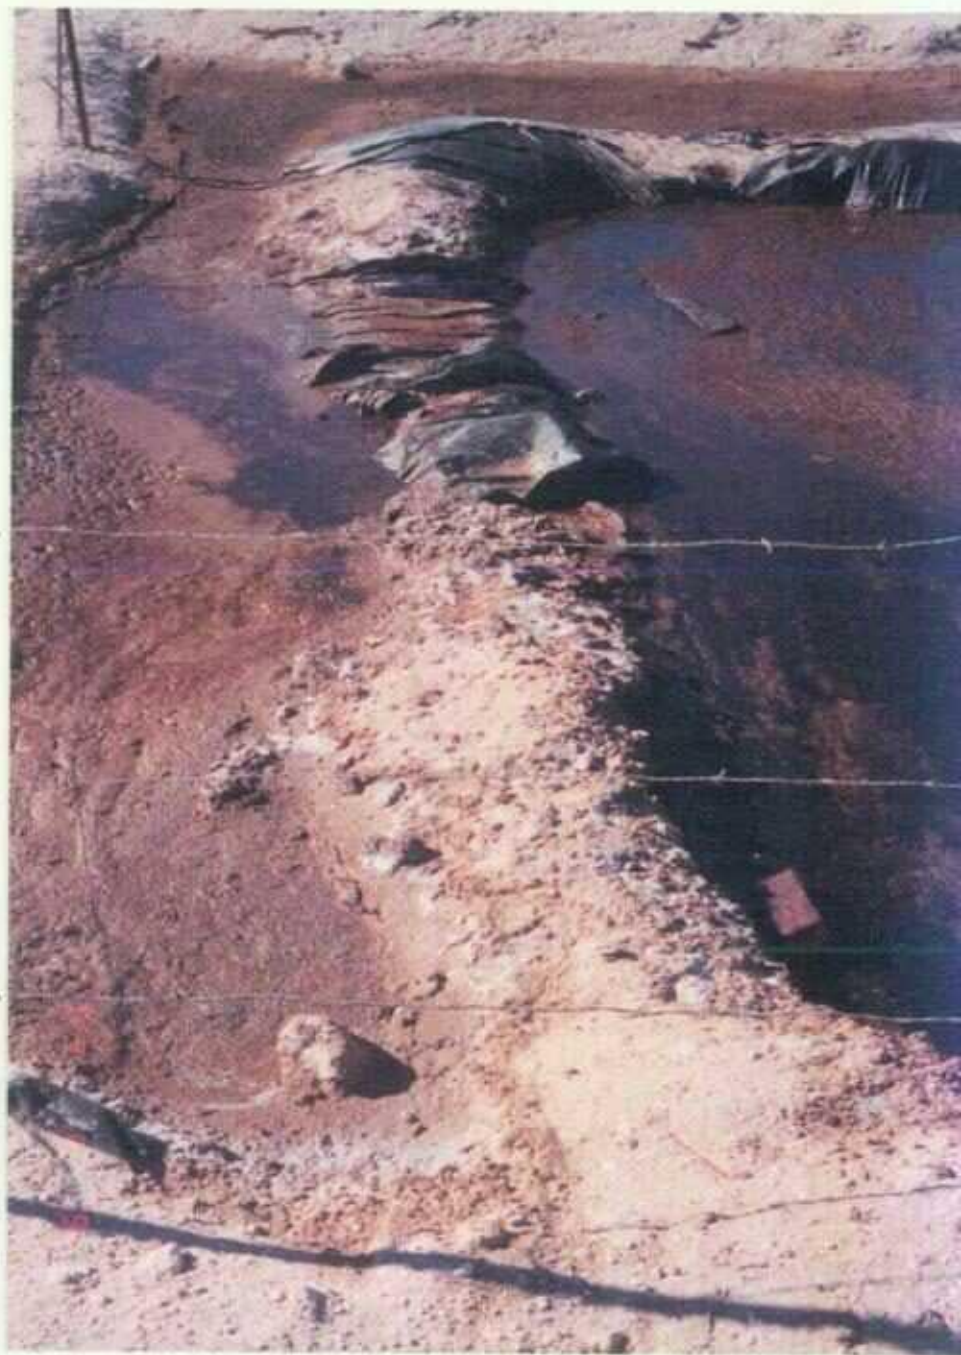
Fence

Oil

Pits overflowing
behind liner

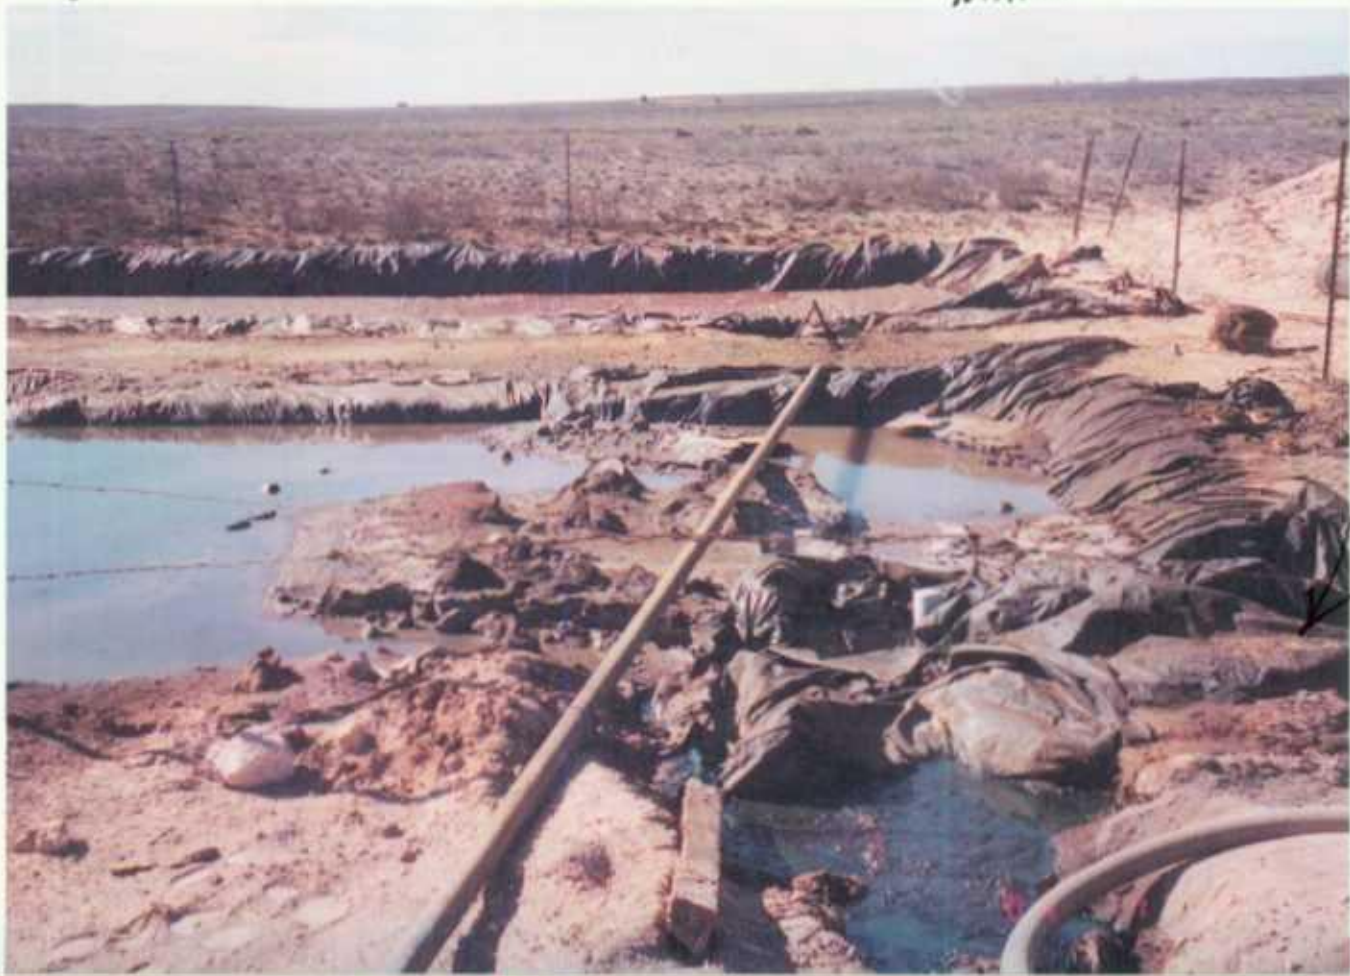
Oil

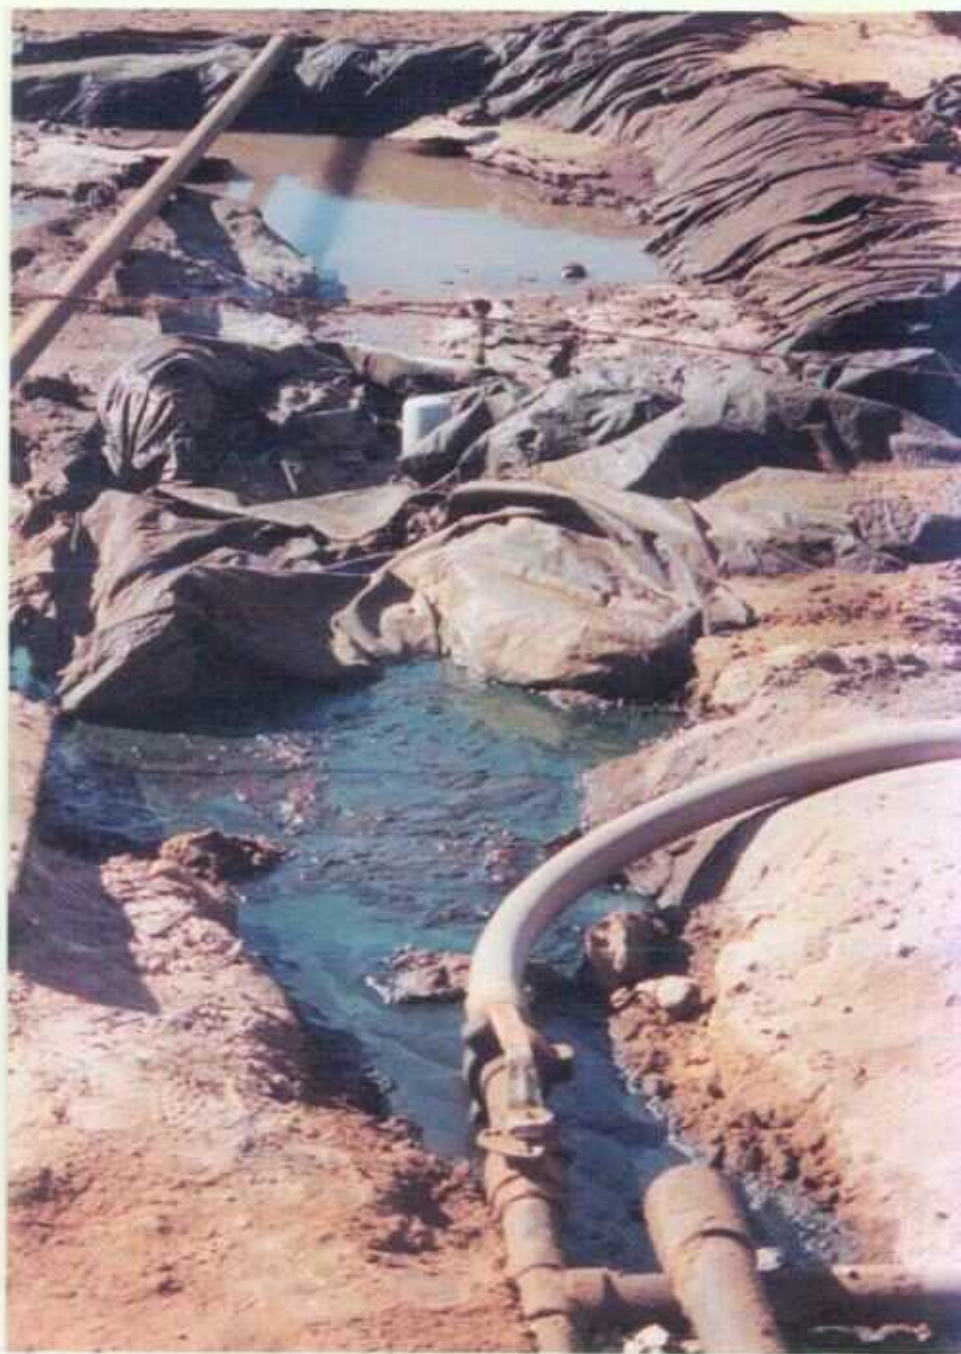
Pits overflowing before liner
