# DISCLOSURE REPORT

**RICE OPERATING COMPANY  
JUNCTION BOX DISCLOSURE FORM**

# G-16 EOL

# BD Chevron Cole 'A' EOL upgrade

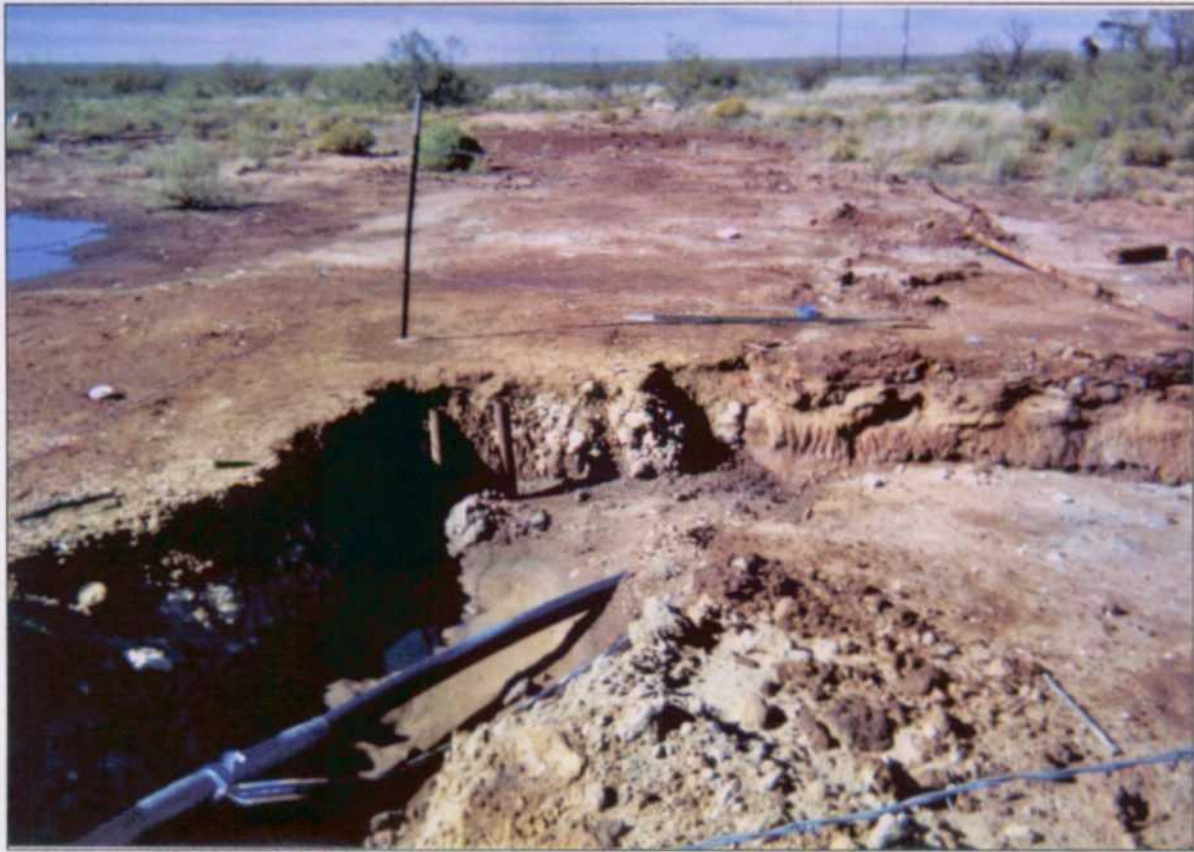
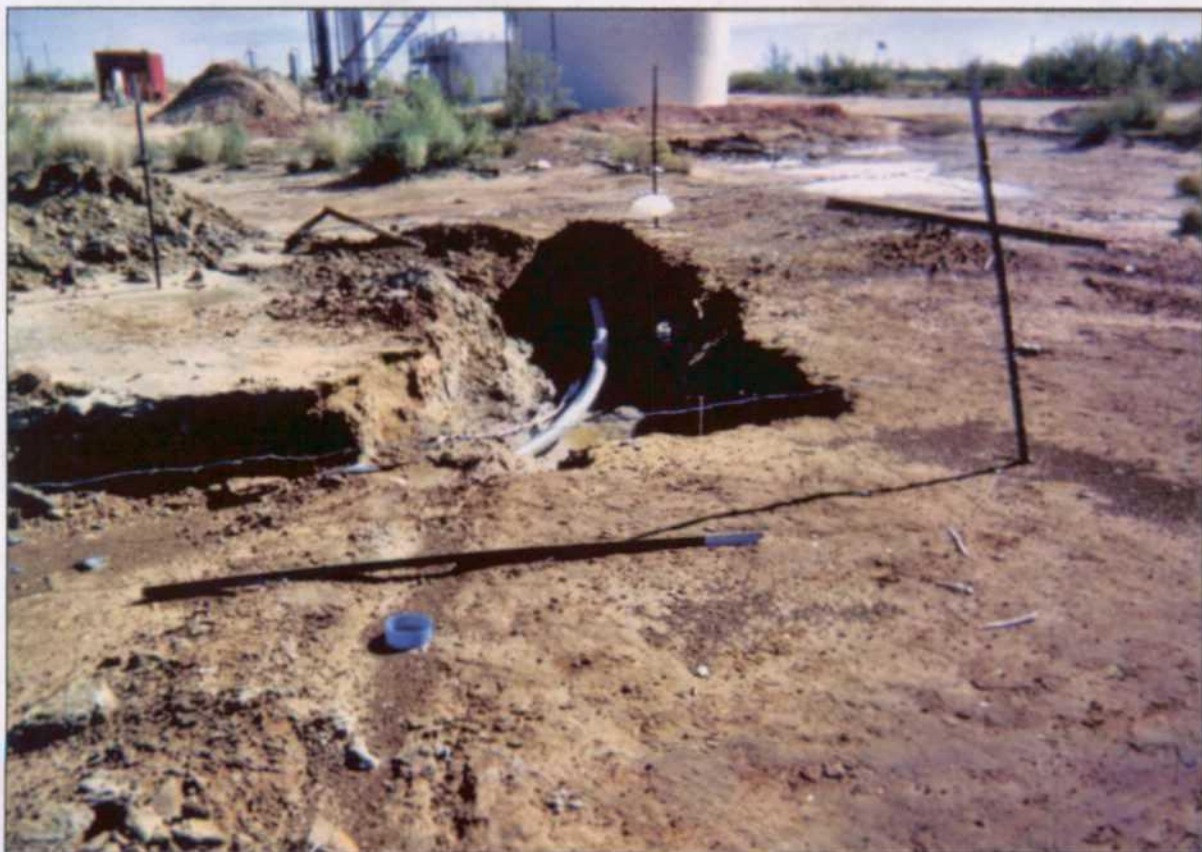
↑ New Plumbing (before remediation) ↓

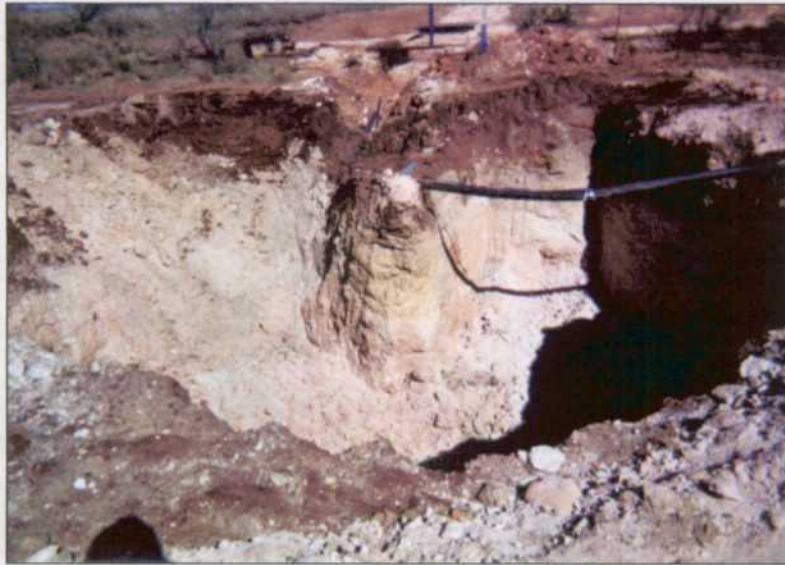
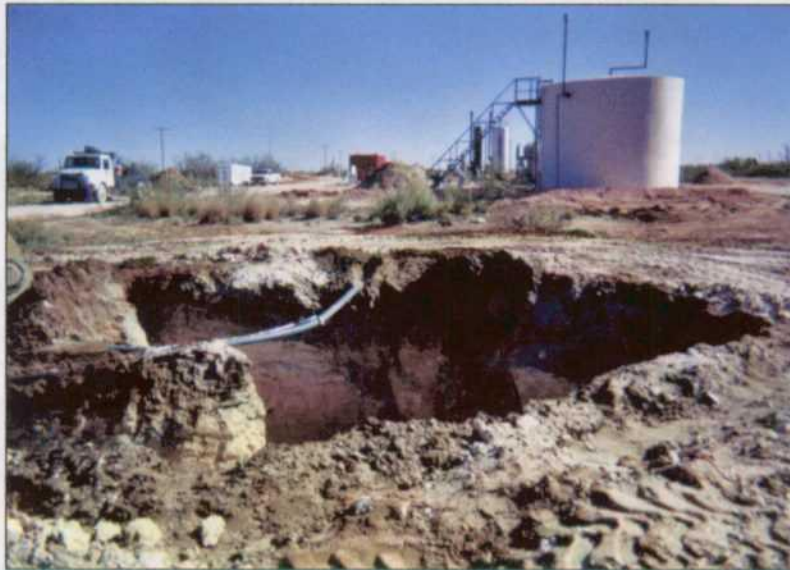
↑ Impact excavation ↓

in all directions and exhibited vertical TPH impact to 7' bgs. A 15' radius around the box was

excavated to 9' bgs. A bottom composite at 9' field-tested 1956 ppm chlorides. A wall

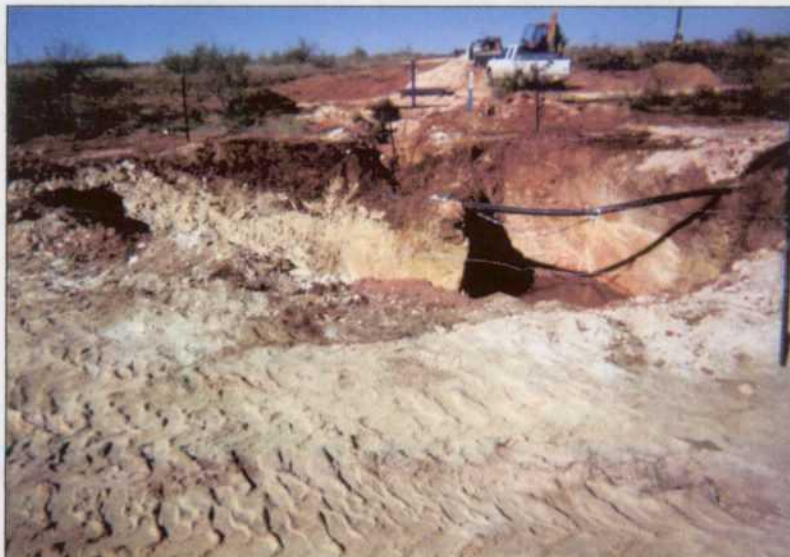
Excavation with Clay Liner

composite field-tested 3029 ppm chlorides. A 1' clay liner was installed at 9' to inhibit further

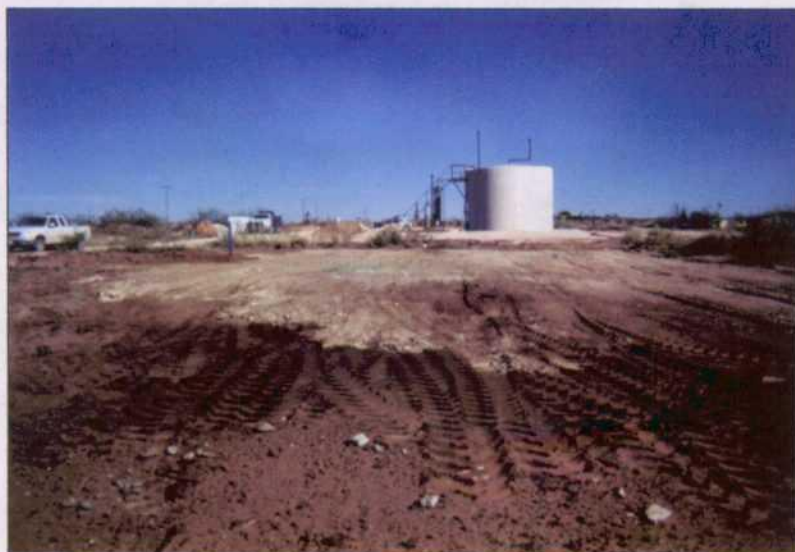
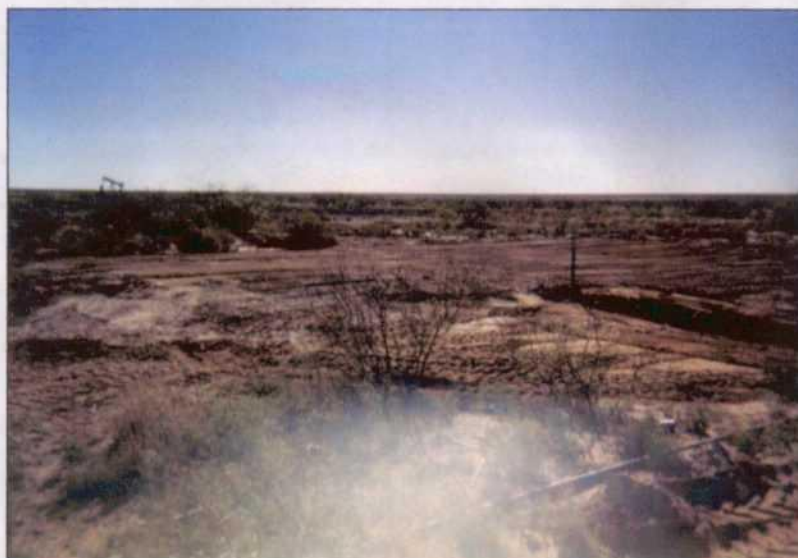
↑ Backfilled ↓

vertical chloride migration. The excavation was then backfilled and contoured to the

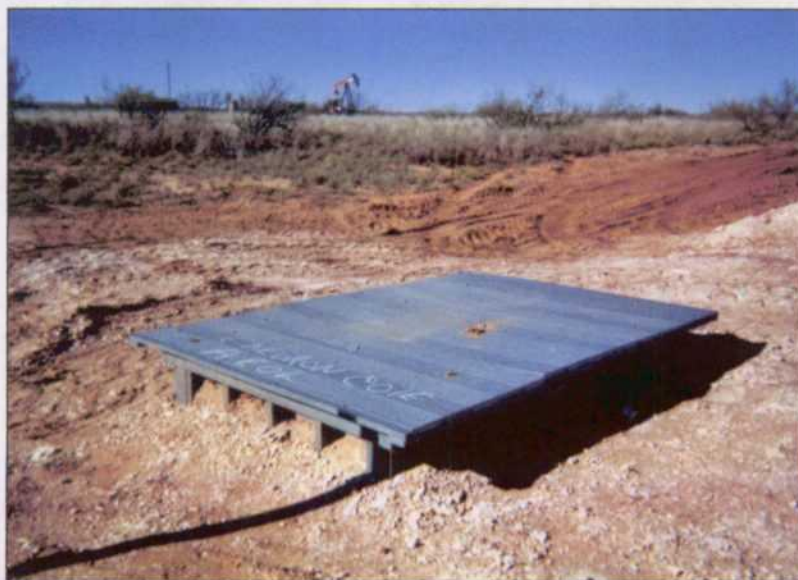
New Junction Box Approx. 20' North of Old Location
