**Navajo Refining Company
Pipeline Division**

Artesia Station Discharge #2 Closure Report
Eddy County, New Mexico

*Safety & Environmental Solutions, Inc.
703 E. Clinton Suite 103
Hobbs, New Mexico 88240
(505) 397-0510*

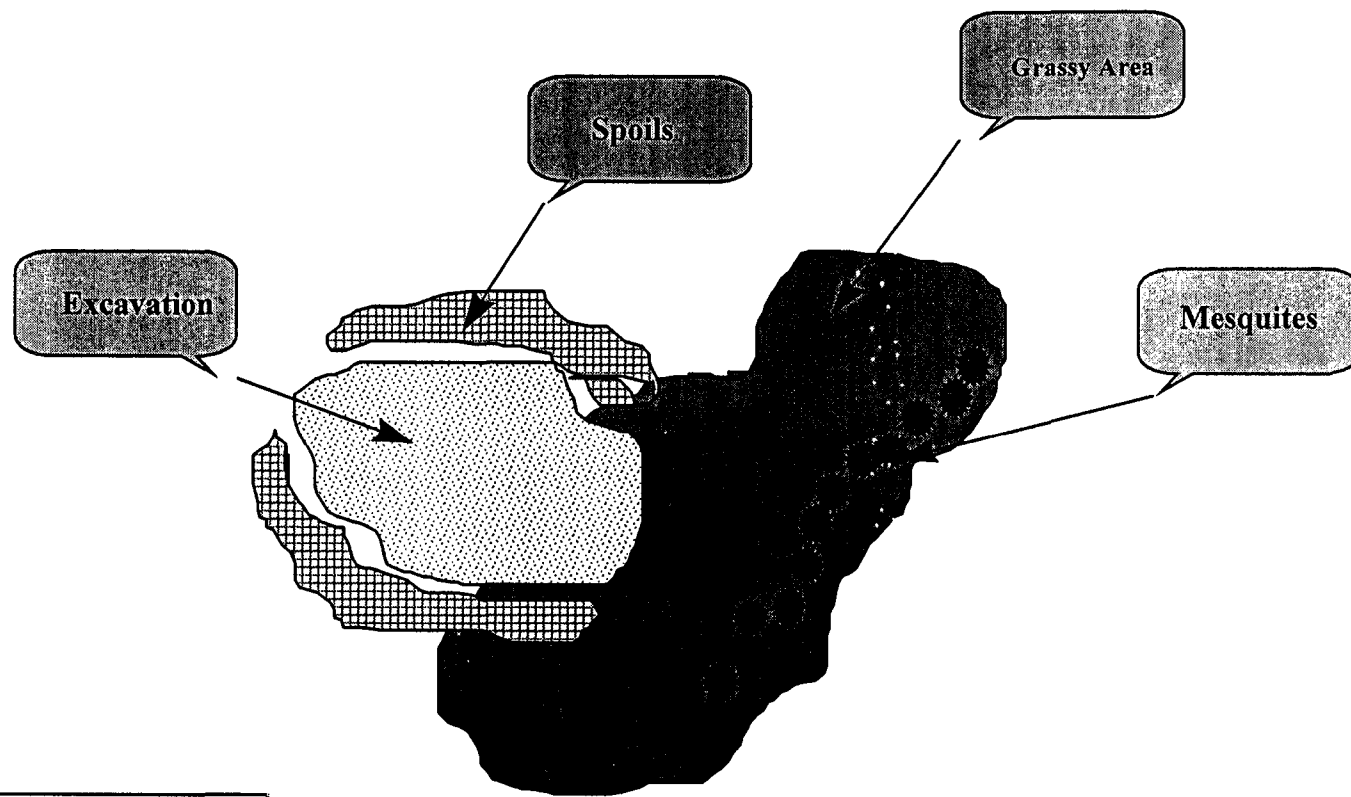
Navajo Refining Company
Figure 1

The leak in the pipeline resulted in oil being discharged. The leak flowed along the pipeline over an area approximately 415 feet in length, 75 feet to 190 feet in width. No evidence of other contaminants was observed.

Site Map
Artesia Station #2

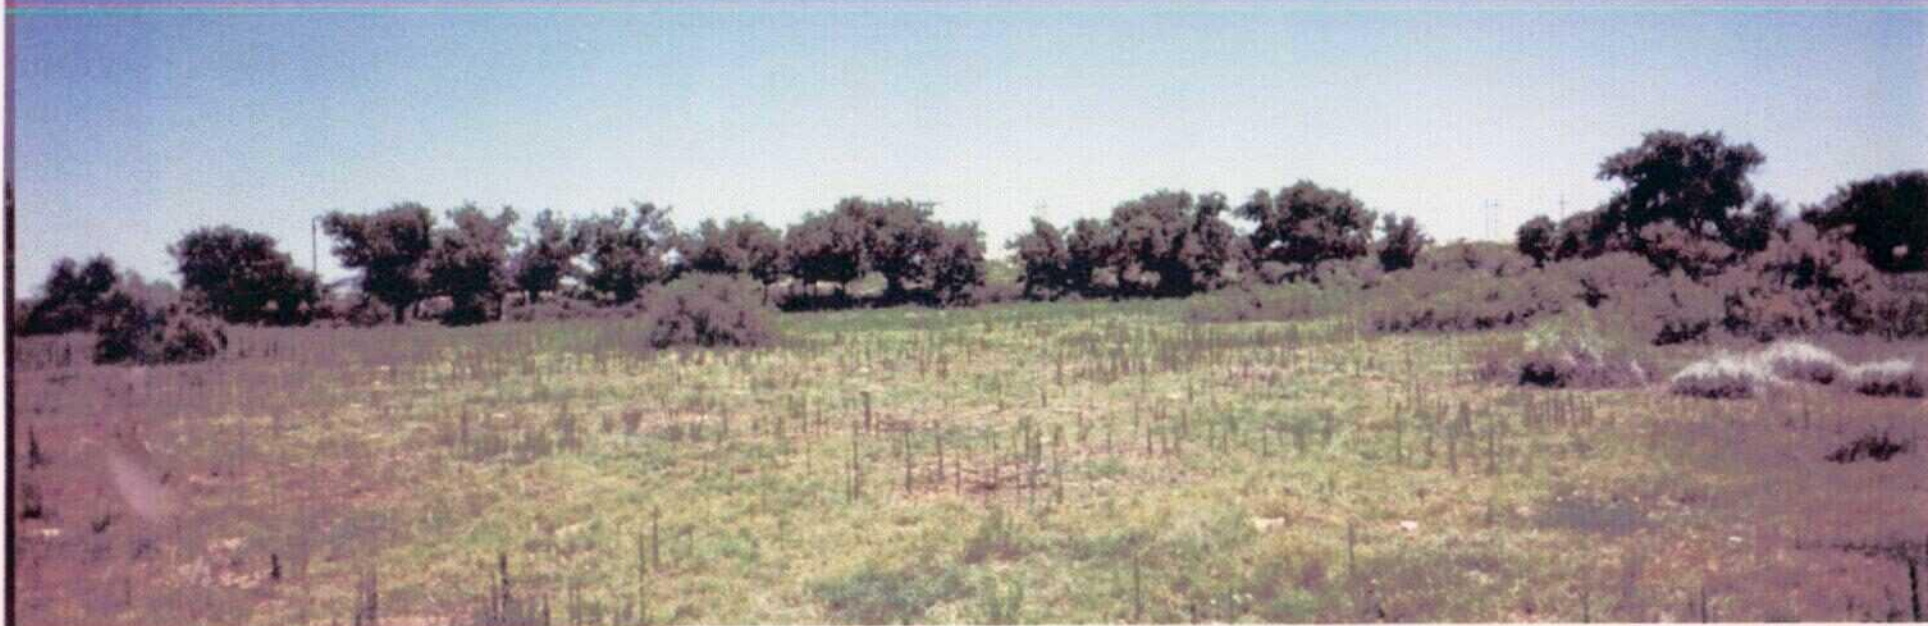
Navajo Discharge #2 - Photo #1 Prior to Project Facing East

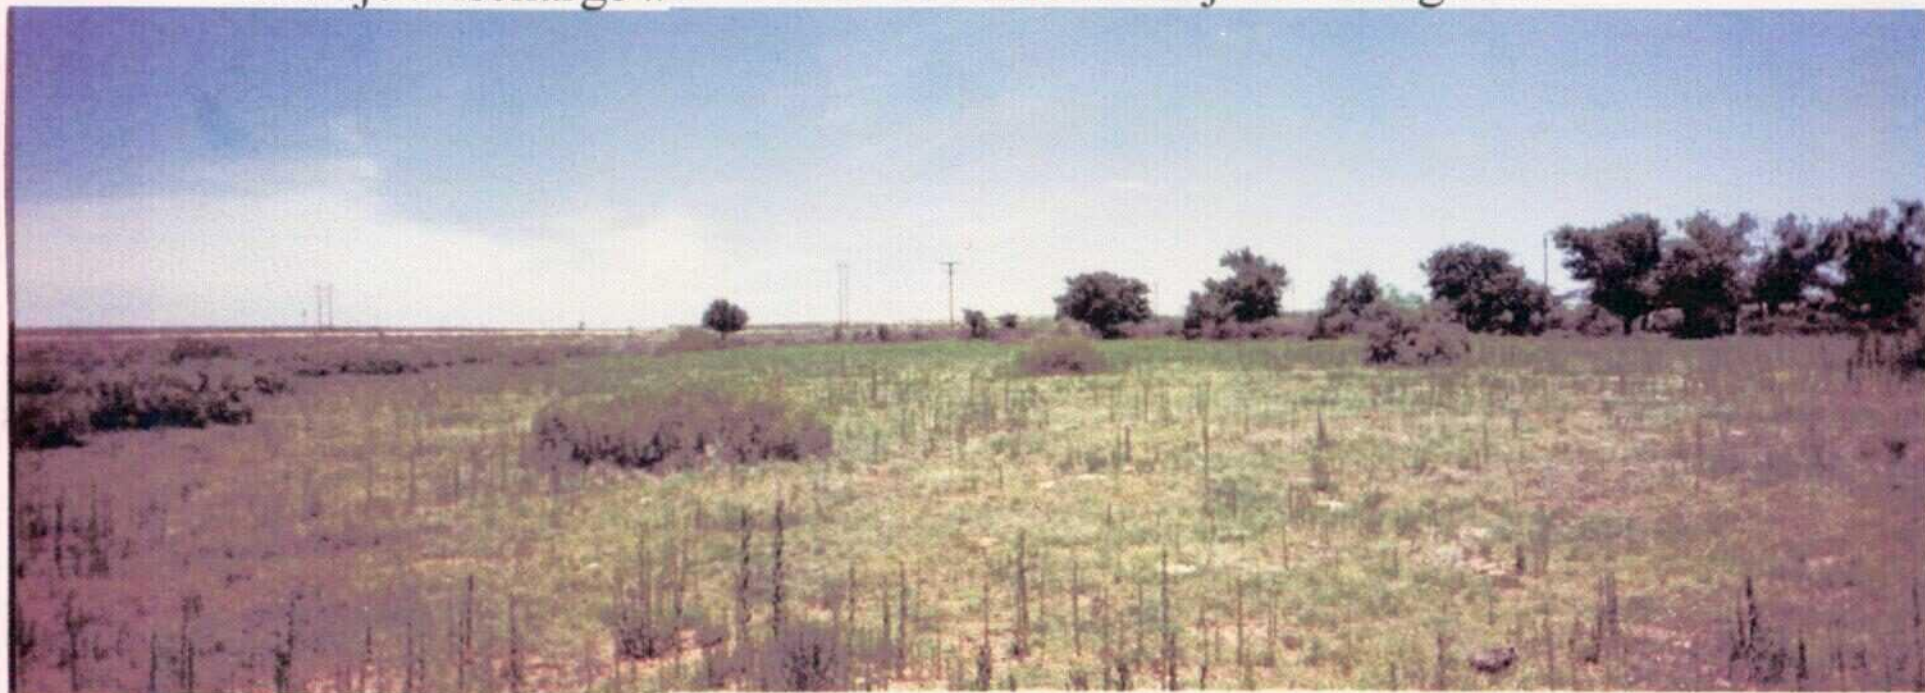
Navajo Discharge #2 - Photo #2 Prior to Project Facing East

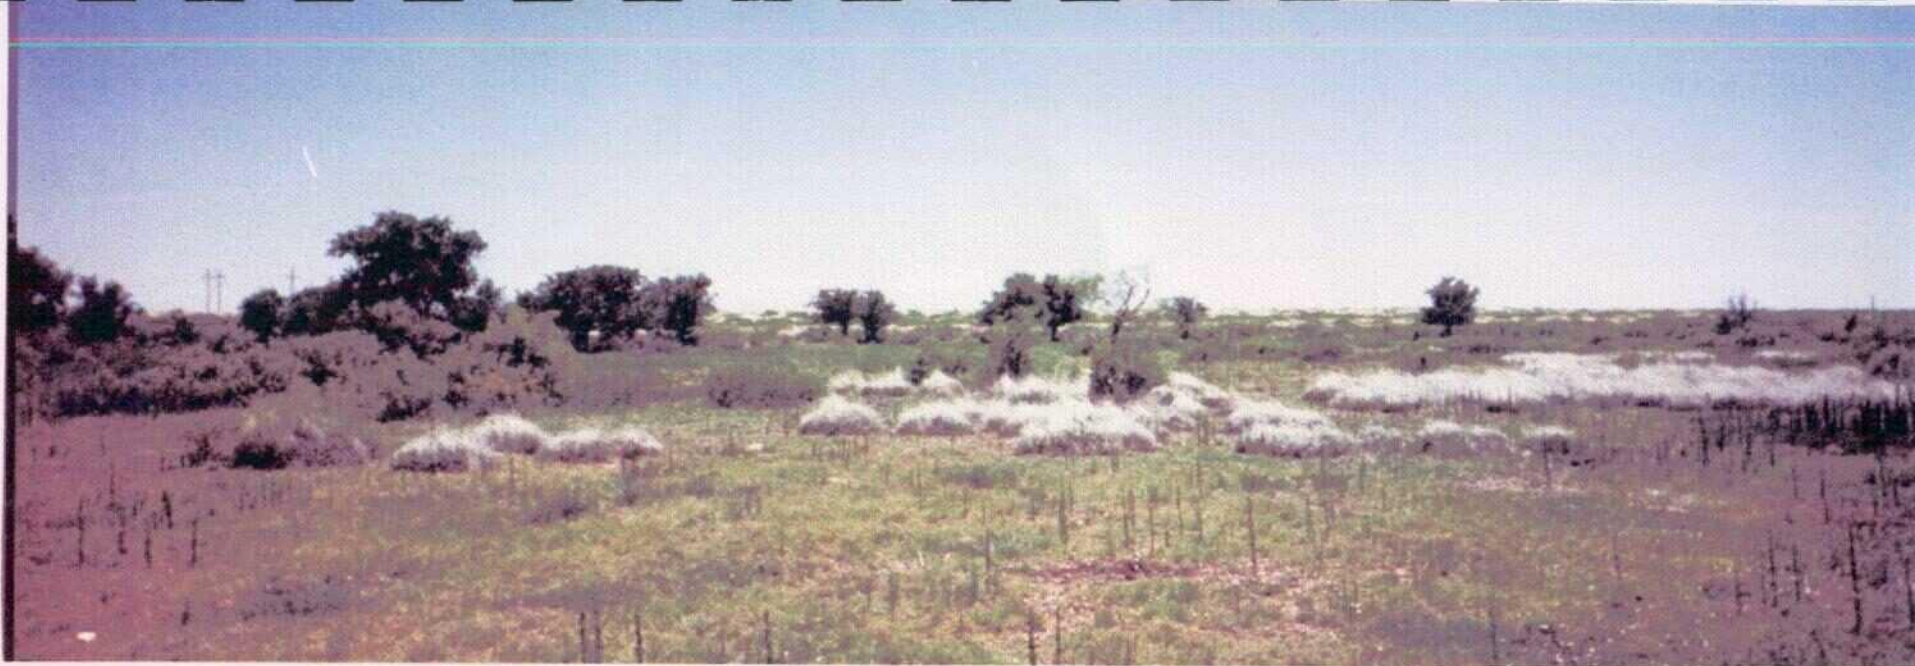
Navajo Discharge #2 - Photo #3 Prior to Project Facing Southeast

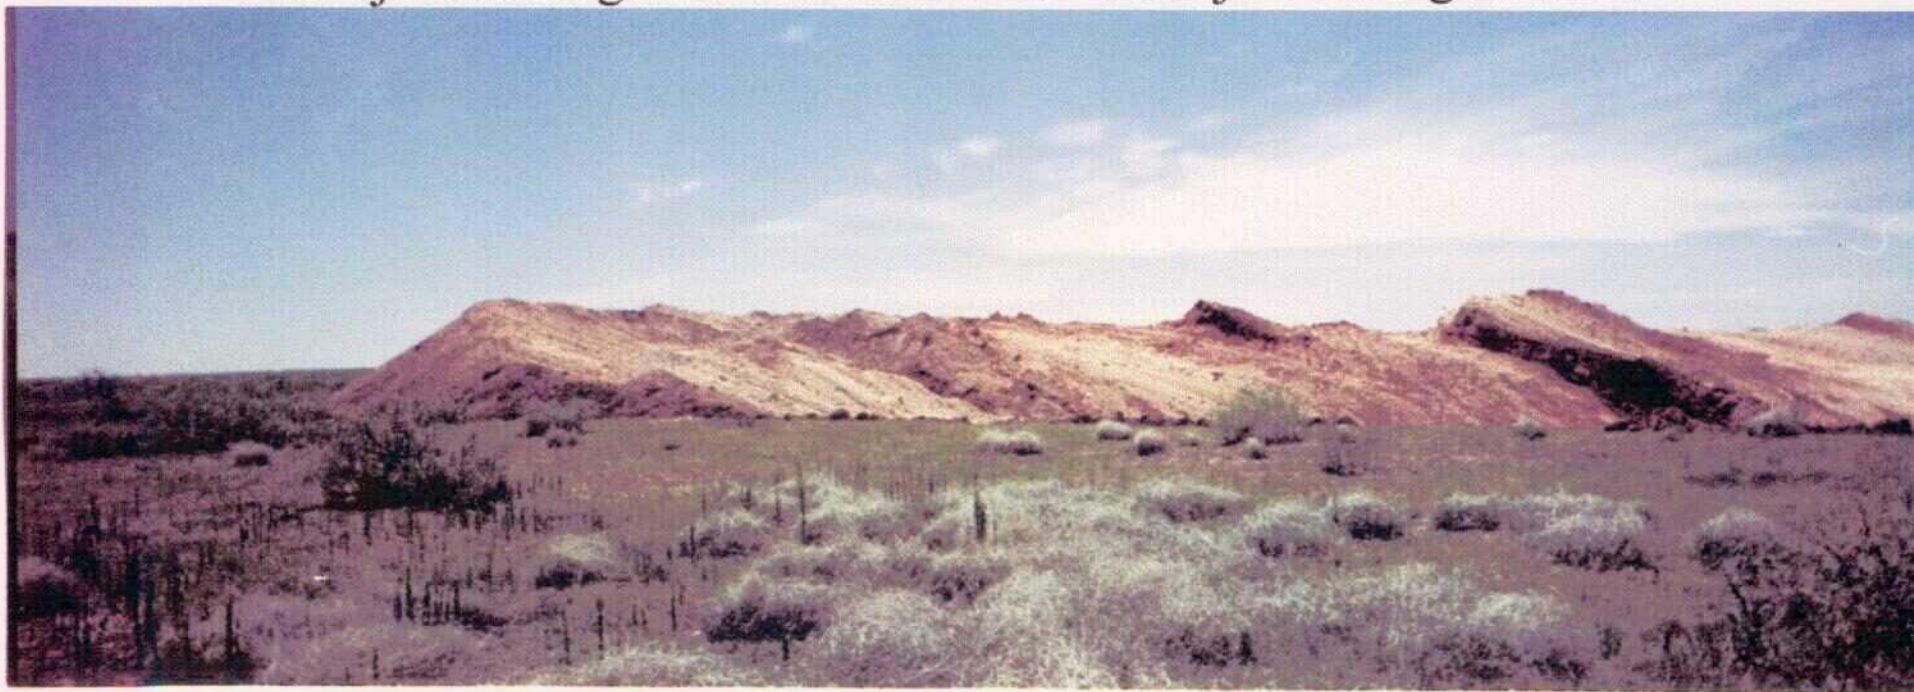
Navajo Discharge #2 - Photo #4 During Project Facing Southwest

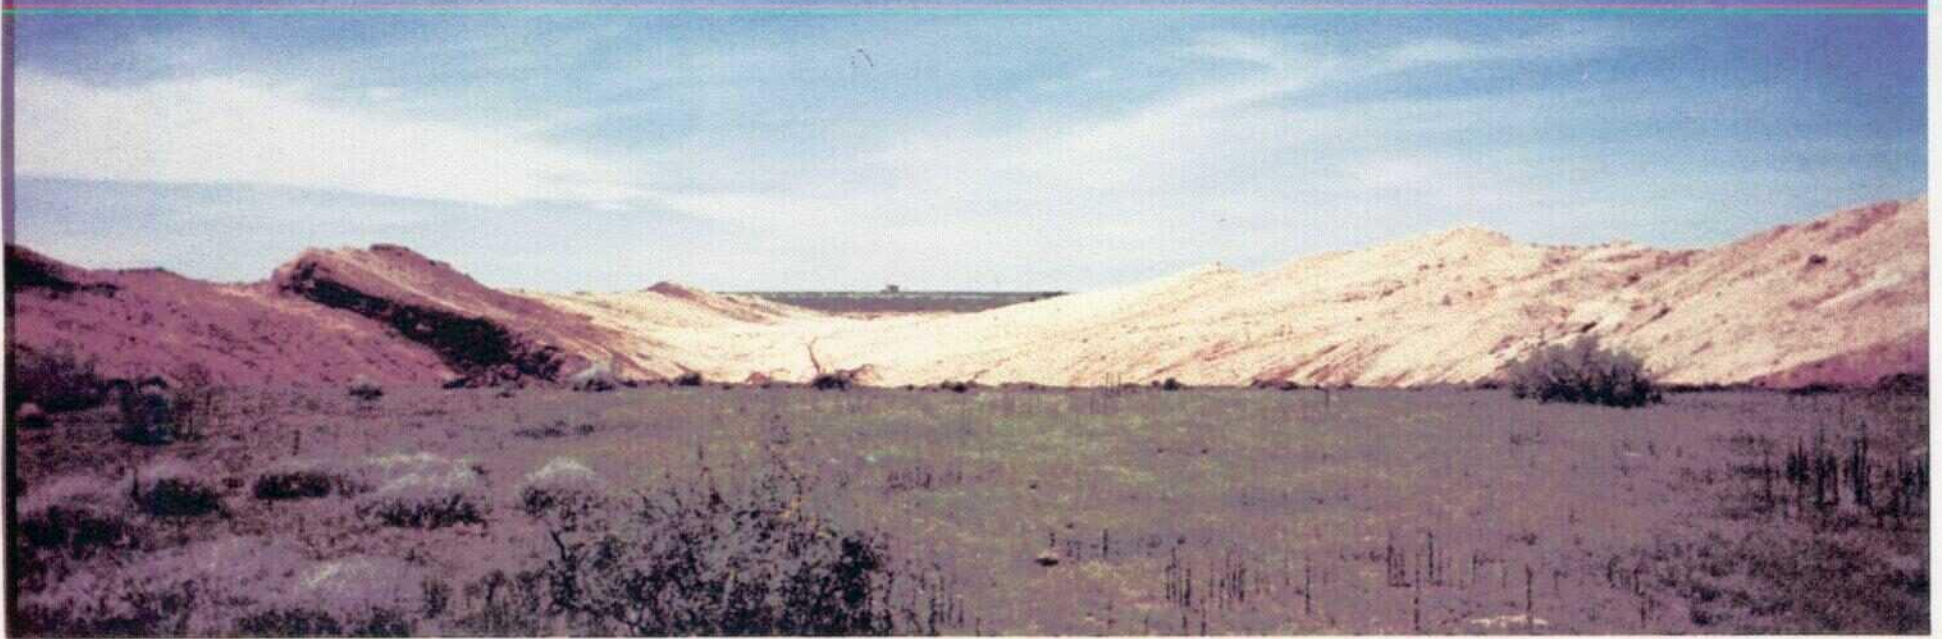
Navajo Discharge #2 - Photo #5 During Project Facing West

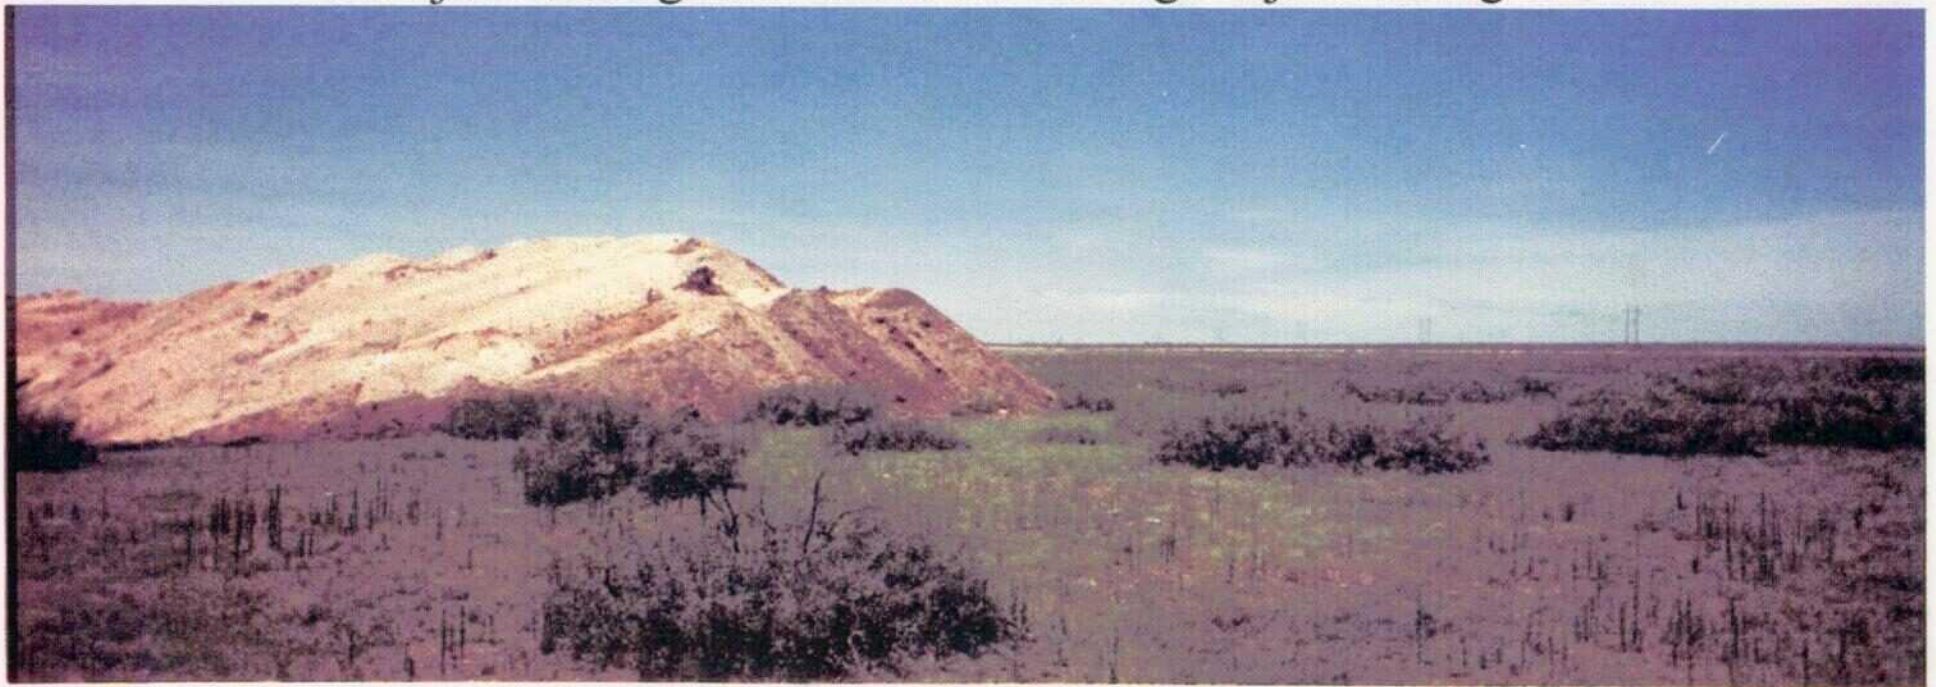
Navajo Discharge #2 - Photo #6 During Project Facing Northwest

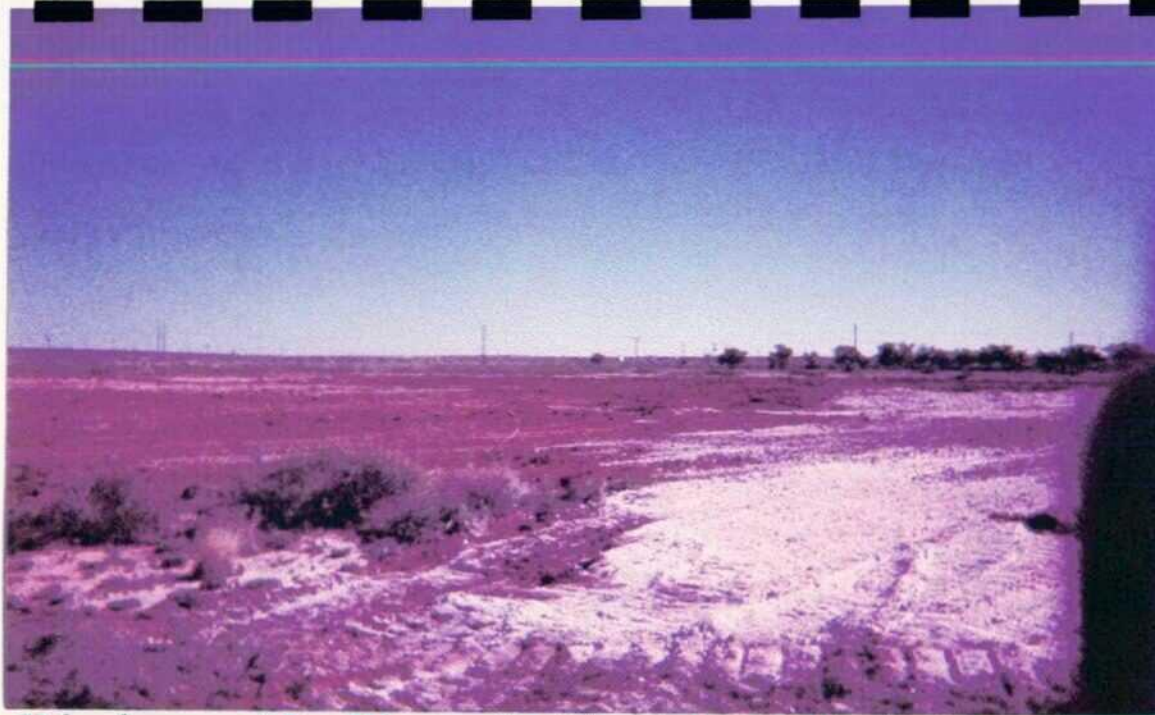
Navajo Discharge #2 - Photo #7 Completed Project Facing Northwest

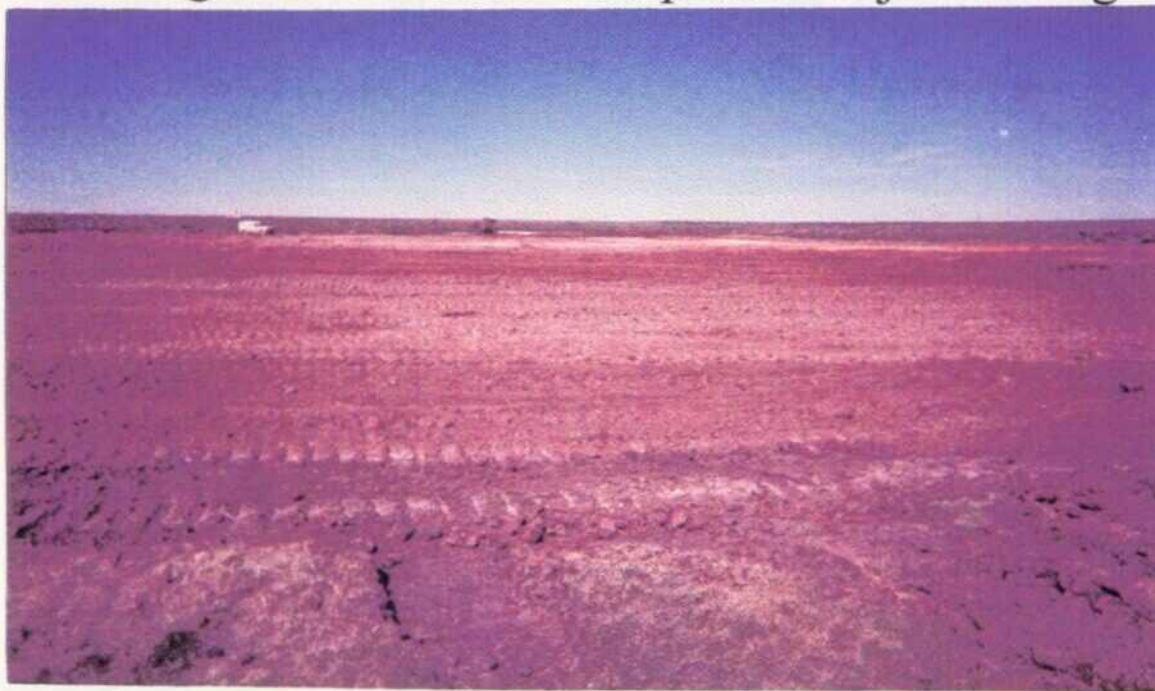
Navajo Discharge #2 - Photo #8 Completed Project Facing West

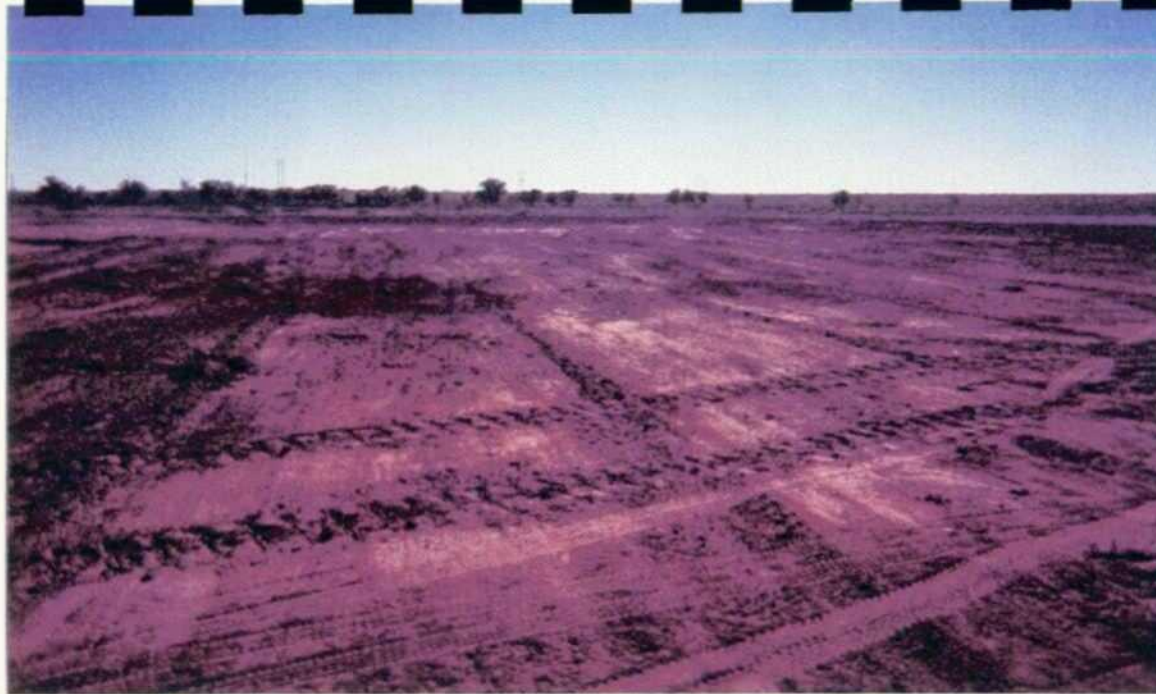
Navajo Discharge #2 - Photo #9 Completed Project Facing East

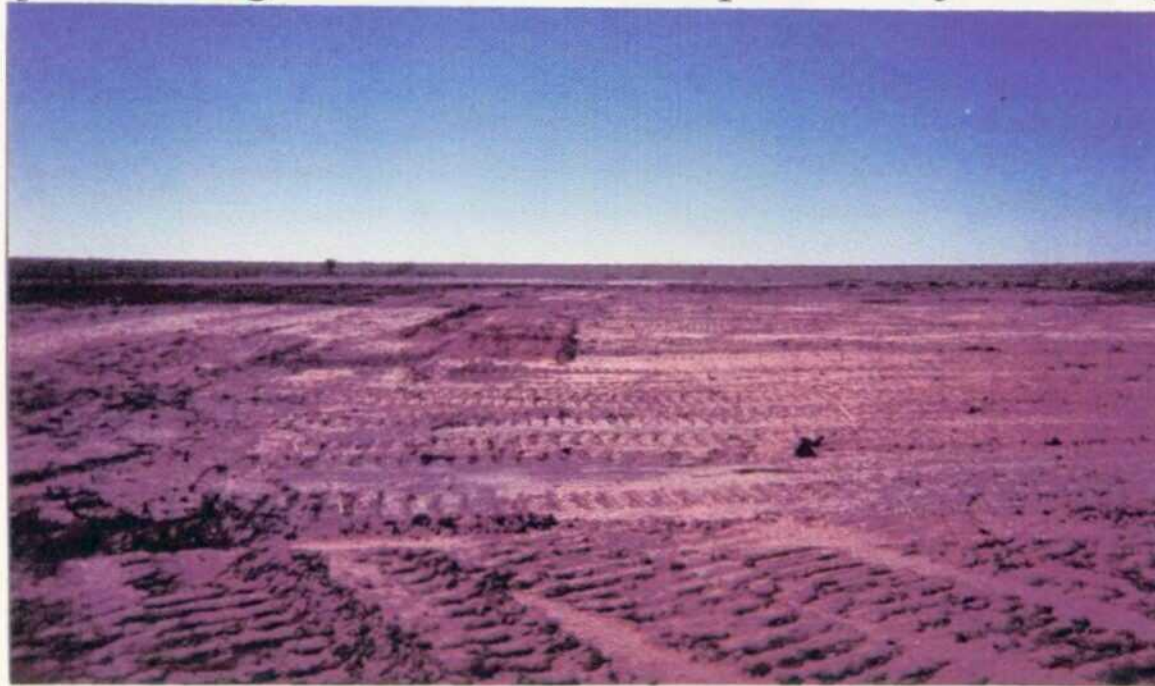
Navajo Discharge #2 - Photo #10 Completed Project Facing South
