August 19, 1987

A subsequent inspection by the Oil Conservation Division revealed that you are illegally disposing of produced water on your Ruth #1 24-19S-28E.

SUBJECT: OIL FIELD PROBLEMS ON AGRICULTURAL LEASE NUMBER GT-1329 (Pardue Farms').

SUBJECT: Oil Field Problems on Agricultural Lease Number: GT-1329
Pardue Farms

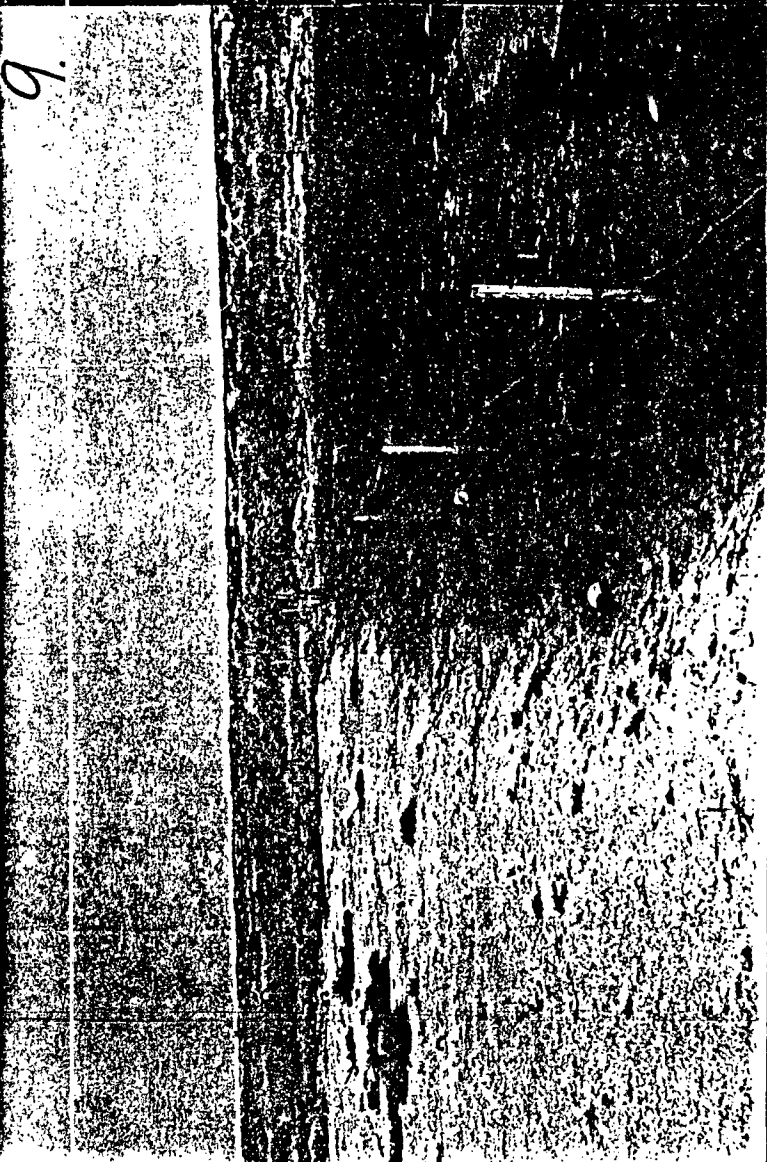
9.

- The site is inadequately fenced (Photos #9, 10, 11)

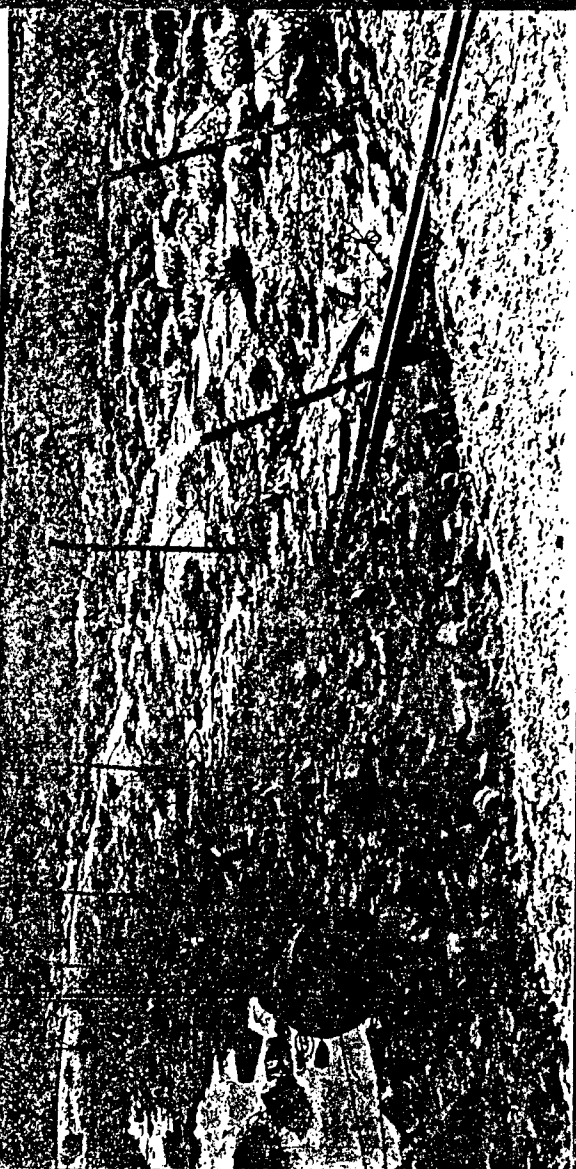
13.

- The site contains a large area of old, uncontrolled and unretained spills. The fencing around overflow pits is not adequate (Photo #13).

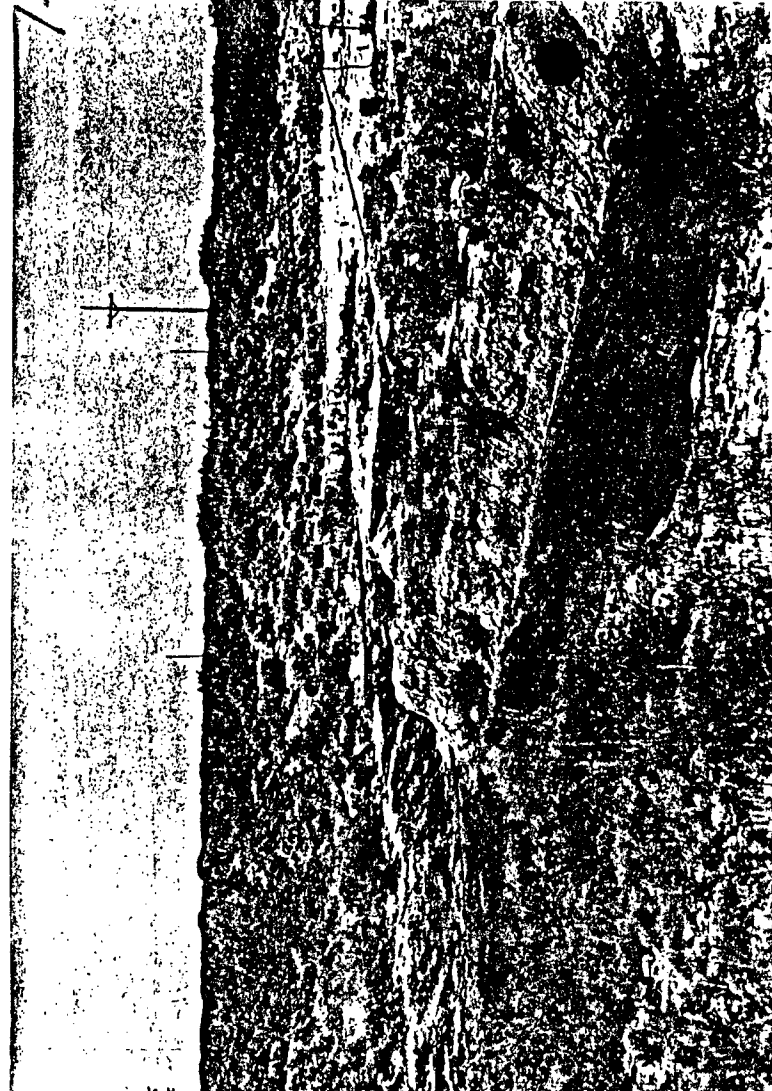
15

- The specific well site is in good condition. The problems are just to the north where oil field trash and debris, and tank bottom clean-out sludge are present (Photo #15)
