Re: Dunnaway Draw Spill Report

**RE: DUNNAWAY DRAW SPILL REPORT
YATES PETROLEUM COMPANY**

Yates Petroleum
Report of Spill in Martha Creek

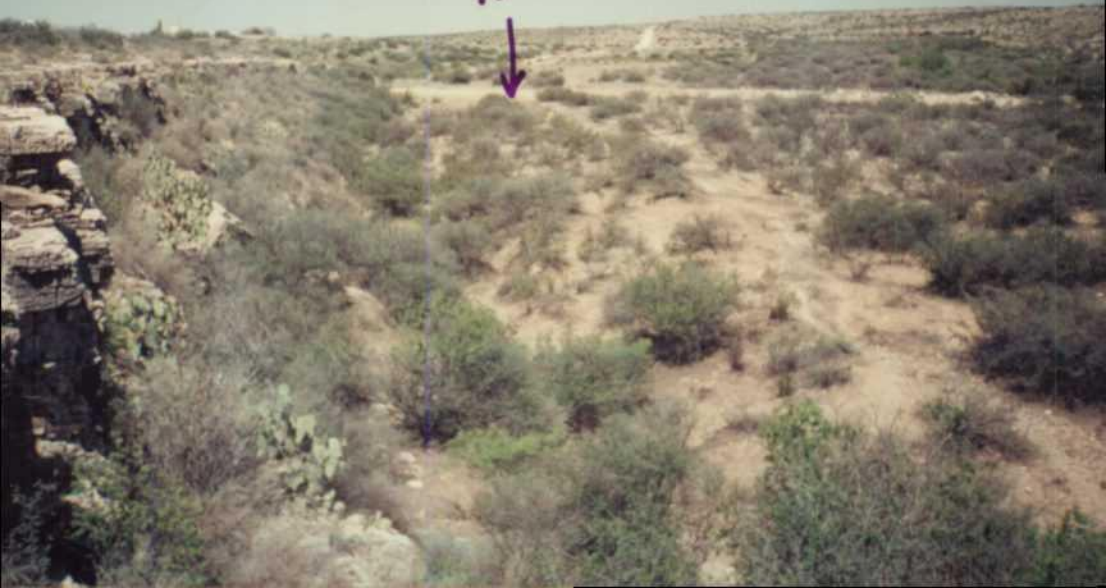
#1

6-6-95 LOOKING WEST TO R.A.W.
WHERE LEAK OCCURRED

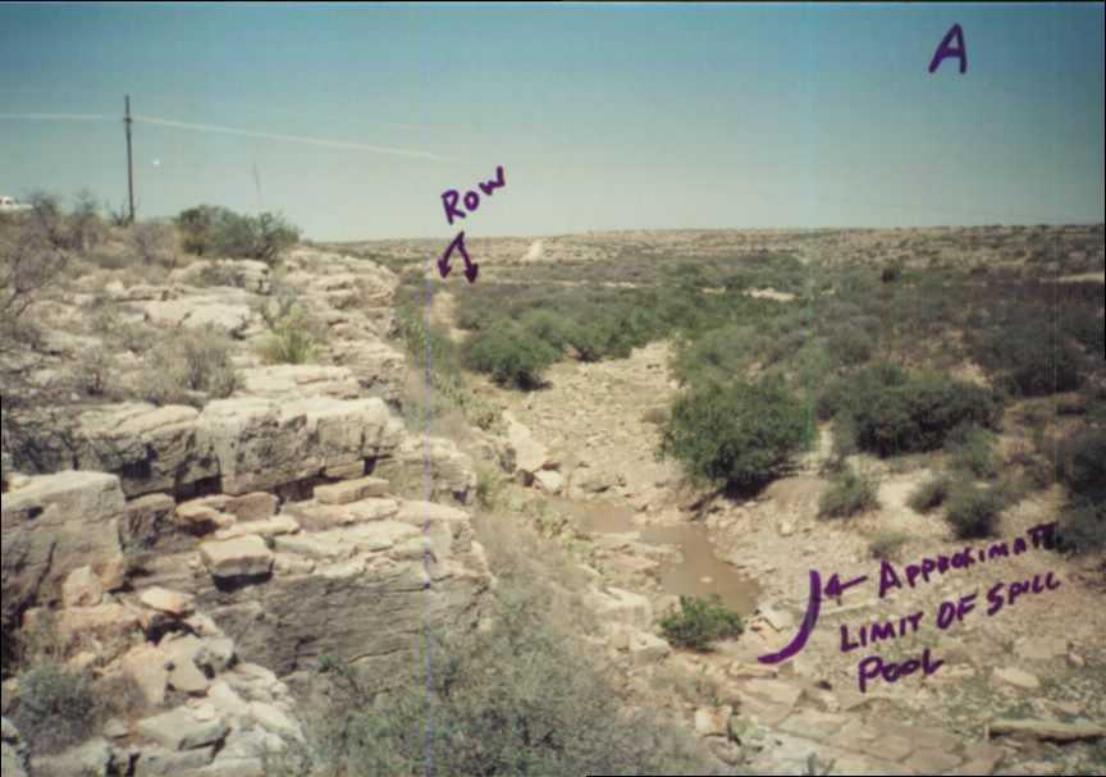
Enclosed are some photographs of the site that were taken on June 6, 1995. The spill area is clearly shown and more specifically the exposed rock area where infiltration would occur. As can be seen in these photos, there is a pool of water in the depression that held the spill. This particular water happens to be storm runoff water that, at the time of the photograph, had been ponded in this depression for at least eight days. Even at the date of this letter there is still some water remaining in this pool. Considering that the immediate aeration that occurred at the pipe rupture, the length of run through the silt lined natural channels, and the short duration of exposure in the rocky creek bottom, it is highly unlikely that any significant infiltration of benzene or other petroleum product occurred. The weight of the evidence presented above demonstrates that benzene has been sufficiently attenuated such that it is not a problem at this site.

6-6-95 LOOKING WEST ALONG CREEK
BOTTOM TO ROW. WHERE LEAK
OCCURRED. NOTE WATER IN POOL
HAS BEEN HERE SINCE 5-30-95
IT HAS NO OIL SHEEN AND NO
SLUDGE WAS FOUND ALONG BANKS
NOTE: WATER IS RUN OFF WATER FROM
RAIN

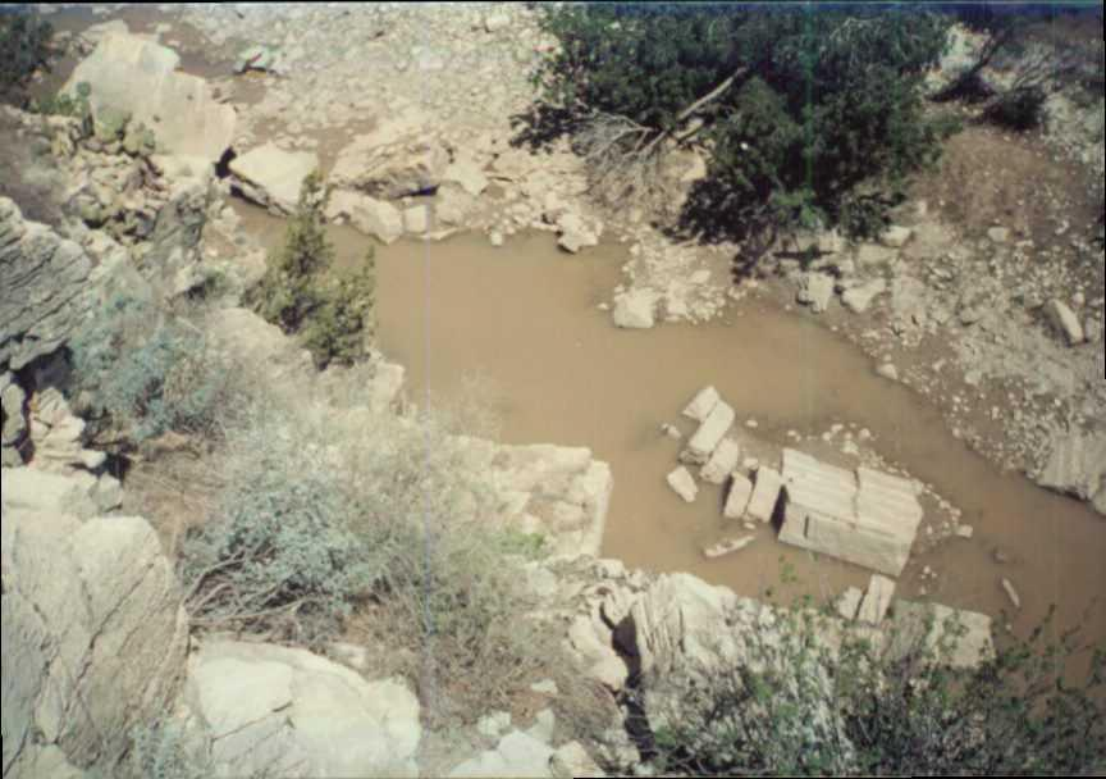
6-6-95 CLOSE VIEW OF POOL AREA
THAT RECEIVED SOME OF THE
SPILL. NO OIL SHEEN PRESENT

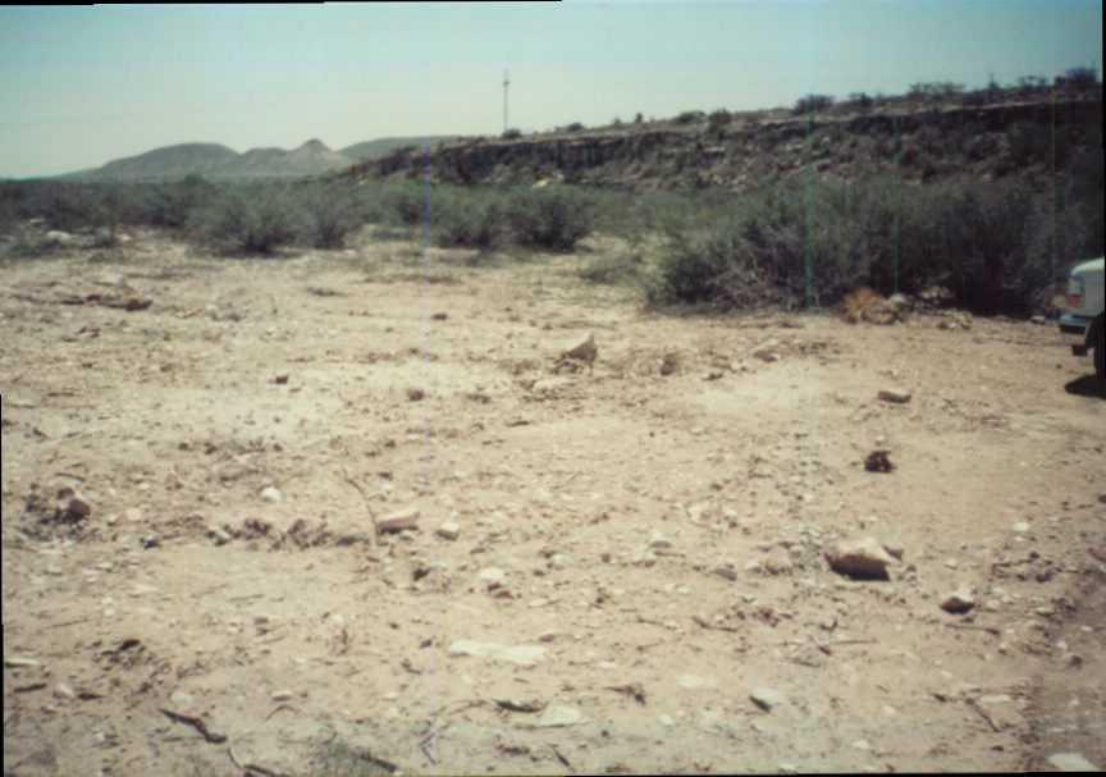
#3

6-6-95 PIPE LINE R.O.W. WHERE LEAK
OCCURRED IN LINE. NO OIL OR
SLUDGE PRESENT

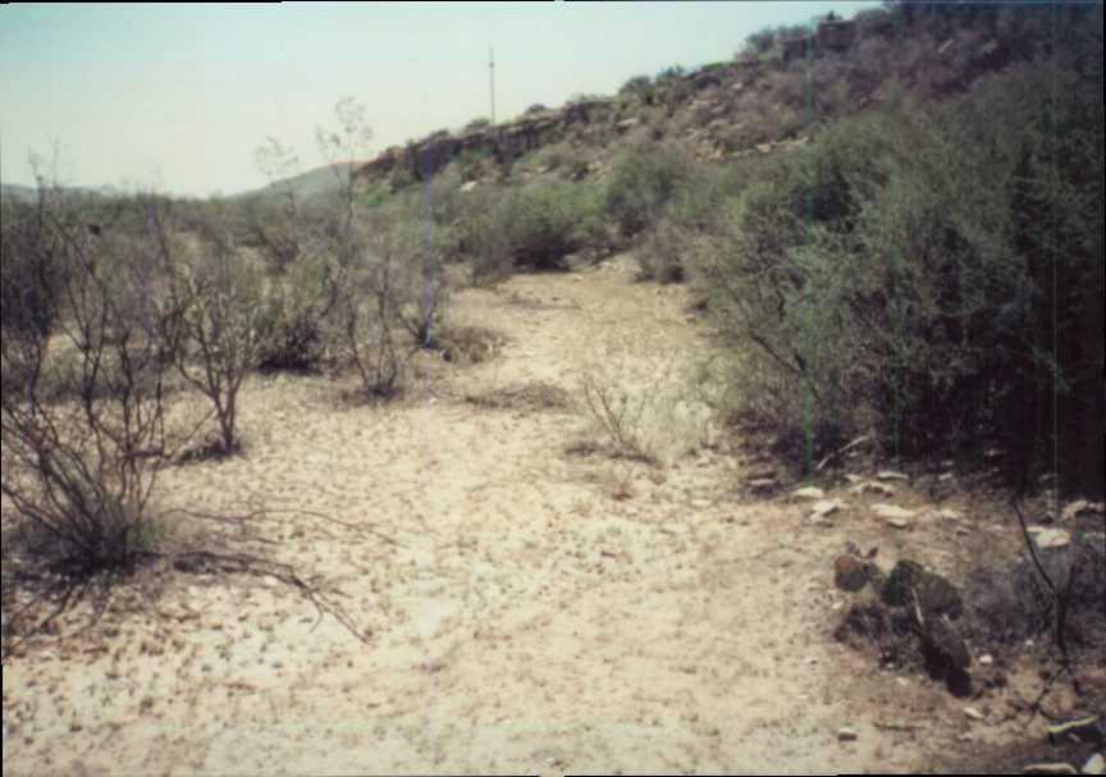
#4

6-6-95 Looking EAST IMMEDIATELY
DOWN STREAM OF PIPELINE. THE
PRODUCED WATER RAN IN THE CHANNEL
TO CREEK BOTTOM.

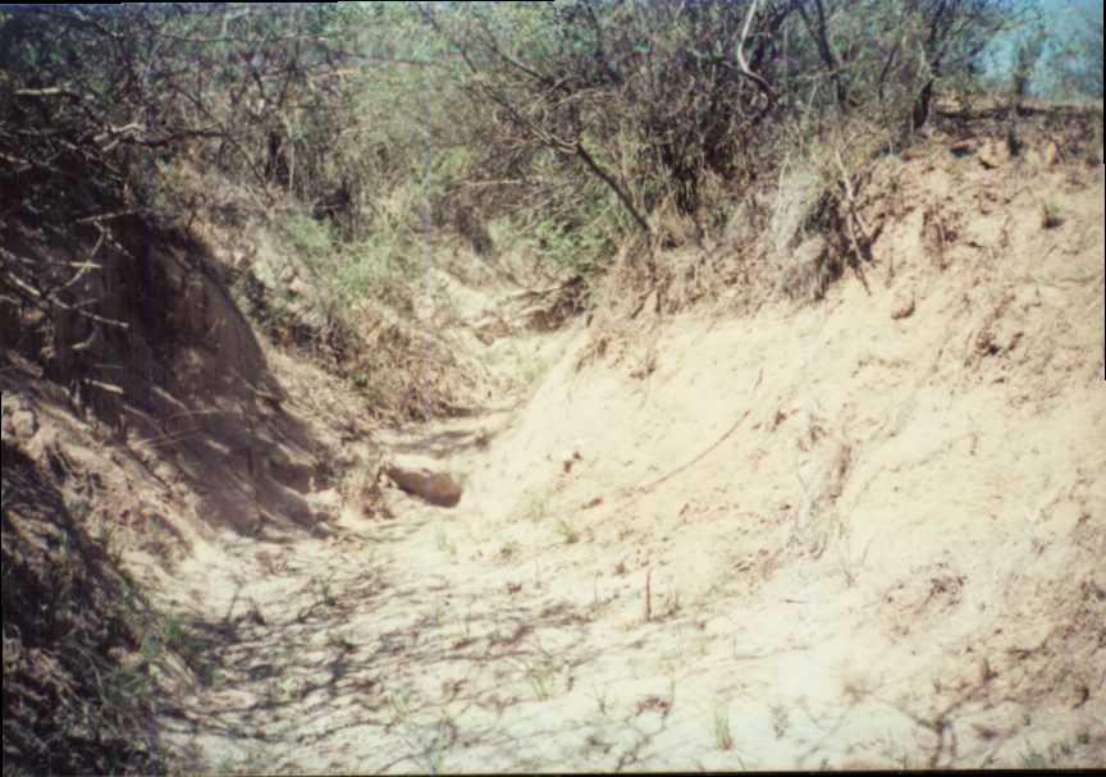
#5

6-6-95 VIEW OF NATURAL CHANNEL
THAT CARRIED SOME OF SPILL
WATER TO CREEK BOTTOM

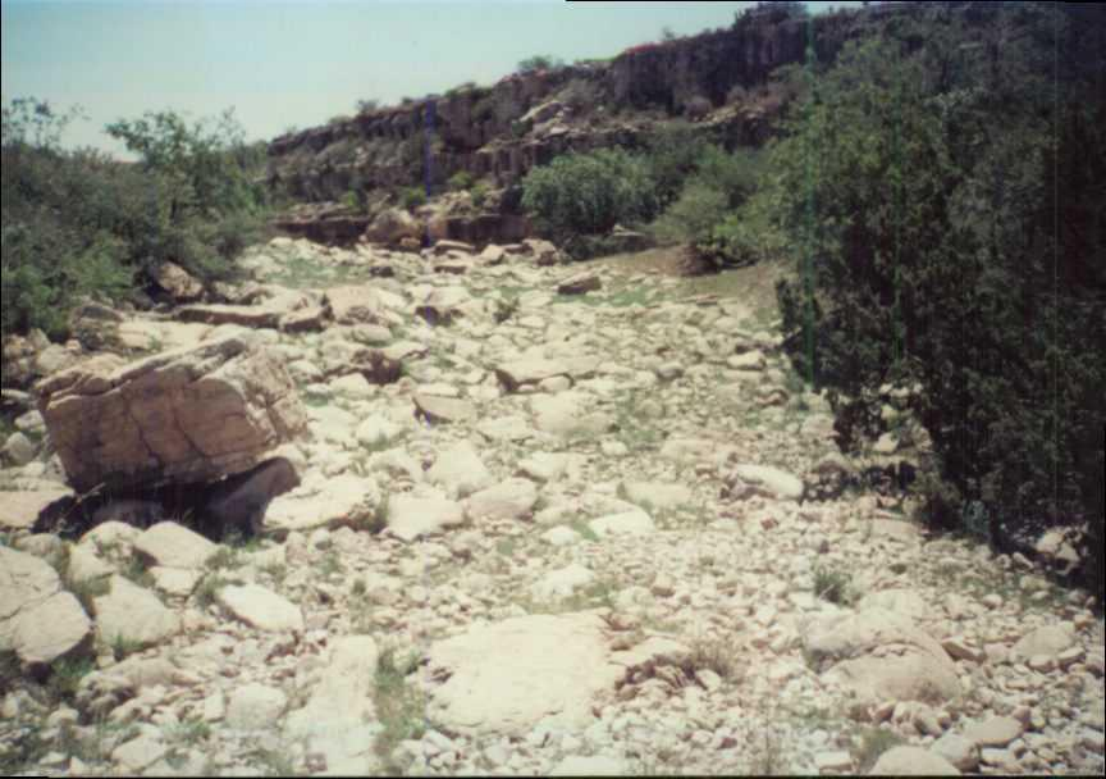
#6

6-6-95 . LOOK EAST FROM THE MOST
WESTERN POINT OF SPILL
FLOW IN BOTTOM AREA.

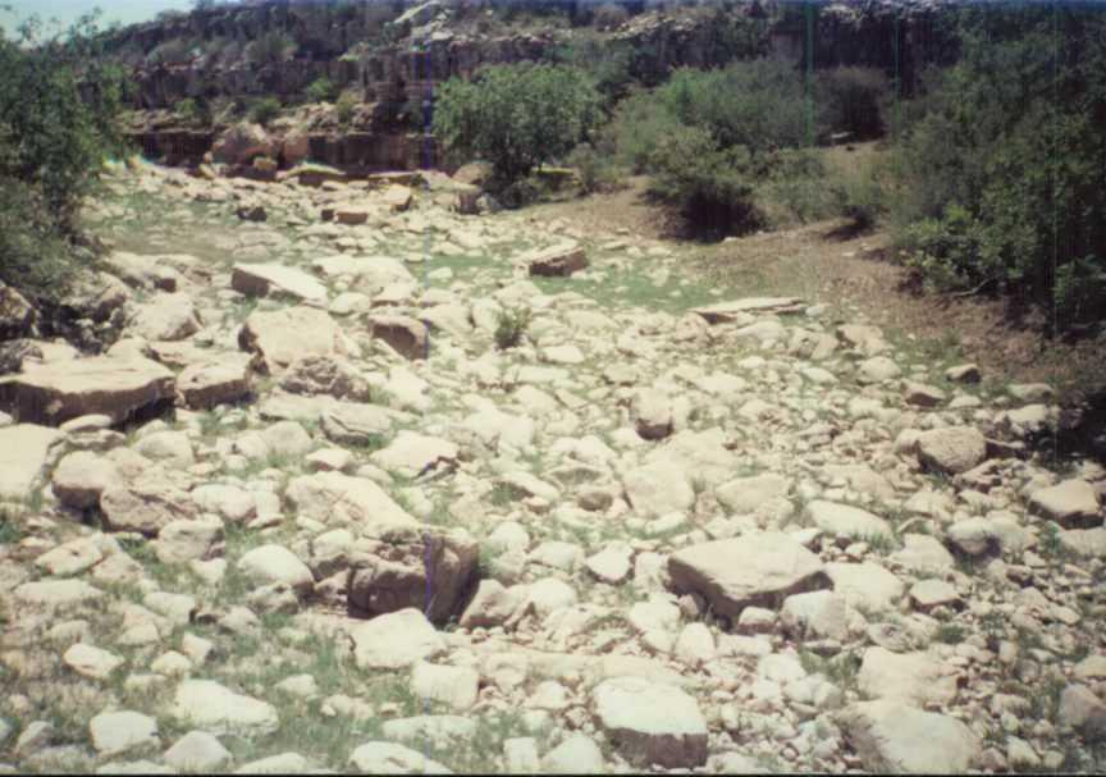
#7

LOOKING EAST FROM UPPER
END OF SPILL AREA. NO SLUDGE
OR OIL PRESENT.

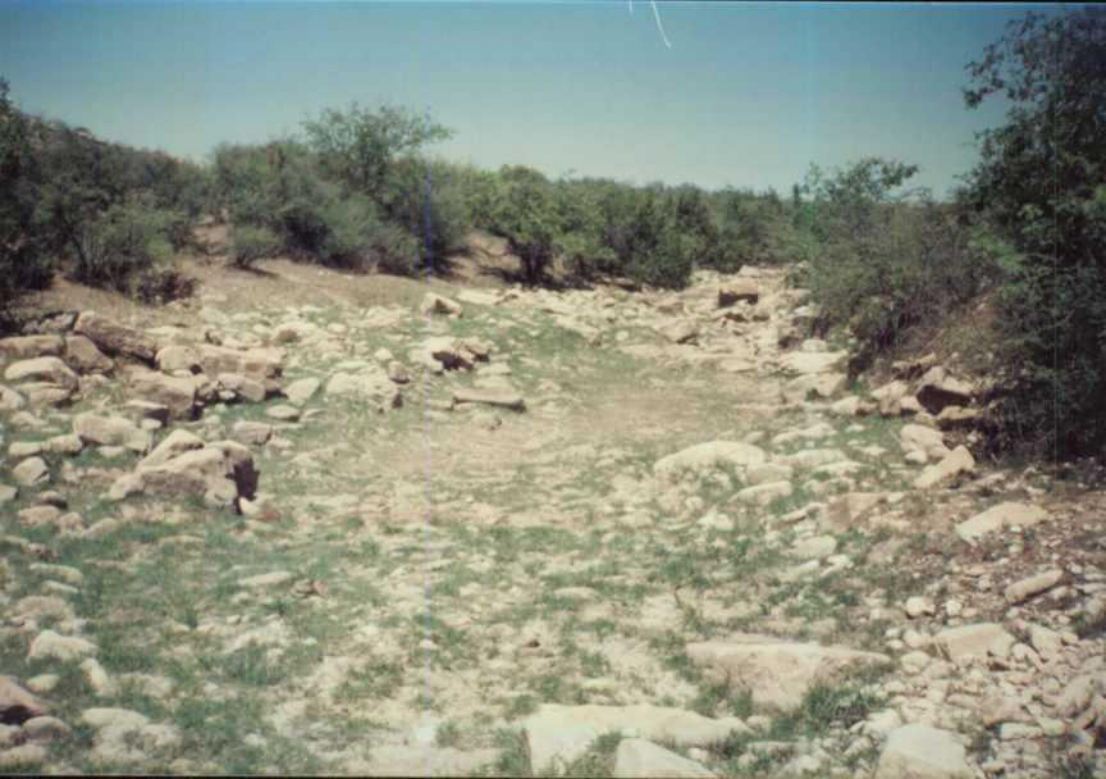
#8

6-6-95 Looking West To West End
Of Spill Flow In Bottom Area
