PHILLIPS PETROLEUM COMPANY

Undesirable Event - Water Spill
32-7 Water Pipeline Leak

NOTIFICATION OF FIRE, BREAKS, SPILLS, LEAKS, AND BLOWOUTS

32-7 Coal Seam Water Pipeline Leak
Chain of Events

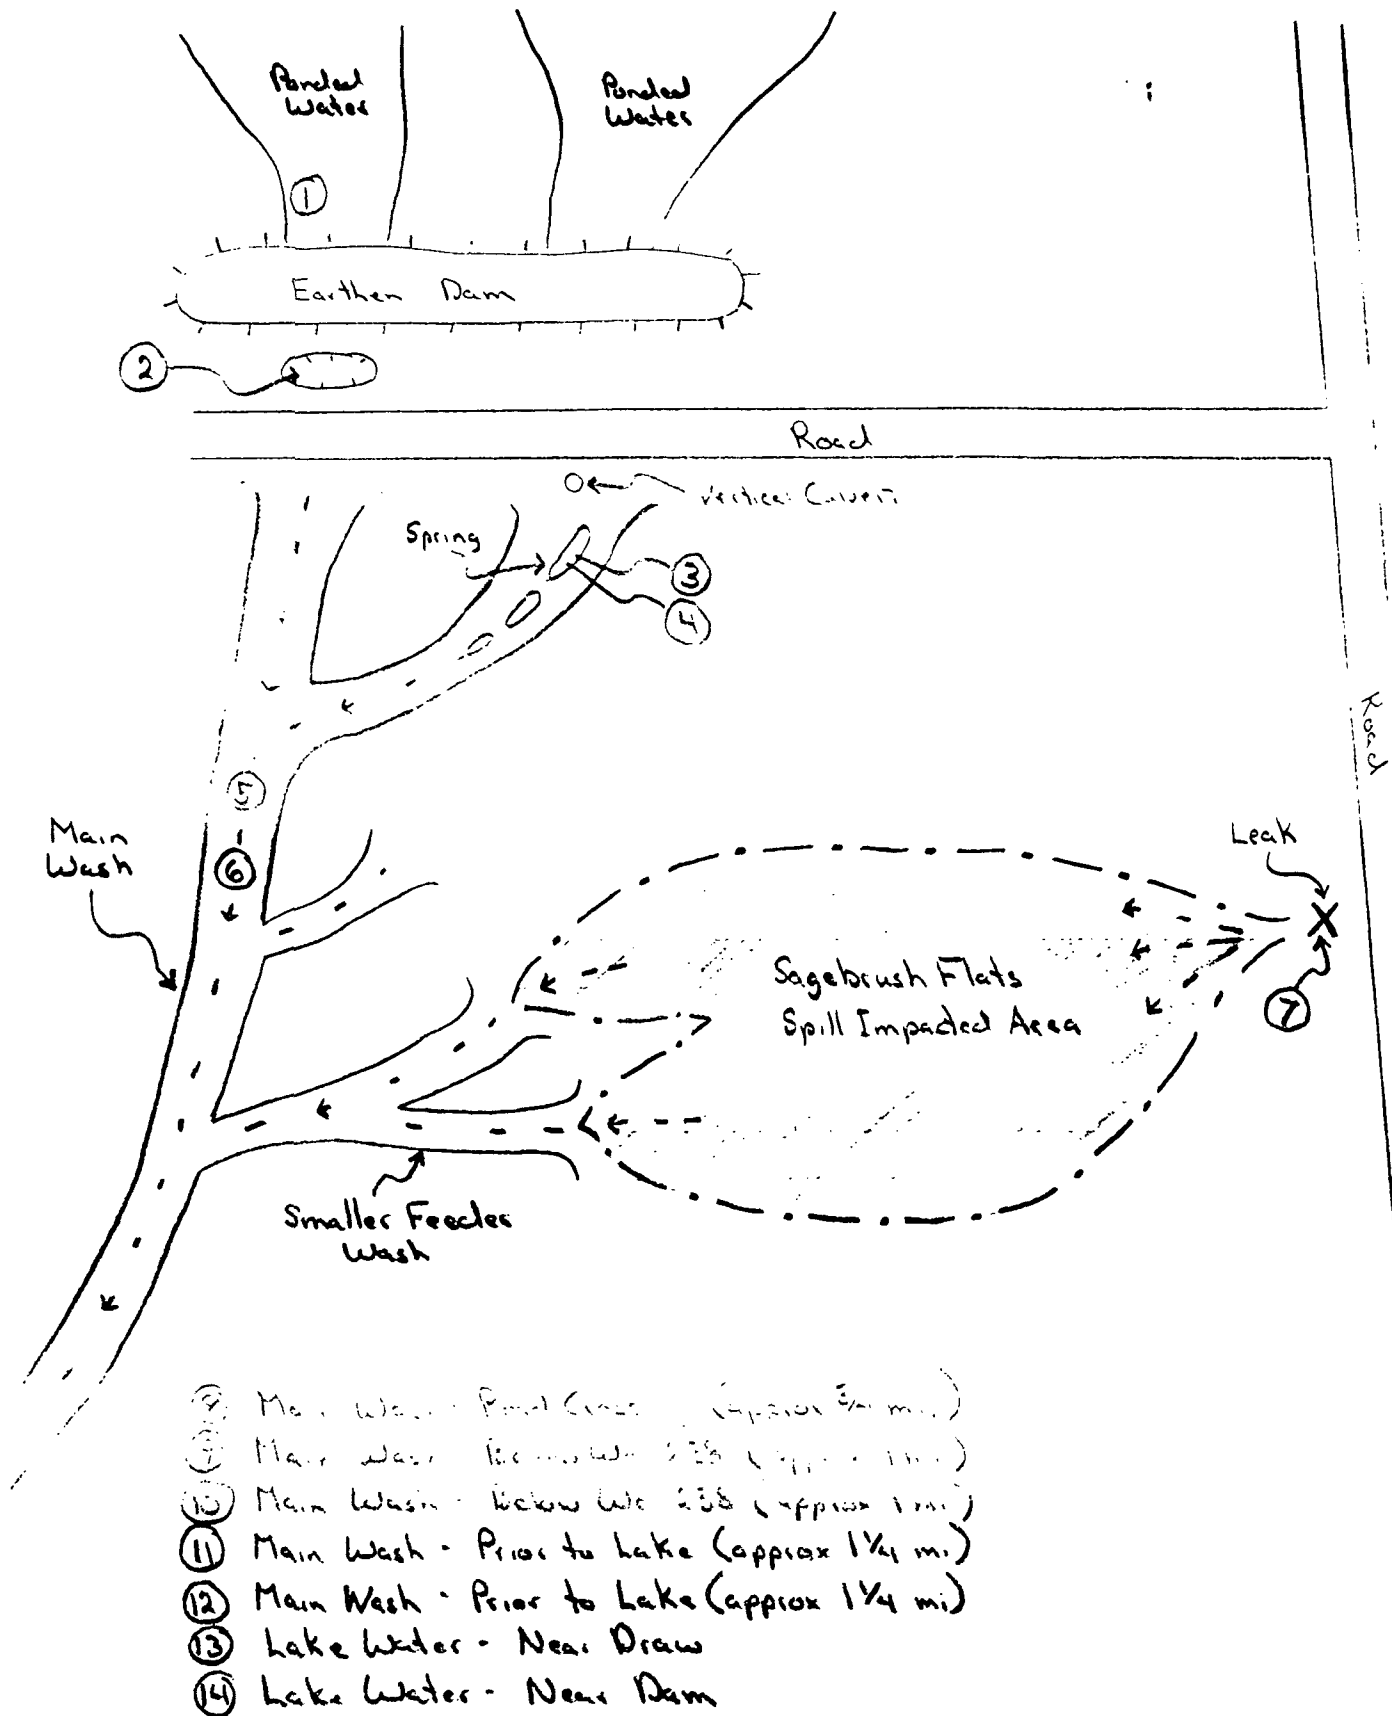
Water Sample Locations · 32-7 Water Leak

Sample #		TDS (mg/L)	Bicarb (mg/L)	Sulfate (mg/L)	Sodium (mg/L)	Alkalinity (mg/L)	Cations (meq/L)
	Backgrounds						
1.	(2/25) Upper Pond	97	78	11	9.9	64	2
2.	(2/25) Lower Pond	201	176	10	41	144	4
3.	(2/23) Spring	2640	342	1300	644	280	39
4.	(2/27) Spring	3440	508	1710	841	416	52
5.	(2/25) Main Wash	5400	544	2750	1390	446	81
6.	(2/27) Main Wash	3800	486	1860	997	398	58
	Spilled Water						
NA	(2/93) Well #224	7080	5970	4.9	2920	5980	129
NA	(10/93) Well #238	6820	7380	1.6	2830	6160	126
7.	(2/23) Leak	7120	7580	4	3000	6210	133
	Downstream Water						
8.	(2/23) Road X-ing	276	254	17	96	208	5
9.	(2/23) Below #238	149	133	18	44	109	3
10.	(2/24) Below #238	198	159	35	51	130	4
11.	(2/24) Before Lake	759	305	340	96	250	13
12.	(2/27) Before Lake	878	339	387	99	278	14
	Lake Water						
13.	(2/27) Lake at Draw	125	106	22	14	87	2
14.	(2/27) Lake at Dam	129	92	35	12	75	2

Note: Samples #3, #7, #8 and #9 were collected prior to the water leak being stopped.

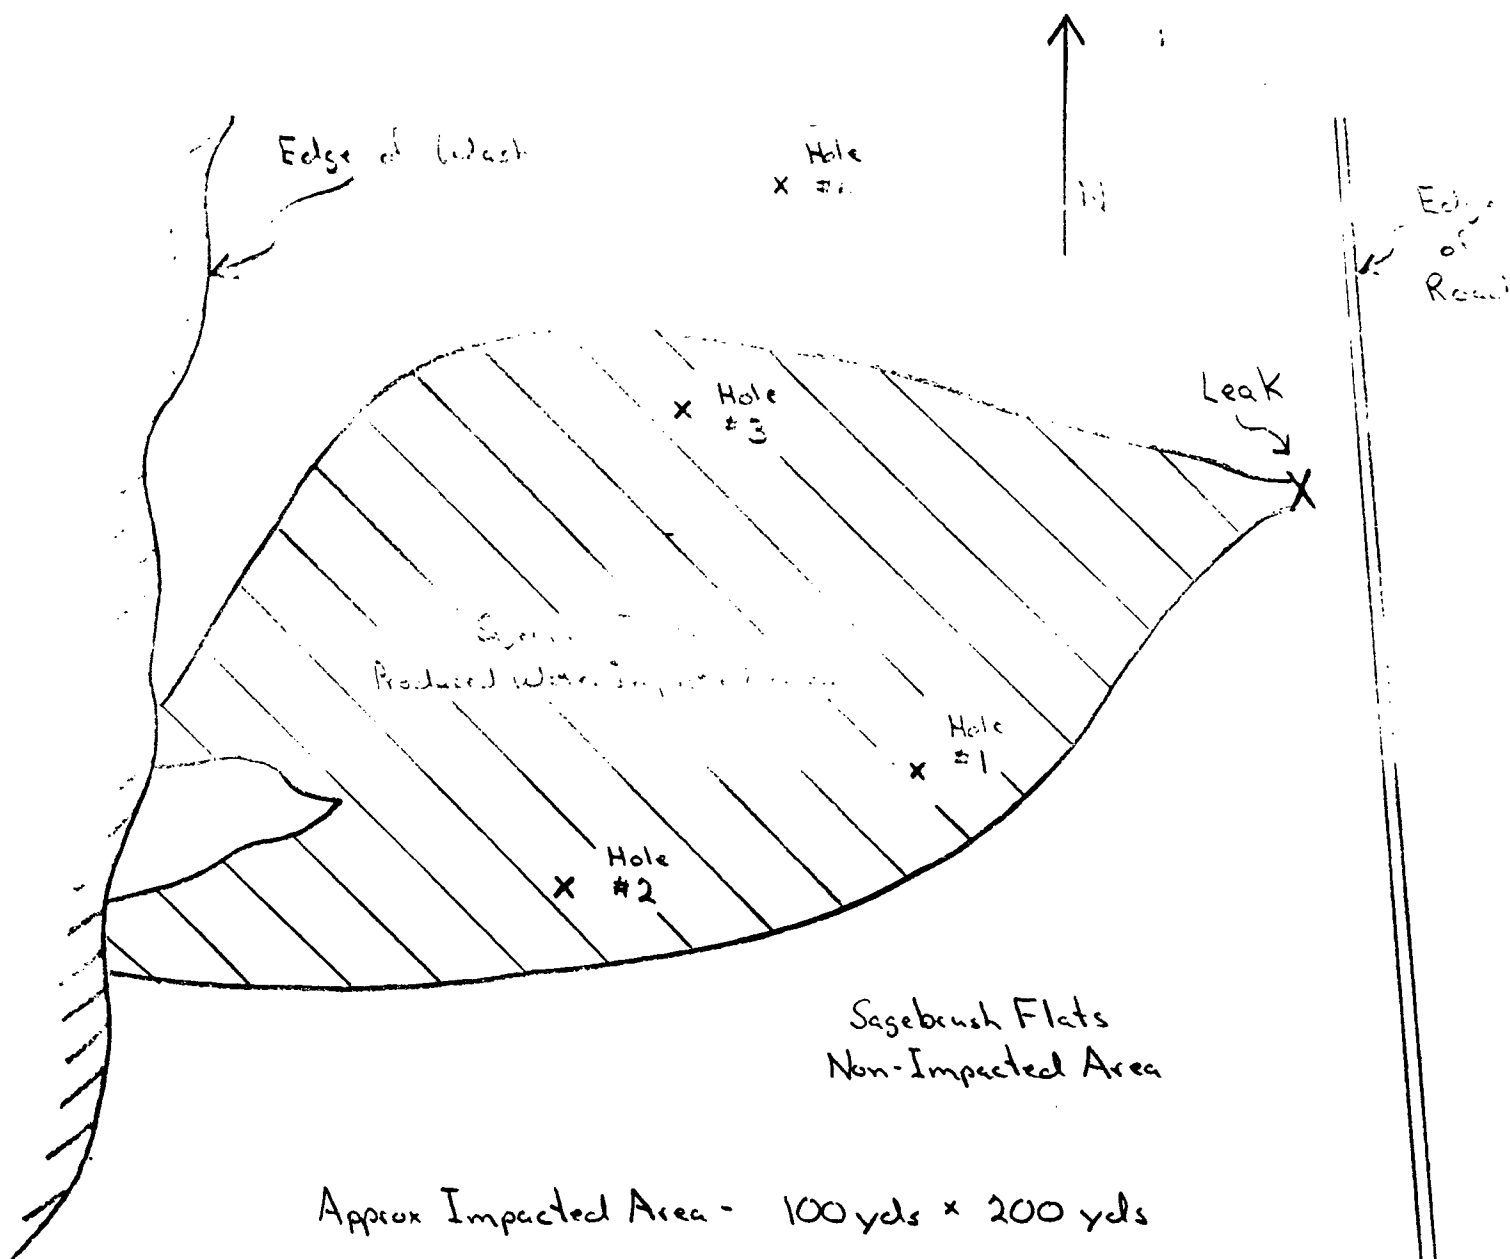
Soil Sample Locations - 32-7 Water Leak

TEST HOLE	SAMPLE DEPTH	ELECTRICAL CONDUCTIVITY (mmhos/cm)	EXCHANGEABLE SODIUM % (ESP)	pH
#1	Surface	6.14	85.8	9.7
#2	Surface	3.83	0.8	9.8
#3	Surface	5.12	101.0	9.8
#4	Surface	0.26	1.0	6.7
#1	One Foot	1.18	12.7	8.1
#2	One Foot	0.69	15.0	8.4
#3	One Foot	0.65	2.1	8.0
#4	One Foot	0.31	1.9	7.3
#1	Two Feet	0.69	4.3	7.8
#2	Two Feet	0.57	7.0	8.2
#3	Two Feet	0.74	3.3	7.9
#4	Two Feet	0.35	1.5	7.7
#1	Five Feet	2.50	10.0	7.7
#2	Five Feet	1.04	14.6	8.5
#3	Five Feet	1.89	11.6	8.1
#4	Five Feet	0.56	3.3	8.0

Note: Test Holes #1, #2, and #3 were in spill impacted areas in the sagebrush flats. Test Hole #4 was in a non-impacted area. All samples were collected on 2/27/95.

Approx Impacted Area - 100 yds x 200 yds
