**Progress Report for Reclamation  
of Soil and Groundwater  
at Thomas #1 Natural Gas Well,  
San Juan County, New Mexico**

*September 18, 1992*

**Progress Report, Thomas #1 Natural Gas Well**

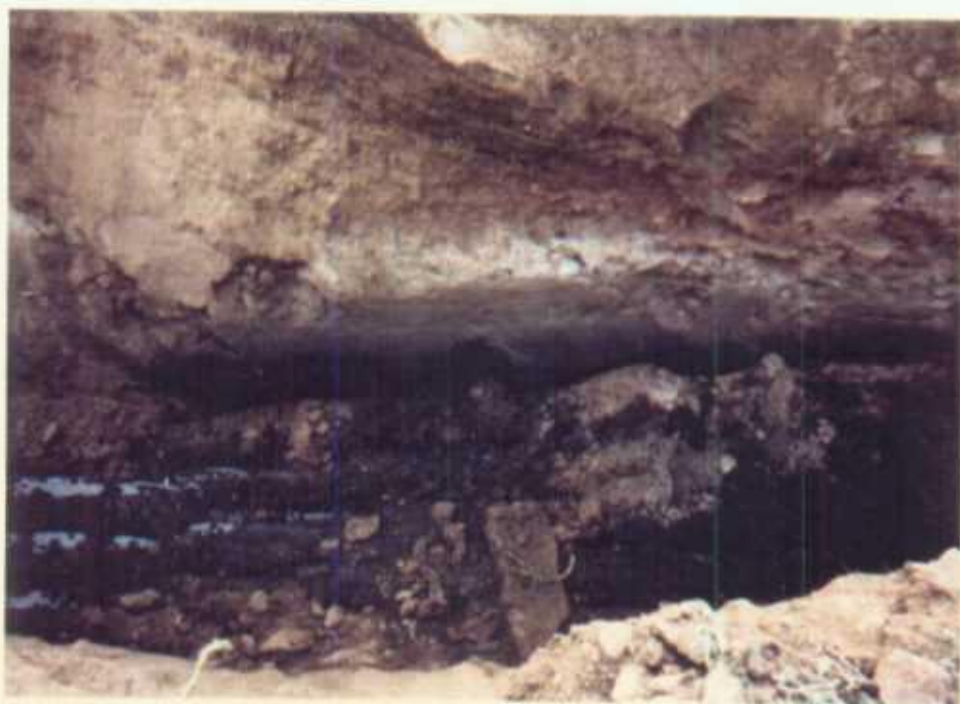
Photo by trench, 55 feet west of storage tank. Groundwater is present in trench. Note thickness of soil contamination is significantly less than near the tank.

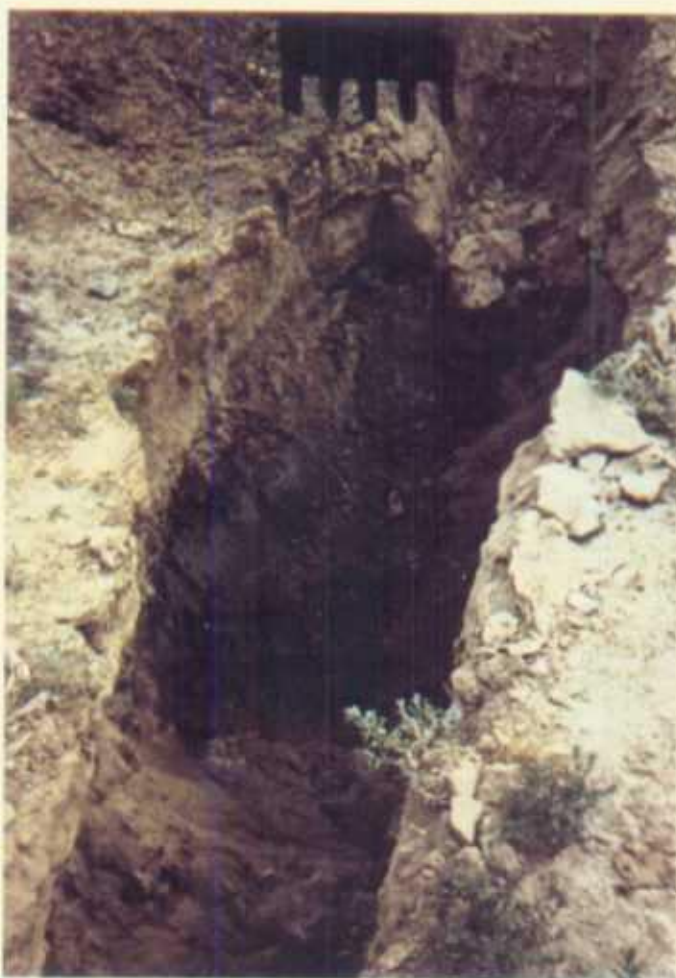
Soil contamination observed in trench near production pit.

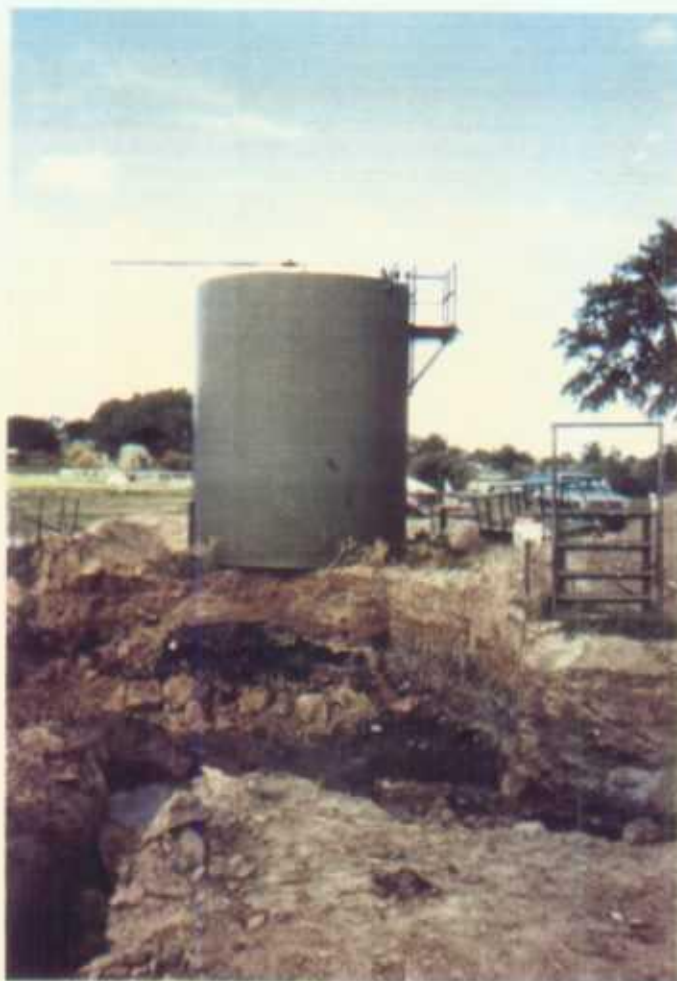
Visual observations and headspace evaluation of soils permitted us to determine relative concentrations of hydrocarbons in site soils. Near the tank, the soils were highly contaminated from 2 feet below land surface to the groundwater. Excavation below the water table showed that the color of the soils changed from black to brown 2 feet below the groundwater level.

Photo looking east showing excavated area west of storage tank.  
 Note discoloration of subsurface soils due to hydrocarbons.  
 Groundwater is present in excavation.

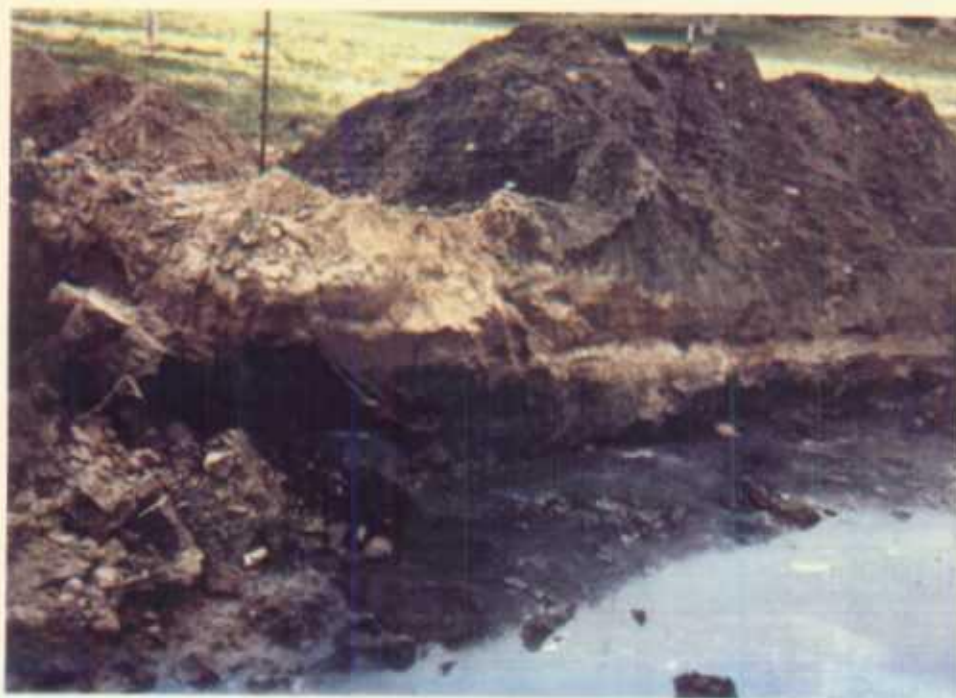
Photo looking west from storage tank. Note groundwater  
 in excavation and thickness of contaminated soil.
