**Navajo Refining Company
Hobbs South GSA 8 in. Gathering Line**

**Investigation/Remediation Work Plan
Hobbs, Lea County, New Mexico**

July 8, 2002

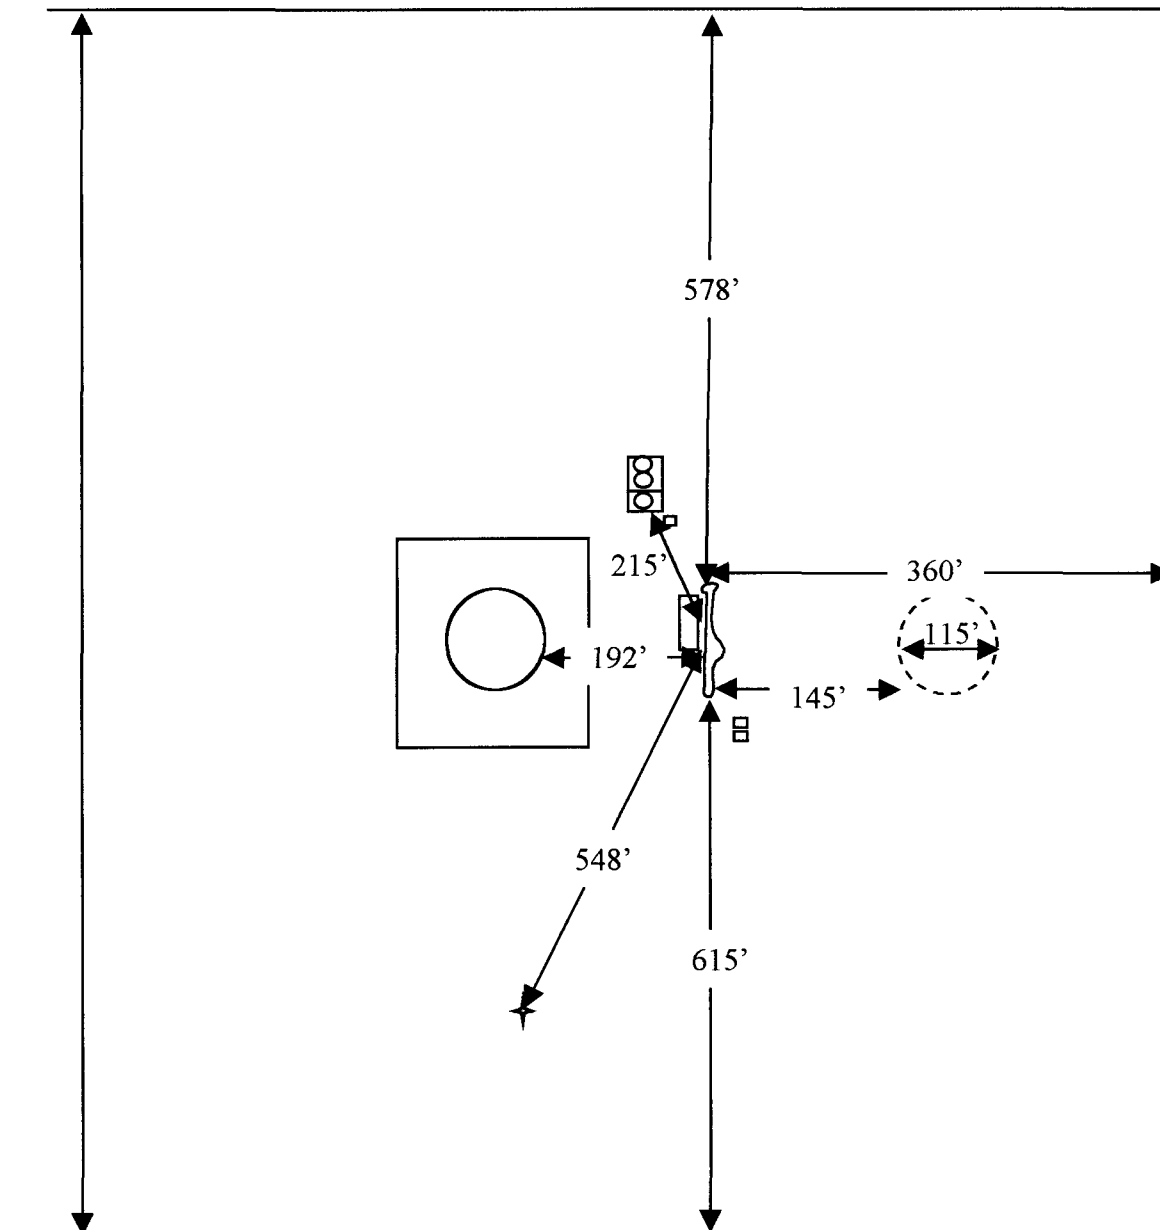
Figure 2. Site Plan

The site is located within a crude oil terminal operated by Equilon pipeline (Figure 2). The leak location is situated on relatively level ground.

Equilon Terminal Leak Site

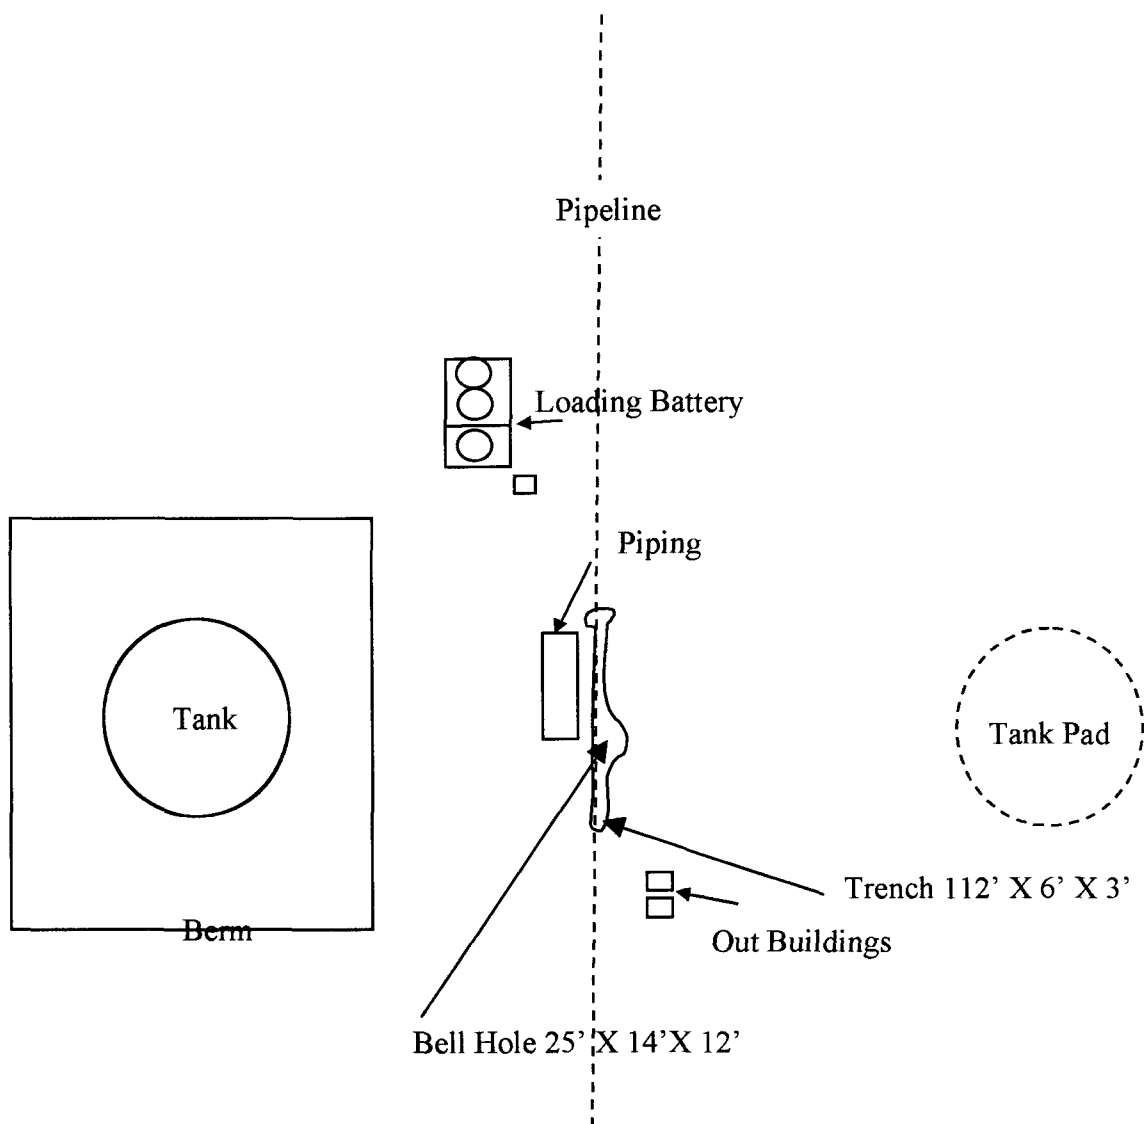
Figure 3. Leak Area Detail

Equilon Terminal Leak Site
