**FANNIE WARD #1**  
**February 2, 2005**

**FANNIE WARD #1 PIT REMEDIATION**  
(April 10, 2003)

**FANNIE WARD #1 RFA MODIFICATION  
SCOPE OF WORK DESCRIPTION**

SOUTHWEST PRODUCTION COMPANY  
FANNIE WARD #1  
K-18-30N-11W  
San Juan County, New Mexico

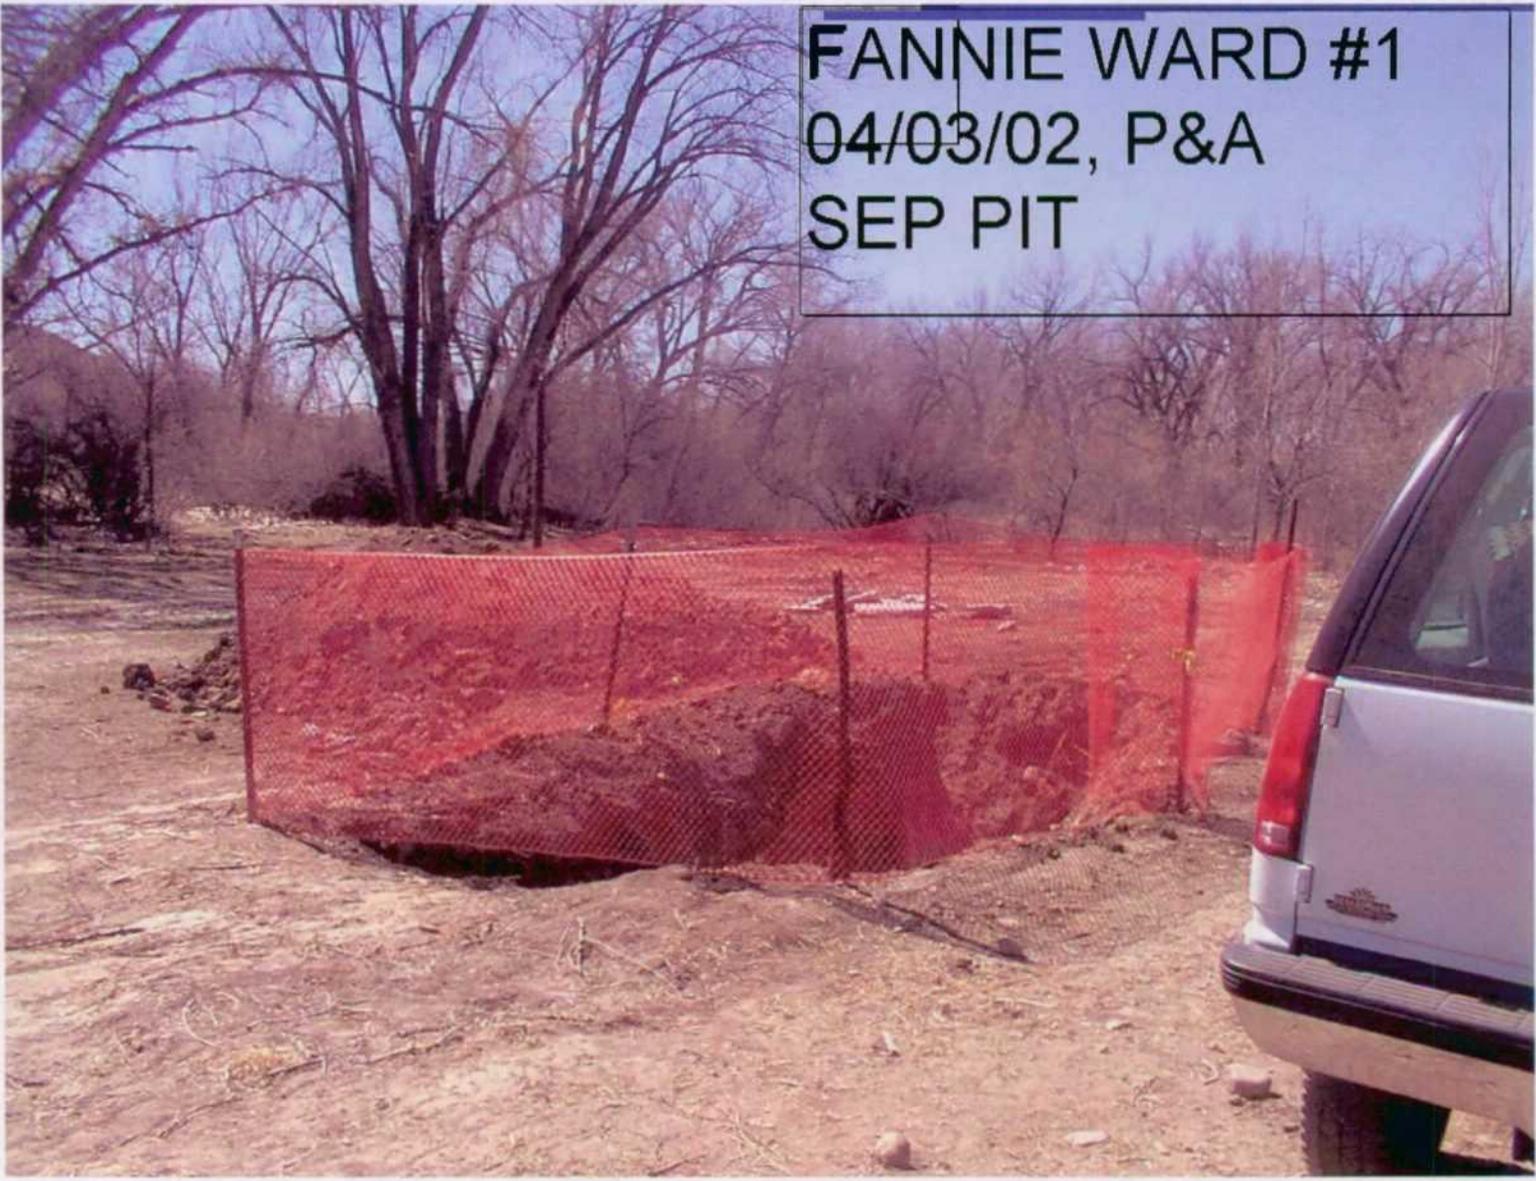
Key completed down hole operations by March 22, 2002. Envirotech was performing contract obligations for surface clean up on March 27, 2002 when the separator pit was determined to have contamination that reached the ground water. Although limited to about a 4' X 6' area yellow paraffin appeared on the ground water at approximately four feet depth. The location is less than 200 feet north of the Animas River between Aztec and Flora Vista. Subsequent investigation of the tank drain pit showed contamination starting at depth of approximately three feet and ground water at approximately four feet. Cobbles start at about four feet depth. At this point we will have exhausted budgeted funds and approved additions. I recommend treating the contamination as an extension of the contract but we are looking at a minimum of six very shallow monitor wells. We will need to excavate the tank drain pit contamination and land farm it on site probably a minimum of 100 cubic yards. I would recommend spraying the ground water with oxidizer in the excavations but Bill Olson will need to determine the extent of testing and the necessary monitor wells although I believe it will take at least six since the pits are 200 feet apart.

FANNIE WARD #1  
04/03/02, P&A  
SEP PIT

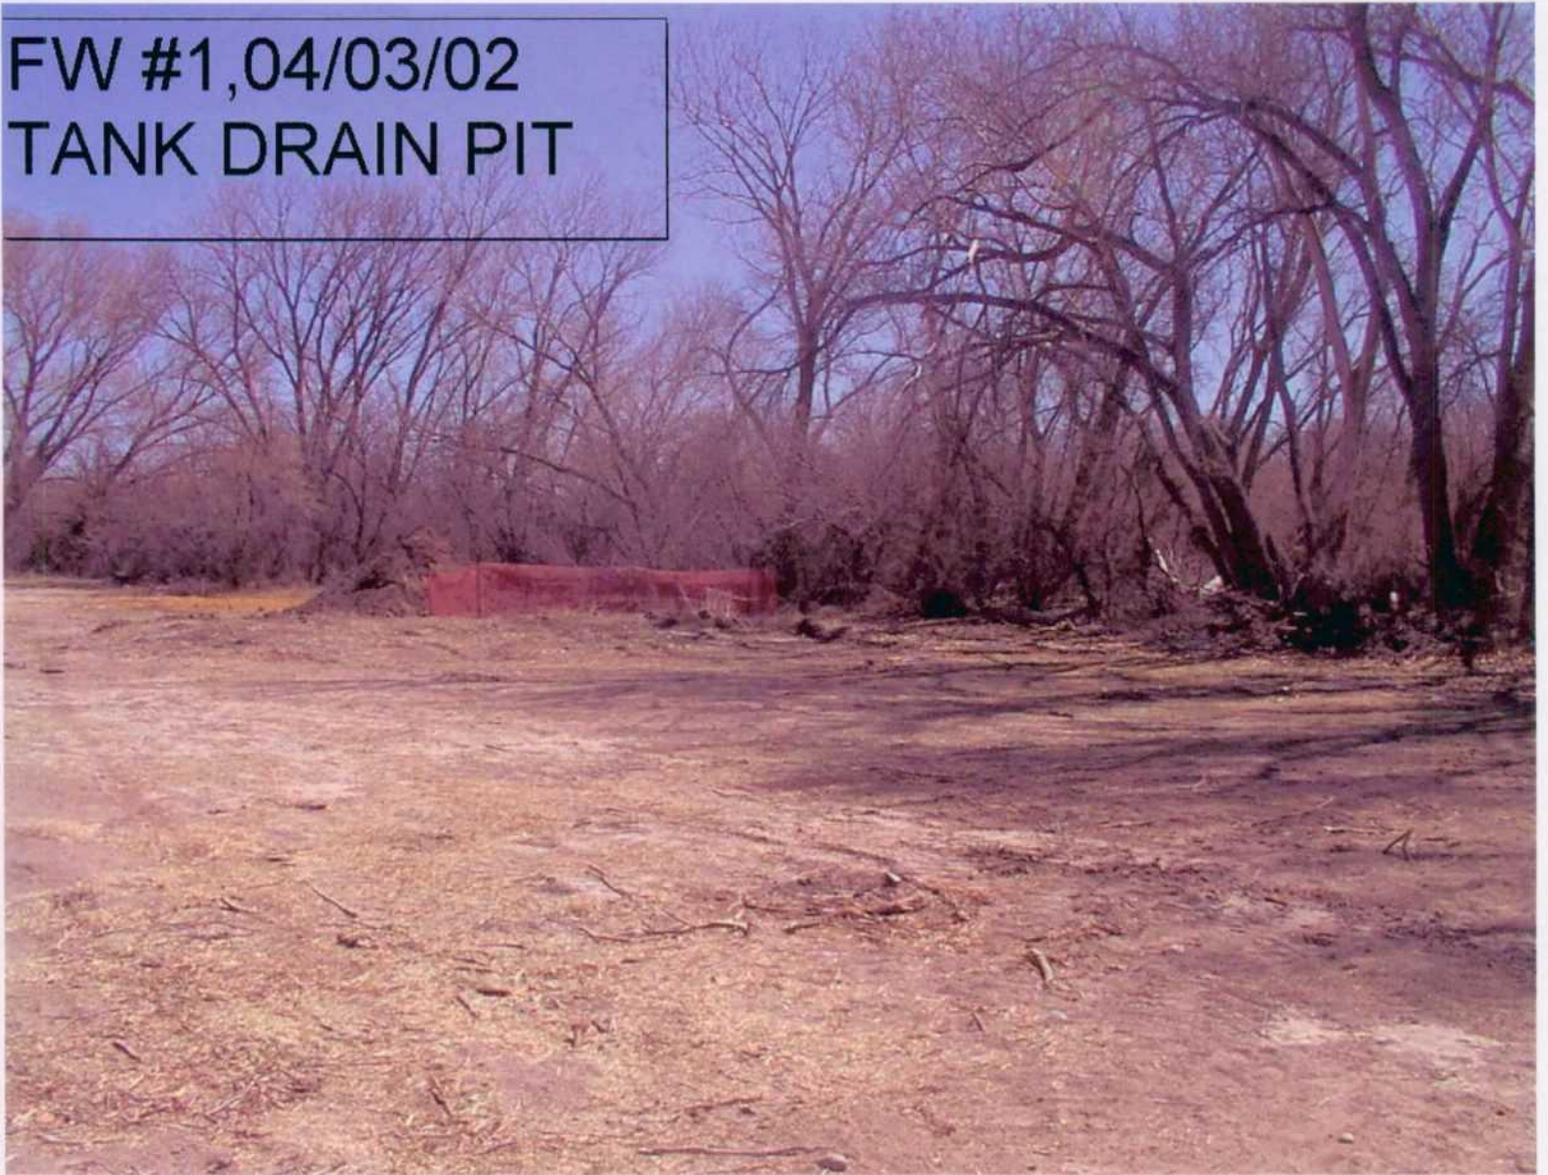
The 8'x 8' separator pit is excavated, possibly another four or five yards of residual material is left. Only about half of this volume would have any contamination. The tank drain pit is approximately 20'X 40' with about 6" of contamination just above the cobbles and water table. This layer is about 4 feet deep. The contaminated layer may extend southwest under the old tank pad. Approximately 60-75 cubic yards of contaminated material will need to be treated on site or hauled off site. The cobbles are generally less than six inches in diameter down to gravel and compactly bedded. The river runs on the east and south sides of the location. The Maralax Scott #1 is located 80' north and 130' east of the Fannie Ward #1.

FW #1, 04/03/02  
TANK DRAIN PIT

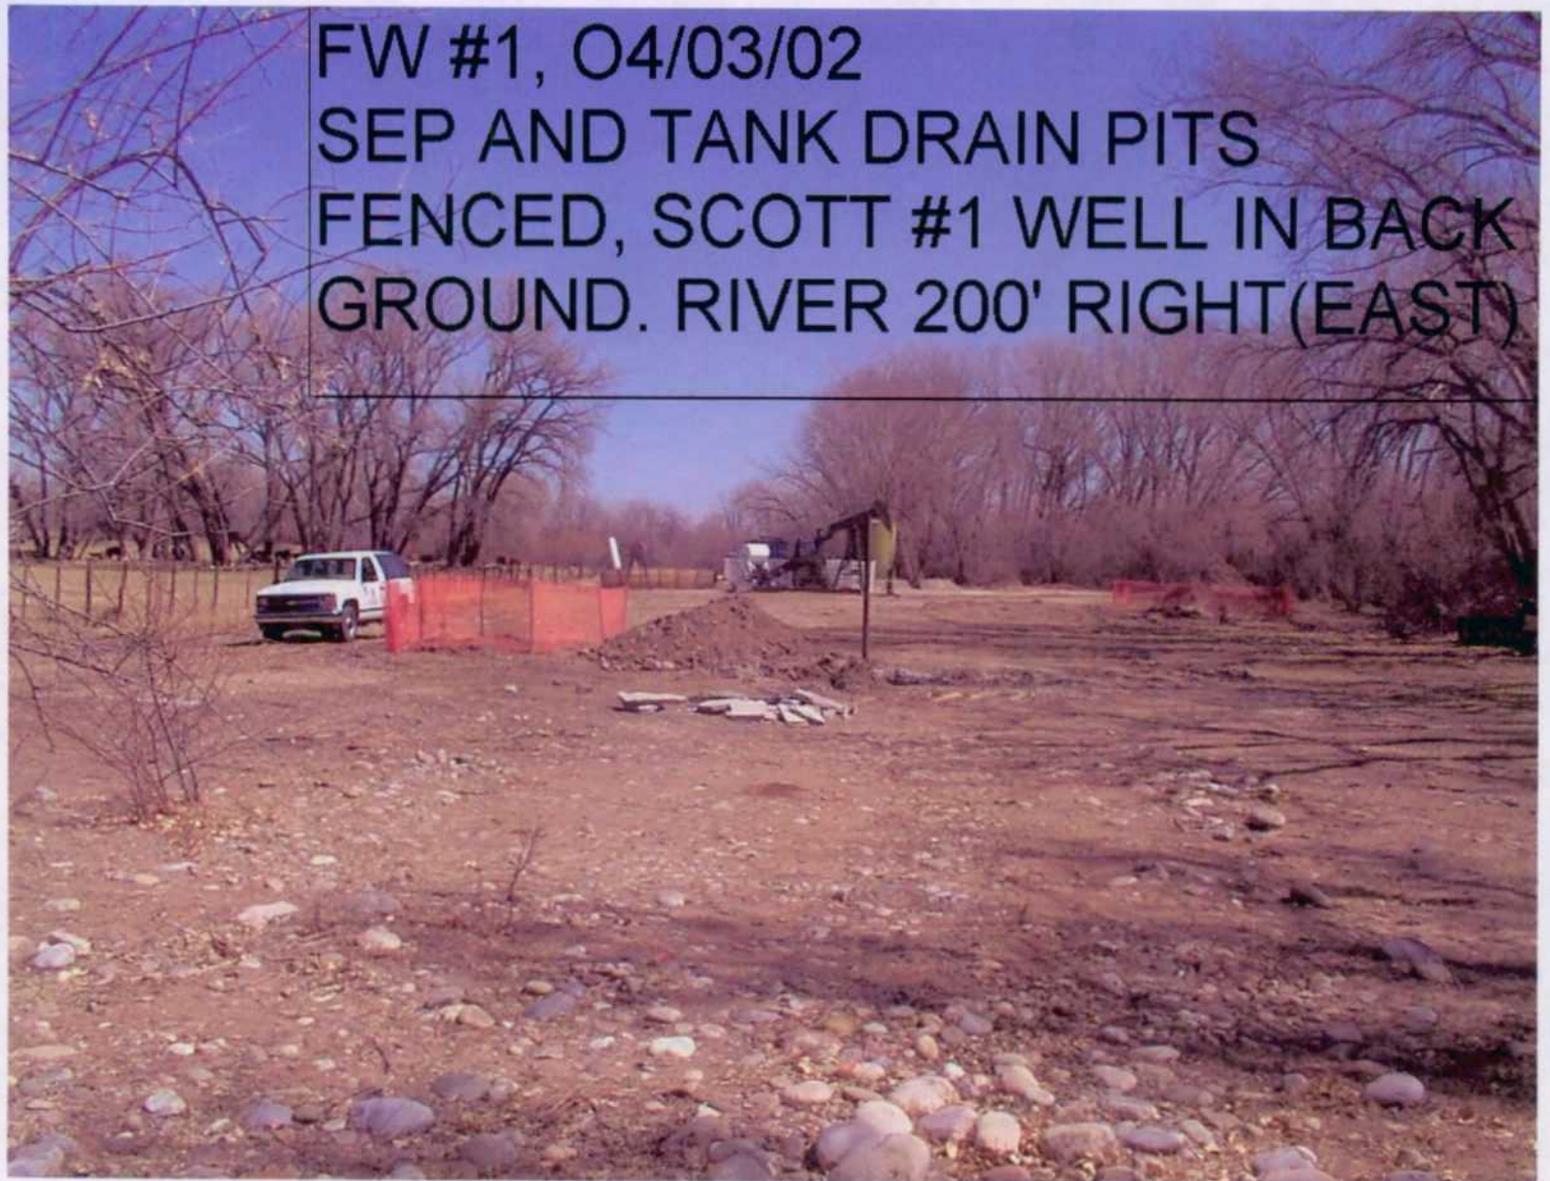
FW #1, 04/03/02  
SEP AND TANK DRAIN PITS  
FENCED, SCOTT #1 WELL IN BACK  
GROUND. RIVER 200' RIGHT(EAST)

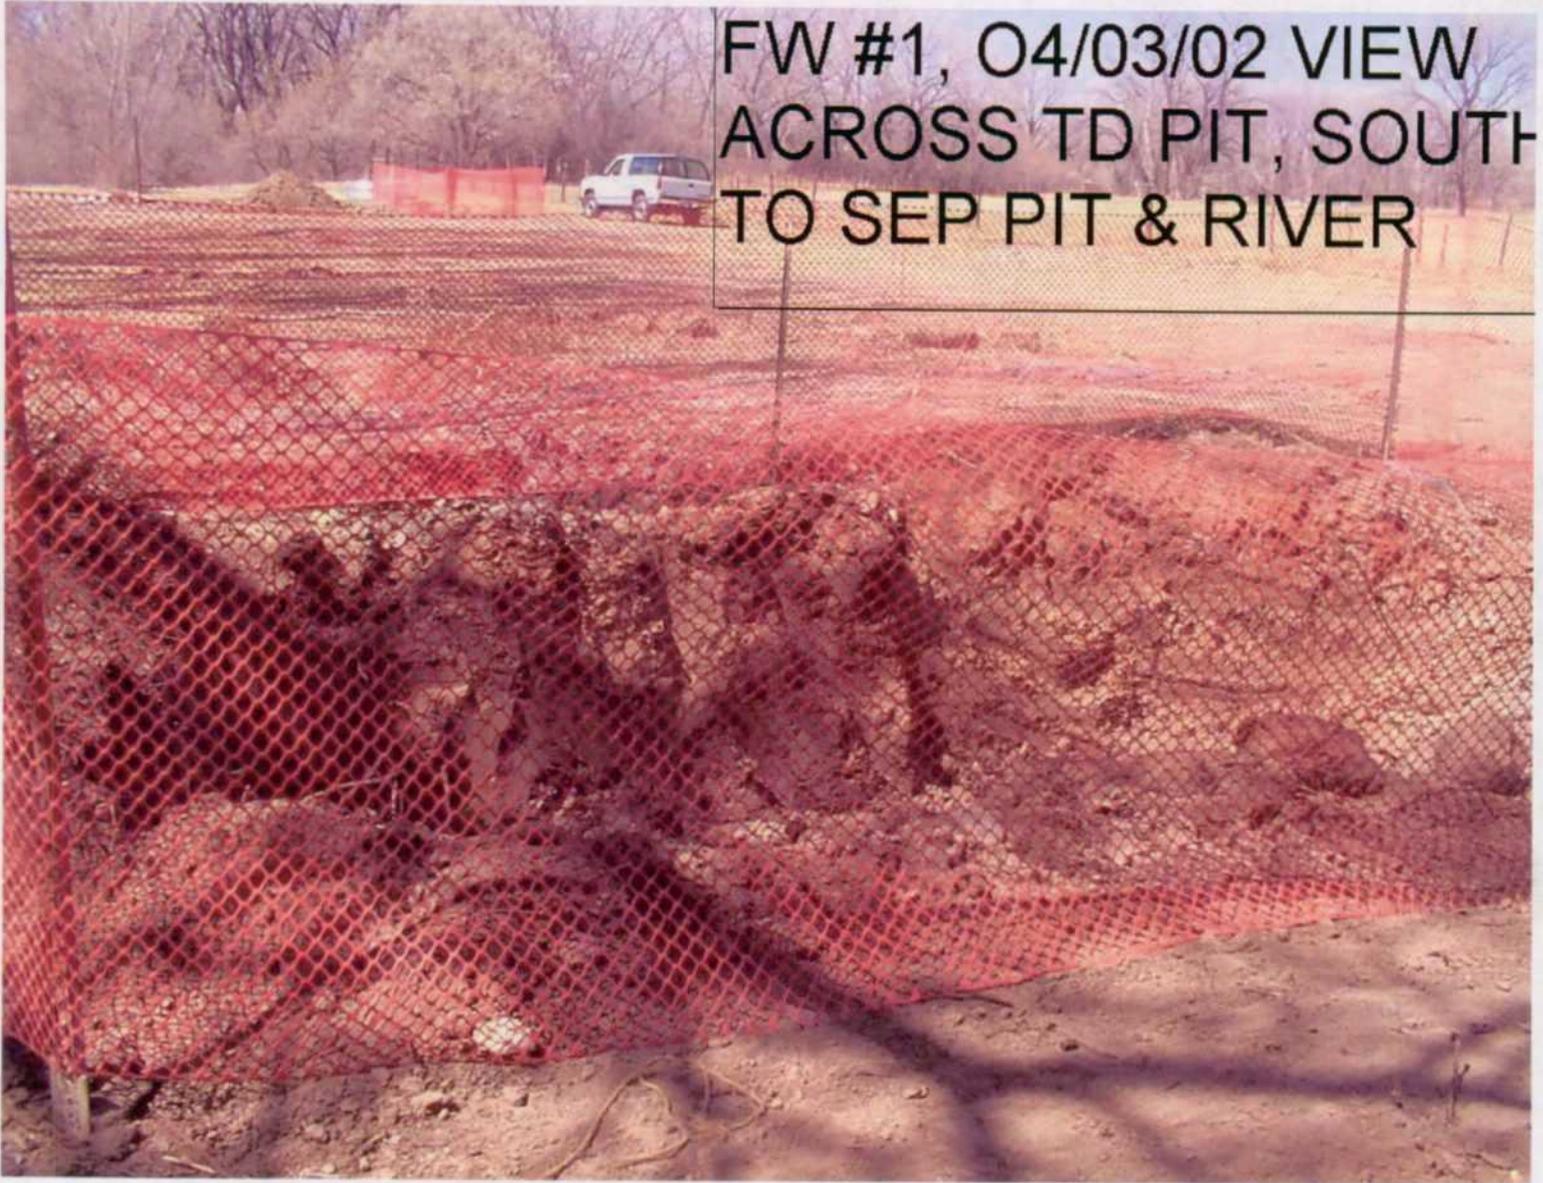
FW #1, 04/03/02 VIEW  
ACROSS TD PIT, SOUTH  
TO SEP PIT & RIVER
