**Re: Closure Request - Salado Draw Compressor
Case No. 1 RP-4272
Lea County, New Mexico**

Re: Salado Draw Compressor
Closure Request
Case No. 1RP-4272
Lea County, New Mexico

SECONDARY CONTAINMENT LINER INSPECTION

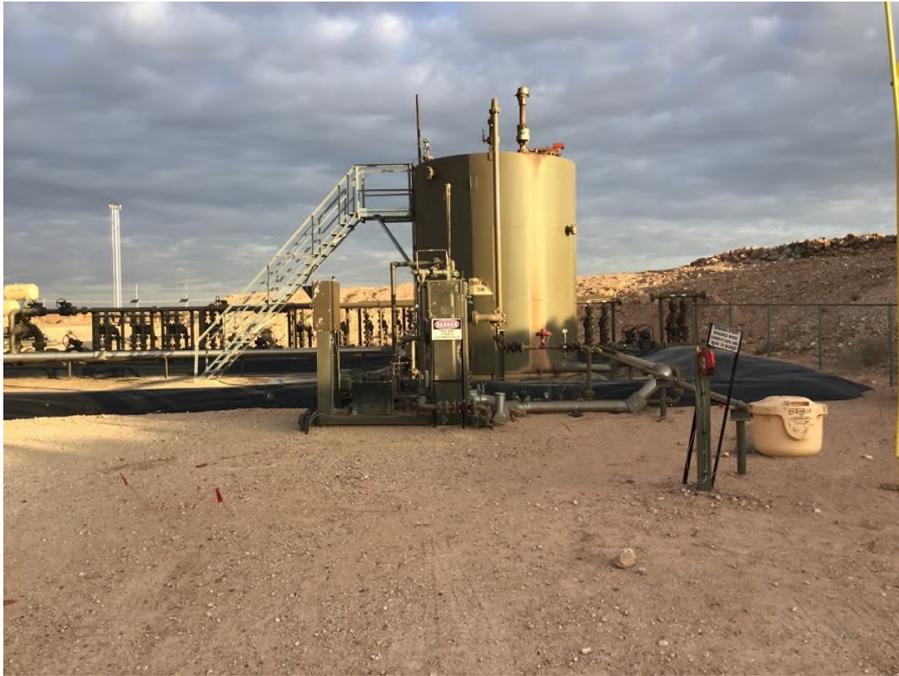
Photo: 1

Description:
Condensate Tank

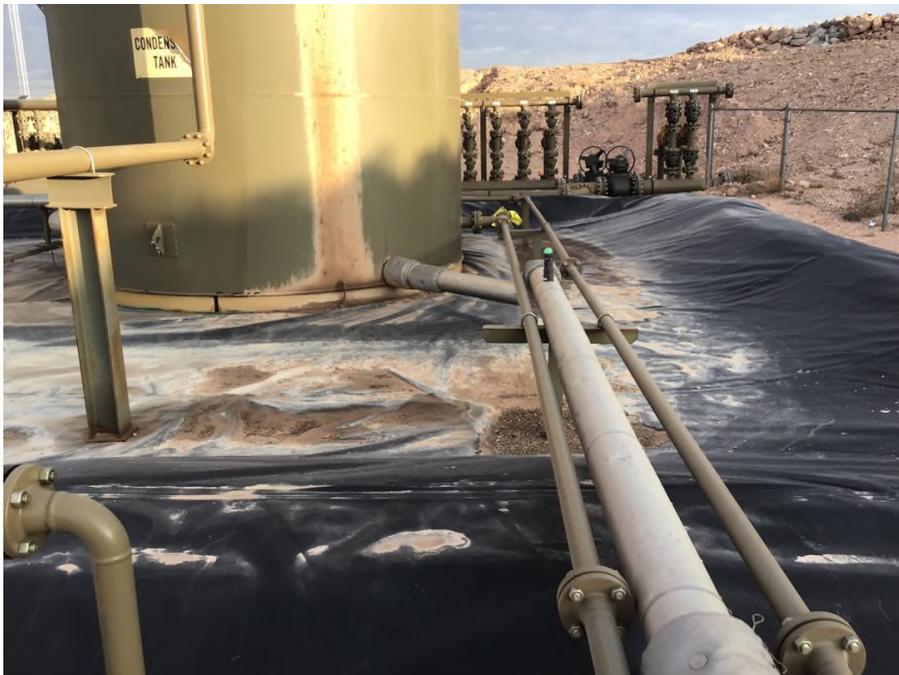
Photo: 2

Description:
Condensate Tank

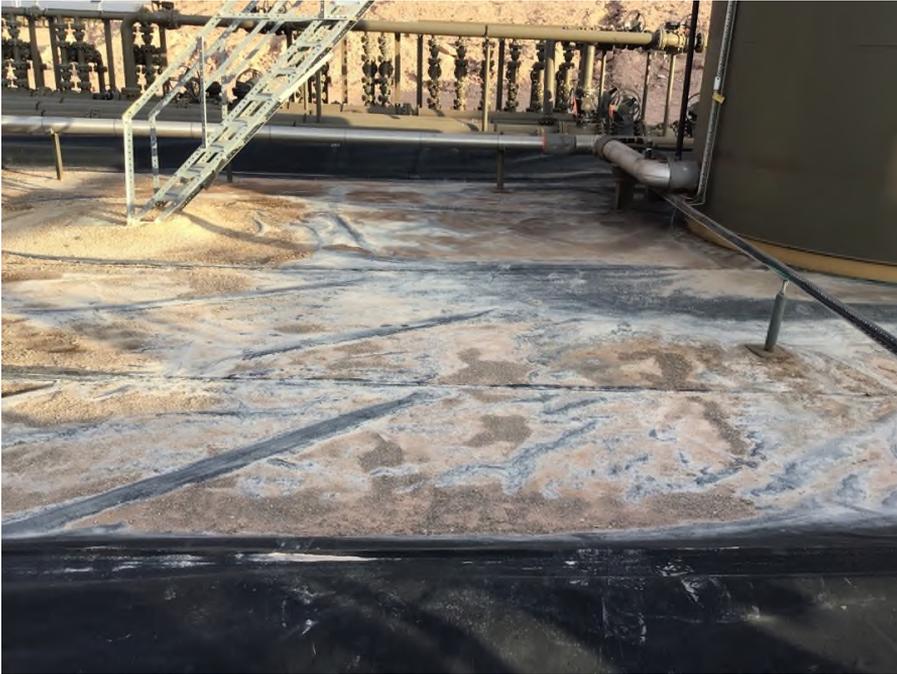
Photo: 3

Description:
Condensate Tank

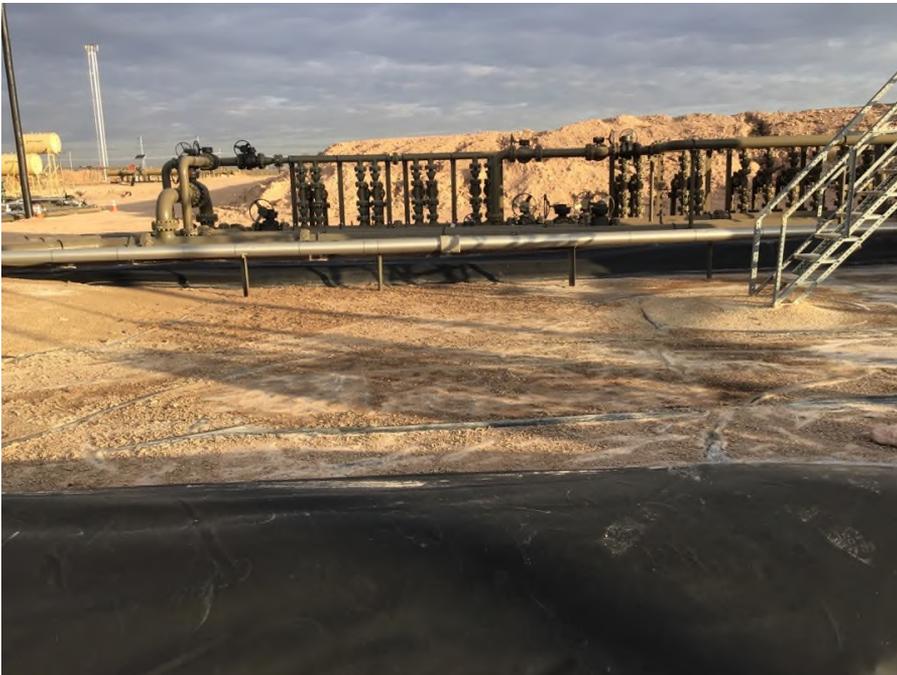
Photo: 4

Description:
Condensate Tank

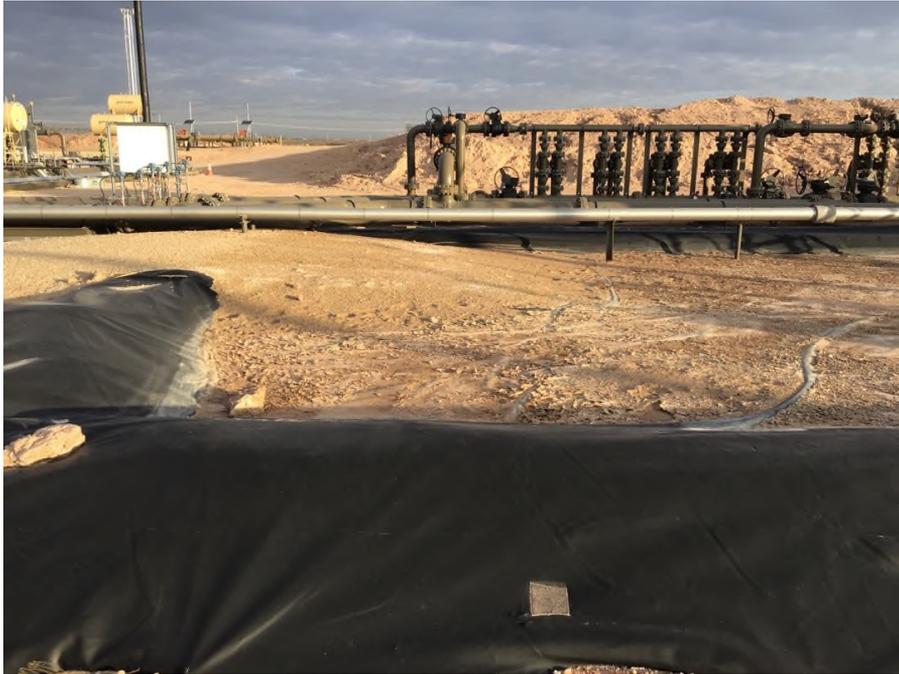
Photo: 5
Date: 12/16/2019
Description:
Condensate Tank

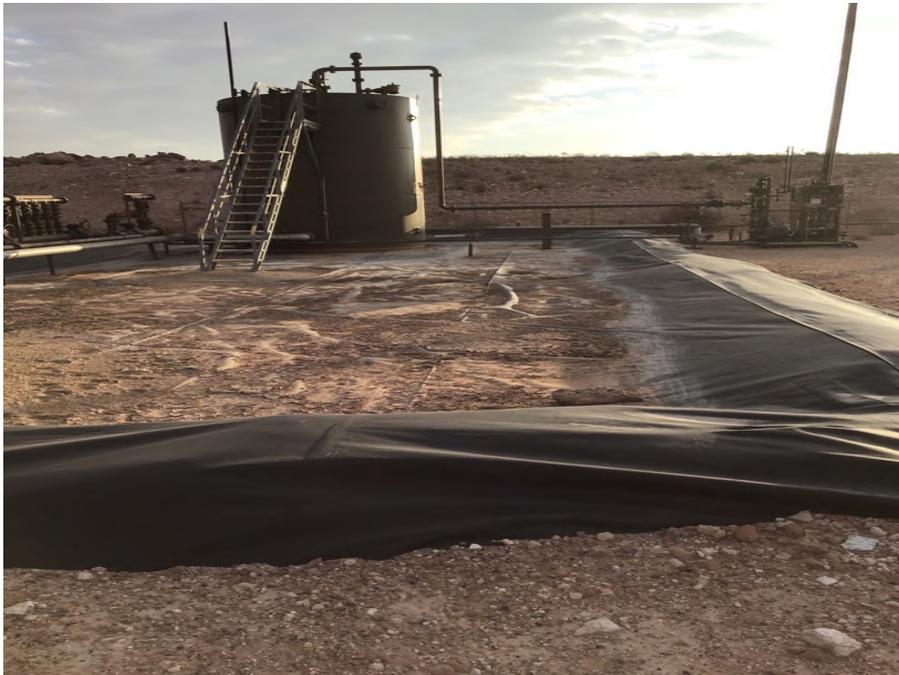
Photo: 6
Date: 12/16/2019
Description:
Condensate Tank

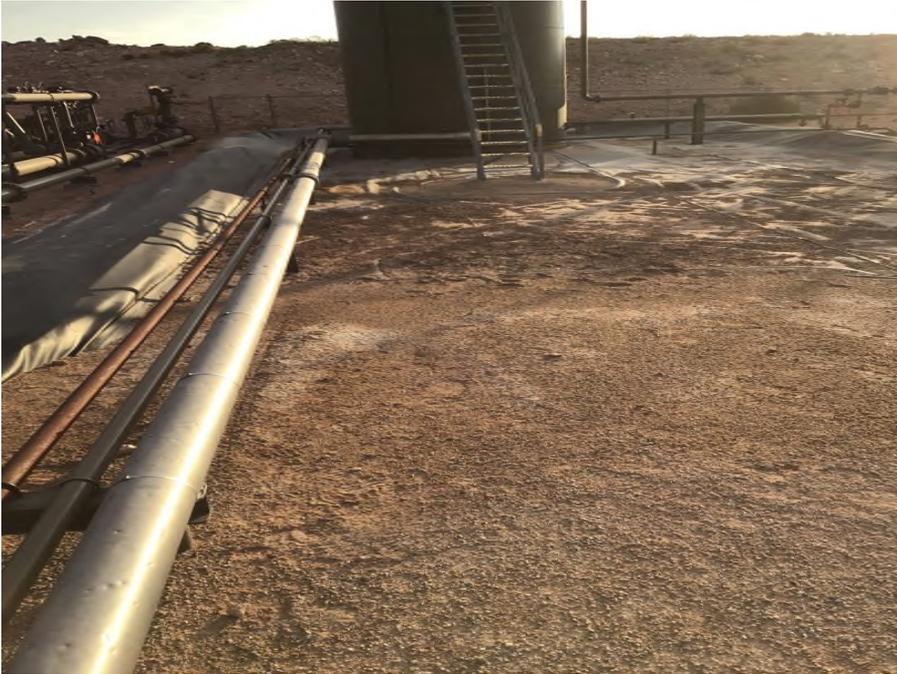
Photo: 7

Description:
Condensate Tank

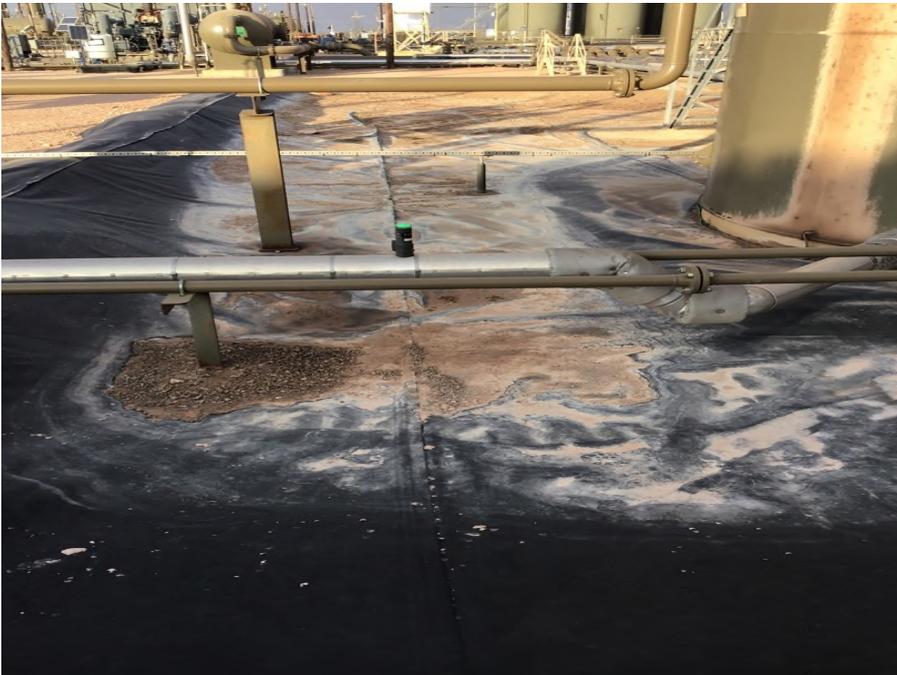
Photo: 8

Description:
Condensate Tank

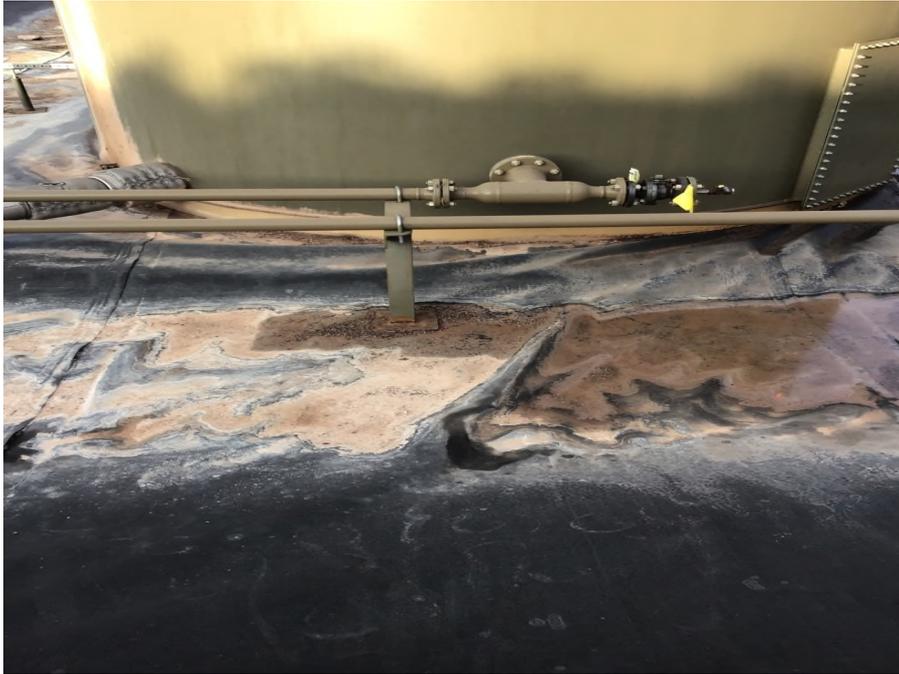
Photo: 9

Description:
Condensate Tank

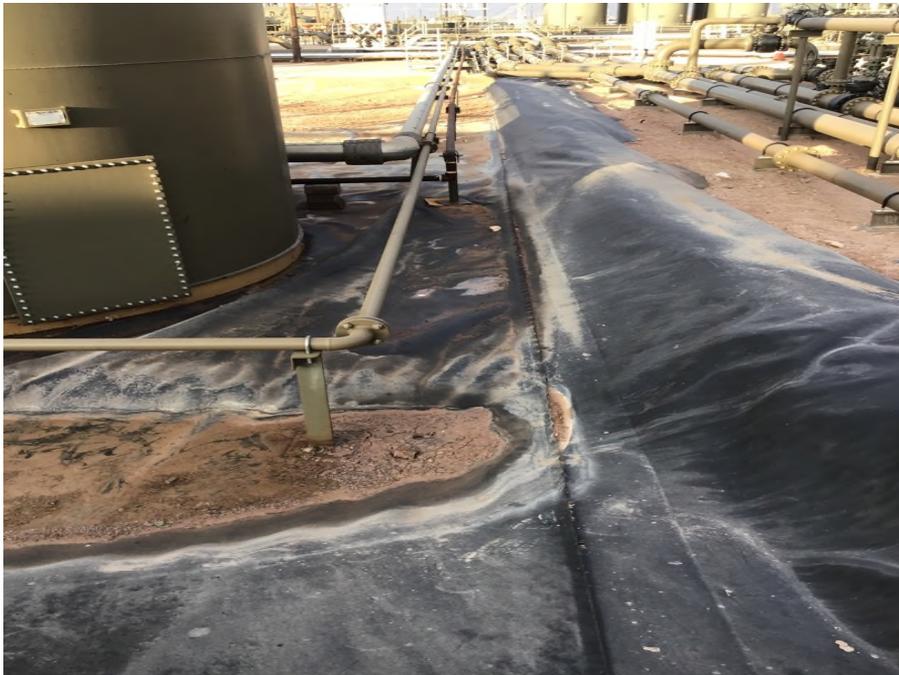
Photo: 10

Description:
Condensate Tank

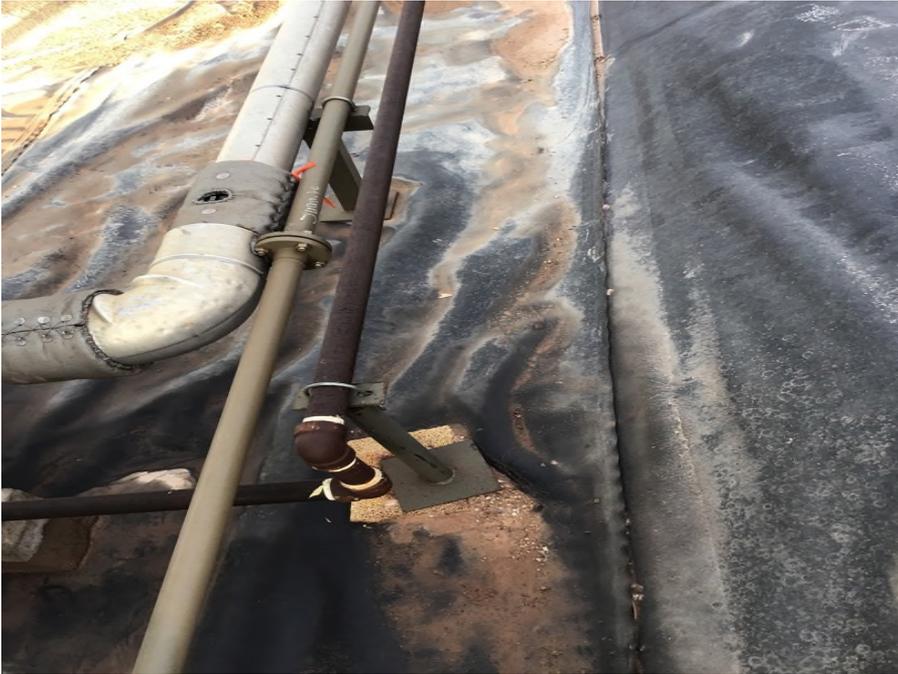
Photo: 11

Description:
Condensate Tank

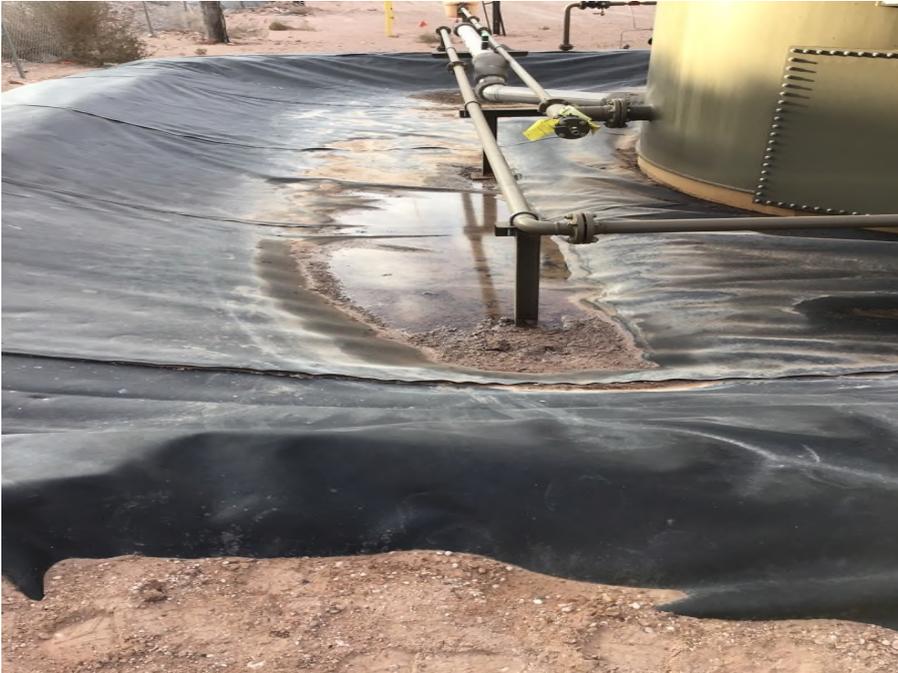
Photo: 12

Description:
Condensate Tank

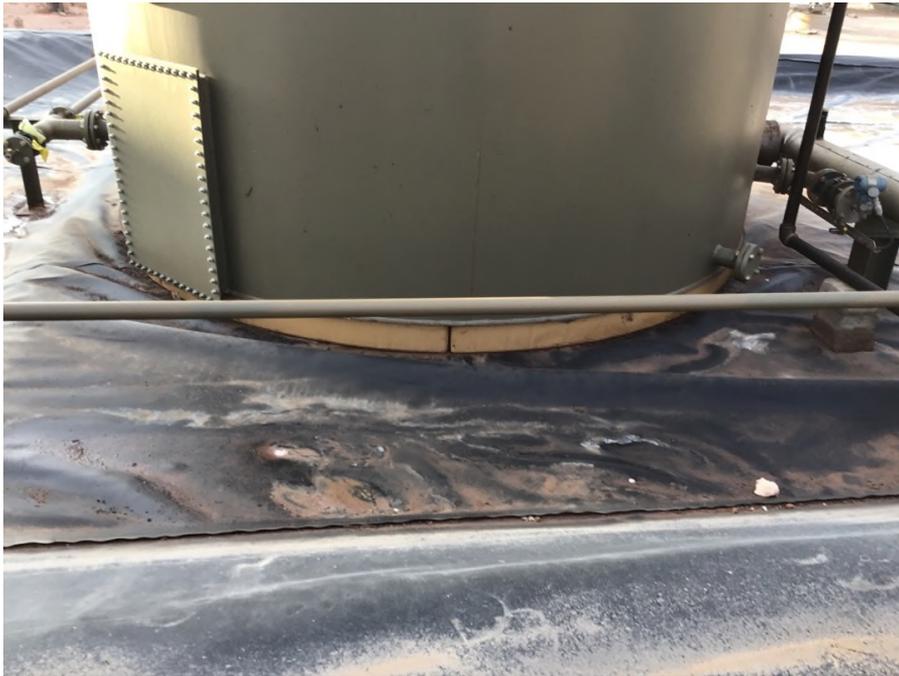
Photo: 13

Description:
Condensate Tank

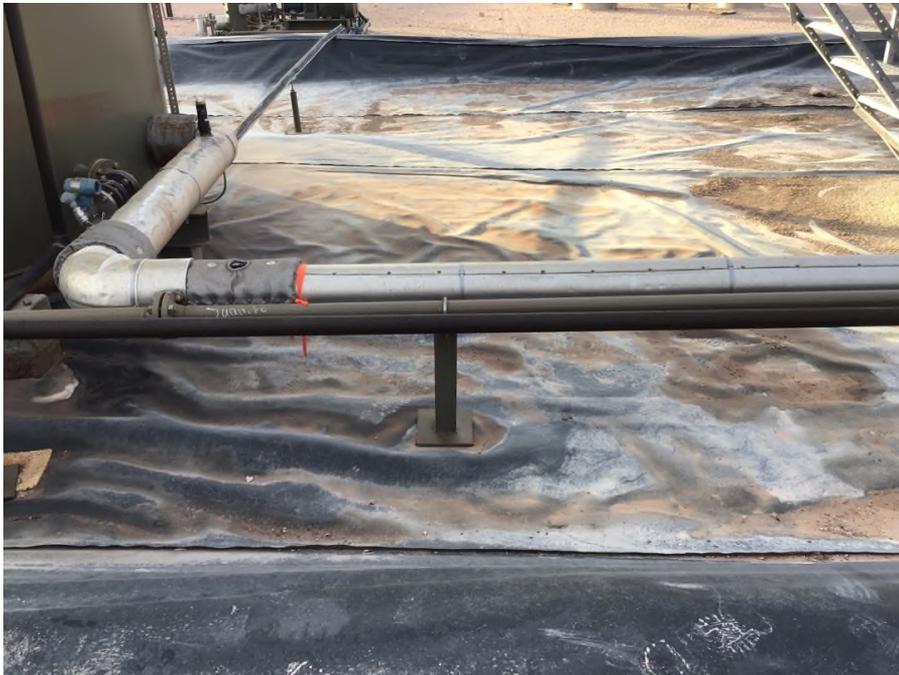
Photo: 14

Description:
Condensate Tank

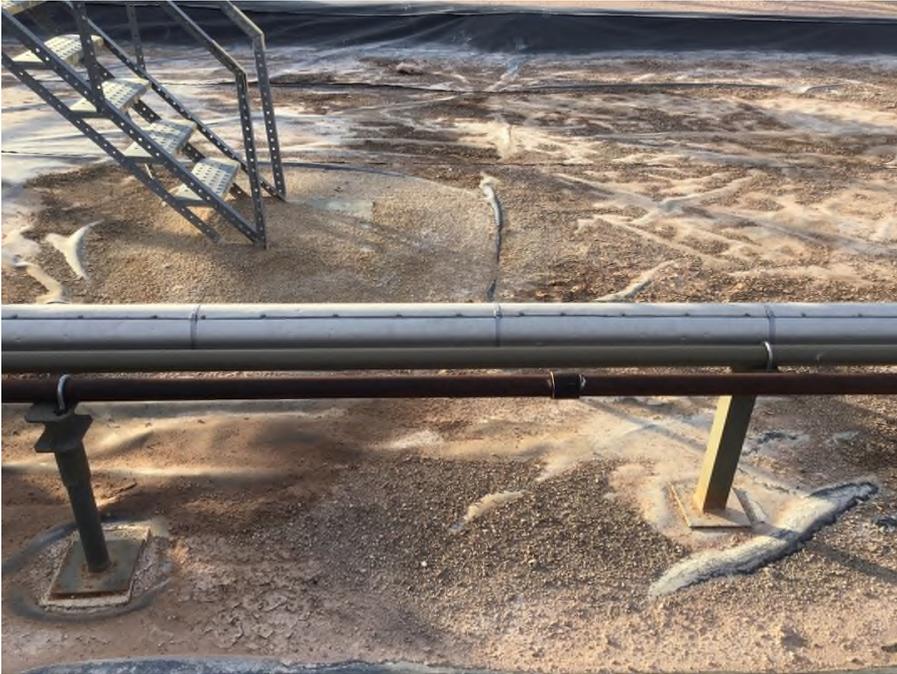
Photo: 15

Description:
Condensate Tank

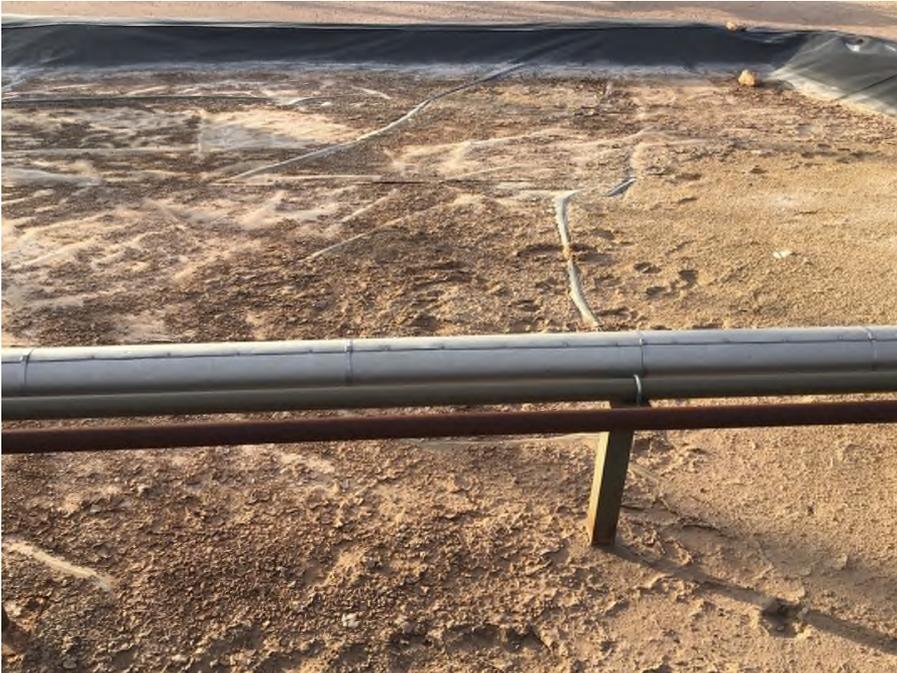
Photo: 16

Description:
Condensate Tank
