Release Notification

Site Name: MC 5 COM 112H	Site Type: Wellsite
Date Release Discovered: 6/16/2020	API# (if applicable) 30-045-35605

MC 5 COM 112H Narrative

Enduring Resources, LLC
MC 5 COM 112H Photo Page

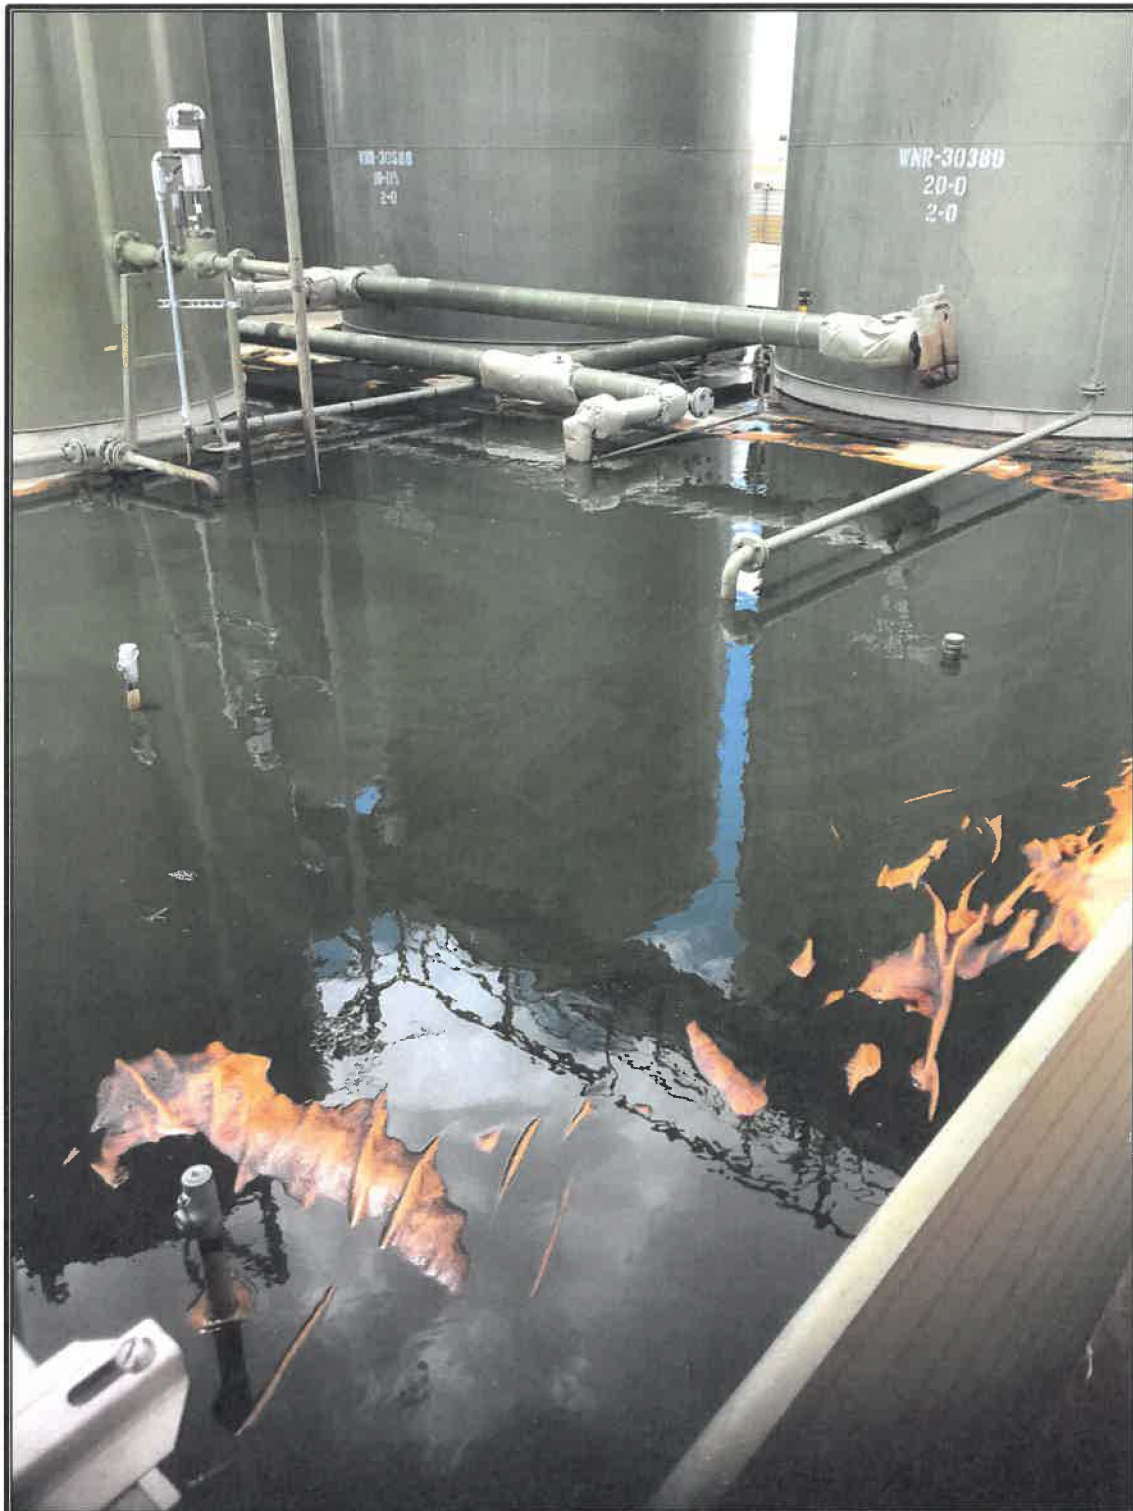
On 6/16/2020, a pit tank overflow was discovered at the MC 5 COM 112H wellsite. Upon investigation, it was determined that a valve on the produced water tank header was opened, allowing the contents of the above ground produced water tank to be emptied into the pit tank, causing the tank to overflow onto the liner secondary containment. The volume was determined by measuring the area and depth of the overflowed area, and calculating the volume of the liquid. The fluids were recovered, and the liner sprayed clean. The cause of the release is suspected to be vandalism.

Photo 1: View of Overflowed BGT

A pit tank overflow was discovered at the MC 5 COM 112H wellsite. Upon investigation, it was determined that a valve on the produced water tank header was opened, allowing the contents of the above ground produced water tank to be emptied into the pit tank, causing the tank to overflow onto the liner secondary containment. The volume was determined by measuring the area and depth of the overflowed area, and calculating the volume of the liquid. A truck was dispatched, and the pit tank was emptied and fluids on the liner were recovered.

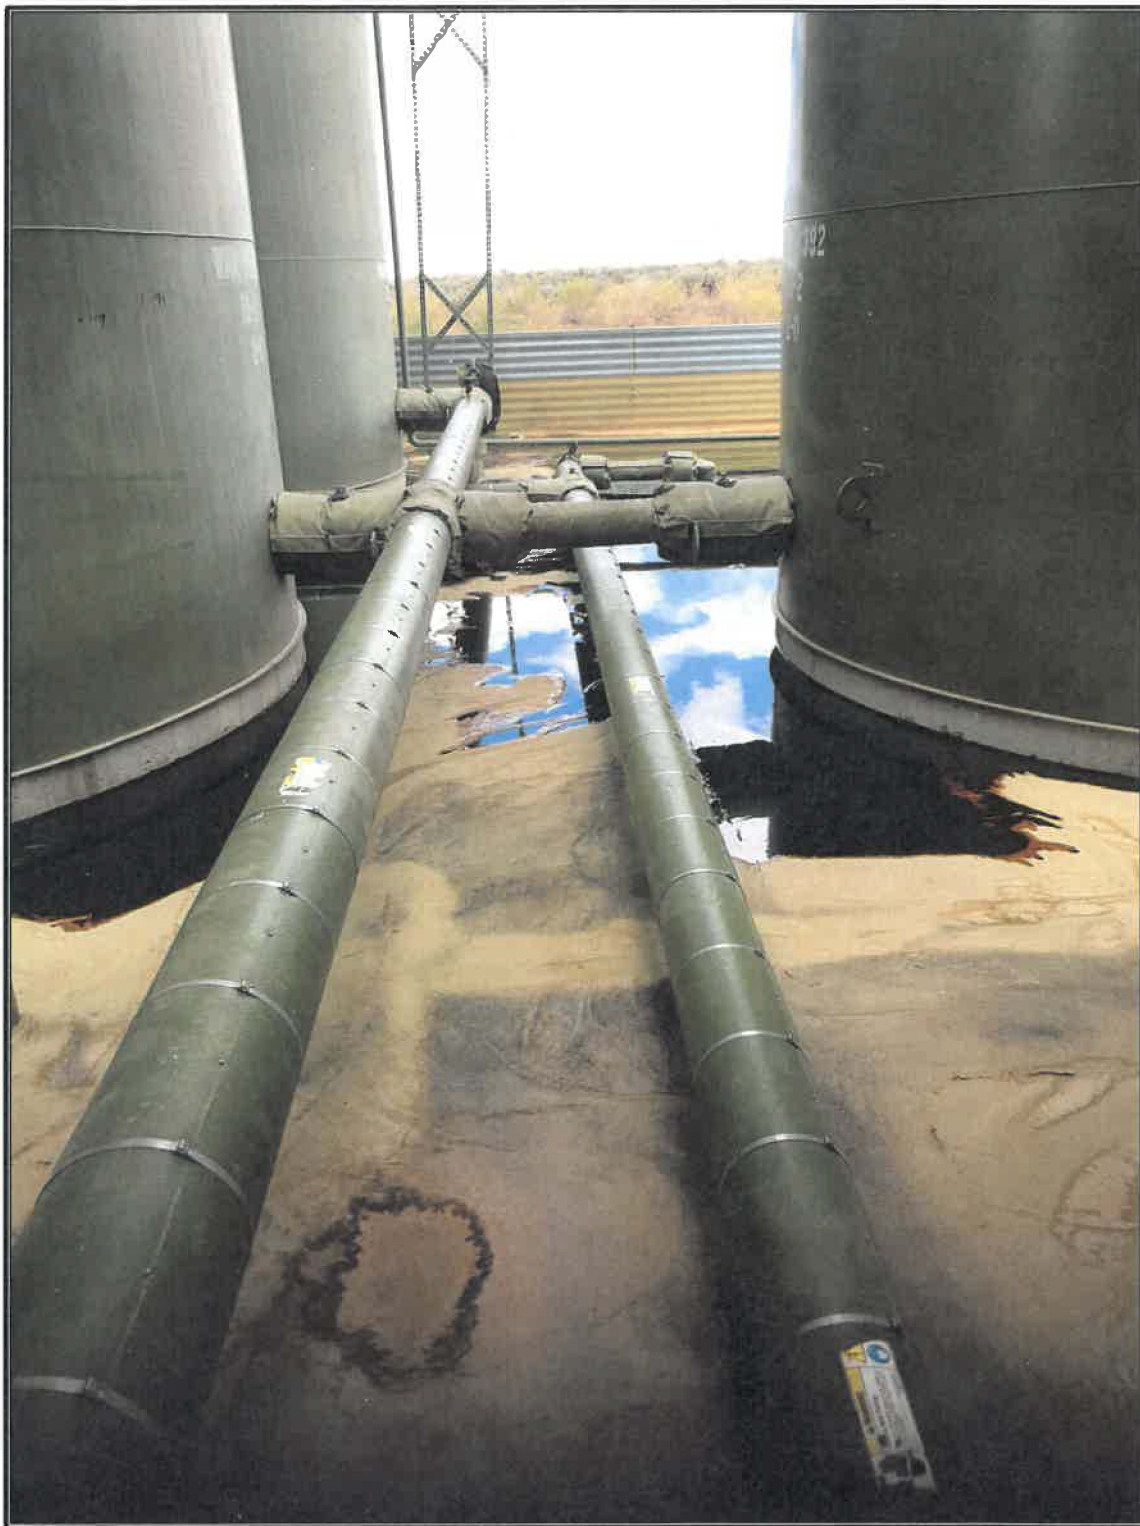
Photo 2: View of BGT Overflow (2)

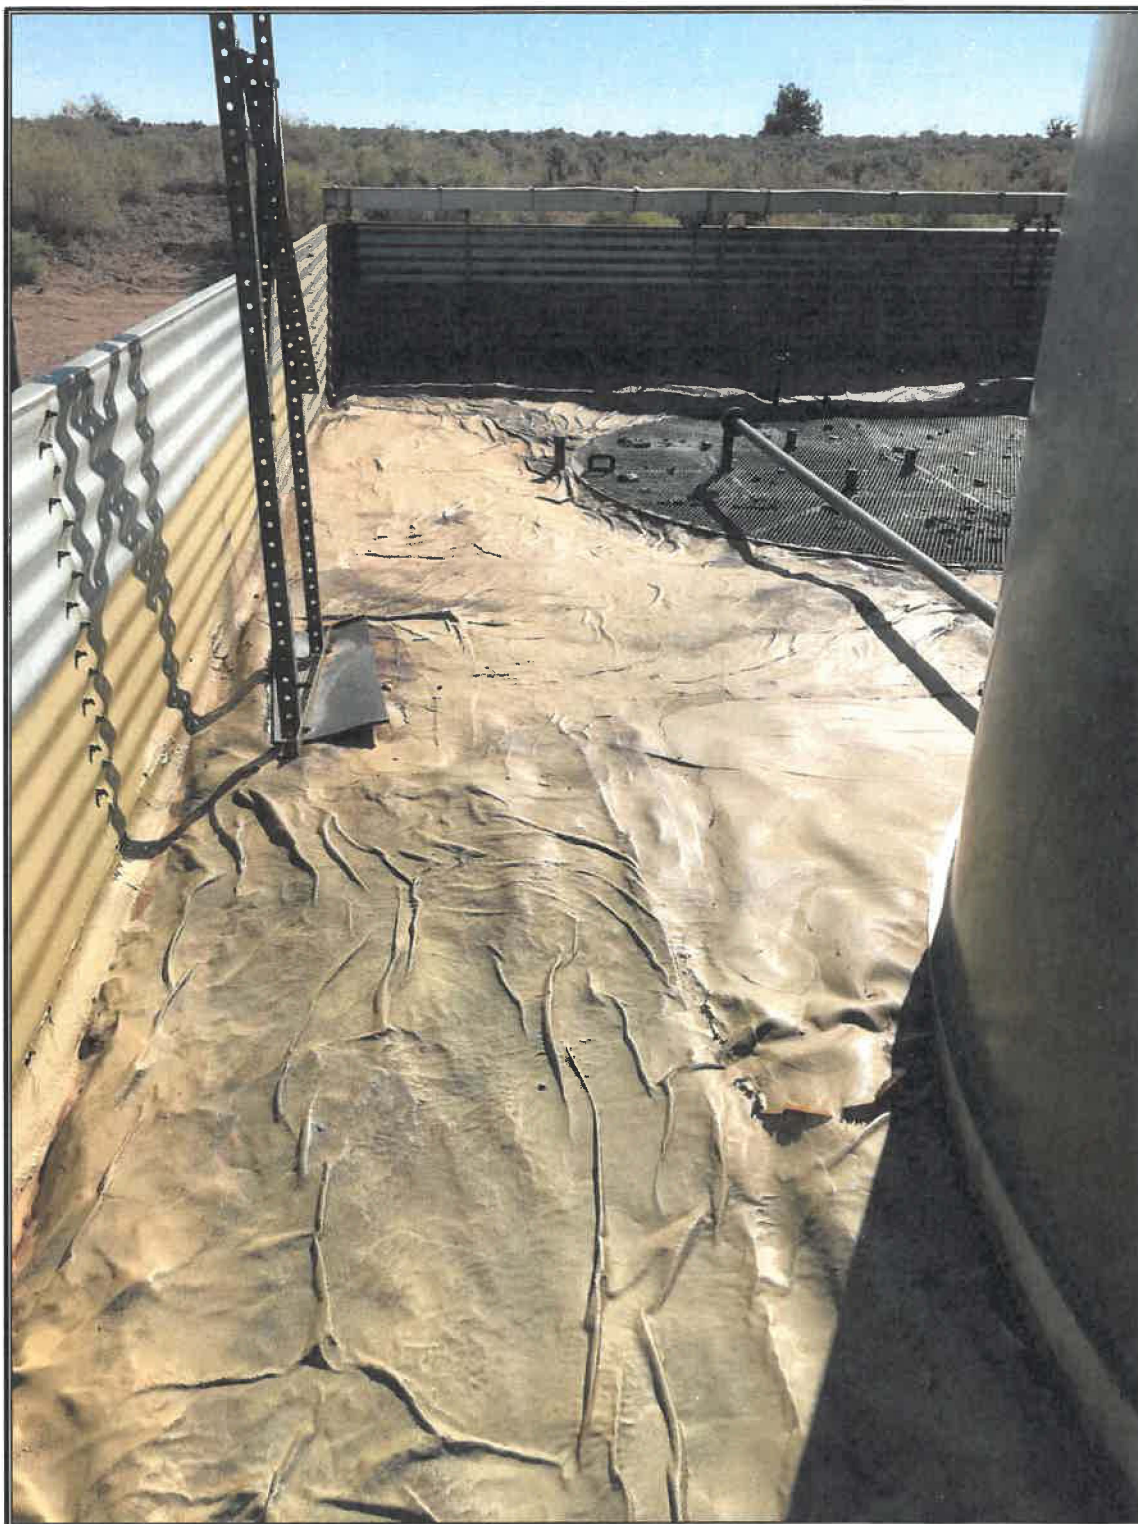
The Enduring HSE Supervisor was on-site at 9 AM to perform the liner inspection. A representative from the NMOCD was not present. The liner was inspected, and no evidence of a liner integrity issue was found during the inspection. Pictures were taken of the liner during inspection and are attached to the closure report for reference.

Photo 3: View of Liner after Cleanup

A wash crew sprayed the liner clean. A notification was sent to Cory Smith, NMOCD, to notify of a liner inspection to take place on June 22, 2020.

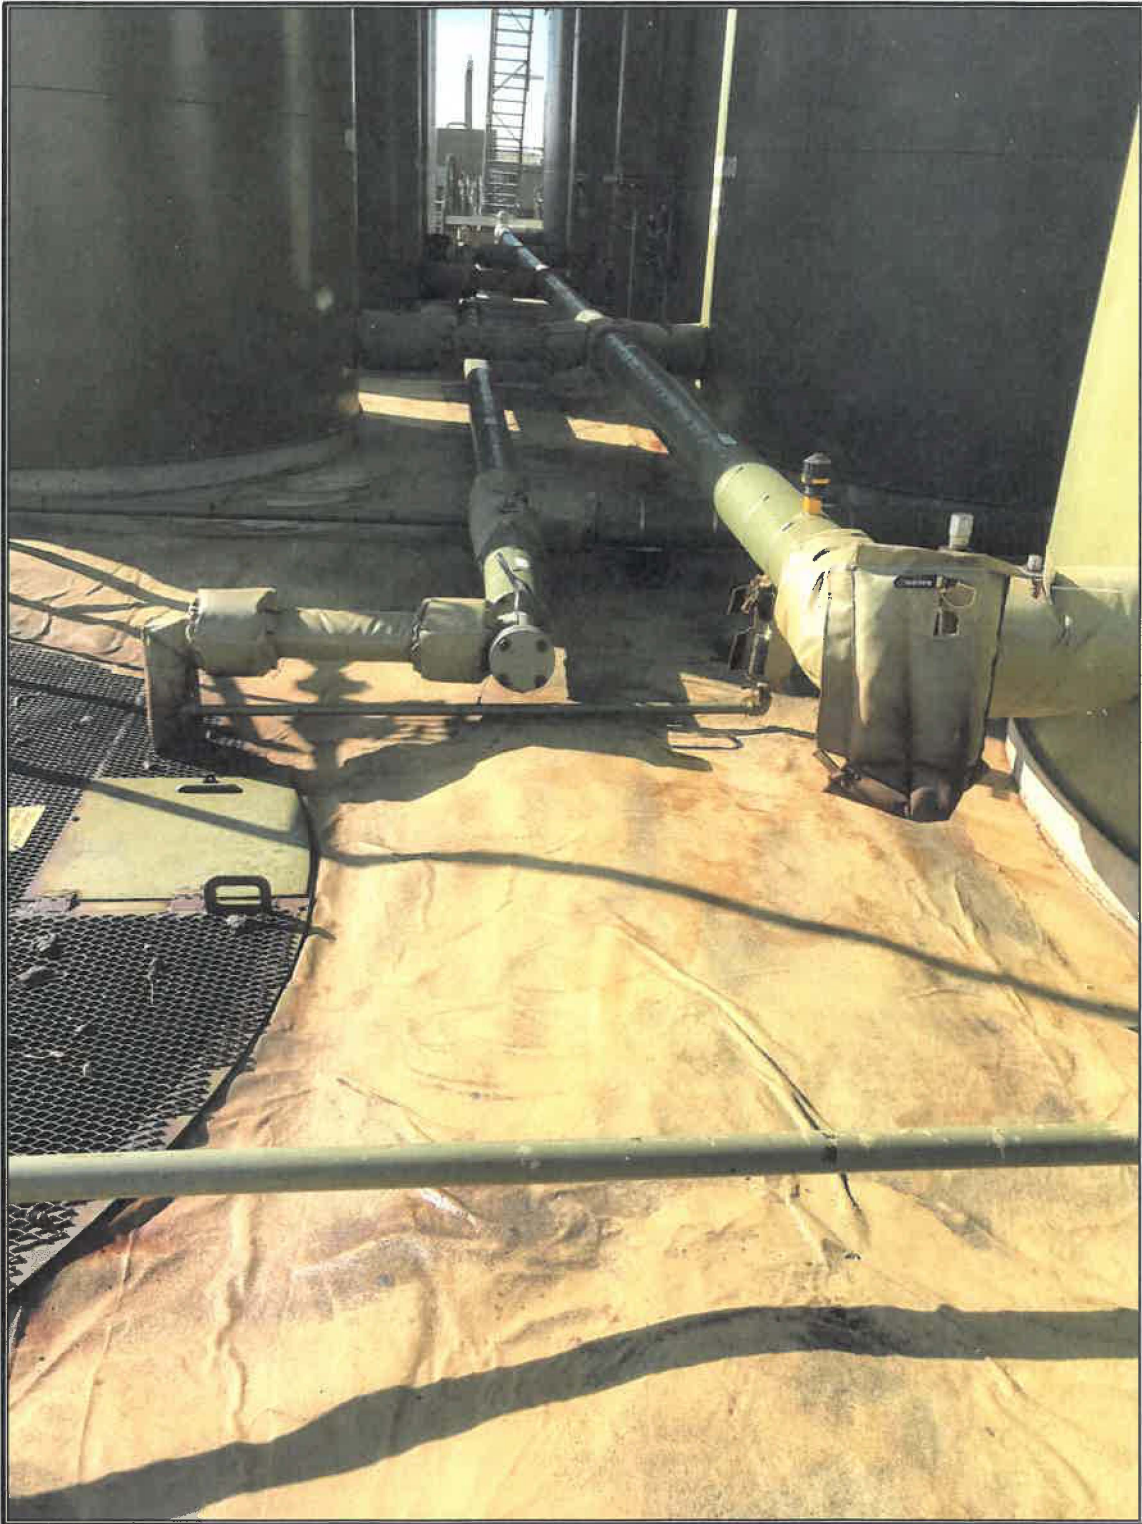
Photo 4: View of Liner after Cleanup (2)

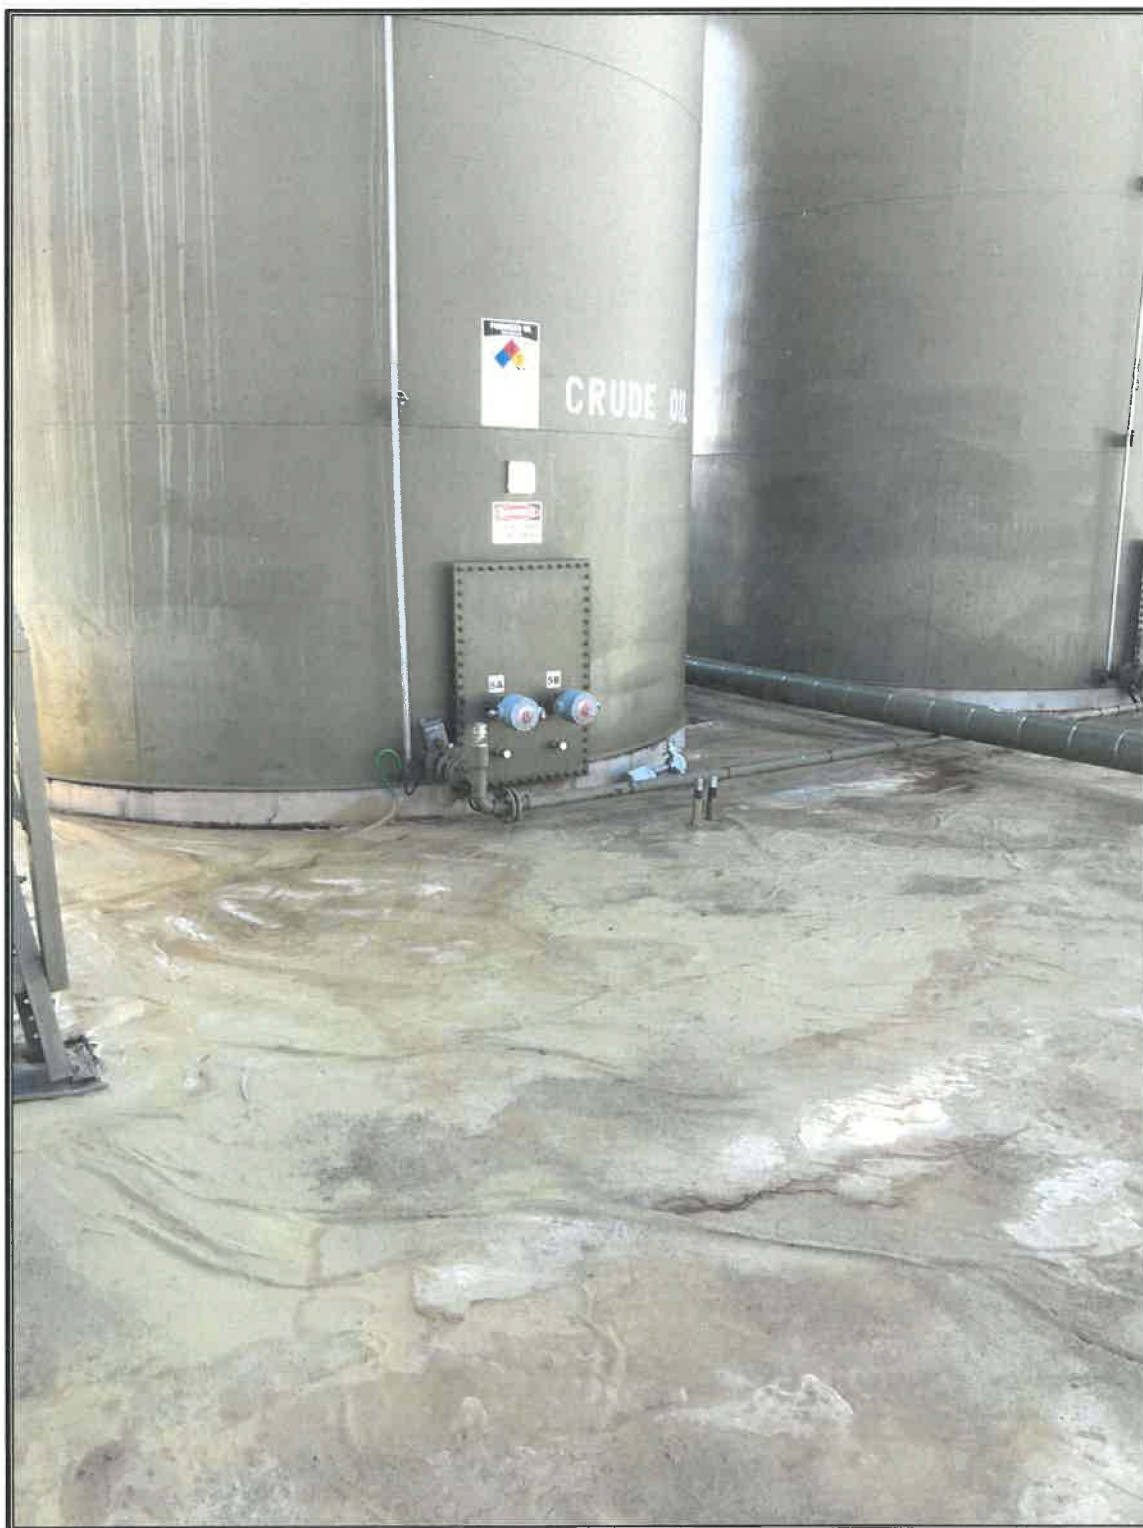
Photo 5: View of Liner after Cleanup (3)

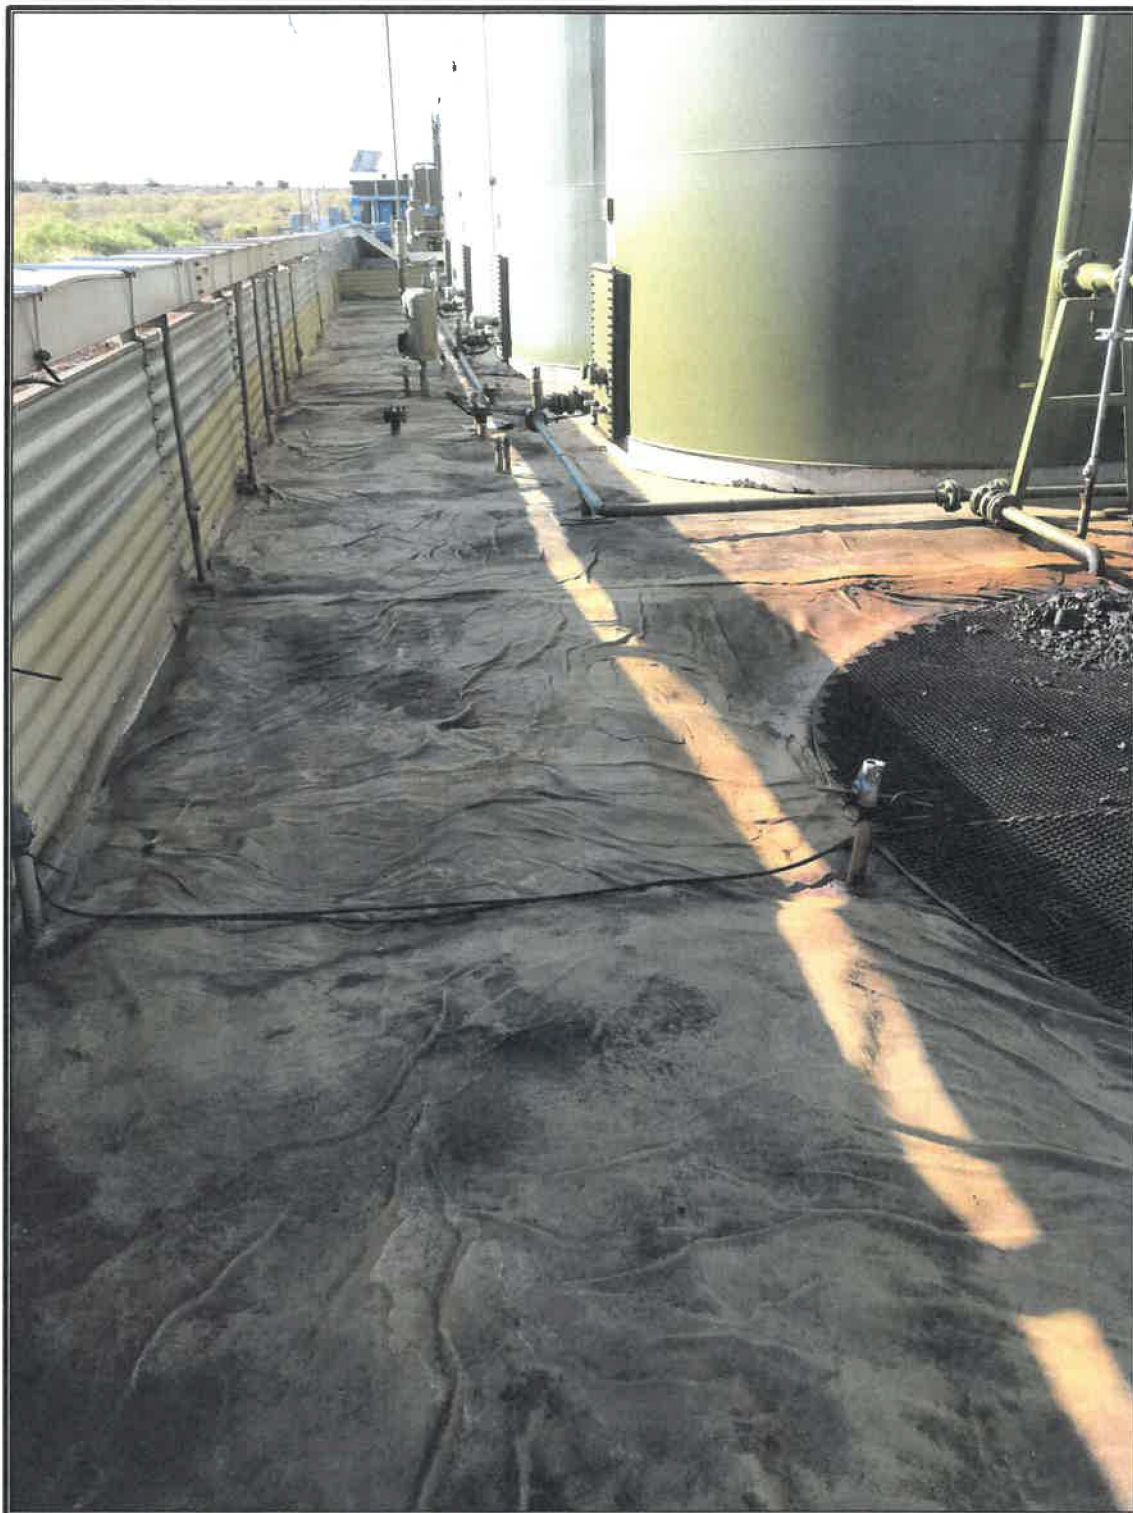
Photo 6: View of Liner after Cleanup (4)
