LINER INSPECTION AND CLOSURE REPORT

Spur Energy Partners
Hearse 36 State Com Battery
Incident ID: NAPP2113945611
Eddy County, NM

Paragon Environmental LLC
1601 N. TURNER ST. STE.500
Hobbs, NM 88240
575-964-7814

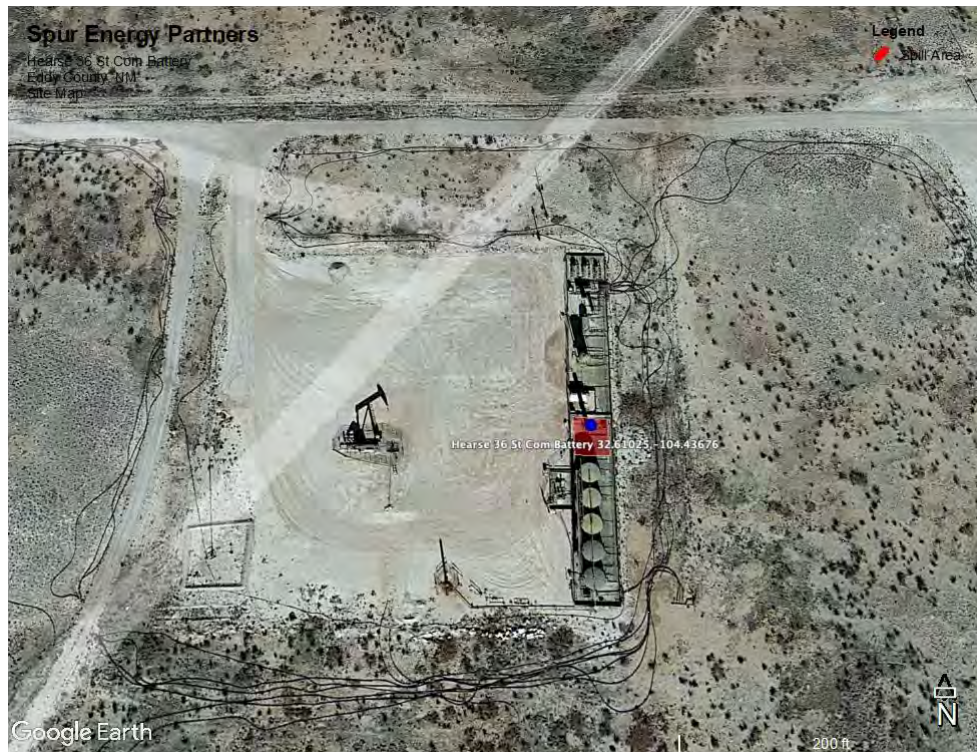
On July 12, 2022, Paragon went to the Hearse and conducted an initial assessment. There was obvious staining on the liner from the spill. There were no signs outside the containment showing no signs that the liner had been breached. Therefore, no samples were taken. See the site map below showing the affected area.

On July 17, 2022, Paragon returned to the site with equipment and personnel to conduct cleanup activities. We initially sprayed the affected area with surface cleaner. We then power washed and squeegeed the runoff to where the vacuum truck could capture the fluids.

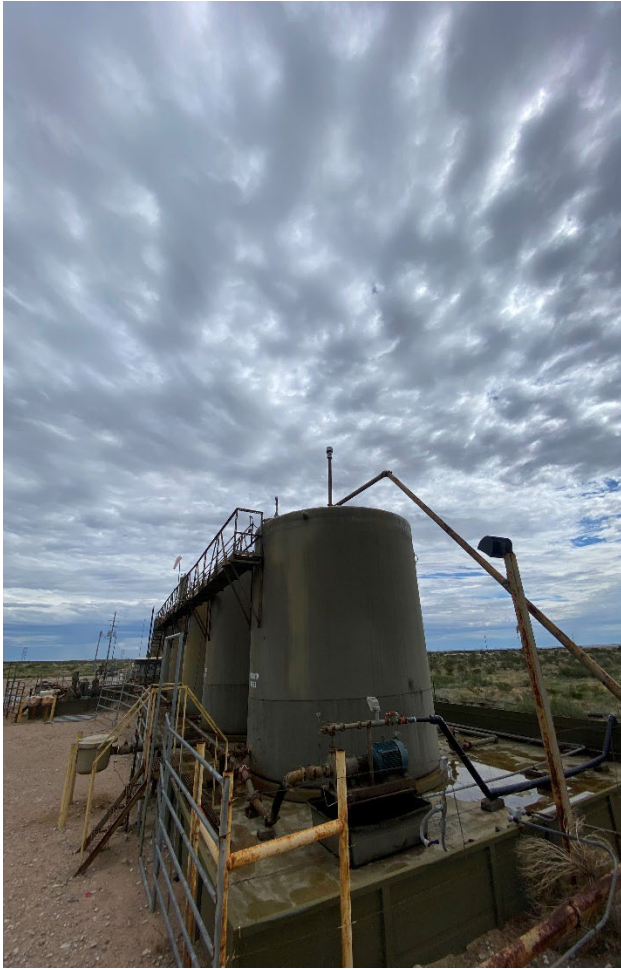
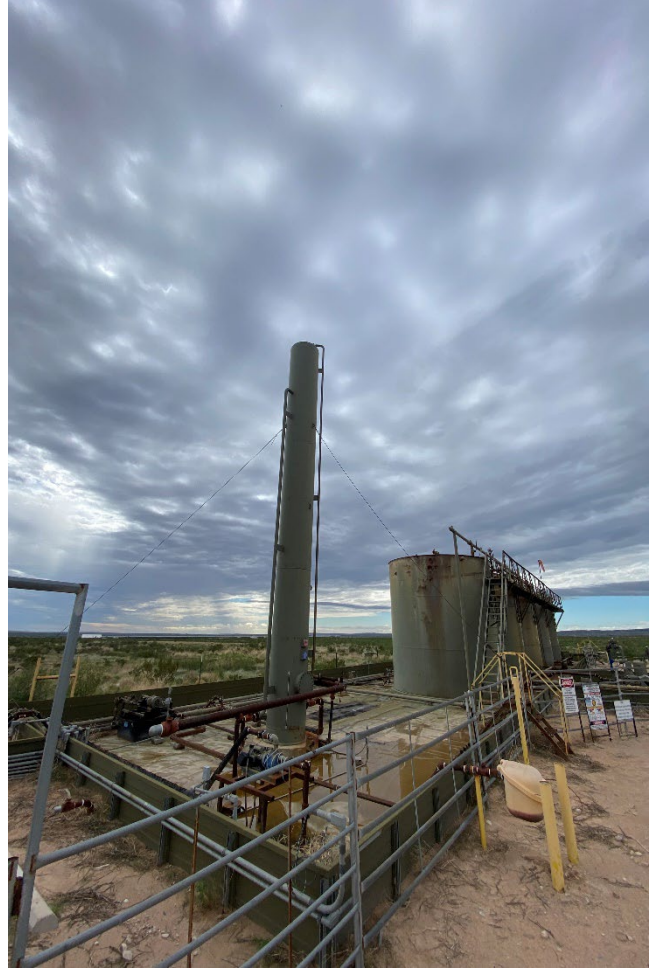
Liner Inspection

On July 20, 2022, Paragon returned to the site to conduct a liner inspection. A 48-hour notification was sent out to the NMOCD on July 18, 2022. The liner inspection concluded that the liner was all intact and in good condition. The integrity of the liner appears to have the ability to contain spills. See Appendix D for the email notification and liner report.

Visualization	Yes	No	Comments
Is there a tear in the liner?		x	
Are there holes in the liner?		x	
Is the liner retaining any fluids?		x	
Does the liner have integrity to contain a leak?	x
